2. Damage caused by the earthquake and tsunami hitting Fukushima NPSs

(1) Seismic ground motion and tsunami height observed at Fukushima Dai-ichi NPS

(2) Seismic ground motion and tsunami observed at Fukushima Dai-ni NPS

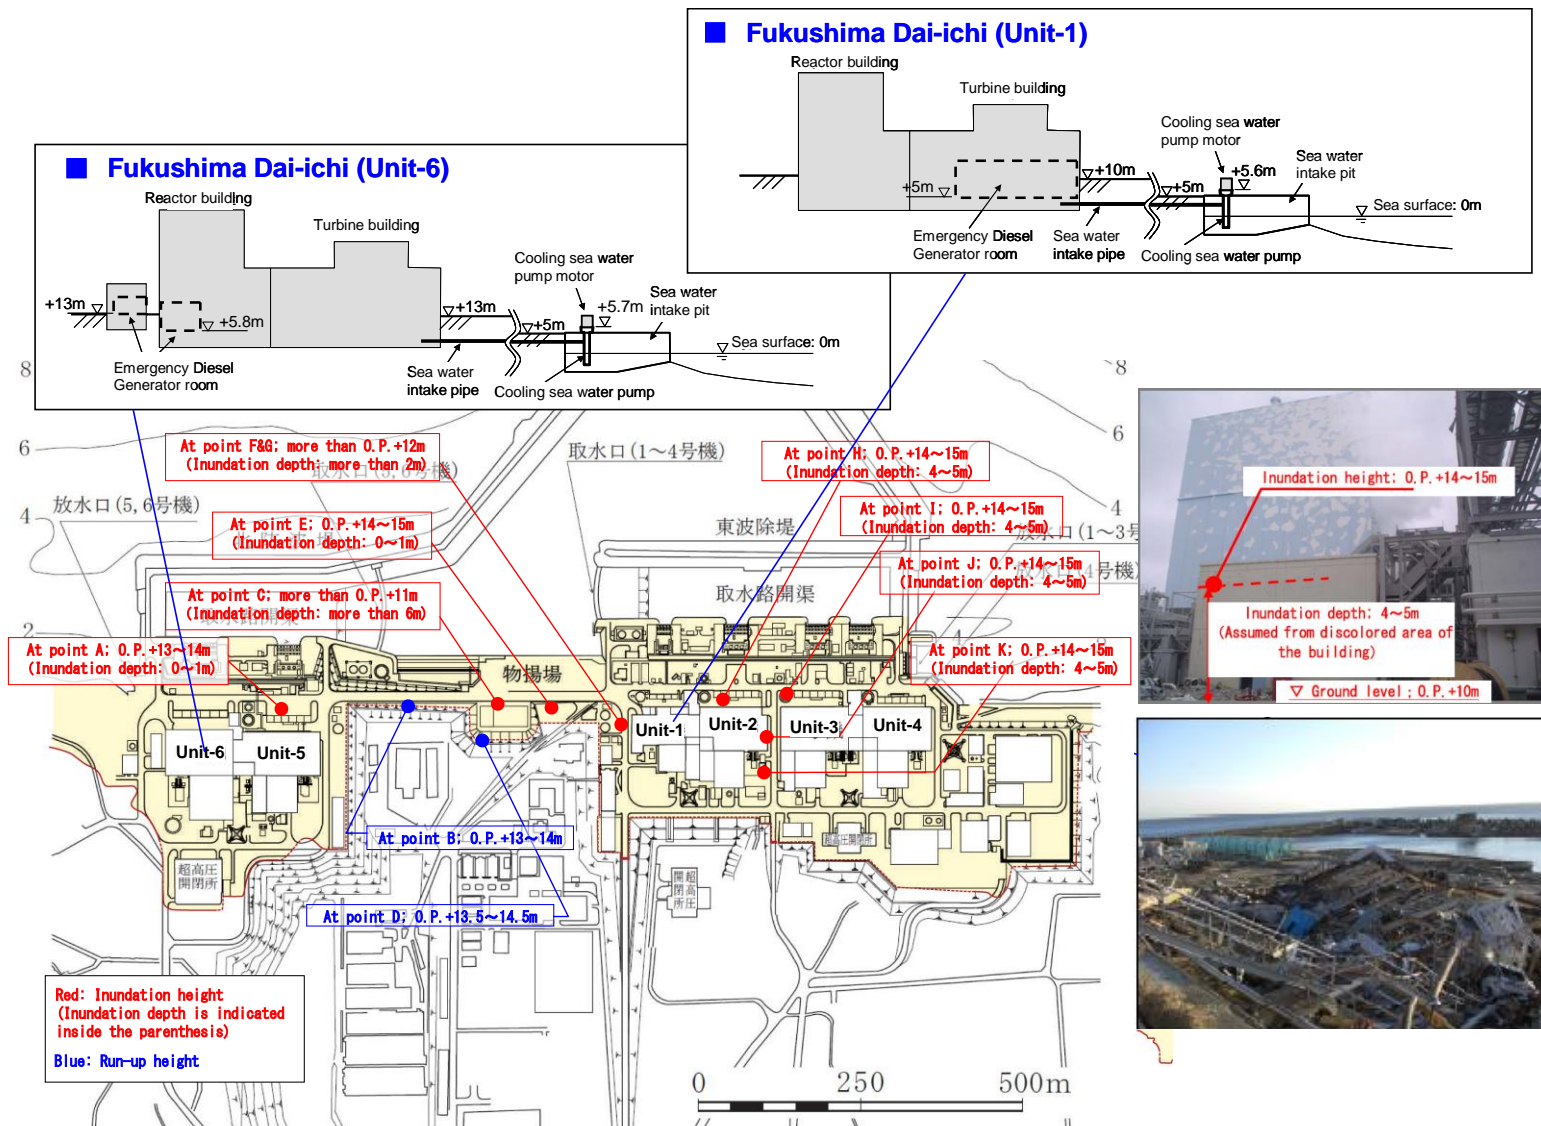
Fig. III-2-4(a) Damage of Fukushima Dai-ichi NPS due to the tsunami.

The site height of Fukushima Dai-ichi NPS is 10 m at Units 1 to 4, and 13 m at Units 5 and 6. At Fukushima Dai-ichi NPS, tsunami rushed from the offshore area in front of the site, and most part of the site where main buildings were placed was flooded. TEPCO reported about the flood height based on the results of trace investigation at flooding. The results of the report are shown in Figure III-2-4. The flood height of the ocean-side site such as reactor buildings of Units 1 to 4, turbine buildings, etc. is O.P. approximately +14 to 15 m at points H to K in the Figure(O.P.: Onahama Port base tide level for construction). Experts estimate that the water level of the tsunami caused by this earthquake is more than 10 m from the picture (refer to Fig. III-2-5) showing the overflow status of tsunami seawall (10 m) released by TEPCO.

As to the sea water pump facilities for component cooling (height: 5.6 to 6 m) at Fukushima Dai-ichi NPS, all Units were flooded by tsunami as shown in Figure III-2-4.

Whether or not they were damaged by wave power is under investigation. In addition, the Emergency Diesel Generators and switchboards installed in the basement floor of the reactor buildings and the turbine buildings (height: 0 to 5.8 m) were flooded except for Unit 6, and the emergency power source supply was impossible. Regarding Unit 6, two out of three Emergency Diesel Generators were installed in the first basement of the

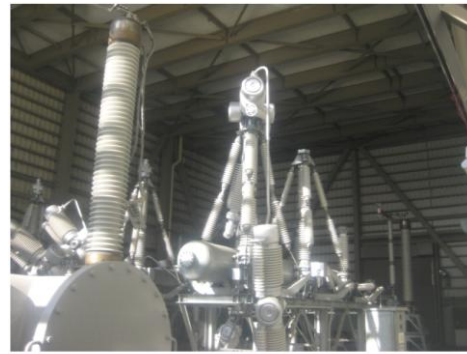
The earthquake caused damage to the breakers of the switchyards of Units 1 and 2. As to TEPCO nuclear line (66 kV) from Tohoku Electric Power, although it's not possible to estimate the cause, cables were damaged. Concerning Units 3 and 4, in addition to the Okuma No. 3 transmission line under construction, the breakers of Nos. 3 and 4 transmission lines on the side of Shin Fukushima Power Substation failed. In addition, about Units 5 and 6, one transmission line tower (No. 27 tower) connecting to the switchyards of Units 5 and 6 was collapsed. So, as a result, although damage caused by tsunami was not clear, all external power supplies of Units 1 to 6 were lost.

**Okuma line 2L (O-81)
Circuit Breaker damaged**

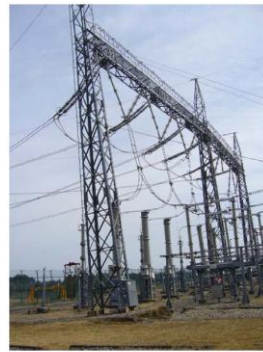
**Okuma line 3L & 4L, Steel
structure for lead-in (tilted)**

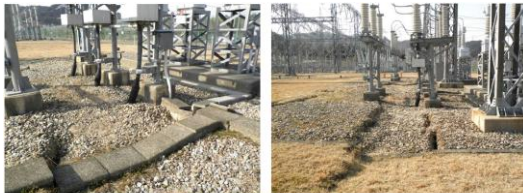
**Yorunomori line, Cable in
substation (subsidence)**

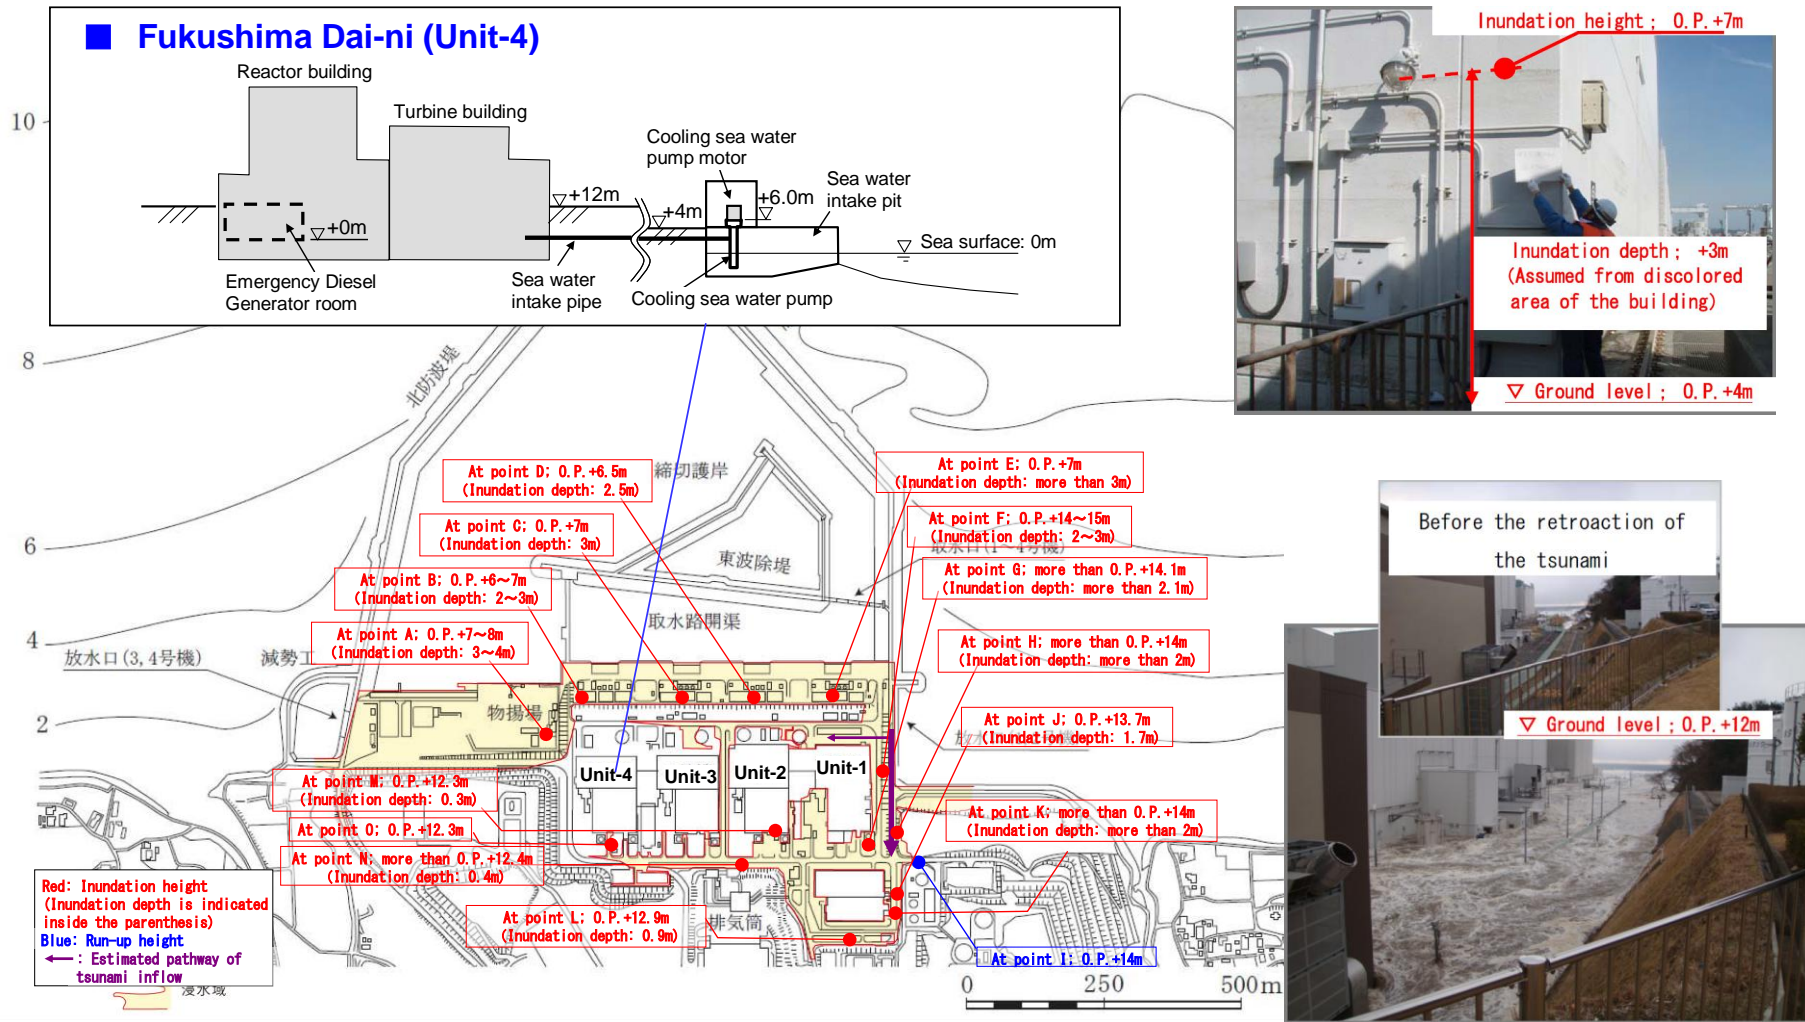
Fig. III-2-11(a) Damage of Fukushima Dai-ni NPS due to the tsunami.

TEPCO reported about the flood height based on the results of trace investigation at flooding as well as Fukushima Dai-ichi NPS previously mentioned in section 2.(1). Figure III-2-11(a) shows the report results. Fukushima Dai-ni NPS consists of the ocean-side area where seawater pumps, etc. are installed and the raised mountain-side area where reactor buildings, turbine buildings, etc. are installed. Tsunami at first flooded

from the ocean-side area in front of the site. Afterward, as shown in the Figure, tsunami flooded from the narrow space between the south side of Unit 1 and the slope in the mountain-side area, and reached the back of the mountain-side area. There was no flooding except from the narrow place. The flood height in the ocean-side area was O.P. approximately +6.5 to 7 m, and O.P. approximately +14 to 15 m in the mountain-side area where O.P. means base level of Onahama Port construction).

The sea water pump facilities for component cooling of all Units (height: 6 m) were flooded by tsunami except Unit 3, which was not flooded and kept its function.

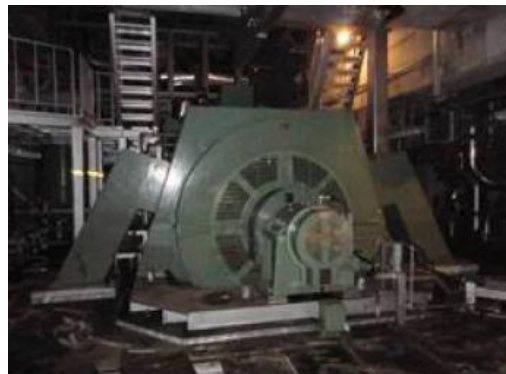
Fig. III-2-11(b) Damage of Fukushima Dai-ni NPS due to the tsunami.

The Emergency Diesel Generator installed in the basement of the reactor buildings (height: 0 m) kept its function for Unit 3 and 4, however, it for the other Units lost its function by completely flooding (Fig. III-2-11(b)).

Damages of reactor building and emergency diesel generator (Unit 1)
