3. Seismic and tsunami damage to other NPSs

(1) Seismic ground motion and tsunami height observed at Onagawa NPS

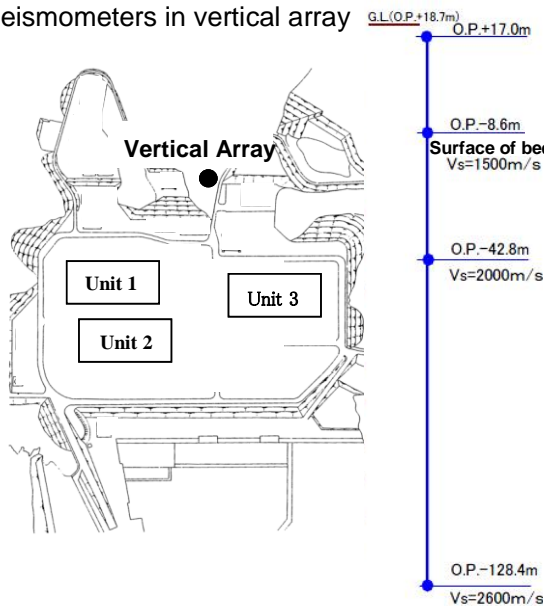
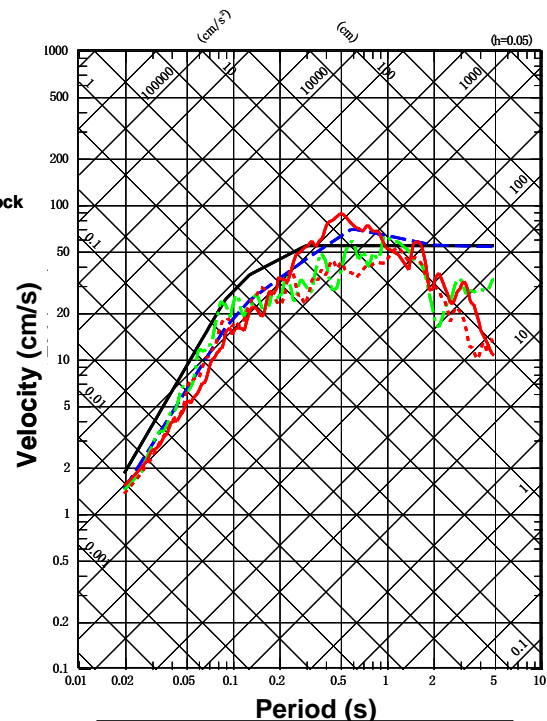
Fig. III-3-1 Deployment of seismometers and comparison of observed response spectra with the DBGM Ss on a free surface (equivalent to the base stratum) at Onagawa NPS.

Figure III-3-1 shows a comparison between response spectra of the observed seismic ground motions at the upper part of the bedrock on the site and response spectra for the standard seismic ground motion Ss. Response spectra of the observed seismic ground motions exceed response spectra for the standard seismic ground motion Ss in the periodic band between 0.2 and 1.0 sec.

Response spectra observed on the position corresponding to the surface of the base stratum exceeded response spectra of the standard seismic ground motion S_s in a certain periodic band.

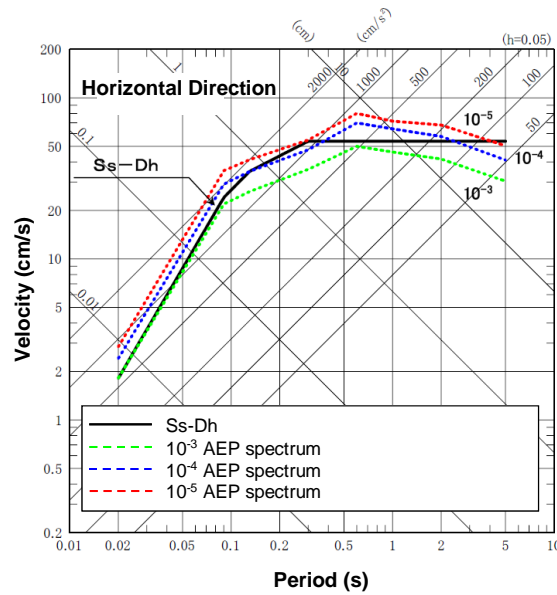
Fig. III-3-2 Annual exceedance probability (AEP) of DBGM Ss for Onagawa NPS.

Figure III-3-2 shows the evaluation of the annual exceedance probability of DBGMSs for Onagawa NPS. Response spectra for Ss-Dh are also shown in the figure. The exceedance probability for Ss is between 10^{-3} and 10^{-5} per year.

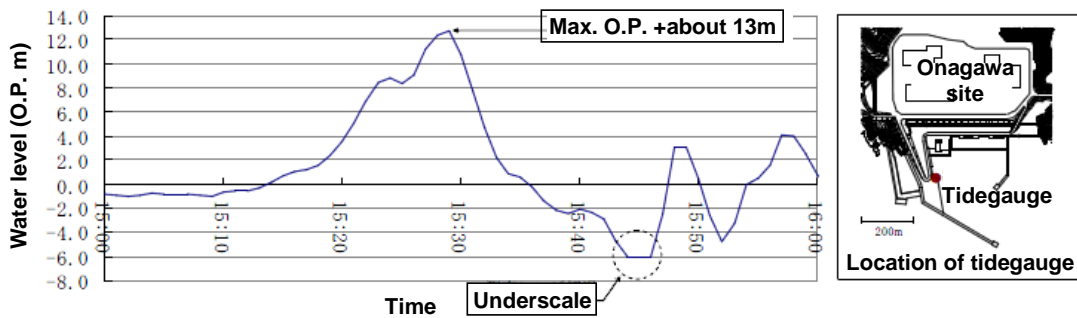
Fig. III-3-3 Time history of water level changes observed at Onagawa NPS.

Figure III-3-3 shows the tsunami time history recorded by the tide gauge. From the record, it can be seen that the first big wave arrived at about 15:29 (43 min after the main shock). The observed tsunami height was about 13 m relative to O.P. (O. P.: the reference surface for construction of Onagawa NPS), which did not exceed the height of the site, i.e. 13.8 m relative to O.P. (the real height of the site is 14.8 m, adjusted to sinking by about 1 m due to crustal deformation, according to the Geographical Survey Institute QE, see Figure III-3-4). Although seawater was found to have entered the sea-facing side of the site, it did not reach the major buildings.

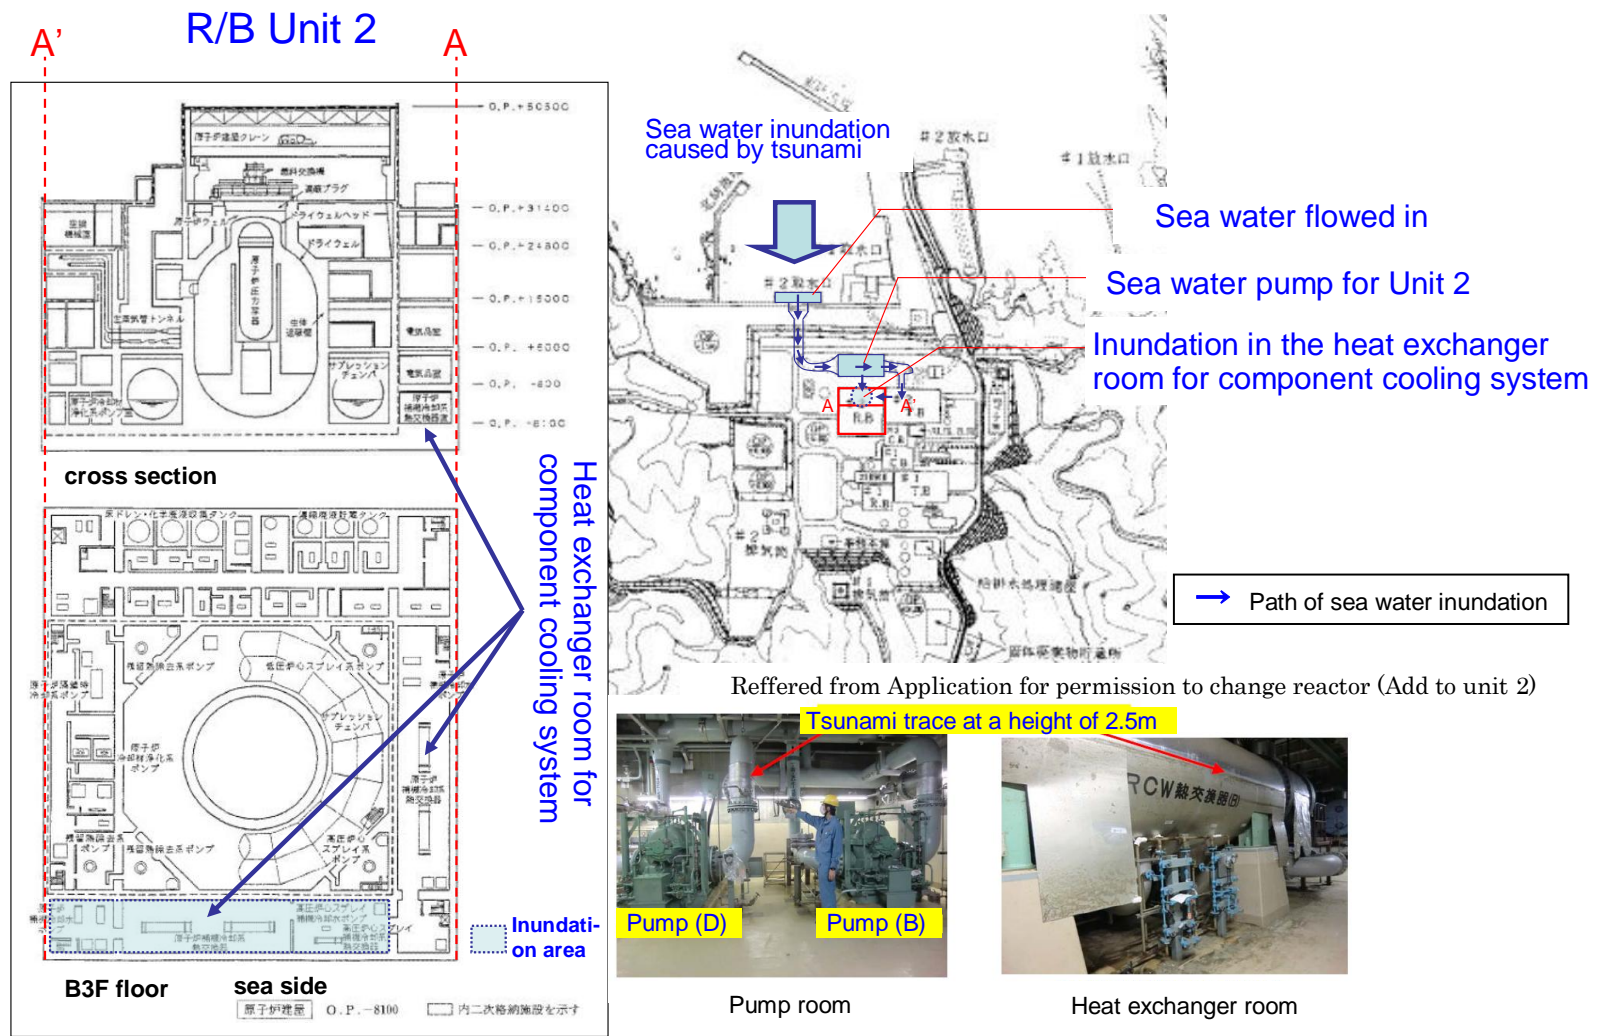
Fig. III-3-5(a) Inundation in the heat exchanger room for a component cooling system (1) at Onagawa NPS.

Figure III-3-5(a) and Figure III-3-5(b) show the layout of intake channel, seawater pump, seawater pump room, and heat exchanger room of the component cooling system. As shown in the figure, the seawater pump room is located on the higher site, which is 14.8 m high, about 100 m away from the coast, and is structurally designed to prevent being submerged by a run-up tsunami. Inside the room, the tide gauge is installed with an opening. This tide gauge is designed to allow the automatic stop of the seawater pump in short of seawater due to the backrush of a tsunami.

The observed tsunami height was 13 m, and despite the land sinking, the tsunami did not cause the seawater pump room (on the site as high as 13.8 m, adjusted to sinking by about 1 m) to be directly submerged. However, as the water level rose due to the tsunami, the water level in the underground intake pit also rose as shown in Figure III-3-5, caused by the siphon phenomenon. This resulted in seawater overflowing through the opening of the tide gauge into the seawater pump room. Then the seawater flowed from the pump room, via the trench, into the basement floors of the reactor buildings, causing the heat exchanger room of the component cooling water system in the second basement to be submerged. In addition, the component cooling water pump of Unit 2 was also submerged, which thereby caused the cooling function of emergency diesel generators to be lost, with two units stopped out of those three generators.

[Inundation pathway to Heat exchanger (B) room for component cooling system]

Tohoku Electric Power Company Inc. took measures to prevent the piping penetrations and the cable tray penetrations from the seawater pump room to the trench from being submerged. They stated that the company would remove the water gauge in the seawater pump room and relocate it to an improved area to prevent exposure to water, and they would also set up a flood barrier around the seawater pump room.

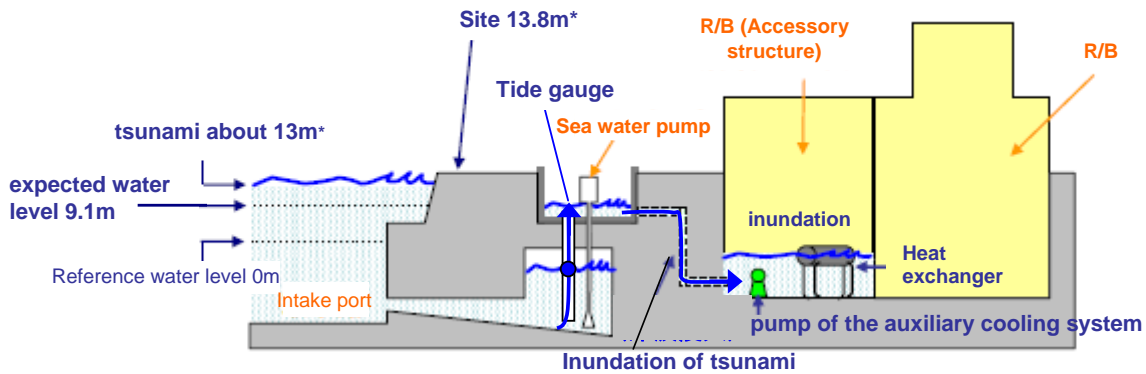
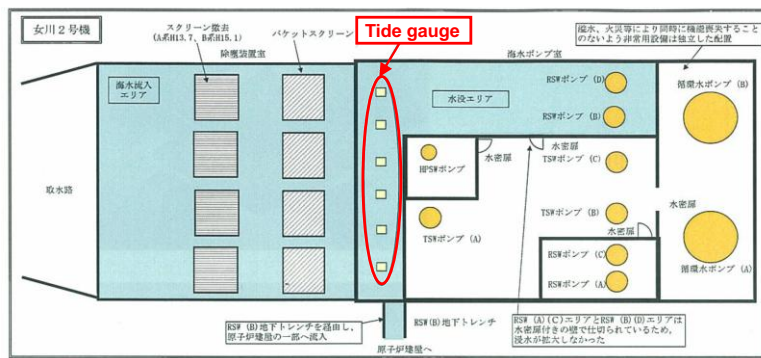
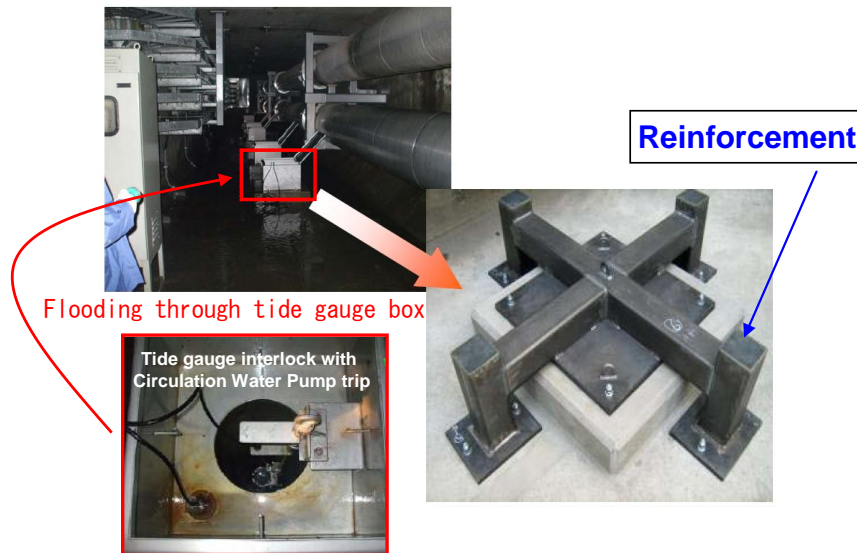
Fig. III-3-5(b) Inundation in the heat exchanger room for component cooling system (2) at Onagawa NPS.

[Installation position of tide gauge interlock with Unit 2 Circulation Water Pump trip]

[Tsunami countermeasure for tide gauge]

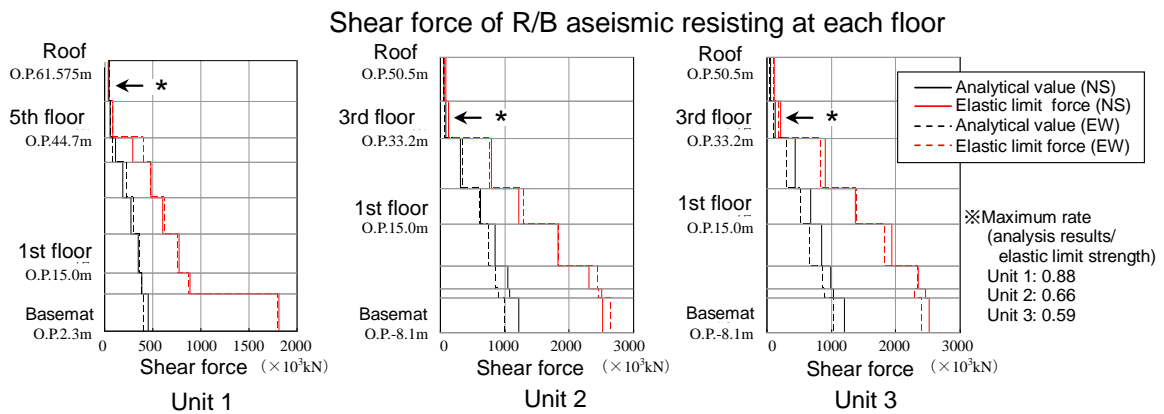
Fig. III-3-6 Verification of shear strain and shear force acted on seismic walls at each floor in R/Bs of Onagawa NPS.

Tohoku Electric Power Company conducted an integrity assessment of the reactor buildings, based on the same procedures as the integrity assessment for the building structure of the Kashiwazaki-Kariwa Nuclear Power Station after the Chuetsu-oki Earthquake in July 2007. The response analyses on the reactor buildings of Units 1 to 3 were made with the observed acceleration records as the input of seismic ground motion. Figure III-3-6 shows the shear strain and shear force at the building by floor for each Unit. It can be seen that shear strain at each floor was below the JEAG4681-2008

evaluation criteria (2.0×10^{-3}), and shear force was also below the elasticity limit. A ratio between the evaluation criteria and shear strain results at each floor was around 2.5 to 5.6.

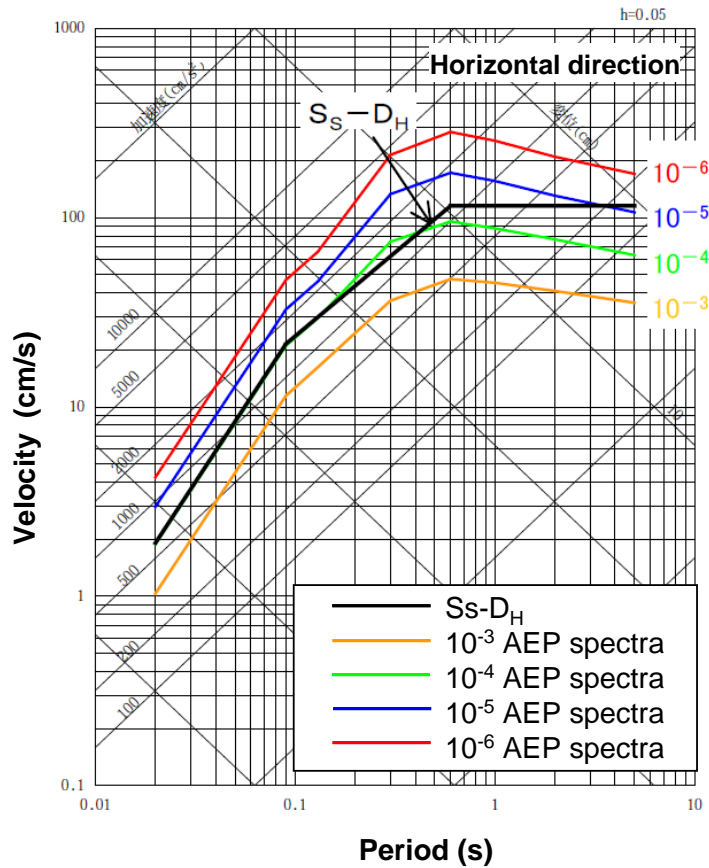
Fig. III-3-7 Annual exceedance probability (AEP) of DBGM Ss for Tokai Dai-ni NPS.

Figure III-3-7 shows the evaluation of the annual exceedance probability of DBGM Ss for Tokai Dai-ni NPS. Response spectra for Ss-D_H are also shown here. It can be seen that the exceedance probability for standard seismic ground motion Ss is approximately between 10^{-4} and 10^{-5} per year.

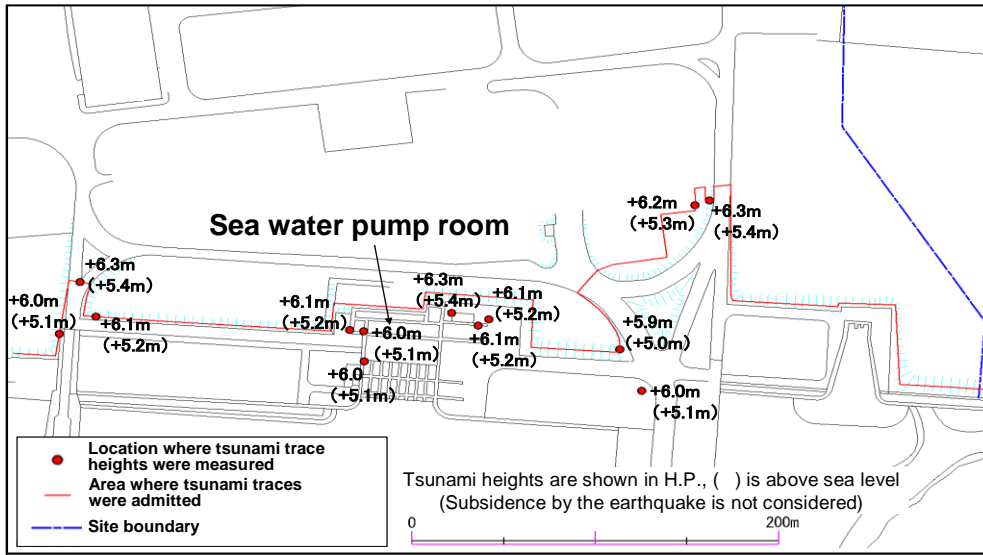
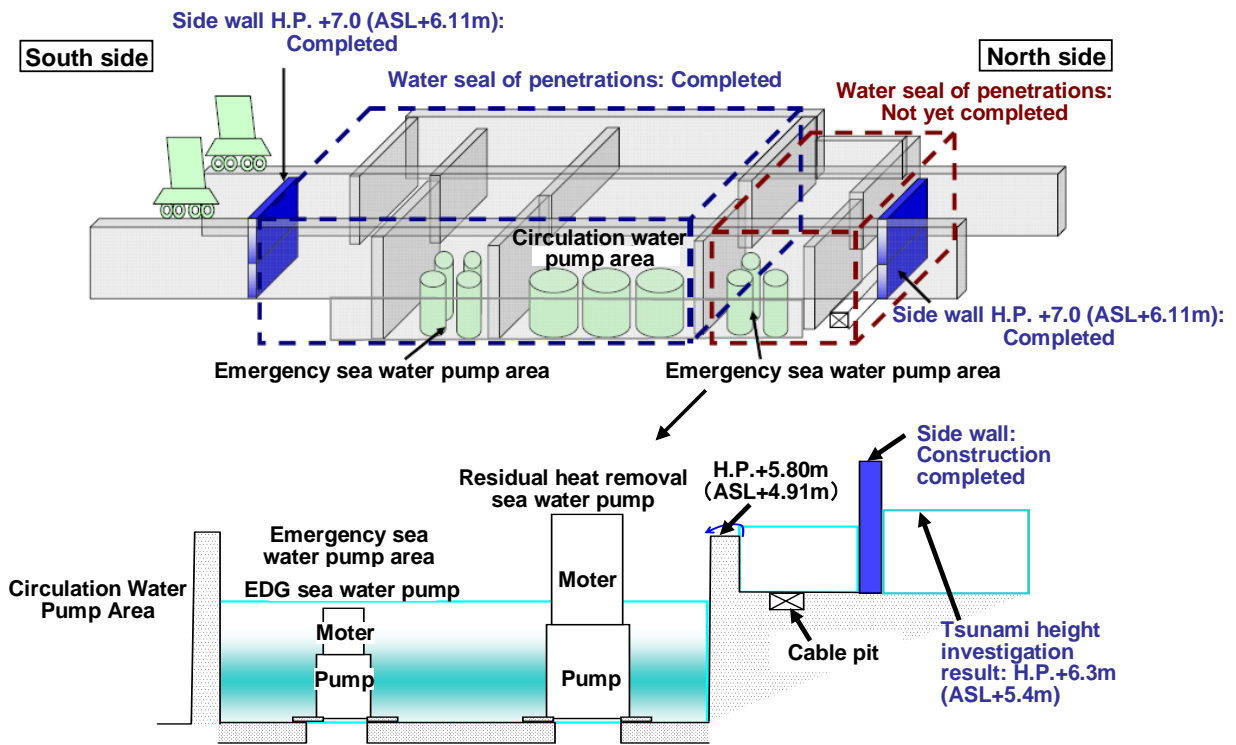
Fig. III-3-8 Map of the areas with tsunami traces identified at Tokai Dai-ni NPS.

Japan Atomic Power Co. has been surveying traces of how high the tsunami ran up on the NPS site. The results are shown in Figure III-3-8. The tsunami marked traces as high as H.P. + 5.9 m (5.0 m above sea level, H.P.: the reference surface for construction of Hitachi Port) to H.P. +6.3 m (5.4 m above sea level, provisional). Based on these findings, the height of the run-up tsunami was estimated to be approximately H.P. +6.3 m (5.4 m above sea level, provisional). The tsunami did not reach H.P. +8.9 m (8 m above sea level), on which the major buildings are located.

The tsunami flooded the north emergency seawater pump area in the seawater pump room, as shown in Figure III-3-8. Consequently one of three seawater pumps for emergency diesel generators was submerged, and one of three emergency diesel generators stopped. Meanwhile, the other two emergency diesel generators were able to operate, successfully ensuring emergency power supply.

When the earthquake hit the site, the north emergency seawater pump room was under leveling construction of its sidewall as protection against tsunami (H.P. +5.8 m, 4.9 m above sea level). This construction work put in place a new sidewall up to H.P. +7.0 m (6.1 m above sea level) outside the existing sidewall, but the waterproof sealing of the penetration (small holes for electric cables, etc.) of the wall had not been completed, and as a result the seawater came through the small holes into the pump room.

The height of the run-up tsunami was approximately H.P. +6.3 m (5.4 m above sea level), not going beyond the new sidewall, which was as high as H.P. +7.0 m (6.1 m above sea level).
