## 6. Situation at Other Nuclear Power Stations

## 7. Evaluation of accident consequences

### (1) Causes of the accident at the Fukushima-Daiichi Nuclear Power Station

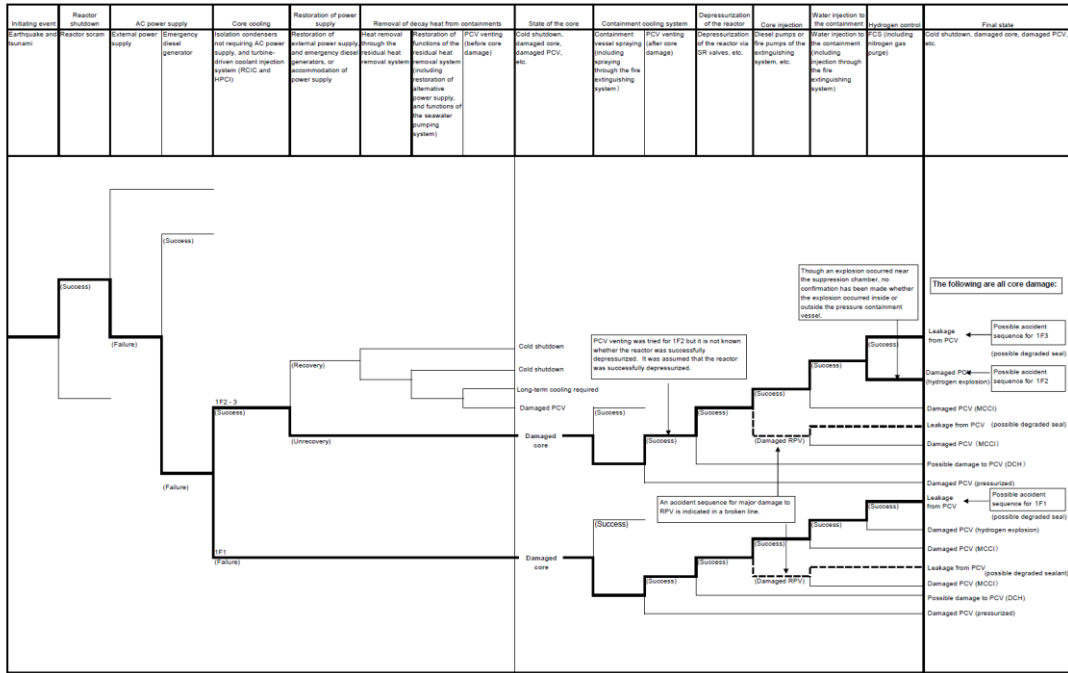
Figure IV-7-1 Function Event Tree of Unit 1 to Unit 3 at Fukushima-Dai-ichi NPS

This accident resulted in serious core damage in Units 1 through 3 of Fukushima-Daiichi NPS. But Units 5 and 6 of Fukushima-Daiichi NPS and Units 1 through 4 of Fukushima-Daini NPS succeeded in cold shutdown without causing core damage. If any disturbance occurs in a plant during power operation, such as an event of loss of off-site power supply, the following three functions are required to shift the plant into the cold shutdown state; reactor sub-criticality maintenance, core cooling, and removal of decay heat from PCV. Figures IV-7-1 through IV-7-3 show function event trees indicating event sequences these plants followed. These function event trees develop event sequences headed by main functions, such as reactor sub-criticality maintenance, core cooling, removal of decay heat

from PCV, AC power, water injection to PCV, and hydrogen control, which were caused by the earthquake and accompanying tsunami and are considered to have seriously affected the progress of events before and after core damage. Estimated event sequences of this accident are shown by thick lines. Based on the above-mentioned event sequences, whether or not a unit suffered from core damage in this accident was mainly estimated by the following events:

- a) AC power was not recovered early because:
  - it was impossible to interchange electricity because of simultaneous loss of AC power for neighboring units,
  - metal-clad switchgear and other accessory equipment were inundated due to tsunami, and
  - off-site power supply and emergency DG was not recovered early.
- b) Due to accident management carried out at the time of total AC power loss, core cooling was maintained for some time but was not sustained up until recovery of power supply.
- c) The tsunami caused loss of functions of the system of transporting heat to the sea, which is the ultimate heat sink.
- d) There was no sufficient means to substitute for the function of removing decay heat from PCV.

Figure IV-7-1: Function event tree for units 1, 2 and 3 of Fukushima-Dai-ichi Nuclear Power Station
