INPO 11-005  
November 2011

# **Special Report on the Nuclear Accident at the Fukushima Daichi Nuclear Power Station**

Revision 0

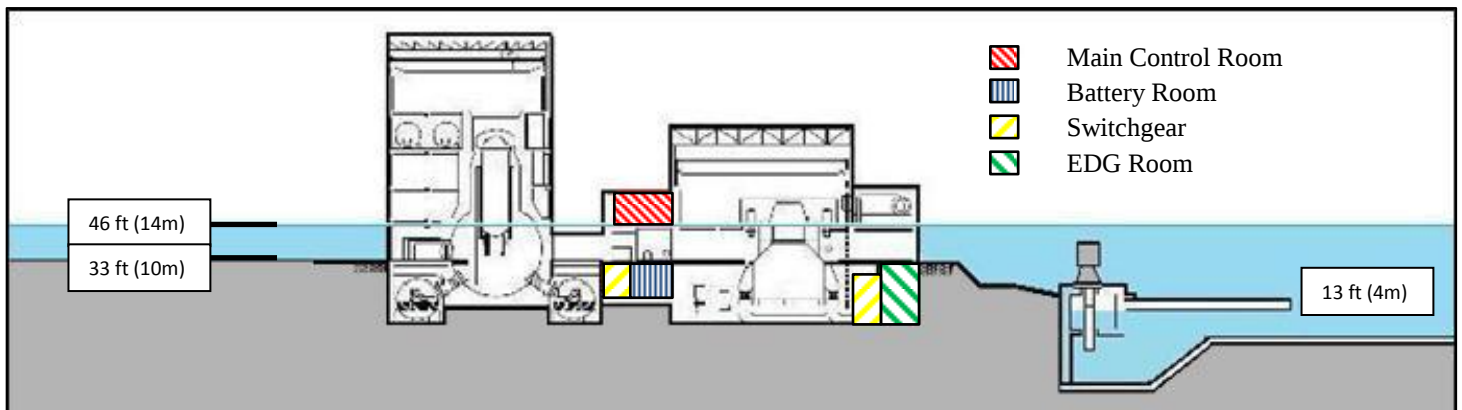
Figure 3.3-1 General Elevations and Inundation Level

The tsunami inundated the area surrounding units 1–4 to a depth of 13 to 16 feet above grade (4 to 5 meters), causing extensive damage to site buildings and flooding of the turbine and reactor buildings. Intake structures at all six units were unavailable because the tsunamis and debris heavily damaged the pumps, strainers, and equipment, and the flooding caused electrical faults. The damage resulted in a loss of the ultimate heat sink for all units. The diesel generators operated for a short time; but by 1541, the combination of a loss of cooling water, flooding of electrical switchgear, and flooding of some of the diesel generator rooms (located in the basement of the turbine buildings and not designed to withstand flooding) caused a loss of all AC power on site for units 1–5. (Refer to Figure 7.4-7.)

Figure 3.3-1 shows the general elevations (typical for units 1–4) and the approximate inundation level. The grade level of units 1–4 is 32.8 feet (10 meters) and is 42.7 feet (13 meters) at units 5 and 6 above mean sea level (commonly referred to as OP, for the level in the Onahama Port). The intake structures were at an elevation of 13.1 feet (4 meters) for all units.

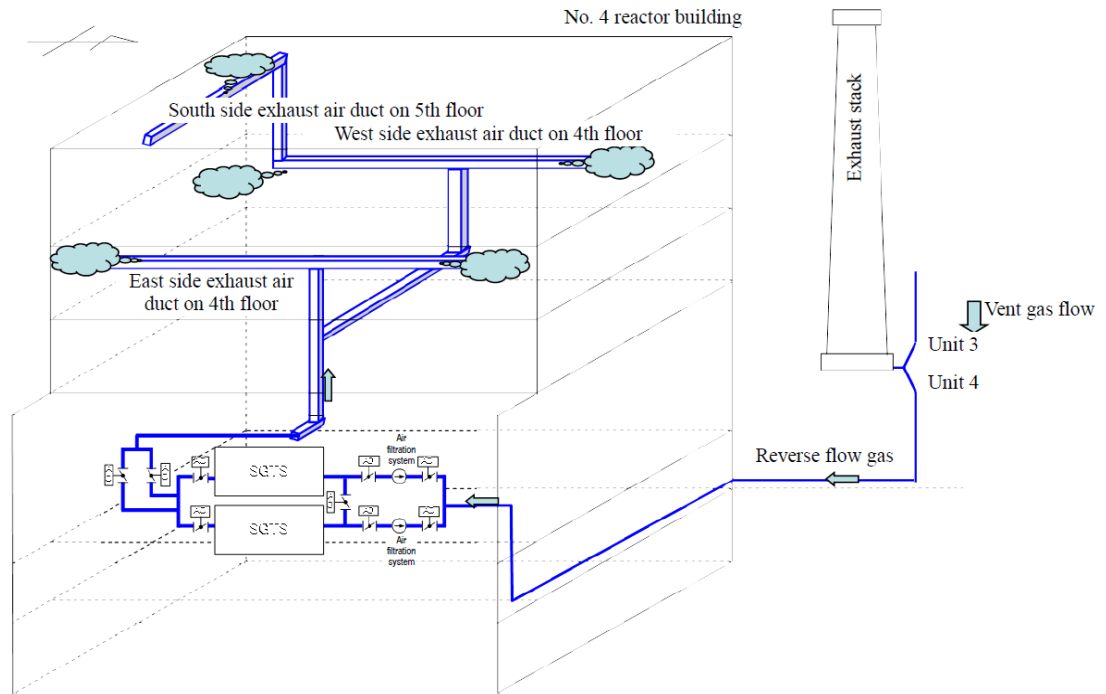
Figure 4.4-1 Unit 4 Standby Gas Treatment System Hydrogen Flow Path

The most widely accepted theory is associated with the backflow of gases from Unit 3 during venting. The containment vent exhaust piping from Unit 3 is connected to the Unit 4 exhaust piping. The dampers on the Unit 4 standby gas treatment system (SGTS) are air-operated and fail open on a loss of power or air (except the cross-connect between SGTS filter trains). Additionally, the system does not have a backflow damper installed in the piping that connects to Unit 3. With no power or air, and no fans in service to direct the gases from Unit 3 up the exhaust stack, the exhaust gases from Unit 3 would be directly aligned to the Unit 4 SGTS filters. This piping arrangement may have allowed

gases from the Unit 3 containment to be vented to the Unit 4 reactor building via reverse flow through the Unit 4 standby gas treatment system.

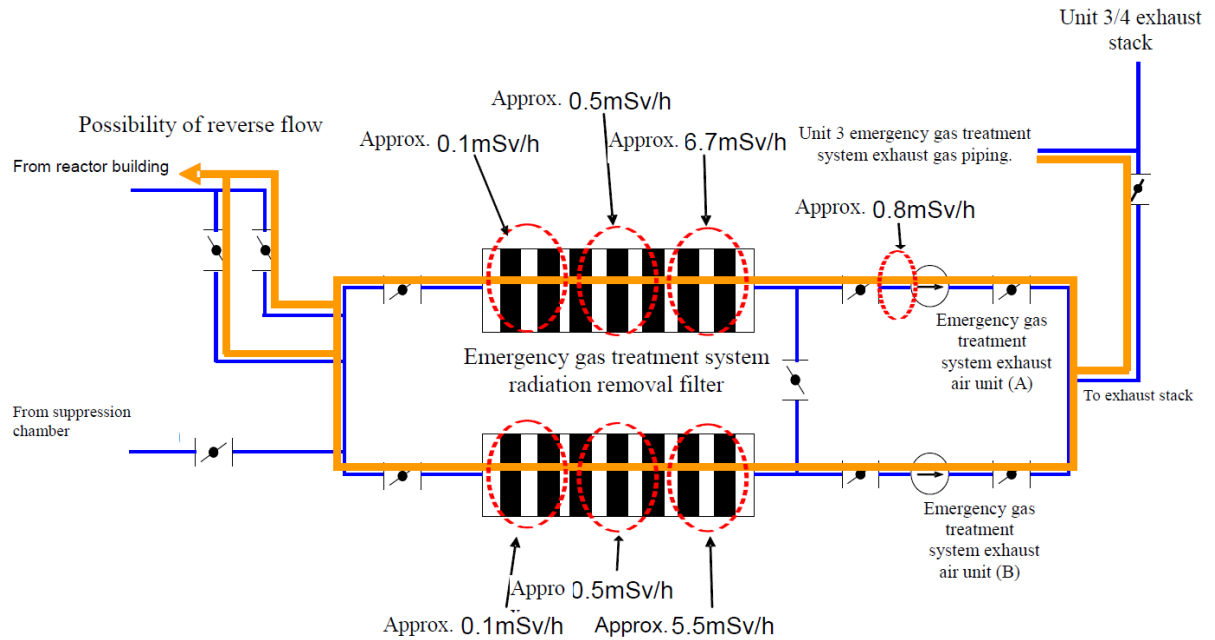
Figure 4.4-2 Unit 4 Standby Gas Treatment System Filter Survey Results

To confirm this theory, on August 25 TEPCO personnel performed radiation surveys on the Unit 4 SGTS filters. The survey results, shown in Figure 4.4-2, revealed higher radiation levels at the locations closer to Unit 3. These survey results support the conclusion that there was backflow from Unit 3 to Unit 4. Further inspections are needed to confirm this theory; but based on this information, it is postulated that the hydrogen explosion in the Unit 4 reactor building was caused by hydrogen from Unit 3.

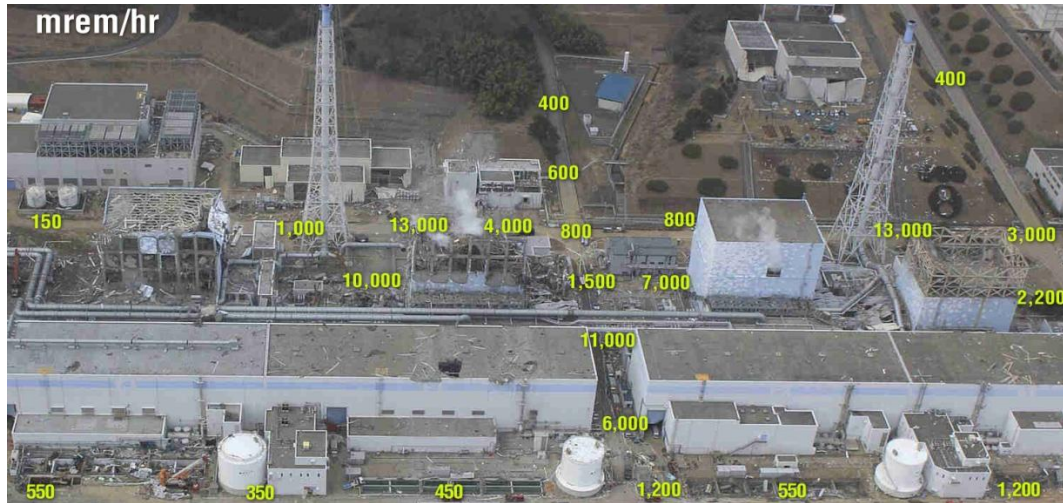
Figure 5.3-1 Site Dose Rates

On March 22 and 23, surveys of the airborne radioactivity and dose rates around the site began to be collected and documented. The dose rates are documented on Figure 5.3-1. Localized dose rates as high as 1,000 rem/hr (10 Sv/hr) were later discovered.

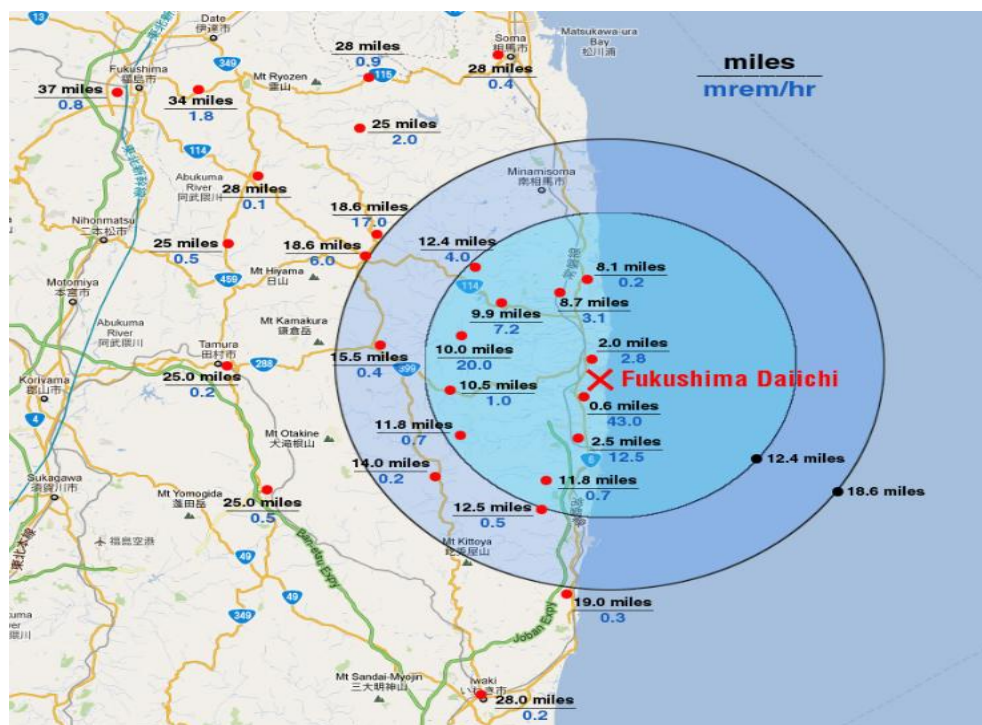
Figure 5.4-1 Initial Off-Site Survey Results

Routine dose rate surveys began to be collected in the area outside the 12.4 mile (20 km) radius of the plant on March 16. The highest dose rate of 17 mrem/hr (0.17 mSv) was measured 19 miles (30.5 km) northwest of the station. The first air samples from the site boundary, on March 22 and 23, had iodine-131 concentrations that were equivalent to approximately 80 mrem (0.8 mSv) of thyroid dose each hour if inhaled by an unprotected individual. The concentration remained between 25 and 200 percent of this value until April 18, 2011. Surveys inside 12.4 miles (20 km) began on March 30. The map shown in Figure 5.4-1, which was created based on survey results, is representative of these initial surveys.

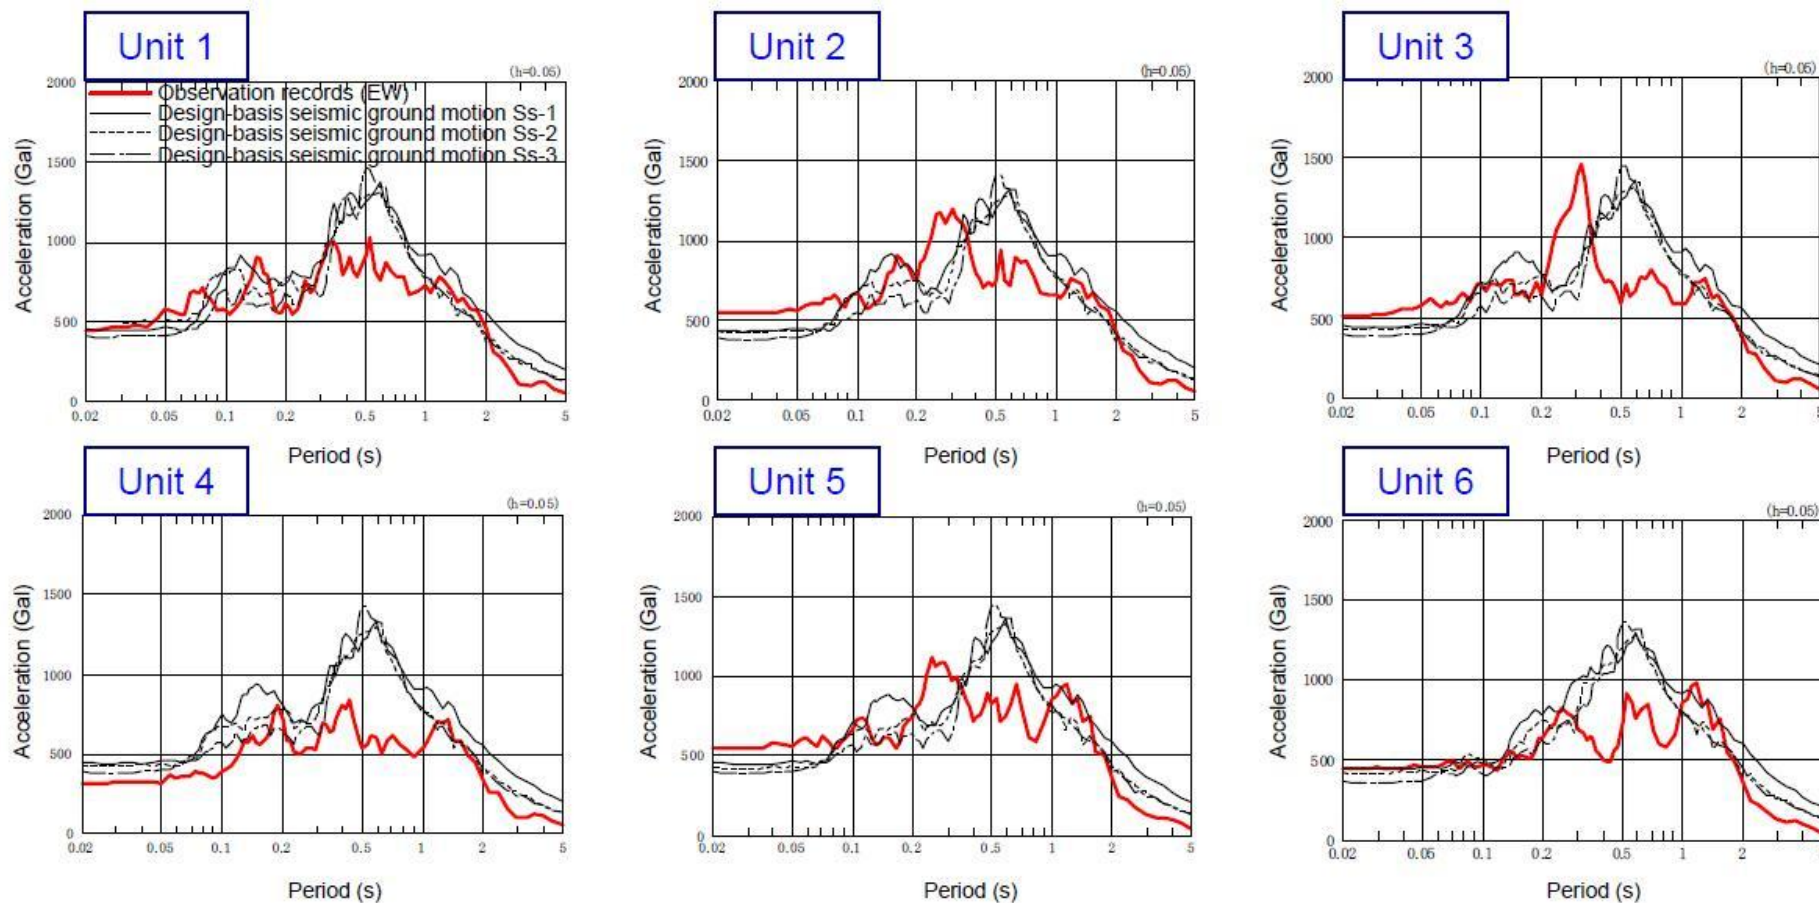
Figure 7.1-1 Preliminary Seismic Data

While no formal seismic walkdowns have been performed, a review of plant indications and operator logs does not indicate any seismic damage that affected the operator response to the earthquake. Before the tsunami, all emergency diesel generators that were operable started and loaded as expected, and each emergency core cooling system the operators used appeared to function as designed. Reactor pressure, reactor water level, and containment pressure indications for units 1, 2, and 3 appeared as expected following a scram and did not indicate any potential breach of the reactor coolant system from the earthquake.

Graphs indicate the observed values as compared to the design basis seismic criteria.
