Microstructural Analysis Of The Steels From Buildings 7, & 1 or 2 From The World Trade Center

R. R. Biederman,* Erin M. Sullivan,* George F. Vander Voort** and R. D. Sisson, Jr.,*

*Materials Science & Engineering Program, Mechanical Engineering Department, Worcester Polytechnic Institute, Worcester, MA 01609-2280

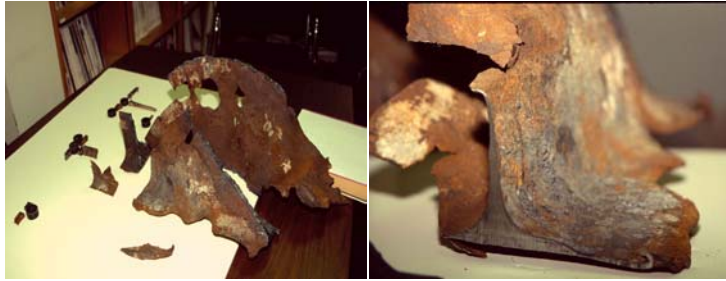
Several samples from Buildings 7, and 1 or 2 of the World Trade Center were collected during the FEMA forensic investigation shortly after September 11, 2001. Macroscopically these samples revealed severe “erosion” of the steel beam thickness from 1/2 inch to total metal loss in some regions, as well as localized plastic deformation. We were asked to determine the cause of this “erosion” as well as the temperature that the steel experienced. Figure 1 shows typical examples of the severe erosion that occurred in the beam.

FIG. 1. Severely Eroded 1/2 inch wide flange beam from WTC 7.

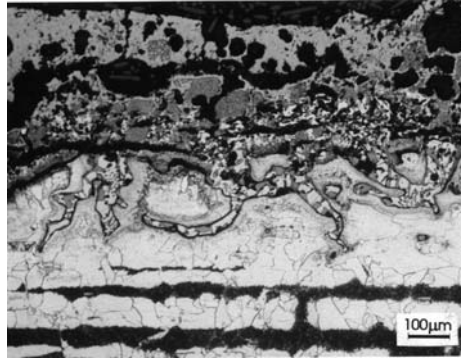
A microstructural analysis of these steel samples has been completed. In Building 7, the structural steel was A36. Figure 2 shows the near surface microstructural changes that occurred in the steel.

The as-fabricated microstructure consisted of a hot worked banded structure of ferrite and pearlite. In severely “eroded” regions where the thickness had been reduced to less than a 1/16 of an inch significant decarburization was observed. In addition, some pearlite bands presented regions that had re-austenitized as well as regions where the pearlite had started to spheroidize. These observations indicate that steel had experienced temperature between 550 and 850°C.

An examination of the “slag” that formed on the surface of the steel found iron oxides and iron sulfides. It appeared that the “slag” was liquid at high temperature and easily attacked the grain boundaries. A eutectic microstructure was seen within the “slag” of iron oxides and iron sulfides. If these compounds were pure Wustite (FeO) and Iron sulfide (FeS), the eutectic temperature is 940°C. It appears that the severe “erosion” was due to the sulfidation and oxidation (i.e. hot corrosion) of the steel followed by the liquid “slag” attack of the grain boundaries.

FIG. 2. Near surface oxidation and intergranular sulfidation.

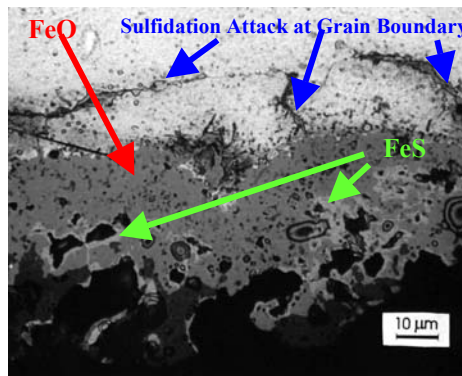
A sample from either Building 1 or 2 presented similar macroscopic observations. In these buildings, the steel was a High Strength Low Alloy Steel (HSLA). The microstructure revealed somewhat different phase distributions. This steel contained less carbon and an alloy addition of copper. The “slag” while comprised of both iron oxides and iron sulfides presented a significantly different microstructure near the surface as shown in Figure 3.

FIG. 3. Surface reaction region in WTC 1 or 2 column member.

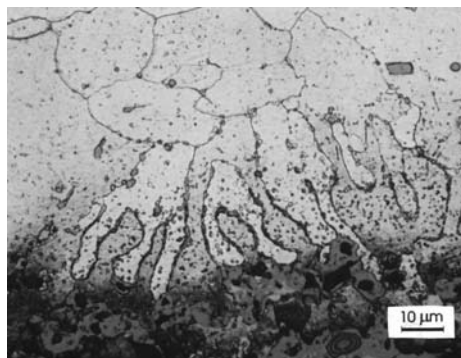
Evidence of grain boundary attack by sulfidation is clearly visible. A gradient in sulfur concentration inward from the surface is shown in Figure 4. The internal sulfides appeared to interact with the penetration of this liquid “slag.”

FIG. 4. Hot Corrosion in WTC 1 or 2 steel.
