Service Bulletin

4 - STROKE GS/GSX/GSX-R BULLETIN NO. 147 DATE: 1/25/2006

SUBJECT: SECONDARY THROTTLE VALVE ACTUATOR (STVA) REASSEMBLY

AFFECTED UNITS: GSX-R1000K1, EARLY GSX-R750K2, EARLY GSX-R1000K2

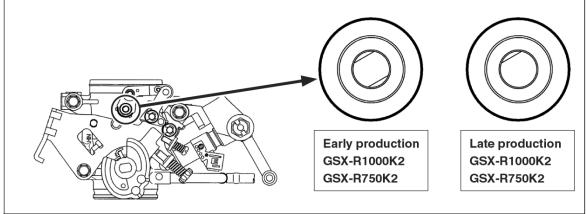
IDENTIFICATION of GSX-R1000K2 & GSX-R750K2 EARLY and LATE THROTTLE BODY DESIGN Applicable throttle bodies can be identified by checking the secondary throttle valve shaft end face. The

STV shaft end was changed from the middle of K2 model assembling. The modified shaft end shape prevents installing the STV upside down.
