THIS IS A REFORMATTED VERSION OF
THE ORIGINAL APPENDICES TO THE
REPORT ON
ACCIDENT TO
VISCOUNT 803 AIRCRAFT EI-AOM
NEAR TUSKAR ROCK, CO. WEXFORD
ON 24th MARCH, 1968
APPENDICES TO THE REPORT ON AN INVESTIGATION
MADE UNDER REGULATION 7 OF THE
AIR NAVIGATION (INVESTIGATION OF ACCIDENTS)
REGULATIONS, 1957 (S.I. No. 19 of 1957)

Appendix 1

"OPERATION TUSKAR"

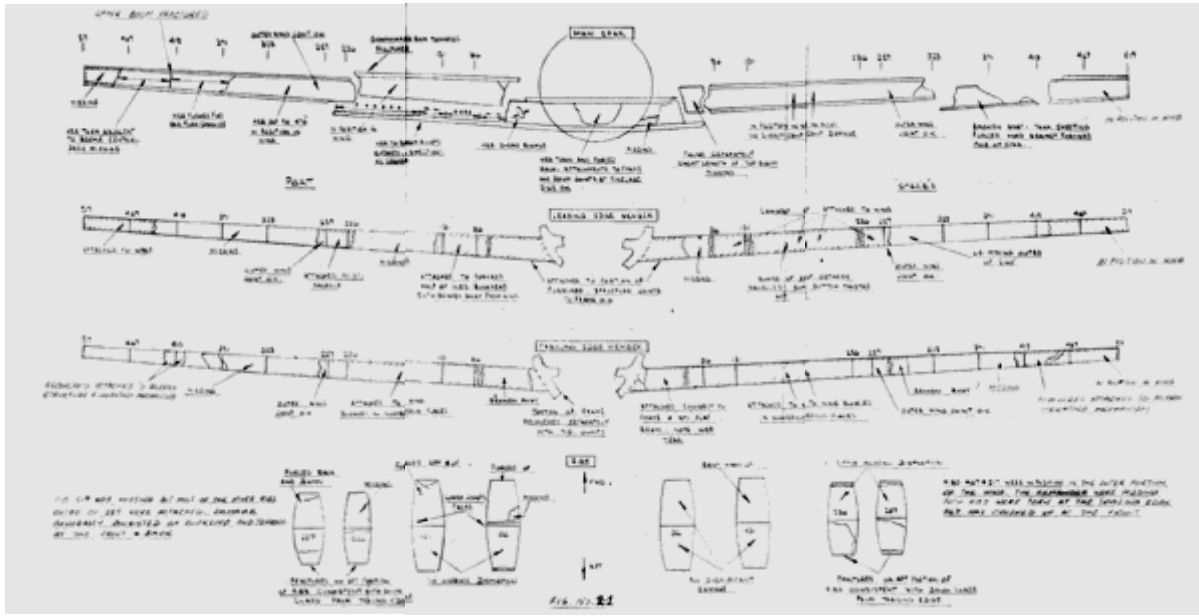
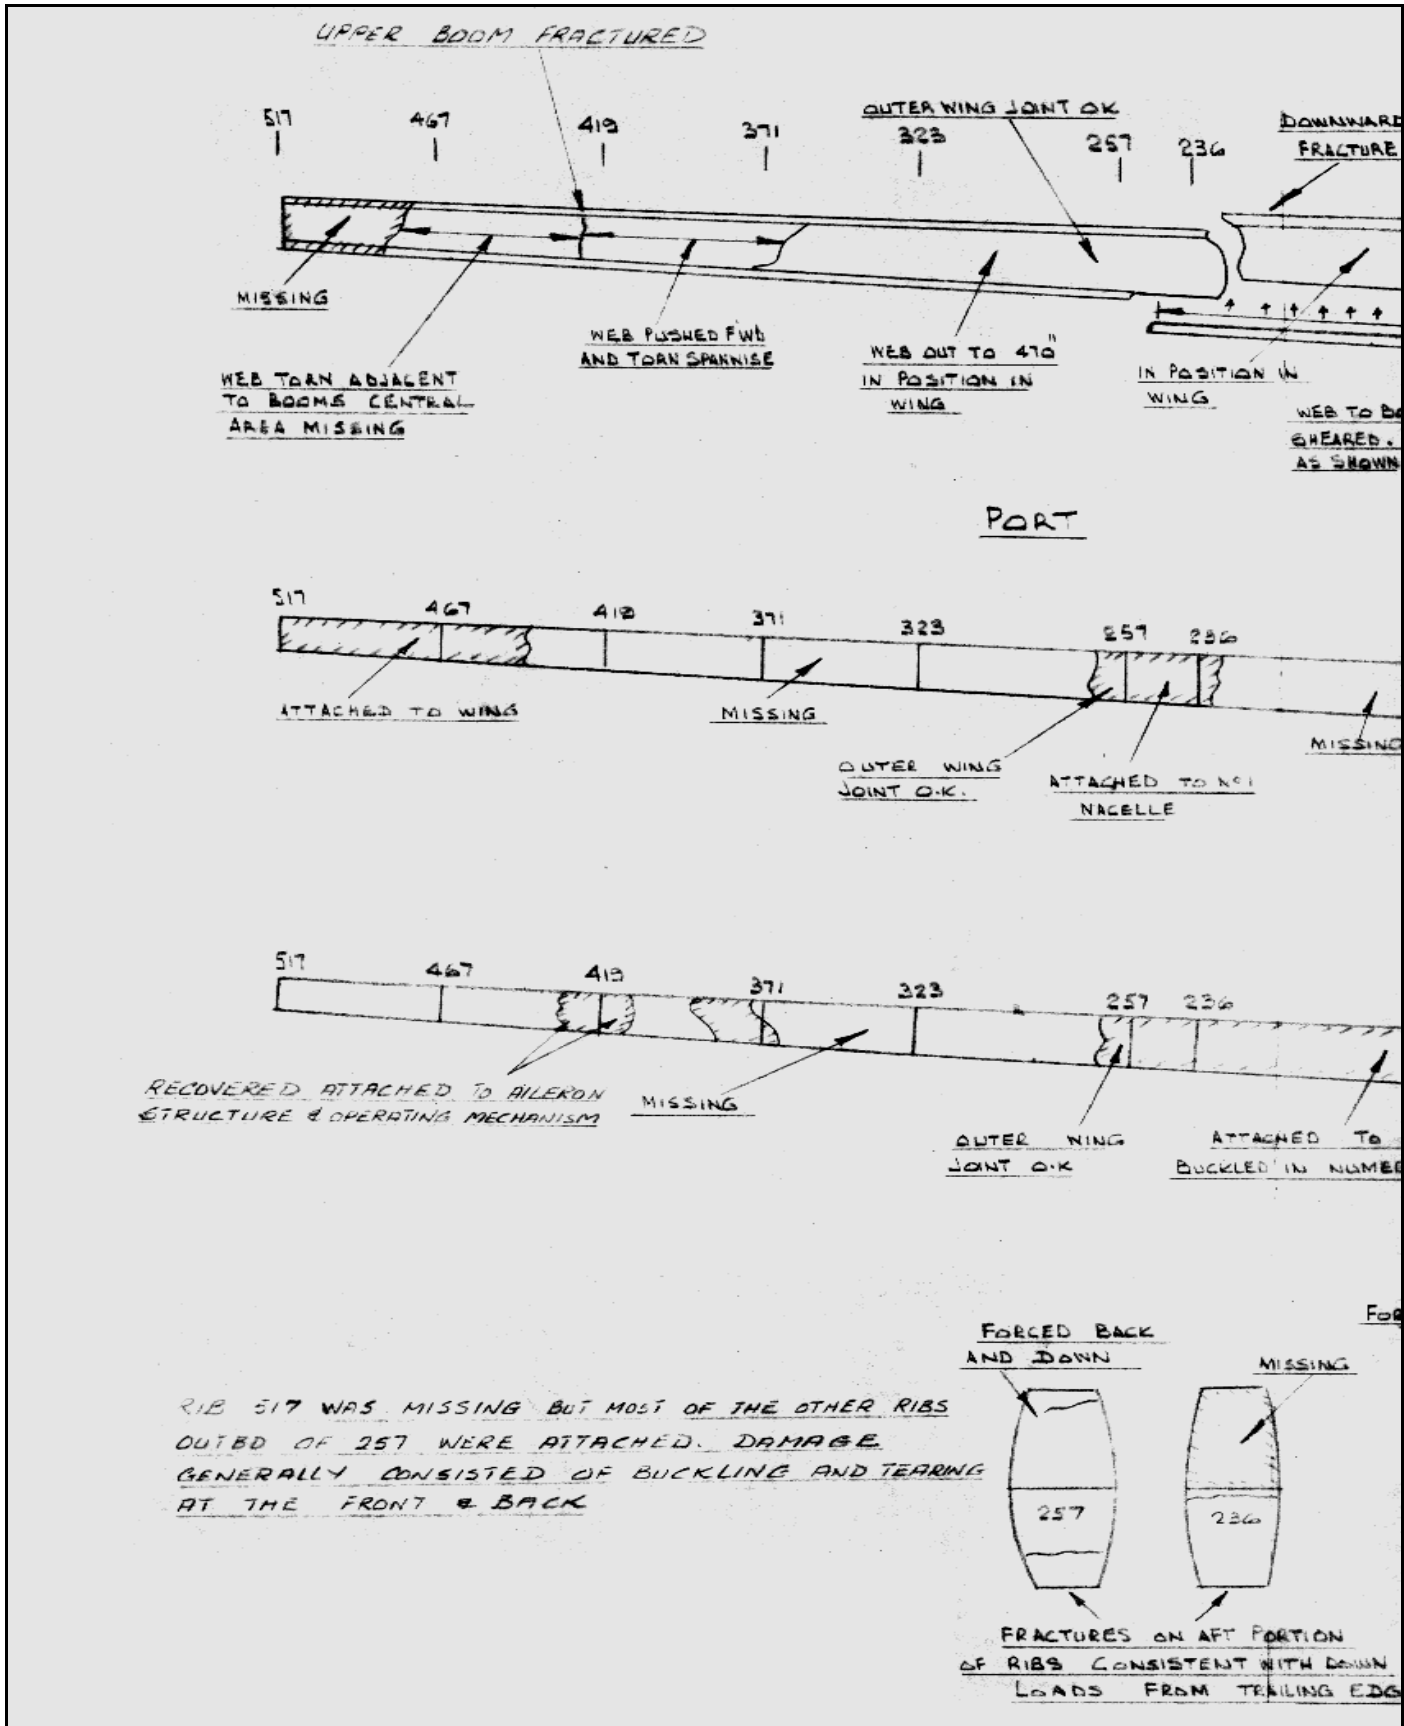
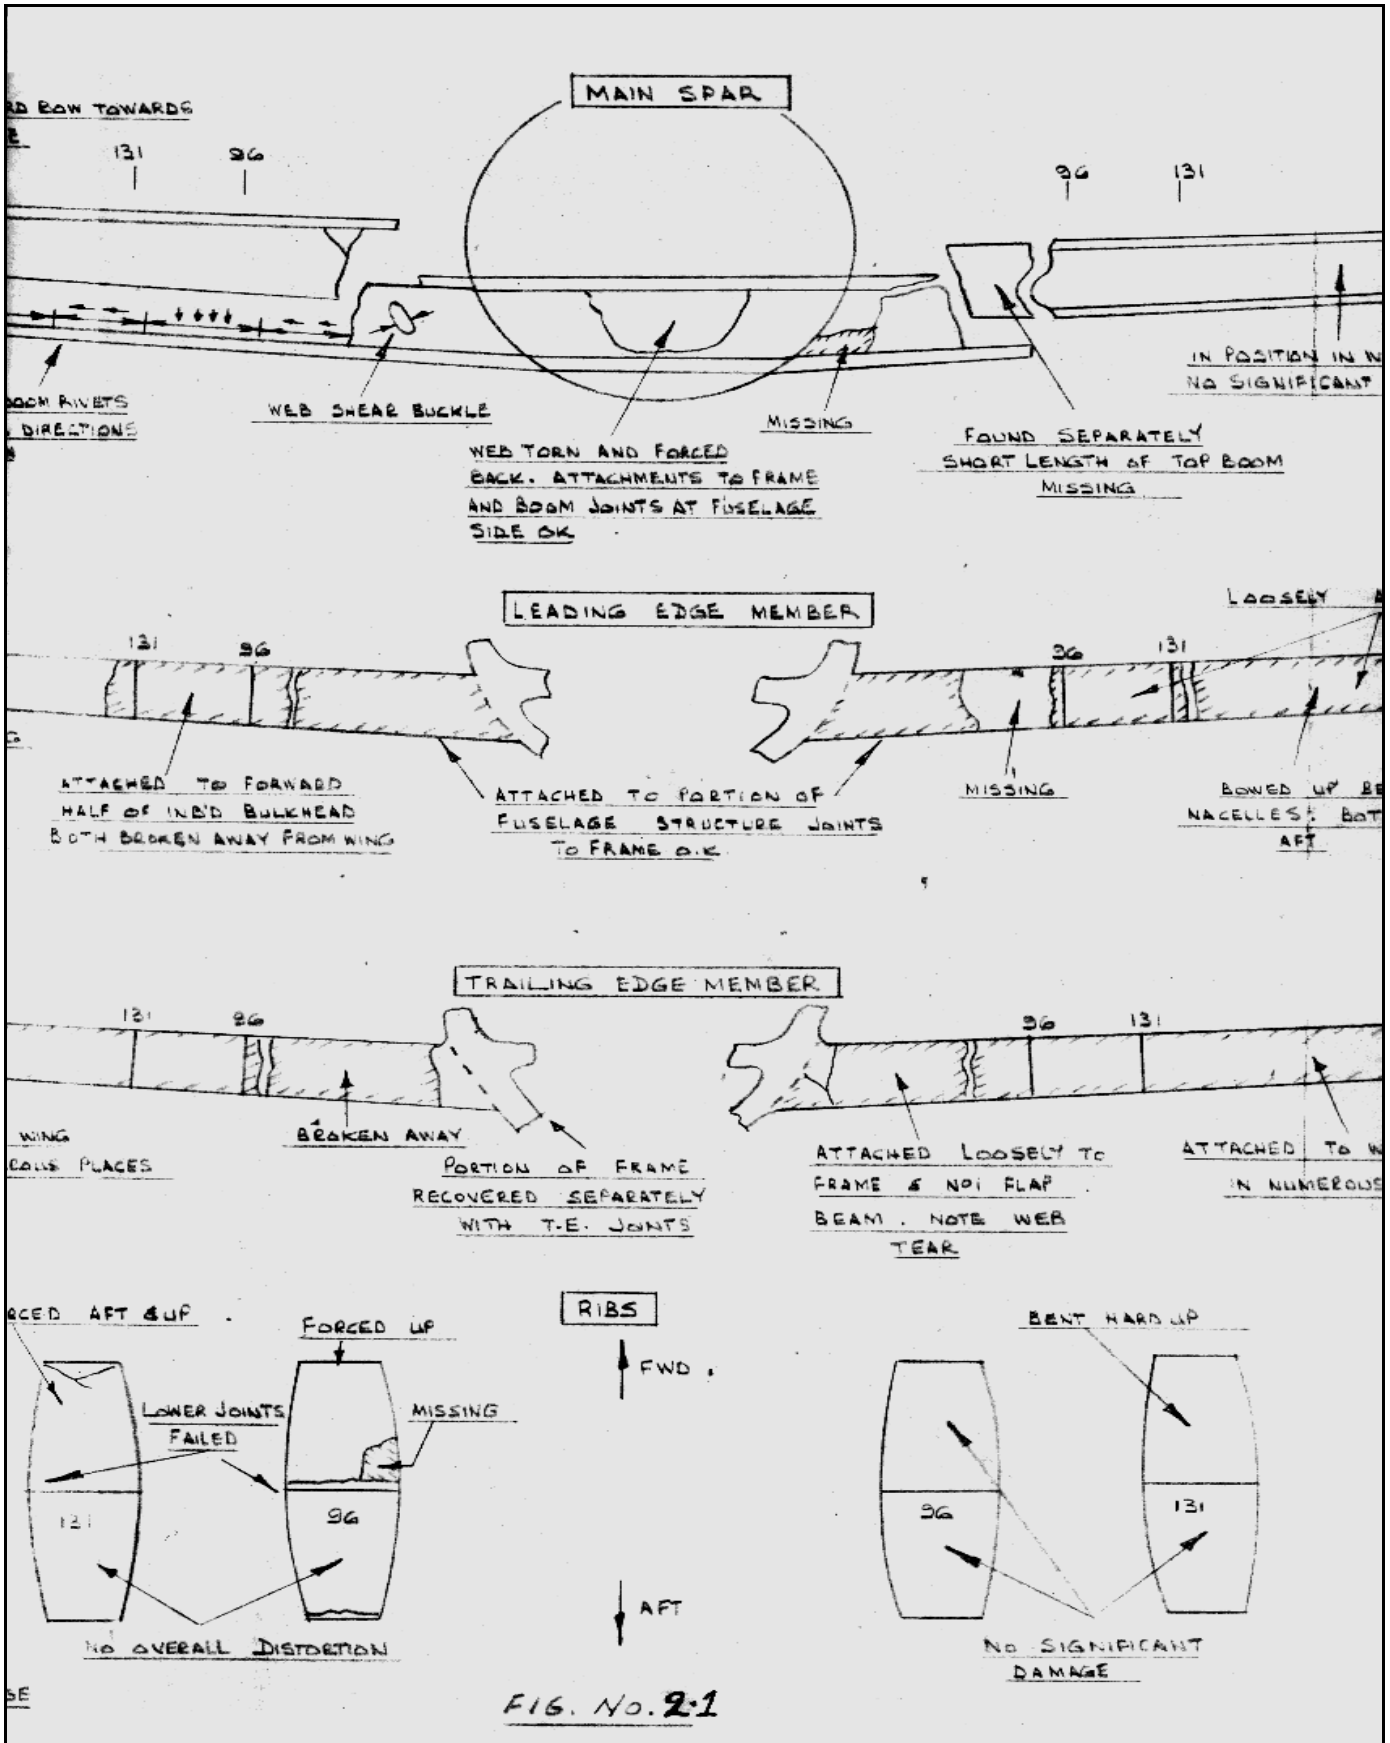
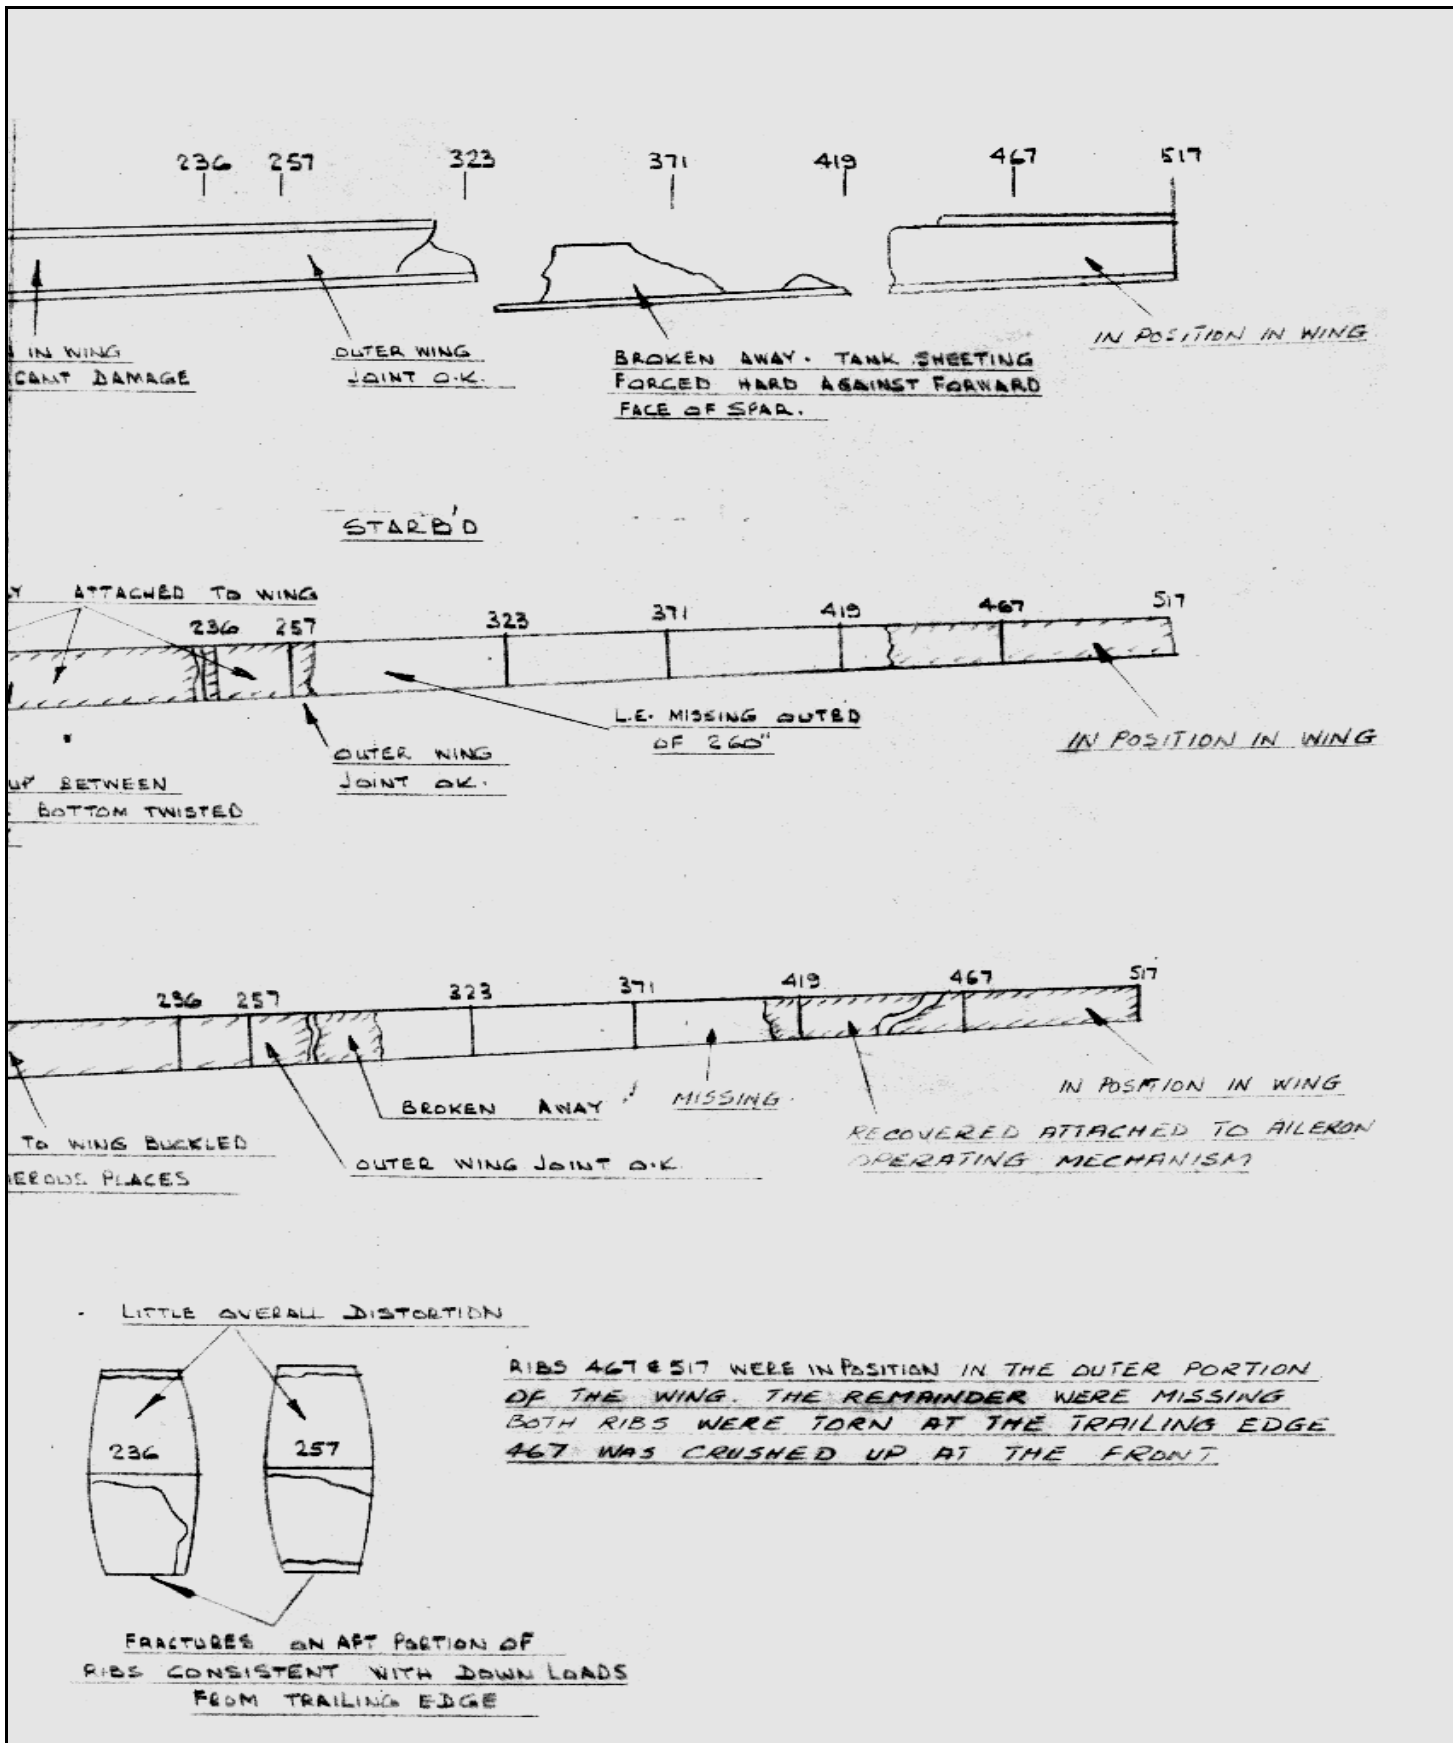
Fig 2.1

2.1. Introduction. The wings were severely damaged but fragmentation was not generally as severe as on the fuselage. The structure recovered and the salient features of the damage are shown in Figs 2.1. and 2.2. Pieces of the trailing edge shroud structure were also recovered, some loosely attached to the wing. A large amount of the wreckage was contained in five pieces:-

2.4. (Ref. Fig. 2.1.) Leading Edge Member. The Leading Edge member had fractured into a number of segments, some still in position in the wing, and others broken away with the nacelle or pieces of fuselage structure. The outer wing joints and those to the fuselage frame were intact. The damage was influenced largely by local impact forces, nacelle loads and wing fuselage interaction effects. The portion between engines 3 and 4 had been bowed up and twisted and the wing skin locally had been rolled up and forced aft against it. This was also apparent on the pieces adjacent to the fuselage side.

2.5. (Ref. Fig. 2.1.) Trailing Edge Member. Most of the trailing edge member recovered was in position and had been shielded to some extent from direct impact forces. The damage is shown in Fig. 2.1 and it may be noted that the positions of the fractures were compatible with those on the main spar.

2.6. (Ref. Fig. 2.1.) Ribs. The ribs recovered were in position in the wing with the exception of the forward half of rib 96 on the portside which was recovered separately attached to a portion of the leading edge member. Damage varied, some of the light ribs recovered were torn and crushed by local impact loads, but there was evidence that at least over the flap area the ribs had experienced high downward inertia loads from the trailing edge and this is confirmed by the flap beams. The loads from the front in the region of engines 2, 3 and 4 were aft and upwards but there was evidence of aft and down loads on the fwd. half of rib 257 port side.

2.7. (Ref. Fig. 2.1.) Main Spar. The structure recovered and the salient damage are shown in Fig. 2.1 and detailed examination revealed no signs of fatigue or pre-impact damage of any sort.

The fractures at stns. 419, 323 and inb'd of stn. 96 on the stb'd wing had all the characteristics of failure caused by upwards bending. Most of the spar on this side was still contained by the surrounding structure, the exceptions being the root area and the portion between 323 and 419. Over this area the wing had been completely disrupted and the portion of the spar shown was recovered separately.

The fractures on the port wing are more complex. The web tear and top boom failure at the wing root was caused by upwards bending but the fracture at stn. 236 particularly on the lower boom exhibited characteristics of failure due to downwards bending, also the top boom inb'd of this fracture was bowed down. It is reasoned from this that at initial impact a large portion of the port wing was clear of the water and since the outer tanks were full of fuel the ensuing downwards bending due to inertia forces caused the failure at stn. 236 and the follow through arrested by upward impact forces caused most of the damage to the port wing.

The rivet shear failure directions on the port lower boom are illustrated in Fig. 2.1. Subsequent to the wing failure at stn. 236 impact loads probably initiated the tearing away of the web from the lower booms in an upwards direction, the change over to outwards failure is consistent with a tension build up in the lower boom caused by upward bending which led to failure of the web and top boom at the fuselage side. The downwards shear between 96 and 131 was probably due to high undercarriage inertia loads.

Over the fuselage area the web was torn and forced back by aft impact loads and damage was severe outb'd of 370 on the port side and between 323 and 419 on the stb'd side. All joints on the spar were intact.

The failure mode throughout the stb'd wing was upwards. The fracture at stn. 236 on the port main spar was down but subsequent to this the complete port wing had been subjected to high up impact loads.

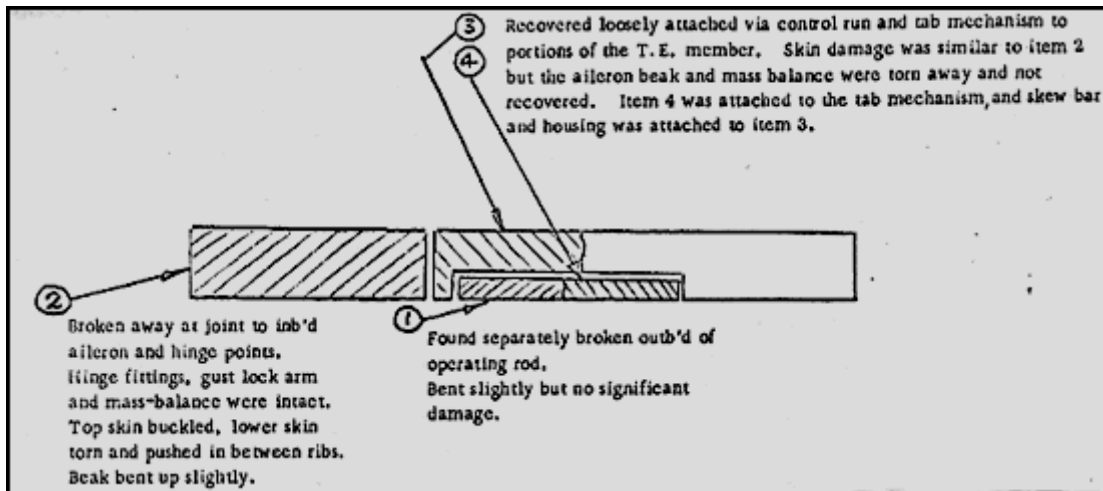
The items recovered on the port side and the damage are illustrated below.

The aileron and supporting structure had broken from the wing. The hinge fittings were attached to the outer aileron but the structure forward of this was missing. Items 3 and 4 which did not include any hinges or supporting structure were recovered loosely attached via the control run and tab mechanism to inb'd portions of the trailing edge member.

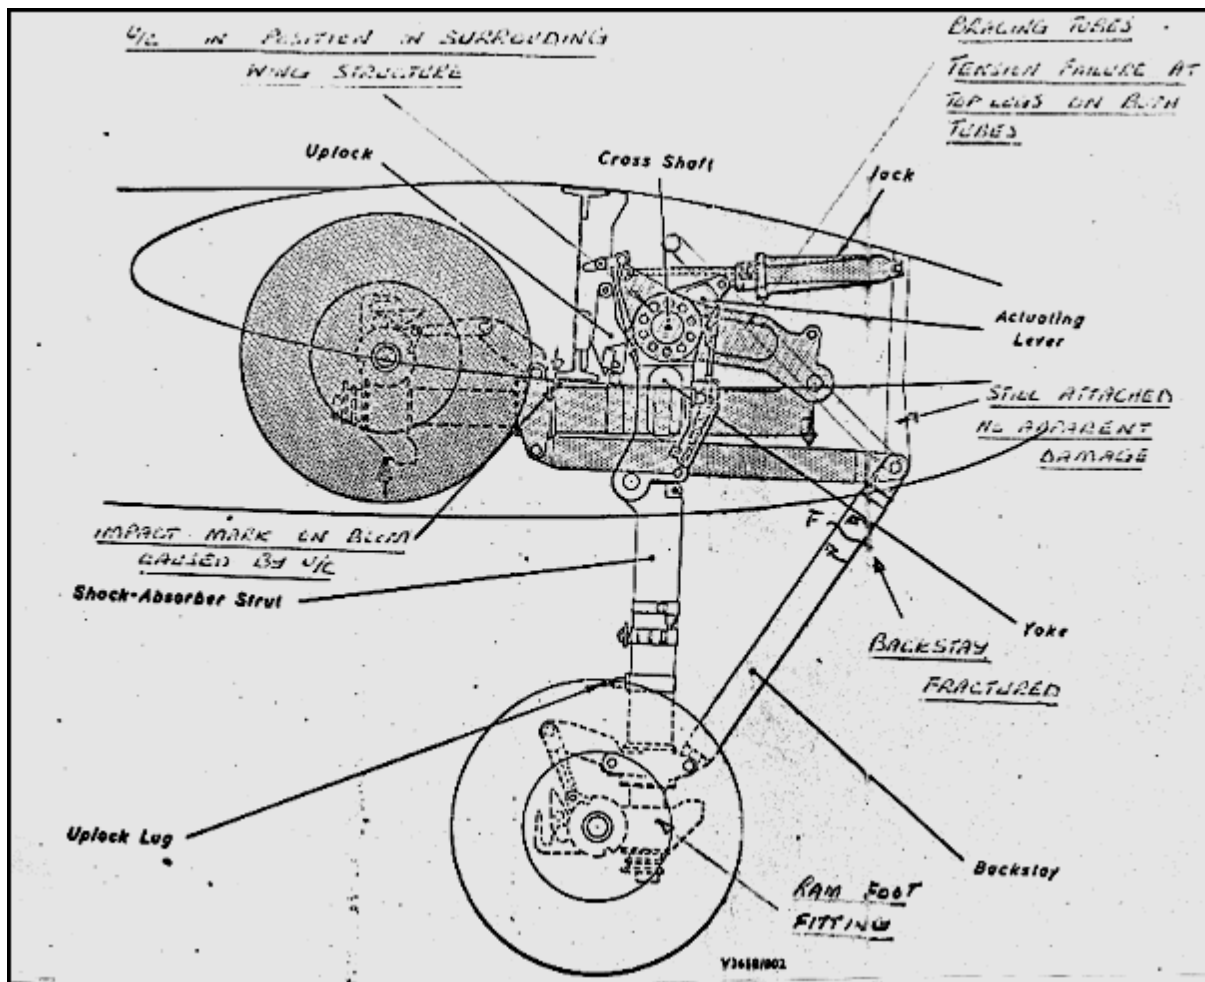
Stb'd Main Unit Fig. 6.1.

The unit was recovered attached to the wing structure with the jack, dampers, locks and supporting structure accounted for, but the inner cylinder, wheels, brakes, gland nut, doors and operating mechanism had been ripped away and were not recovered.

The torque links were attached to the outer cylinder and had broken away from the ram foot fitting at the lower joint.

The remaining damage is illustrated in Fig. 6.1.

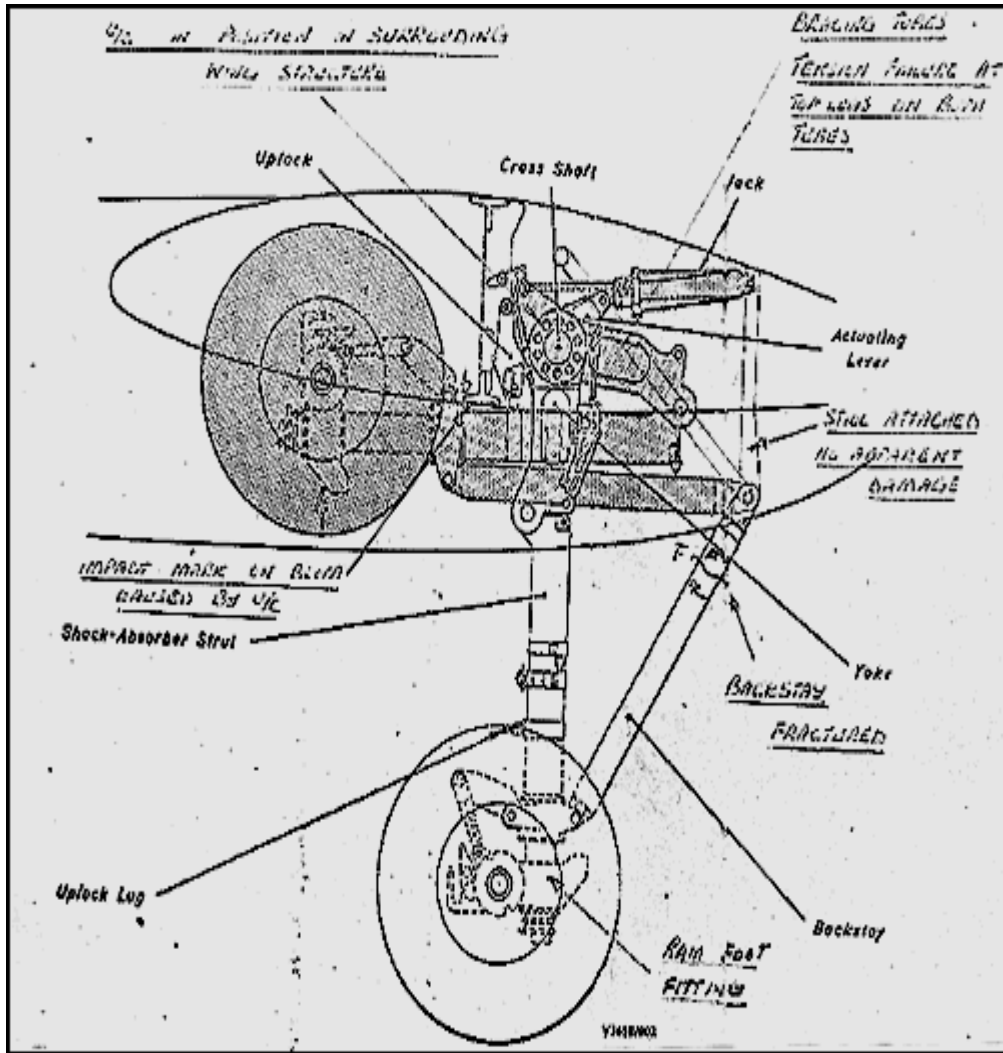
Port Main Unit Fig. 6.2.

The unit was recovered attached to the surrounding wing structure with the jack, dampers, locks and supporting structure accounted for. The inner cylinder, wheels and brakes had broken away and were found floating with the wheels inflated. The doors and mechanism had ripped clear and only the operating beam was recovered.

The torque links were attached to the outer cylinder and broken away at the ram foot fitting joint. The fitting was cracked, the gland nut was missing and the door operating hook was bent out.

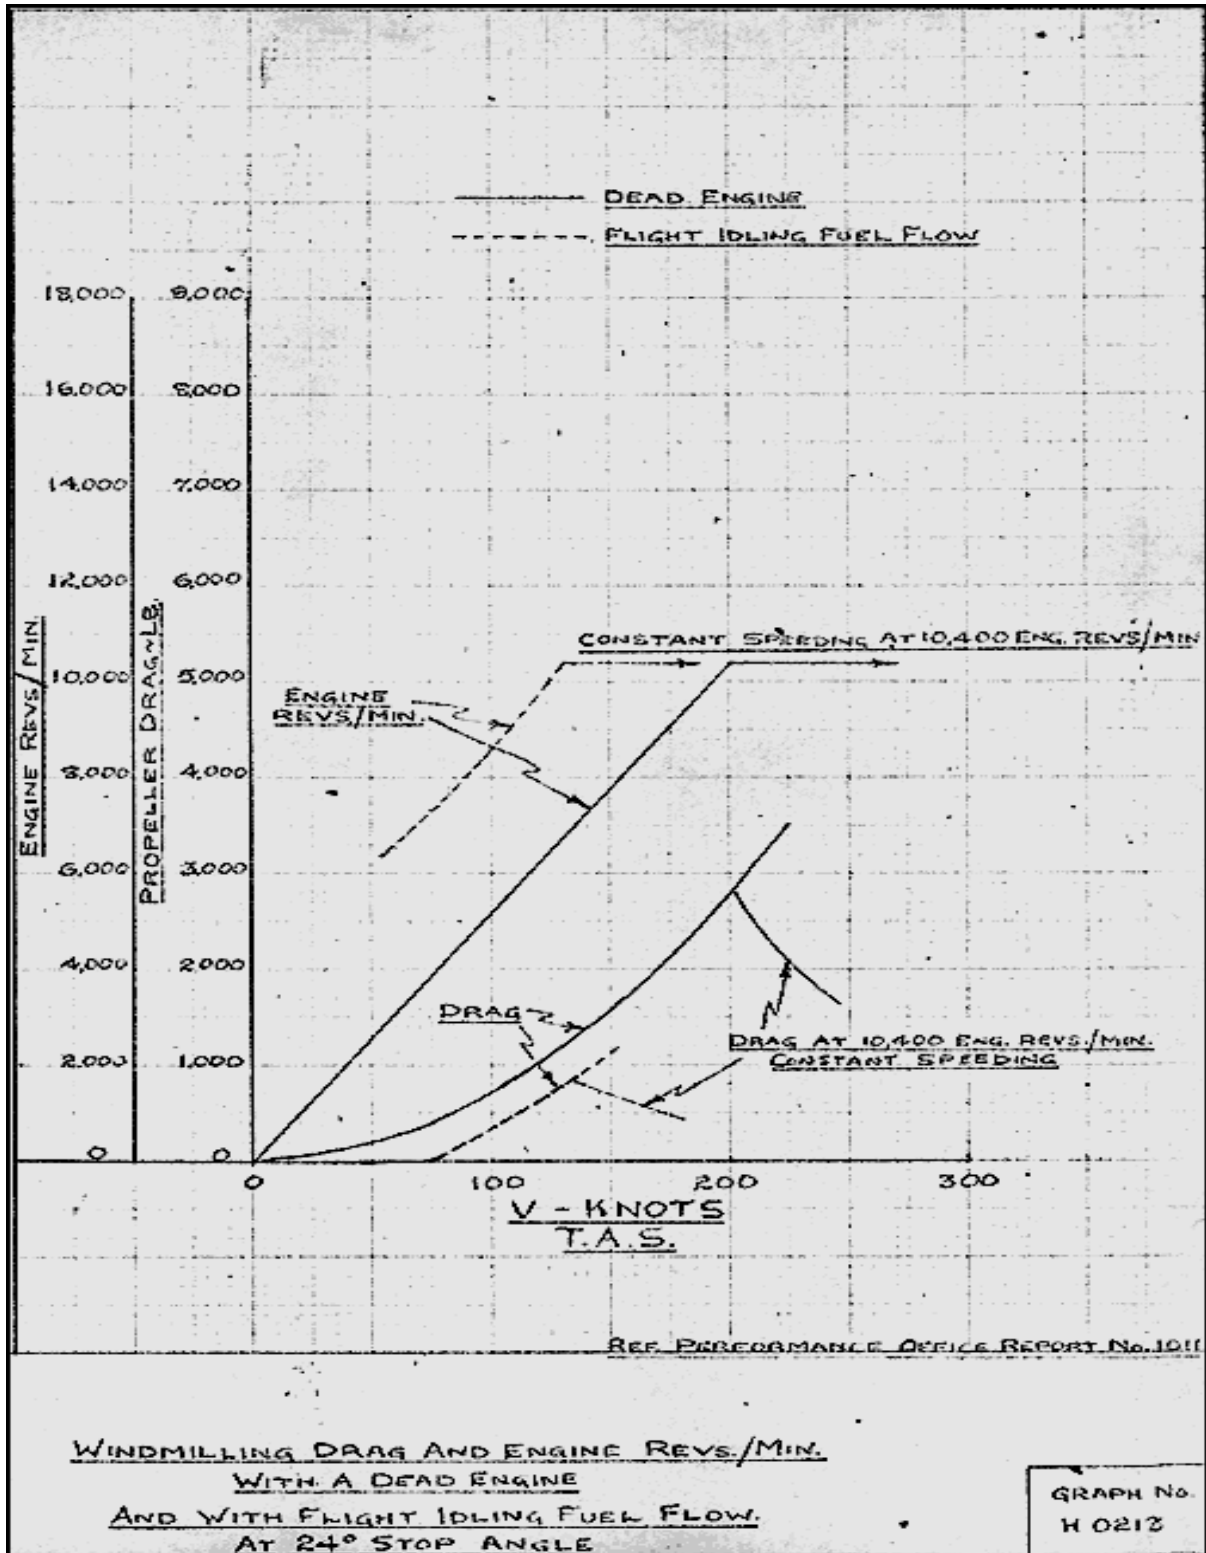
Graph No. H0213

The attached graph NO. H.0213 shows the values of windmilling drag and engine revs/min. Vs forward speed for 10,400 selected engine revs/min. for I.S.A. Sea Level conditions with approximately 275 lb/hr. and zero flow.

From this graph it will be seen that the propeller will be on the flight fine pitch stop (24°) at speeds up to 130 kts. and 200 kts. T.S.A. for flight idling and zero fuel flows respectively.

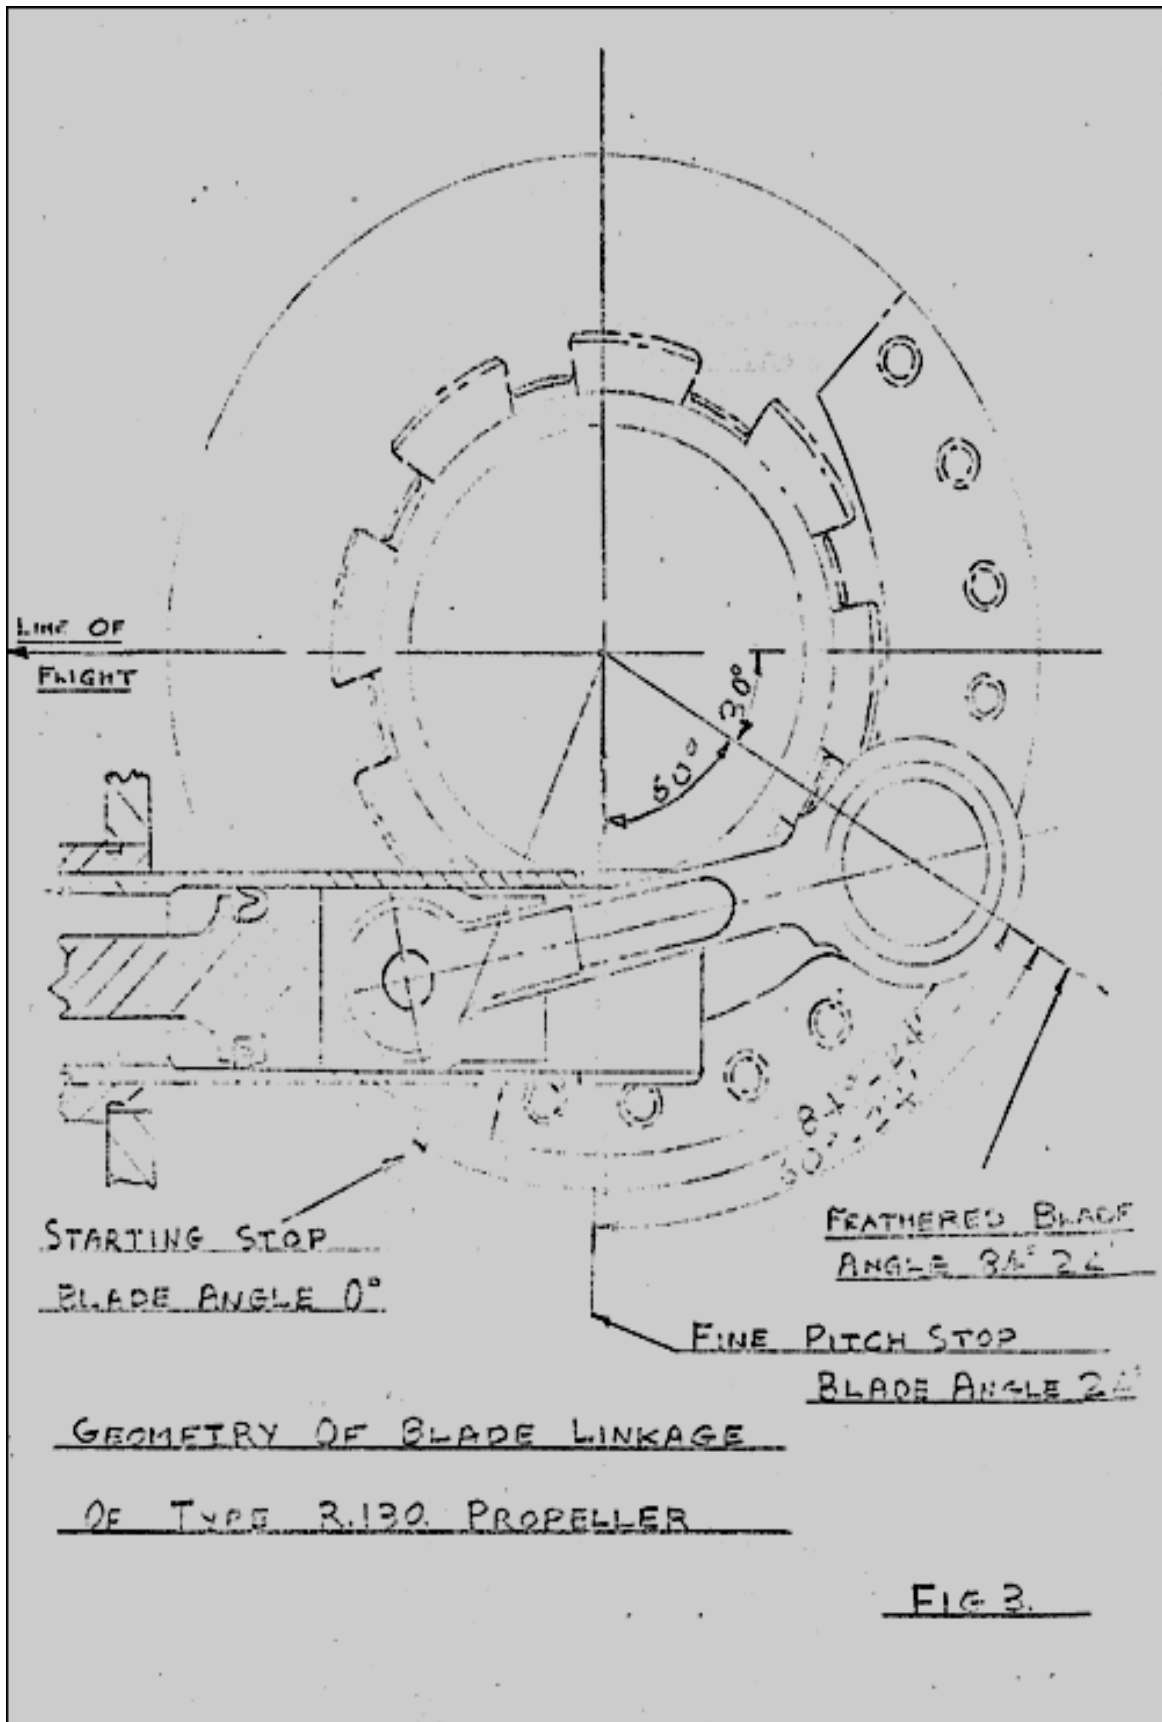
Figure 3

- The geometry of the blade linkage of a Type R. 130 propeller is shown in Fig. 3, as viewed on the end of the blade root. This shows an operating pin position of 90° to be equivalent to a blade angle of 24° 24'.
