日本航空株式会社所属ダグラス式MD-11型JA8580の  
航空事故に係る建議について (建議第10号)

平成9年6月8日志摩半島上空において発生した標記の航空事故については、気象、機体特性、操縦を含め、考えられる全ての原因について調査・解析を行っているところであるが、現在までの調査の結果、機体ピッチが反復して大きく上下に変動したのは、自動操縦装置が切れた後、操縦士が反復して操舵を行った結果、いわゆるPIO (Pilot Induced Oscillation) に陥ったことが関与した可能性が考えられる。

アメリカ合衆国国家運輸安全委員会 (NTSB) の安全勧告

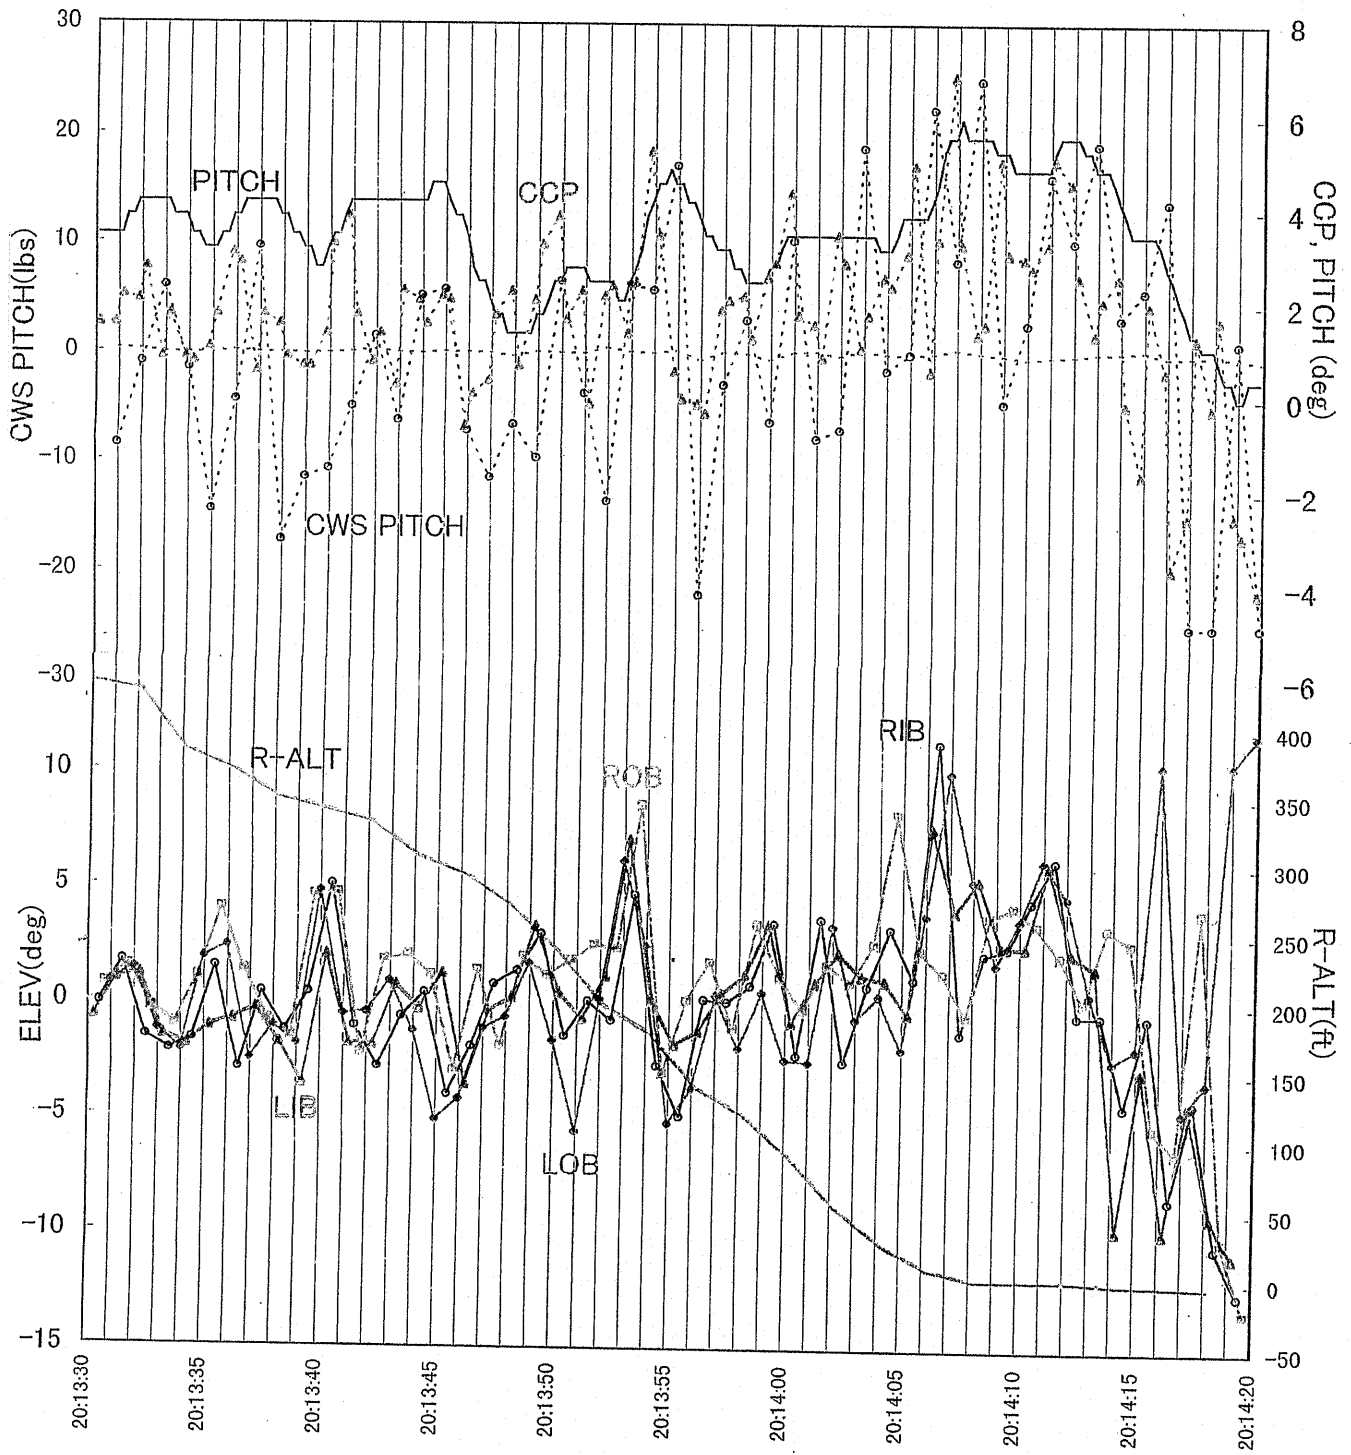
図A14 名古屋空港へのアプローチ中のCWS-PITCHとCCPの記録時間関係

そこで、別添1のグラフが示すCWS-PITCHとCCPの時間関係が事故当時の特別な状況下で生じたものなのか、それとも、ADASの記録方式により通常生じるものなのかを調べるために、当該機の名古屋空港へのアプローチから着陸までのパラメータ（PITCH、CWS-PITCH、CCP、ELEVATORS）を別添1のグラフと同じ方法でプロットしたグラフを図A14に示す。

このグラフから分かるように、CWS-PITCHとCCPの動きの時間関係は、別添1のグラフに示すものと同じであり、このことから、CWS-PITCHとCCPの時間のずれは、データ・バスを含めた記録上の特性であることが言える。したがって、機構的な観点から、CWS-PITCHとCCPの作動は、同時に発生したものであると推定される。
