Chapter 1 Summary of recommendations and opinions issued in 2018

The recommendations and safety recommendations issued by the Japan Transport Safety Board in 2018 are summarized as follows.

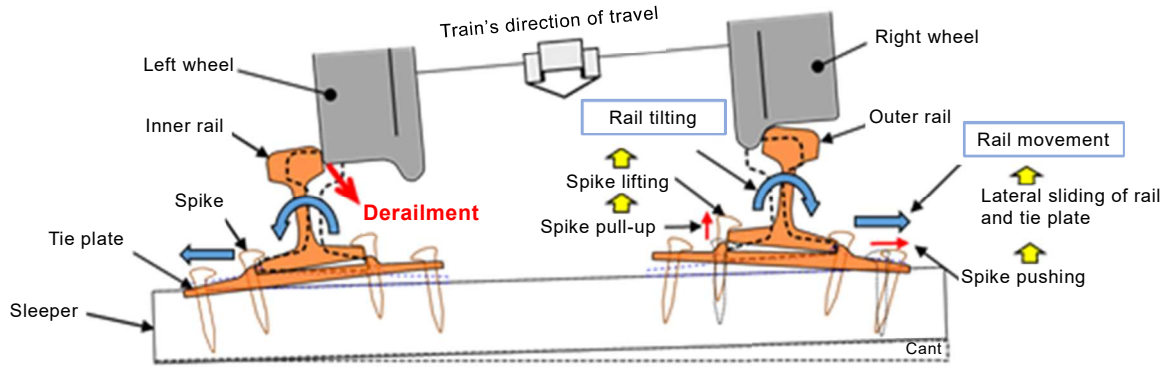
Figure 1: Example of a derailment caused by gauge widening

It is important to control dynamic gauge widening caused by rail tilting, etc., by appropriately managing sleepers and rail fastening devices to prevent derailment of wheels falling down between rails due to gauge widening. (See Figure 1)

*¹ “Gauge widening” refers to a situation in which a track’s gauge has widened due to damage to rail fastening devices caused by lateral pressure (the force generated by wheels pushing the rail laterally) or increasing rail wear. If the gauge widens beyond a certain degree, wheels on either the left or right side will become unsupportable by the rail’s head and derailment will occur. Here, gauge widening caused by lateral pressure associated with running trains is called “dynamic gauge widening.”

Appropriately managing dynamic gauge widening requires the periodic inspection of the condition of materials and maintenance of sleepers and rail fastening devices, record-keeping, and, depending on the situation, the implementation of measures to prevent gauge widening, such as replacing or adding spikes, replacing sleepers, and installing gauge ties (fixtures that maintain gauge).

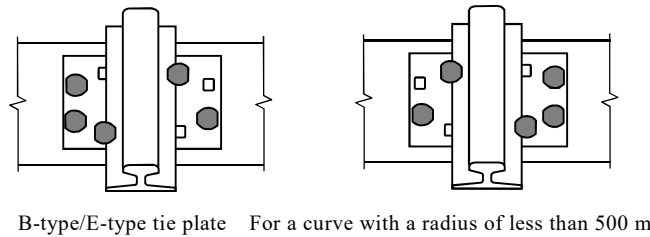
Figure 2: Example of standard tie plate spike driving

Furthermore, it is necessary to pay attention to the number of spikes, method of driving spikes, etc., when using tie plates that affect rail tilting, etc. Figure 2 provides an example of standard tie plate spike driving for reference.^{*3}

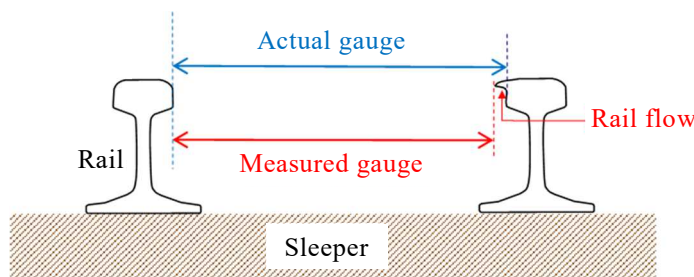
Figure 3: Gauge measurement when rail flow exists

When rail flow occurs on the rail gauge corner side, the rail head's metal surface is deformed and pushed inside the gauge. On the other hand, gauge is defined as the "shortest distance between the rail heads within 14 mm (or 16 mm) of the rail level." Because gauge is measured based on this, if rail flow is occurring, measurement will be from the tip of the rail flow and therefore the measured gauge will be smaller than the actual gauge by the amount of the rail flow (see Figure 3). Such a measurement suggests the danger of gauge widening, and there are cases where rail flow breaks and derailment by gauge widening occurs (see Figure 4).

Accordingly, when the occurrence of rail flow is confirmed through a periodic rail inspection, track patrol, etc., it is desirable to engage in appropriately management by removing the rail flow or taking other measures as necessary.

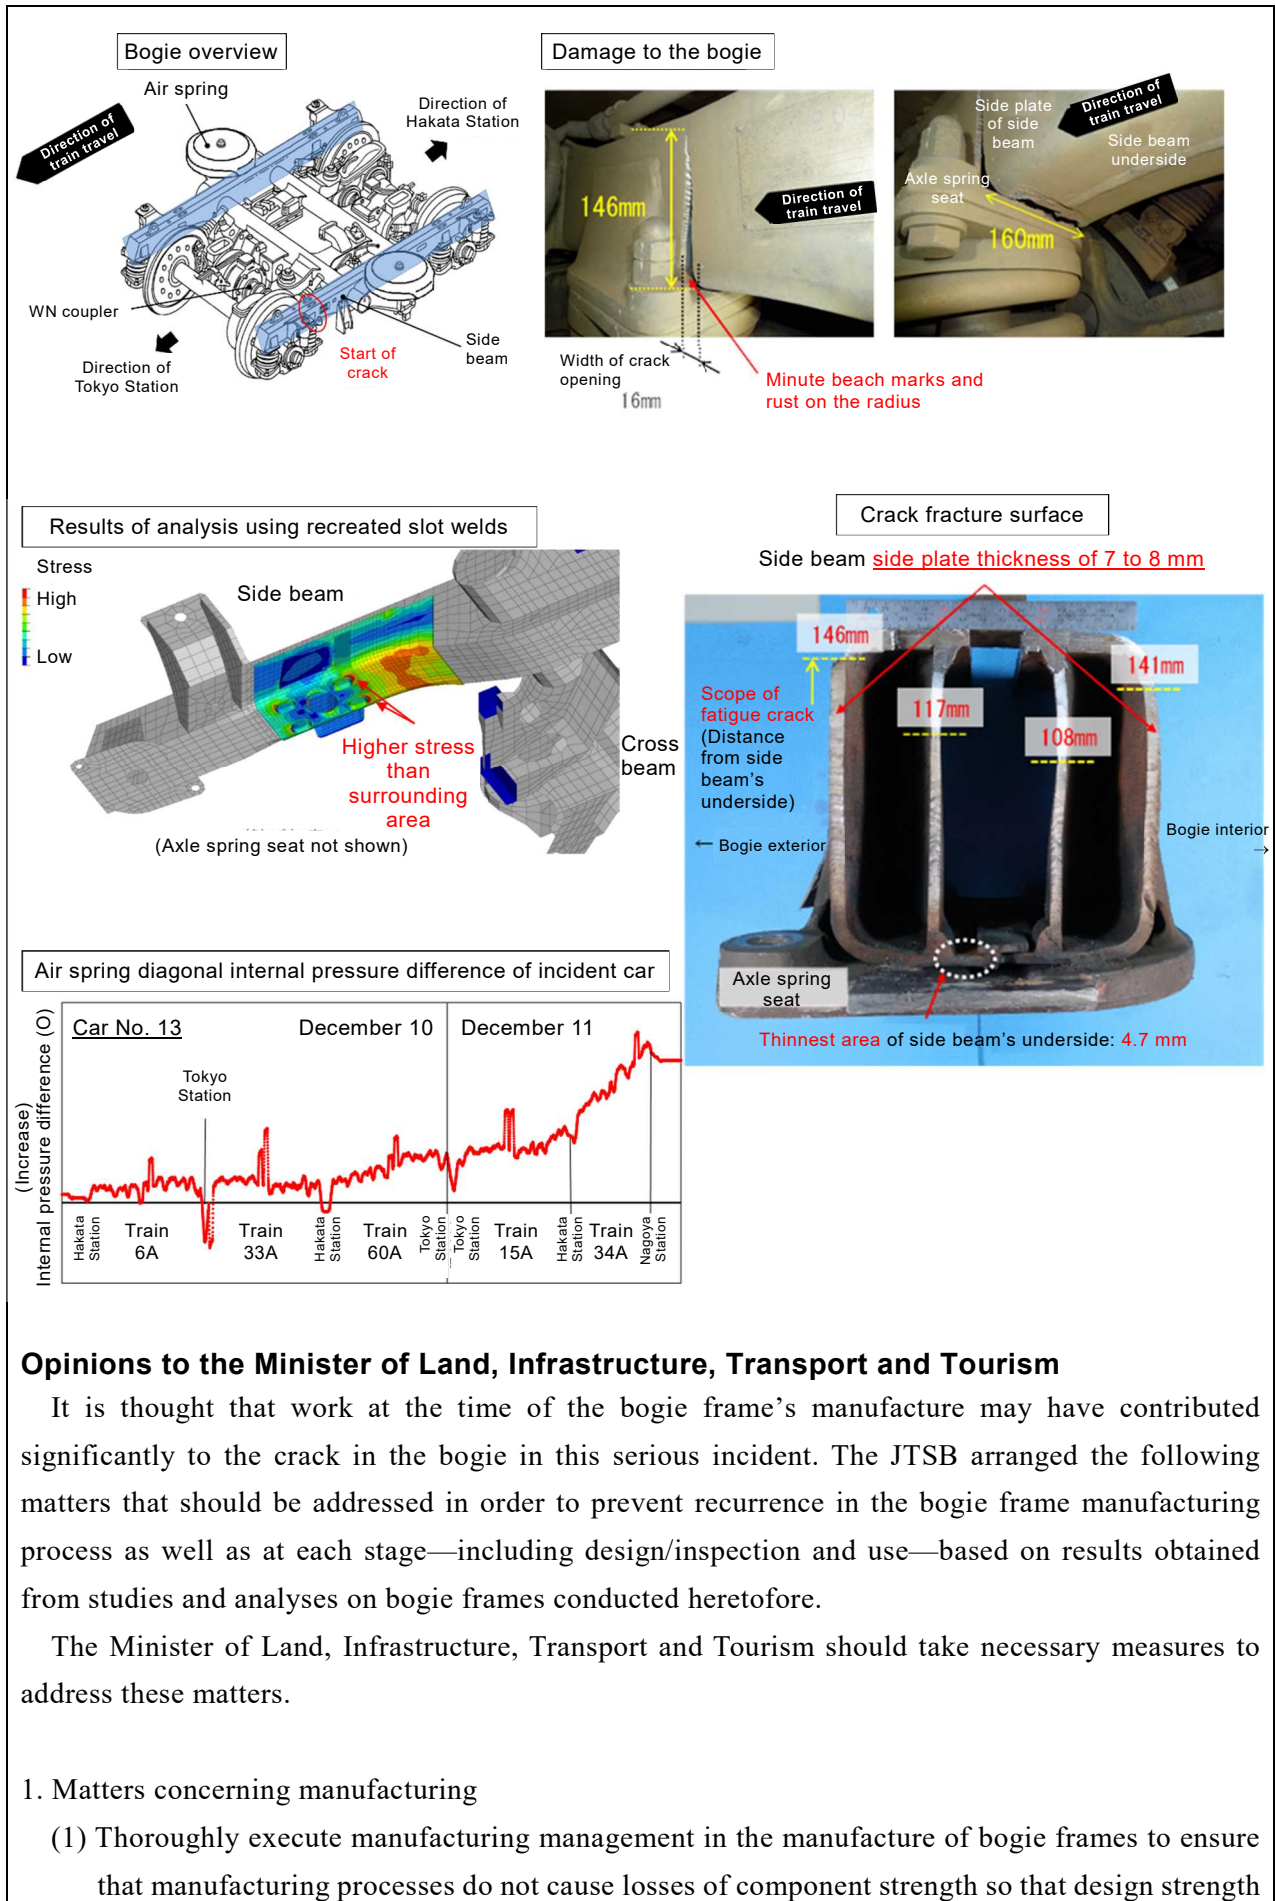
Subsequently, when work was underway to move the vehicle to a depot (Nagoya Rolling Stock Depot), a crack was discovered in the left side beam of the bogie frame of the front bogie of the fourth vehicle at around 23:40.

- It is highly probable the starting point of the crack is near two slot welds that attach the axle spring seat to the underside of the side beam.
- It is thought possible that grinding of the side beam's undersurface at the time of the bogie frame's manufacture (ordinarily plate thickness is at least 7 mm, but the thinnest part of the affected area was 4.7 mm) and overlay welding on the axle spring seat's undersurface contributed to breakage of the slot welds, the occurrence of a fatigue crack, and the crack's growth. It is thought that grinding of the side beam's underside influenced the speed at which the crack grew.

- When an analysis was conducted using a model of the actual structure near the crack (a structure made by overlaying and joining the side beam and axle spring seat), a situation in which stress was higher near the crack's starting point than the surrounding area was observed.

- From air spring internal pressure records, it is thought that the crack had progressed to a degree that it affected the side beam's rigidity on the previous day, and that the crack had spread to the point that it affected other bogie components on the day of the incident.

It is thought that work at the time of the bogie frame’s manufacture may have contributed significantly to the crack in the bogie in this serious incident. The JTSB arranged the following matters that should be addressed in order to prevent recurrence in the bogie frame manufacturing process as well as at each stage—including design/inspection and use—based on results obtained from studies and analyses on bogie frames conducted heretofore.

- (1) Thoroughly execute manufacturing management in the manufacture of bogie frames to ensure that manufacturing processes do not cause losses of component strength so that design strength

2) If a problem arising in production or its solution will affect the safety of bogie frames, cease operations, investigate the cause by going back to the manufacturing process or design, study measures to address the cause, and confirm that the results of the measures are favorable before resuming operations.
