AIRCRAFT ACCIDENT REPORT 2/2013

**Report on the accident to Airbus A330-342
B-HLL operated by Cathay Pacific Airways Limited
at Hong Kong International Airport, Hong Kong
on 13 April 2010**

**Hong Kong
July 2013**

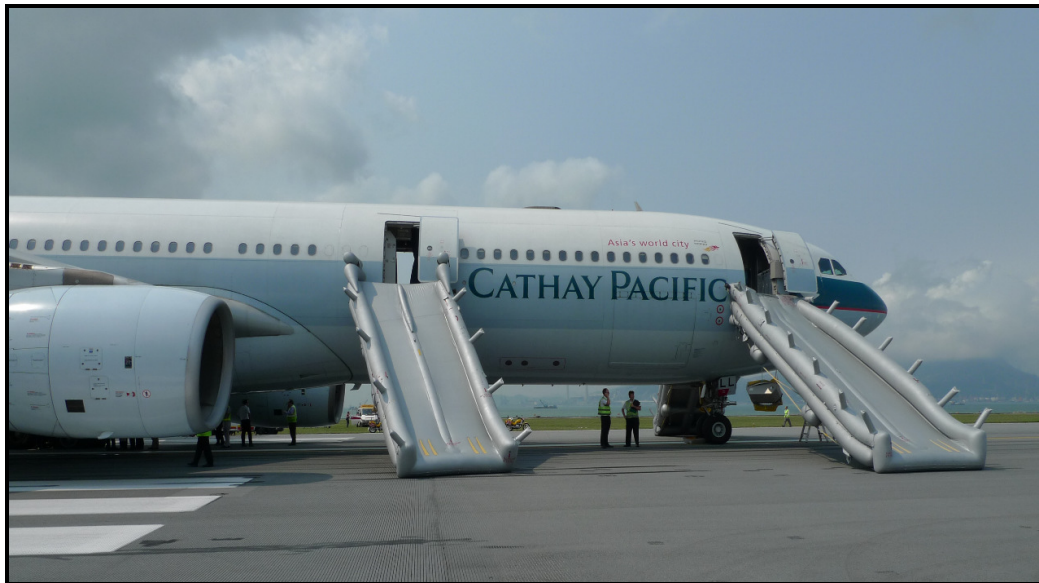
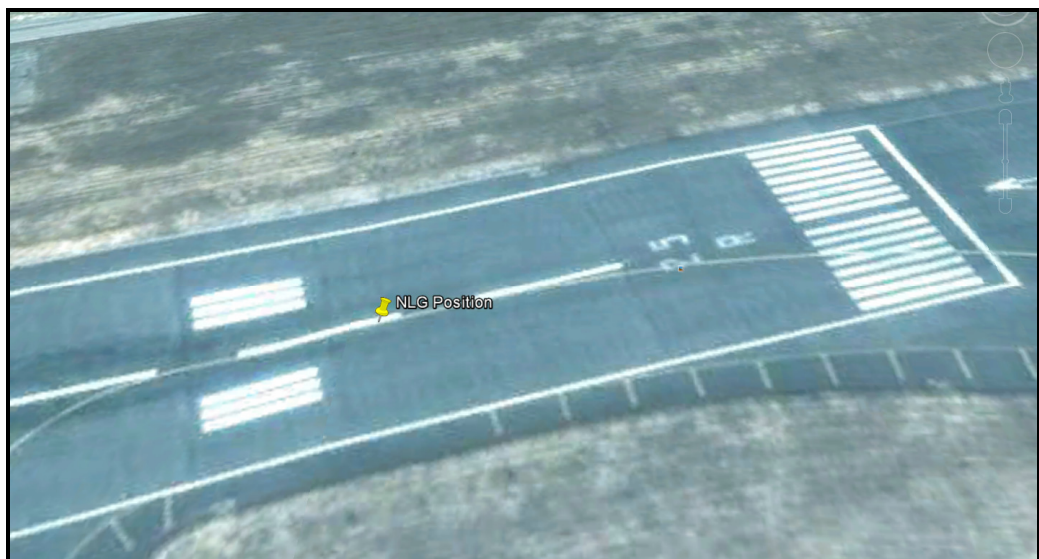
- a. The aircraft came to a complete stop on the runway at a position just passed Taxiway A10, with its nose wheel at about 309m from the end of Runway 07L. The total distance for stopping the aircraft from the initial touchdown was approximately 2,630m. Refer to Figure 1 for aircraft stopped position.

Figure 1: The aircraft stopped on end of Runway 07L (upper photo) with its nose wheel at about 309m from the end of runway (lower photo)

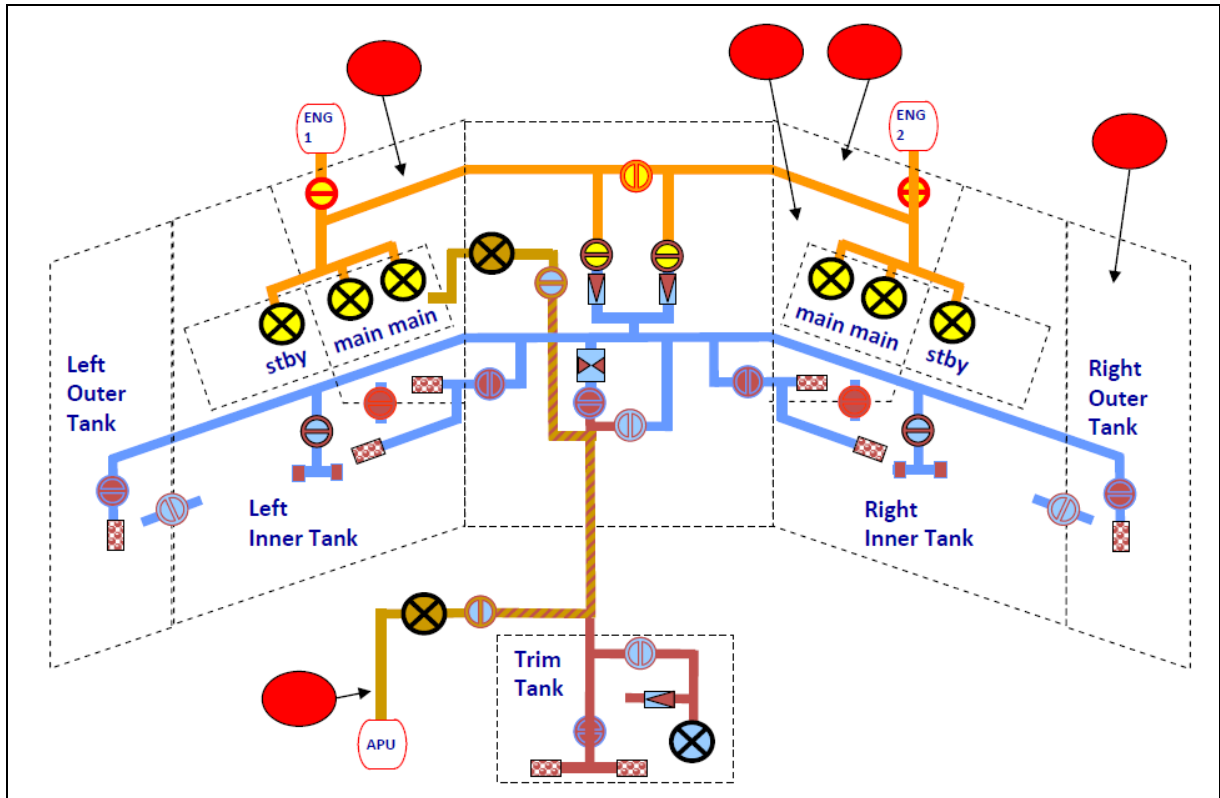
b. There were trace quantity of translucent spherical particulate matters in some fuel samples. As discussed later in this Sub-section, similar spherical particulate matters were also identified in other fuel samples and inside some engine components. The particulate matters were further examined and their structure and source were analysed. The results indicated that they were predominantly made up of carbon, oxygen, and sodium, with moderate amount of chlorine and sulphur, and were mainly sodium polyacrylate which was consistent with the super absorbent polymer (SAP) material used in the filter monitors installed in a fuelling dispenser. This particulate matter will be called “SAP sphere” in this Report and its structure and composition will be further discussed in this Sub-section.

Figure 21: Aircraft fuel sampling locations.
Red dots highlight those locations where the SAP spheres were present.

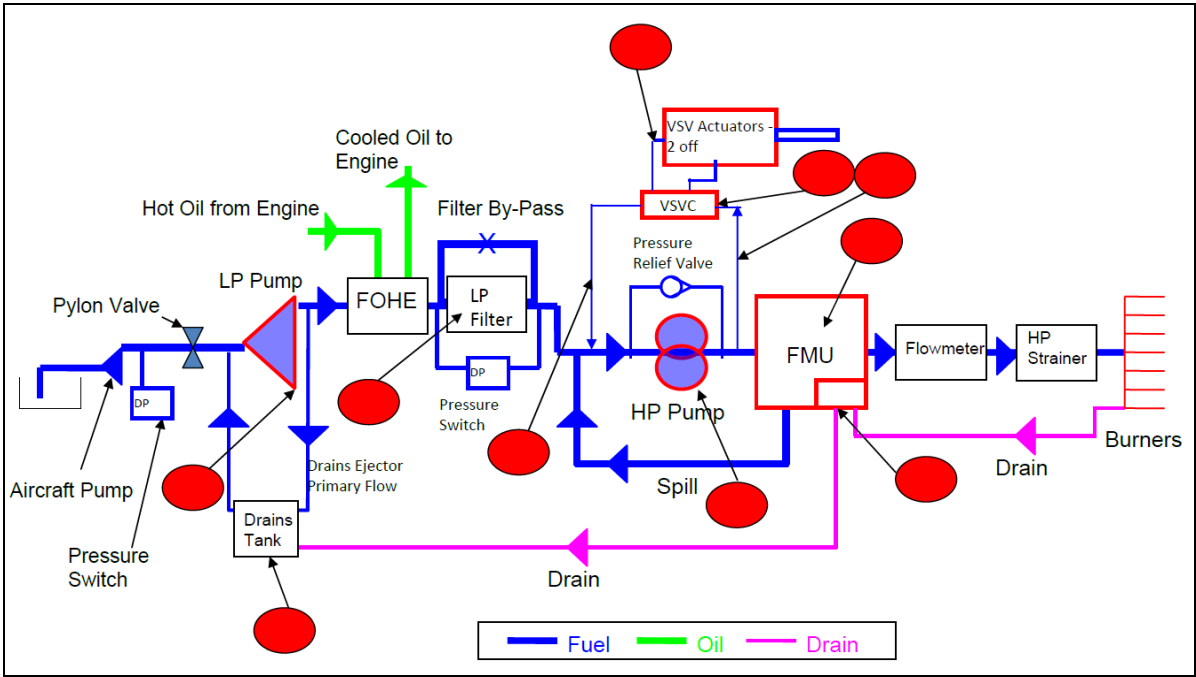
Figure 24: Samples were collected from various locations of B-HLL No. 1 engine. Red dots highlight those locations where the SAP spheres were present.

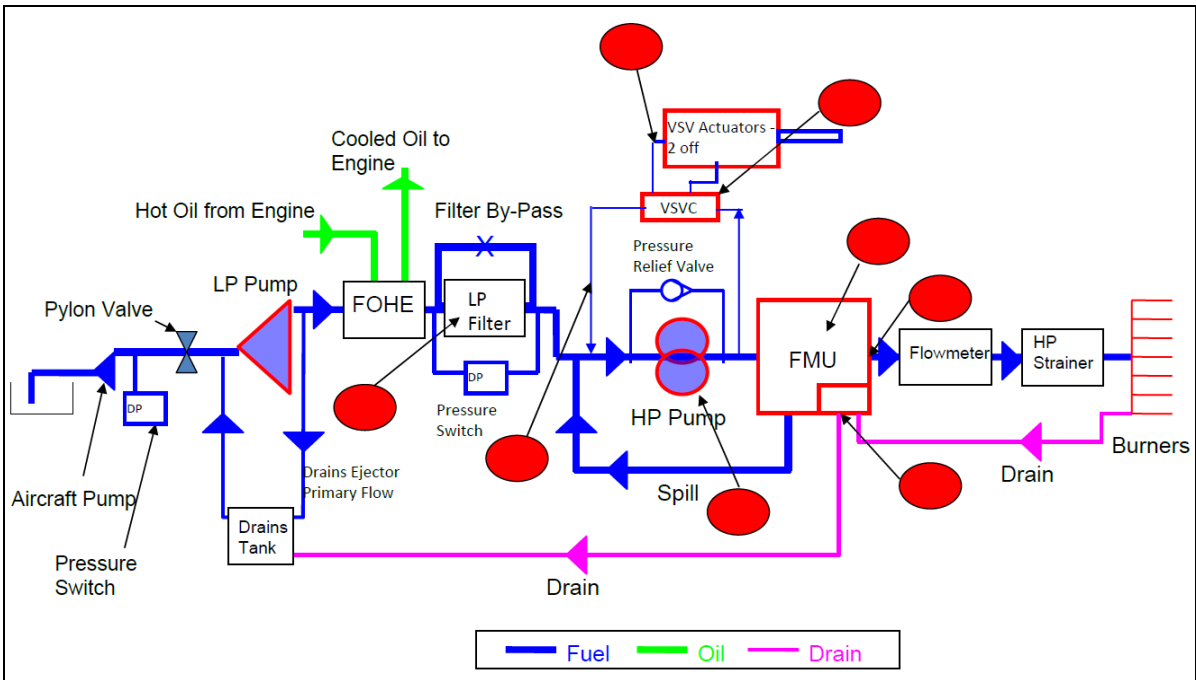
Figure 25: Samples were collected from various locations of B-HLL No. 2 engine. Red dots highlight those locations where the SAP spheres were present.

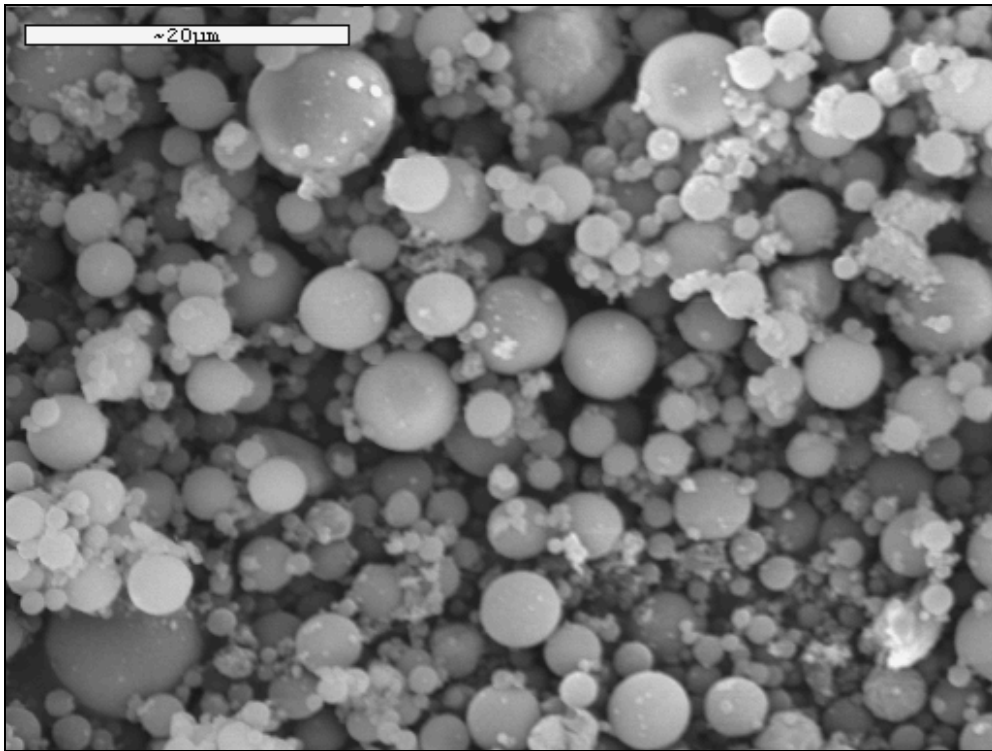
b. Detailed examination of filter media revealed the presence of SAP spheres ranging in size of up to 20µm (see Figure 27). Similar spheres were also found in the media of the LP filters fitted to the aircraft B-HLM engines.

Figure 27: SAP spheres found in the engine LP fuel filter media

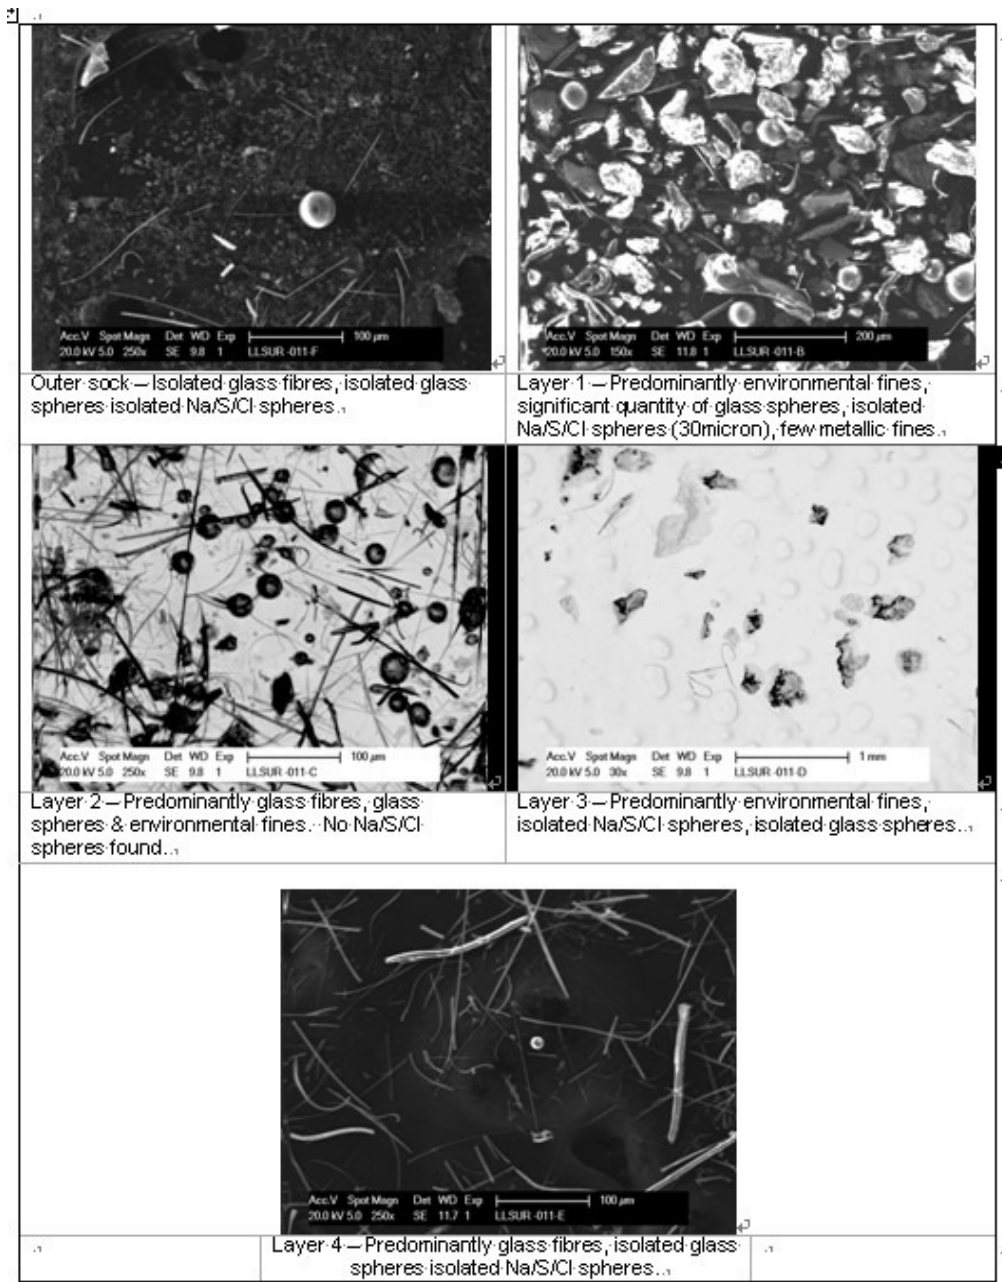
d. Examination of the dissected filter monitors revealed that the construction of the accident filter monitors was identical in terms of media type to a recently manufactured element, and that the SAP layers had been exposed to water. There was very little evidence of dirt trapped in the media layers. Isolated SAP spheres were found in one filter monitor (see Figure 33). No SAP sphere was identified in the new pristine filter monitor when it was dissected and examined by using similar technique.

Figure 33: Isolated SAP spheres (Na/S/Cl spheres) found in the media layers of the filter monitor.

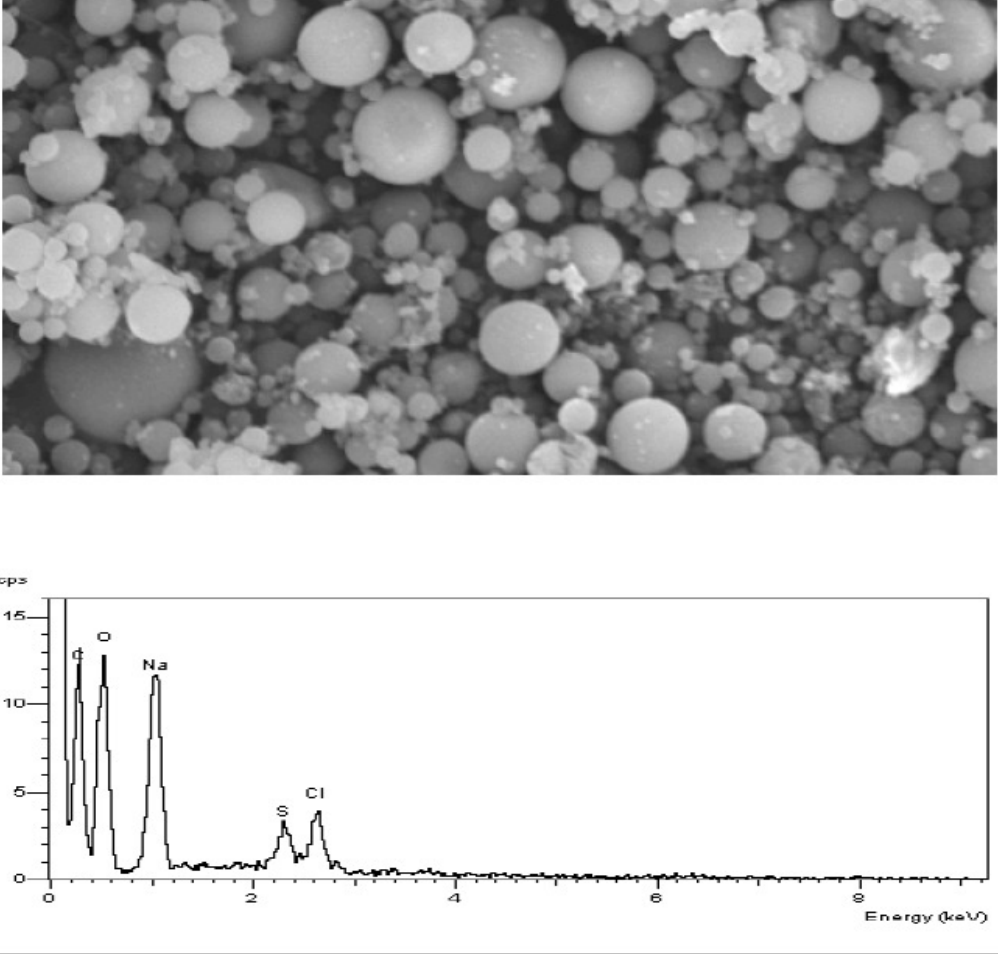
Figure 34: Microscopic view of spheres and their composition under Scanning Electronic Microscope (SEM) analysis.

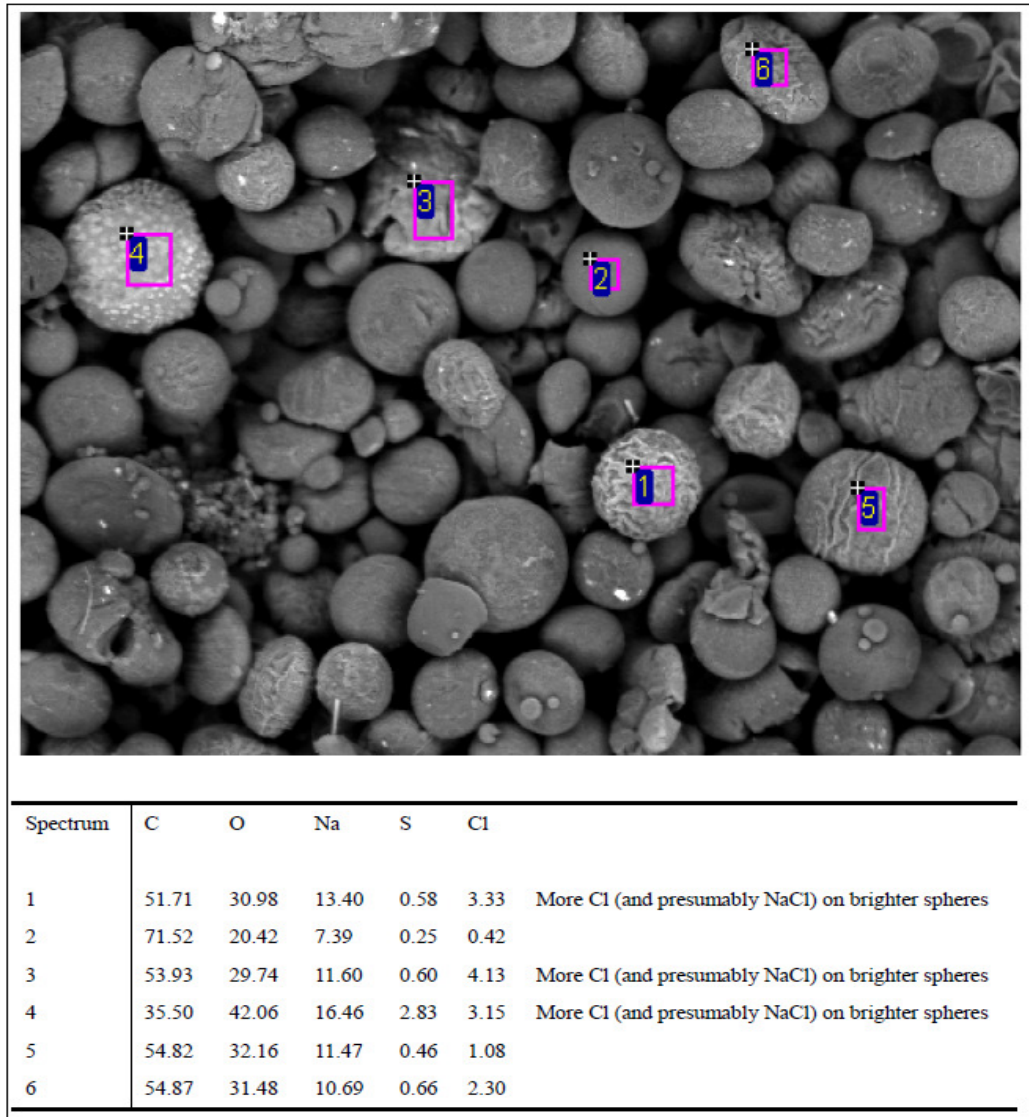
Figure 36: The presence of crystalline sodium chloride on the surface of some spheres

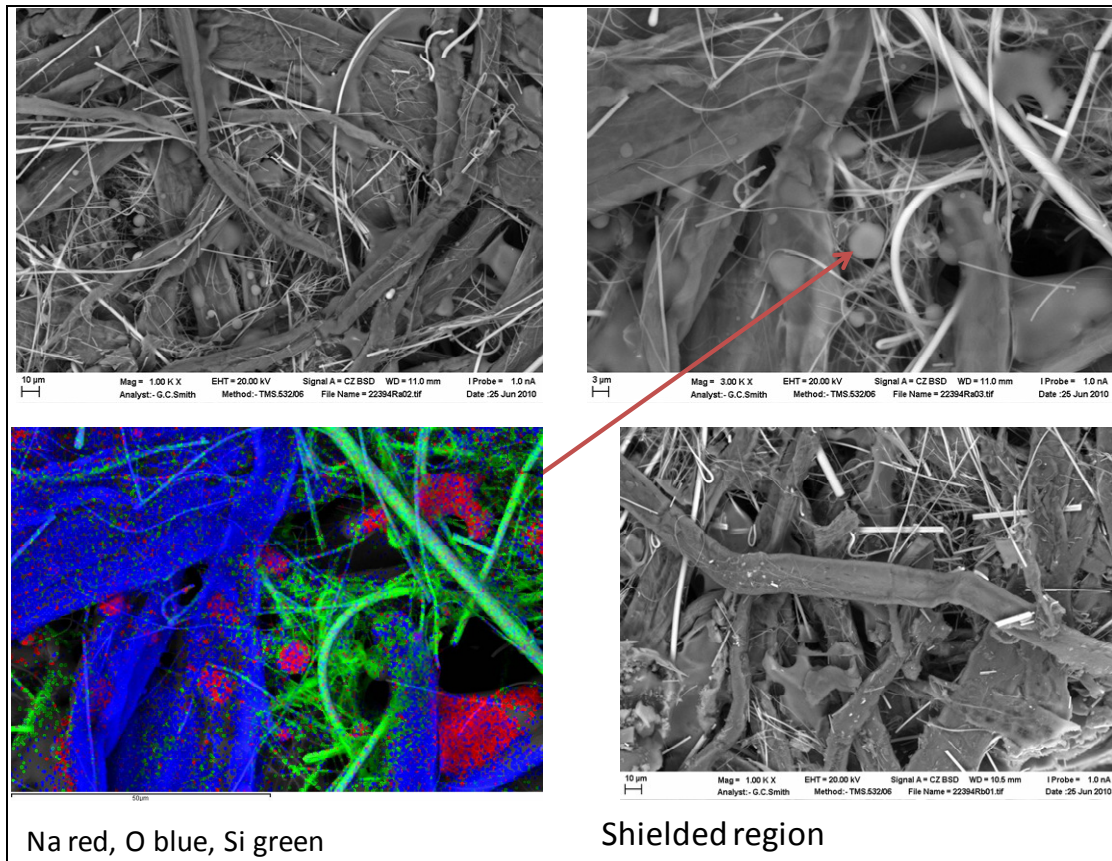
Figure 43: Backscattered electron SEM images and element distribution map from the fuel impact region of the micro-filter. Arrow indicating the presence of a SAP sphere. Lower right is a reference image from the shielded area.

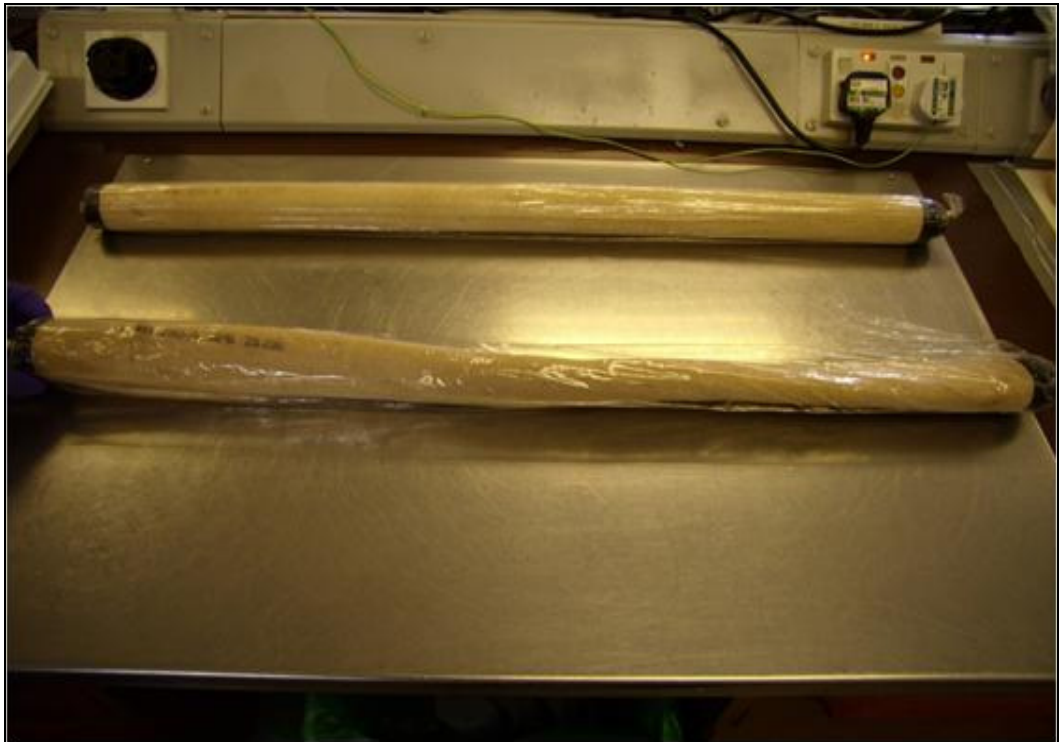
Figure 45: The collapsed Batch 2 filter monitor placed adjacent to a normal filter monitor

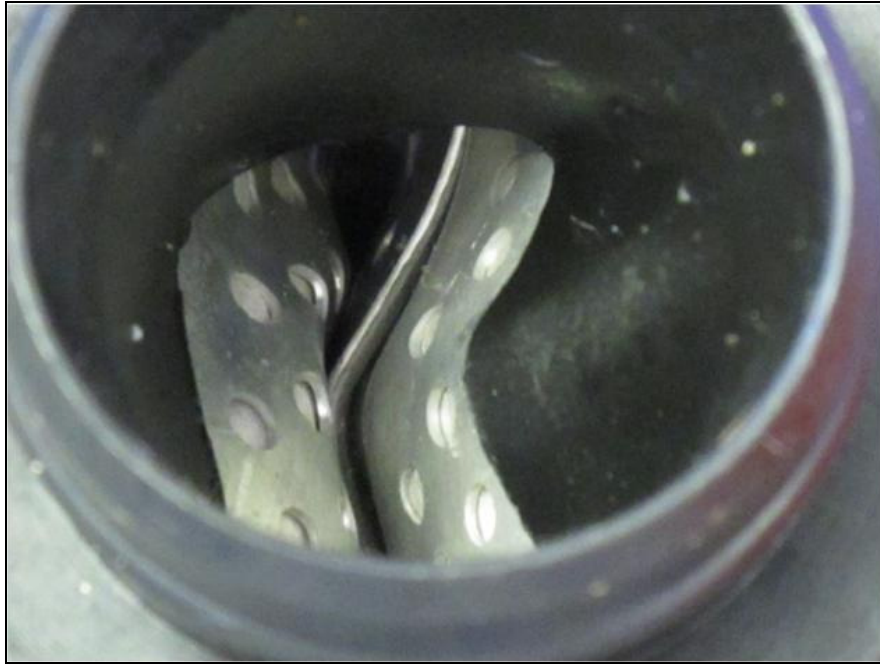
Figure 46: The centre aluminium core tube of the collapsed filter monitor was crushed

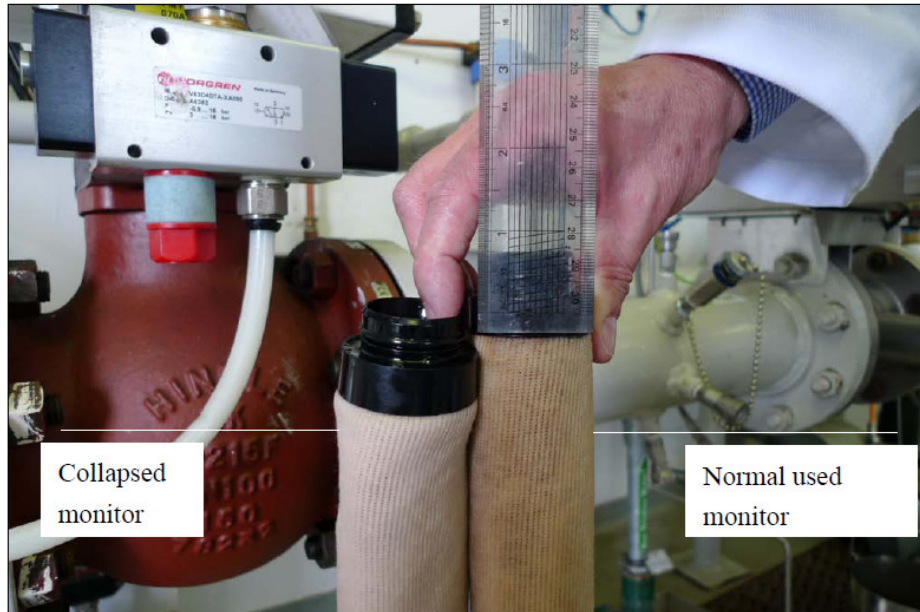
Figure 48: The length of a collapsed filter monitor (left) is shortened

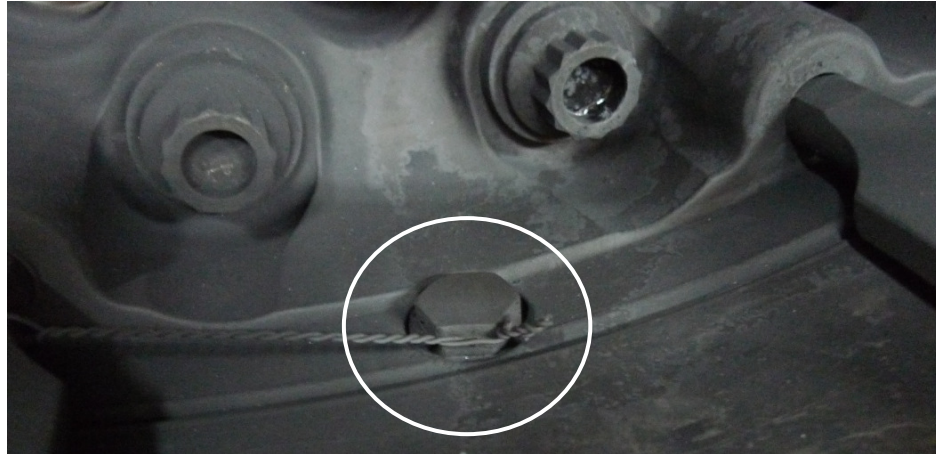
Figure 49: One event fusible plug installed to the wheel showing the centre core was intact
