*Accident
on 25 July 2000
at La Patte d'Oie
in Gonesse (95)
to the Concorde
registered F-BTSC
operated by Air France*

REPORT translation
f-sc000725a

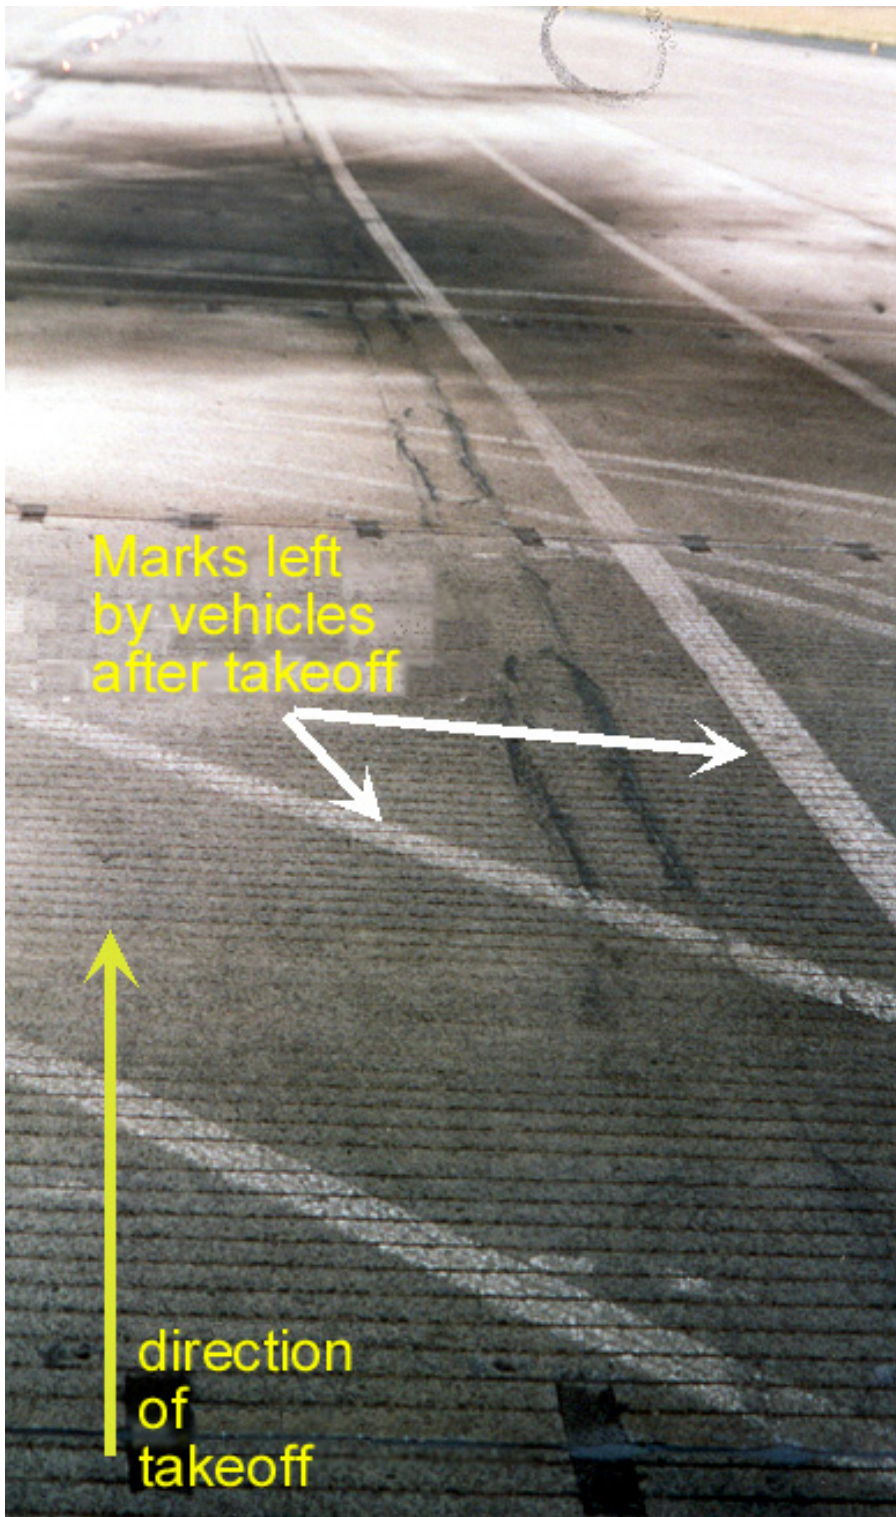
Figure 24: Marks of Wheel No 2 and soot on the runway

When this mark disappeared at about 2,340 m, its displacement from the centreline was about 8 m. This corresponded to the right front tyre of the aircraft's left landing gear.

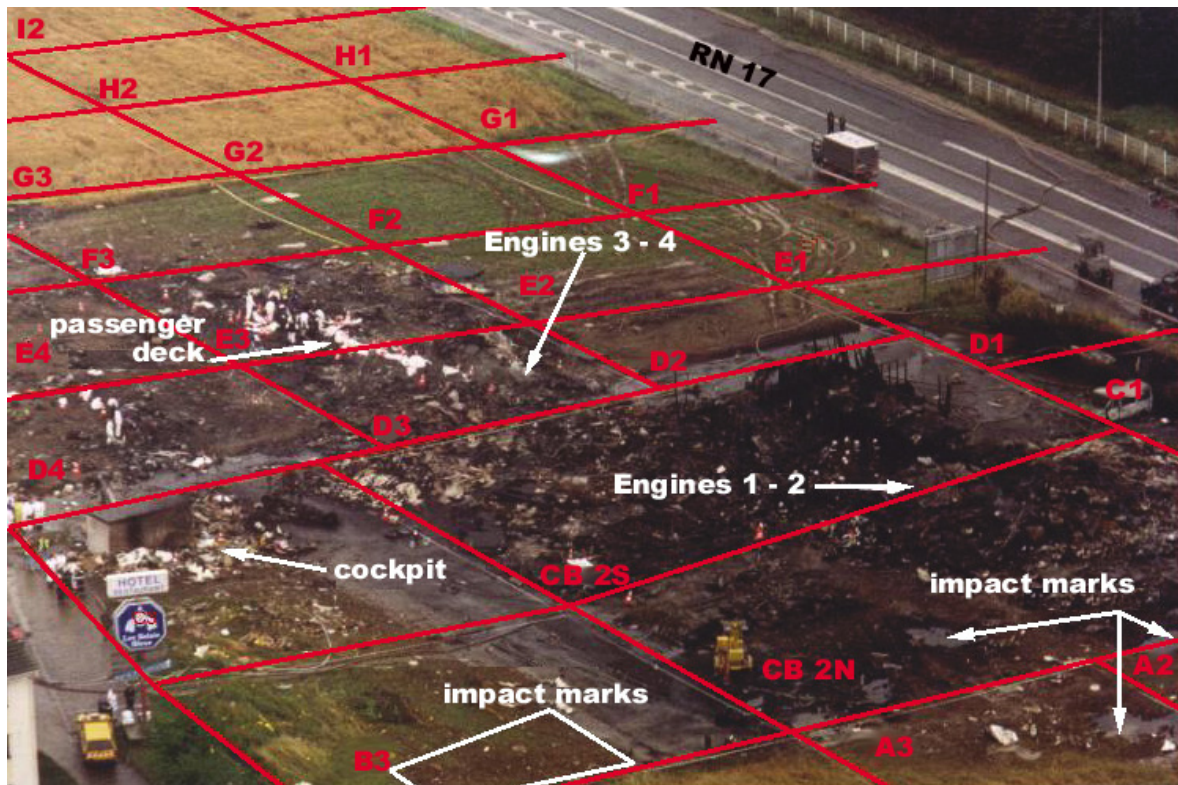
Figure 33: Aerial view with position of main parts

The left main landing gear leg, still connected to its side strut, was found at CB2-South. Examination of the strut's locking mechanism showed that the landing gear was down and locked at the time of impact.

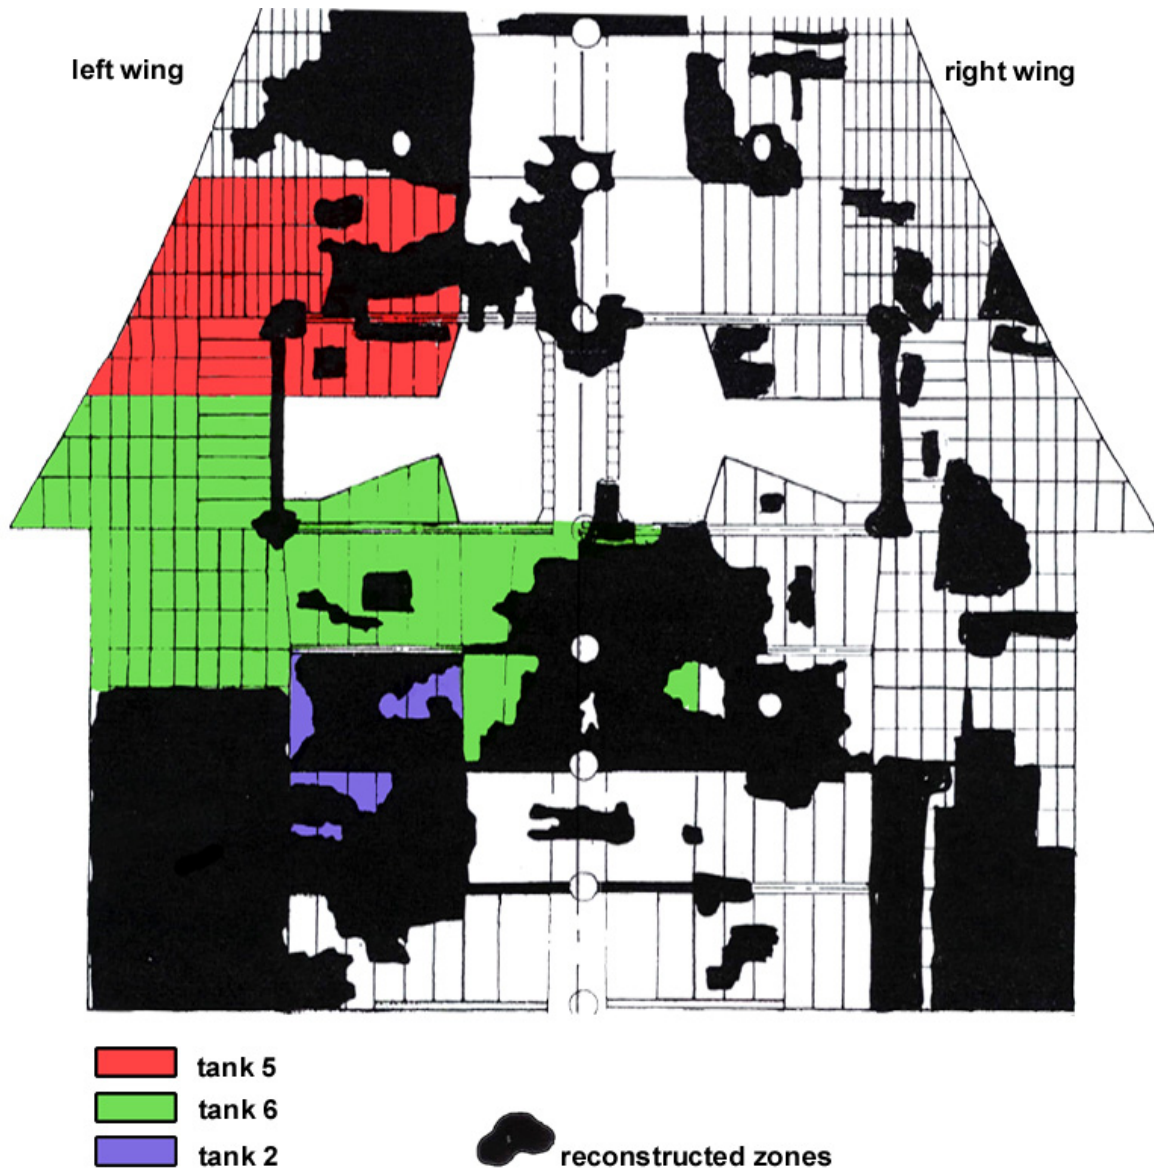
Figure 39: Computer reconstitution of upper wing

It was not possible to reconstruct the surfaces located near the landing gear well, nor the majority of the right wing. A melted piece appeared to have some small punctures.

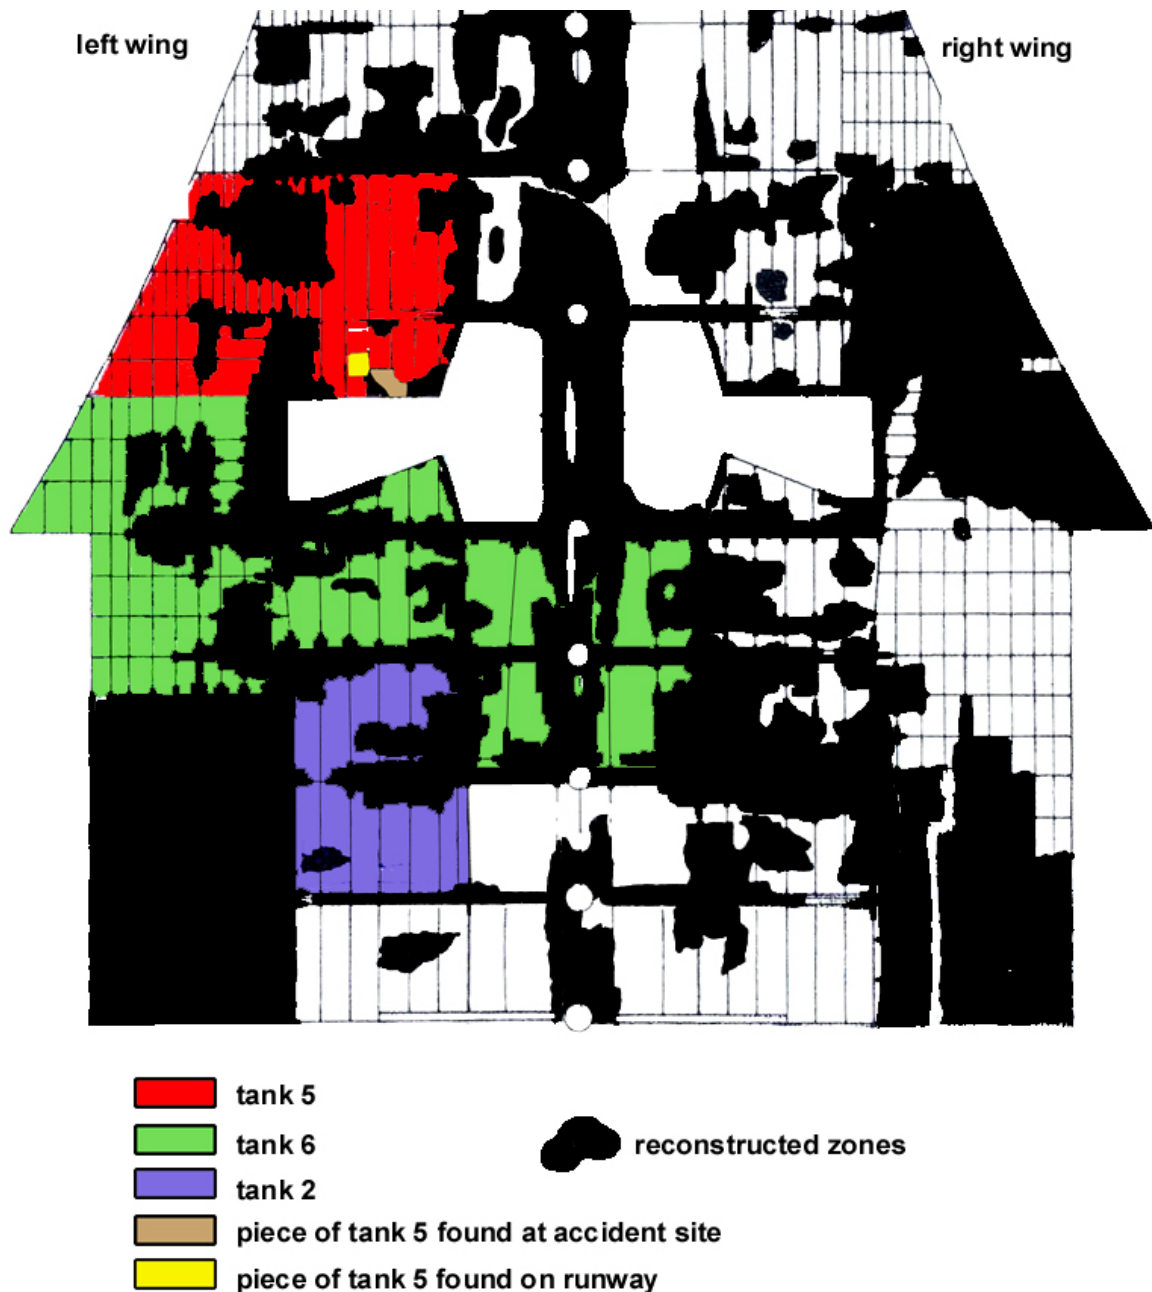
Figure 40: Computer reconstruction of lower wing

Almost nothing from tank 5 was recovered. Only one part of the edge of the landing gear well and two probe locations were still visible near the location of the piece found on the runway. These parts showed no puncture or impact marks, except on one of them.
