ARAIB/AAR0603

Aircraft Accident Report

**Hail Encounter During Approach
Asiana Airlines Flight 8942
A321-100, HL7594
20 miles South East of Anyang VOR
June 9, 2006**

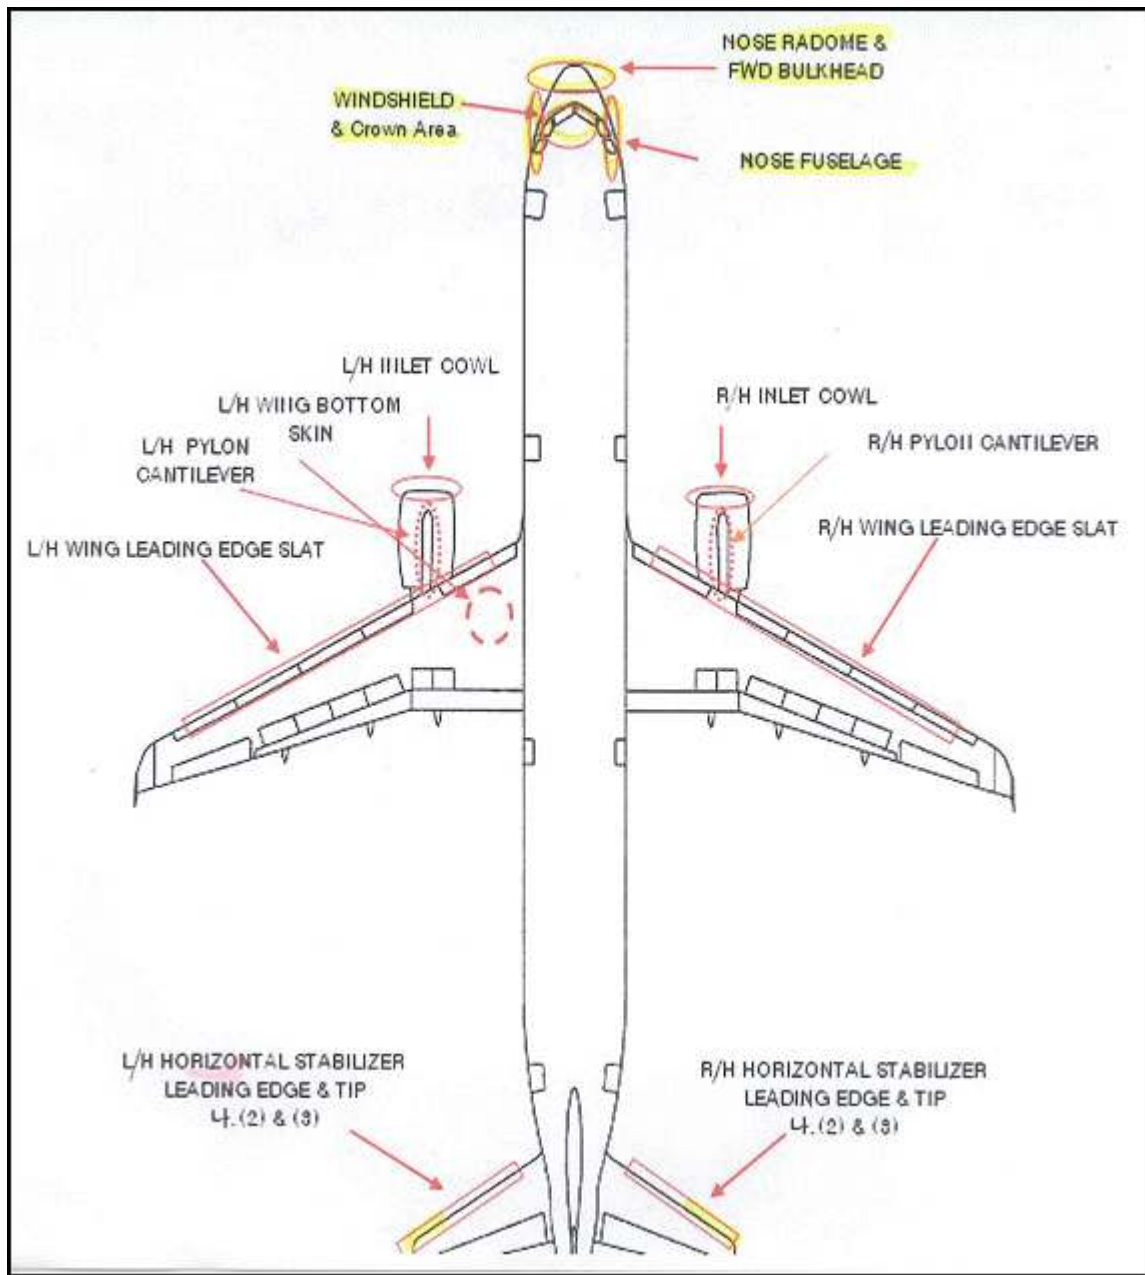
[Figure 2] Damaged Areas (Shown In Red Color)

The airframe of flight 8942 was damaged overall, and the radome in the front section of the aircraft was torn away, and there were about 40 marks found in the forward pressure bulkhead and in the rivets of the inlet cowling. Some of the rivet heads were broken off in a serious case.

Some parts of the engine mounted area were damaged by debris from the radome, and the hail marks were found in wing leading edges.

Horizontal stabilizer leading edges and both tips were also damaged by the hailstorm, and the locations of damage are shown in [Figure 2].

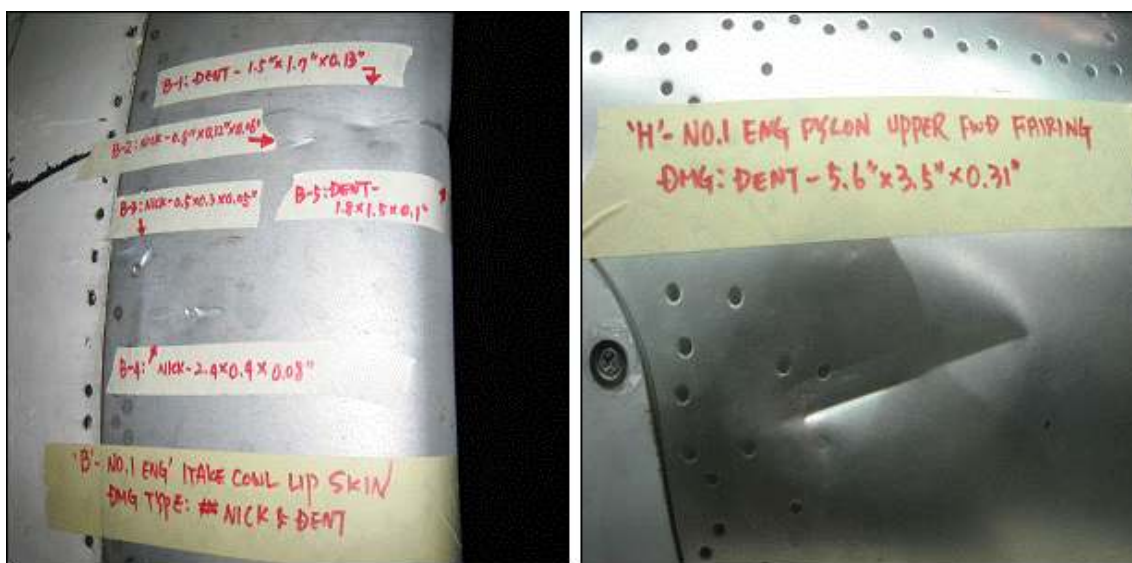
[Picture 11] Damaged Portion from Detachment of Radome

Damages on the cowl of No. 1 Engine, and top and inside of Pylon were due to radome detachment as shown in [Picture 11], and left latch to fasten the radome penetrated into the cowl of No. 1 Engine.

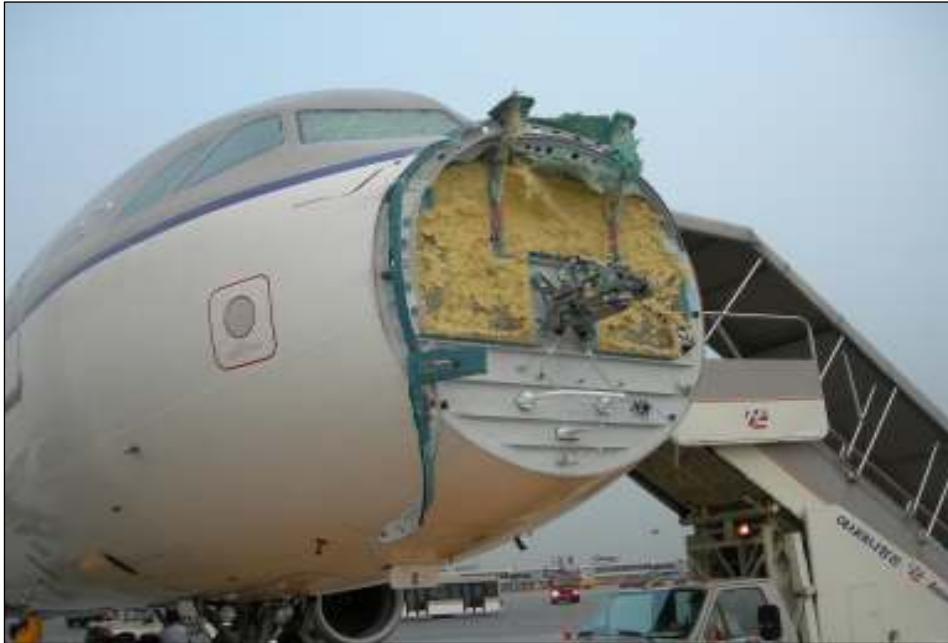
[Picture 12] Damaged Nose of Aircraft

Some debris from the detached radome caused some damages on the No.1 engine cowl and the bottom of left wing. The shape of radome detachment due to thunderstorm is shown in [Picture 12].

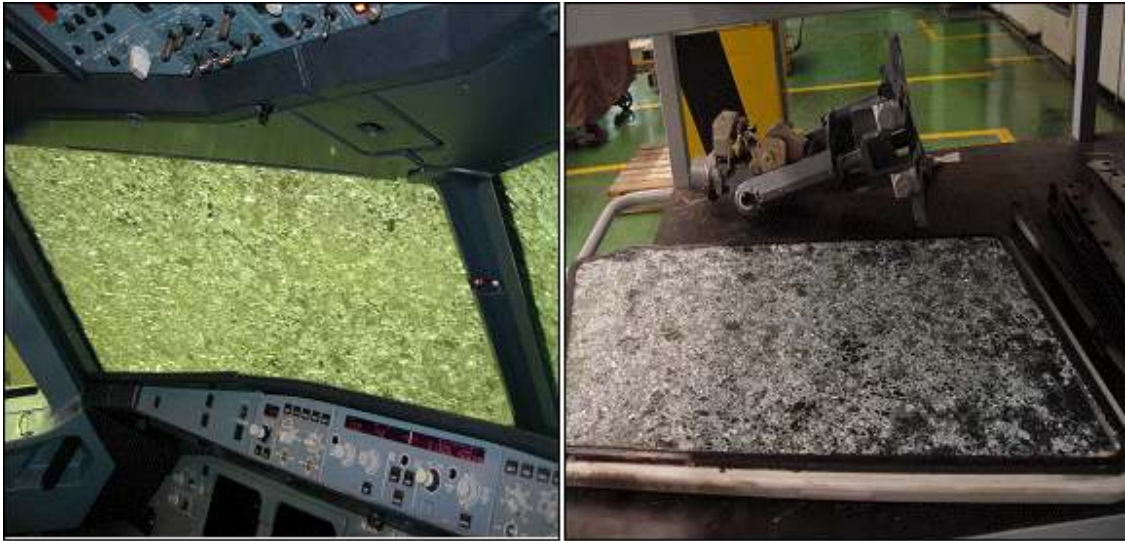
[Picture 13] Damaged Windshield Installed in Aircraft (Left) and After Separation (Right)

The [Picture 13] indicates the damaged windshield. The left Picture was taken from the inside of cockpit and the right one was taken after it was separated from the aircraft.

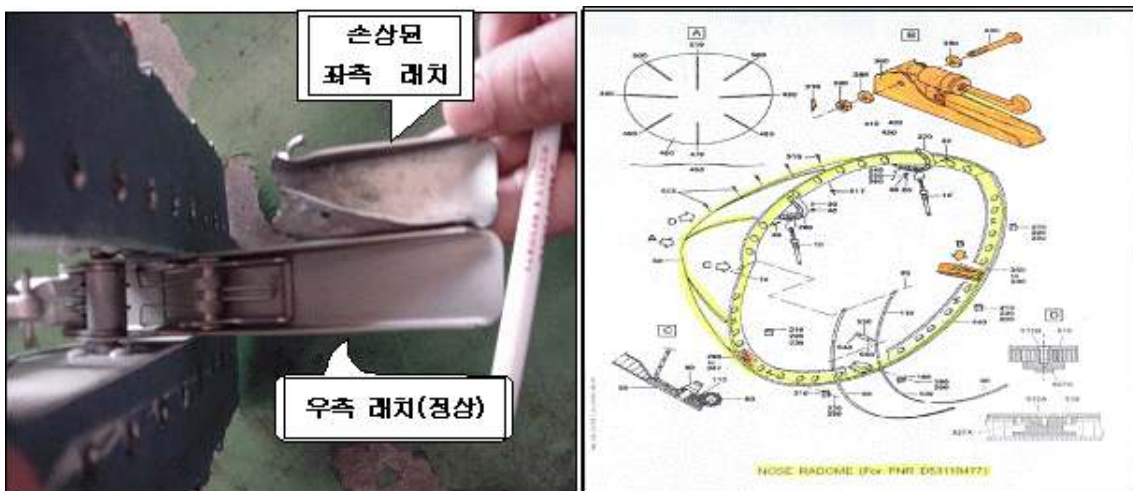
[Picture 14] Comparison of Latches (L/R)

Of the two latches⁵⁹ to fix the radome, the right one was attached to the frame; however, the left latch was separated as shown in [Picture 14] and it caused the damage to the engine cowl and was found inside of it. [Figure 15] indicates the structure of radome.

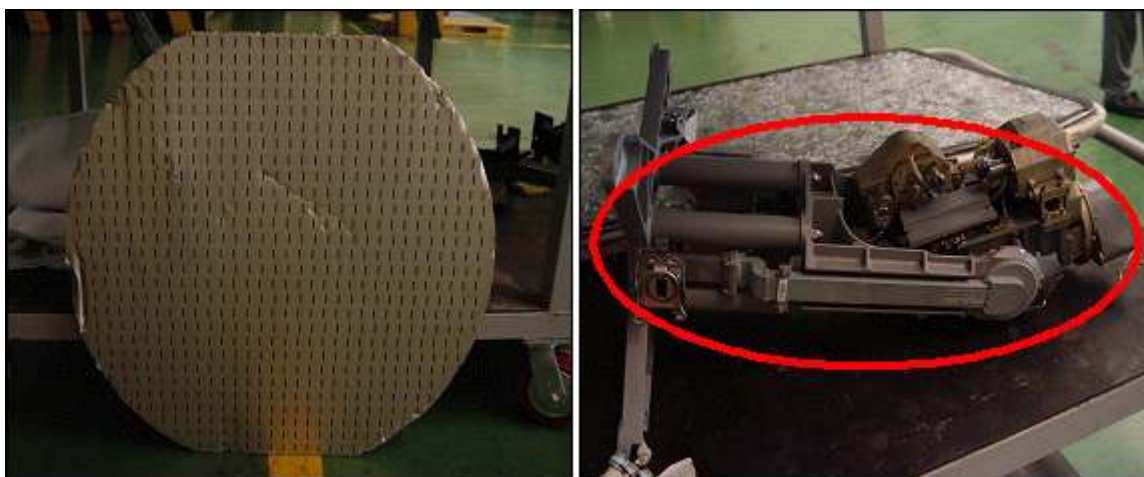
[Picture 16] Weather Radar Antenna and Antenna Drive Unit

One transceiver for weather radar was installed at the avionics compartment⁶⁰, and weather radar control unit was installed inside the cockpit. Therefore, there was no surface damage found on the parts.

The radar antenna was damaged by facing with the external environment installed the inside of the radome by detachment of radome. The antenna was still attached to the aircraft during flight after encountering with the thunderstorm and then fell on the runway due to impact upon landing.

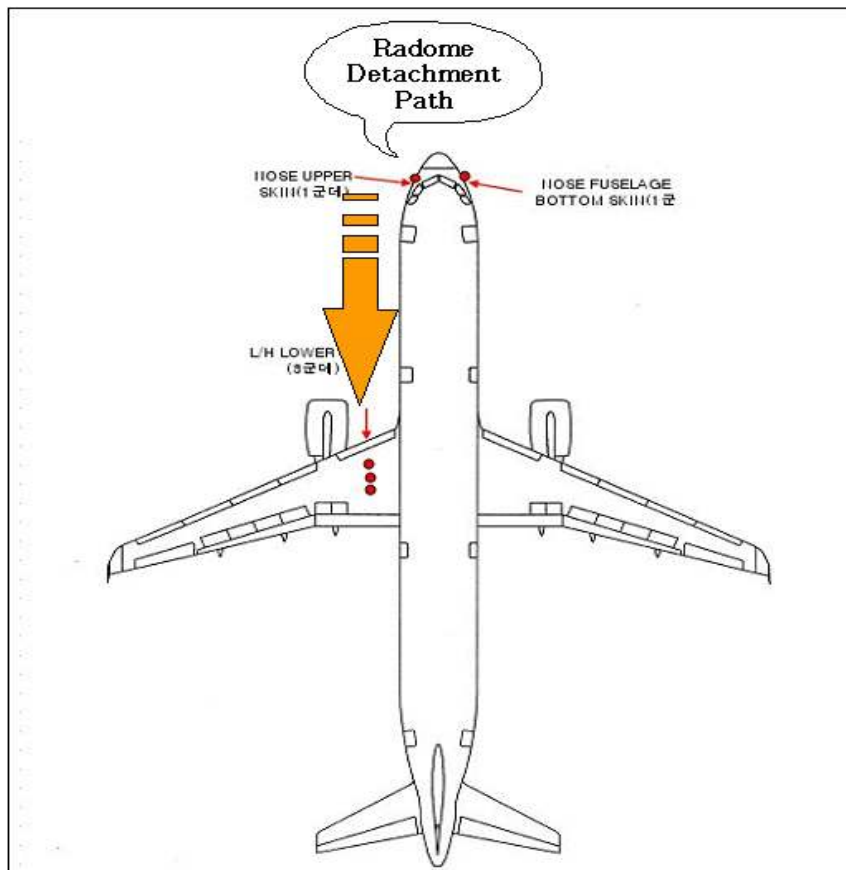
[Figure 19] Inference of Radome Detachment

As shown in [Figure 19], the hail hit the cockpit windshield and the radome and damaged to the radome made of composite material. It is presumed that (1) the radome was broken more and more and then detached due to increase of pressure as the air entered into the inside in case of puncture to the radome, or (2) it was detached from the aircraft as lifted by untied latch which support the radome due to impact by hail hit. It is analyzed that the case (1) is highly feasible and that only this case has to be considered.

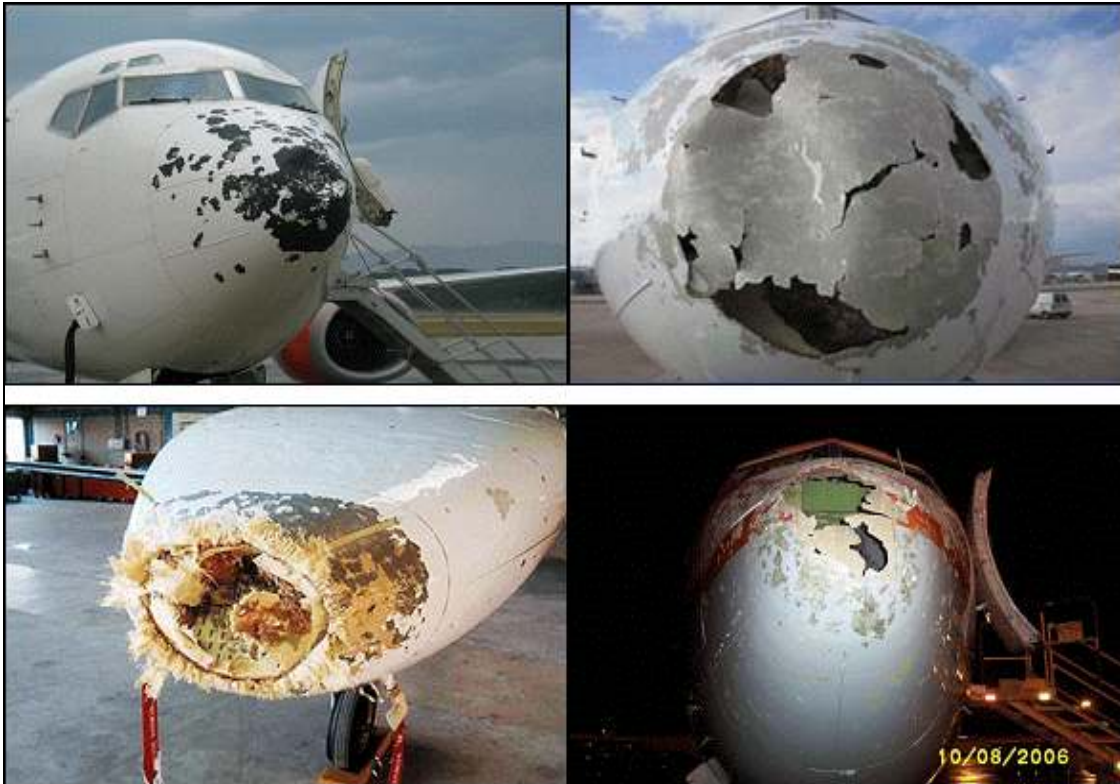
[Picture 18] Shape of Damage to the Front Radome Due to Hailstorm

There have been cases that the radome was damaged by hailstones when an aircraft encountered with a thunderstorm accompanied by hailstones. As shown in [Picture 18], it shows the damage to the radome due to the hail and it was still attached to the airframe in spite of the damage to the radome. Although it was severely damaged and partially detached, the radome itself was not detached. The shape of damage to the front radome can be seen in [Picture 18] due to the hailstorm.

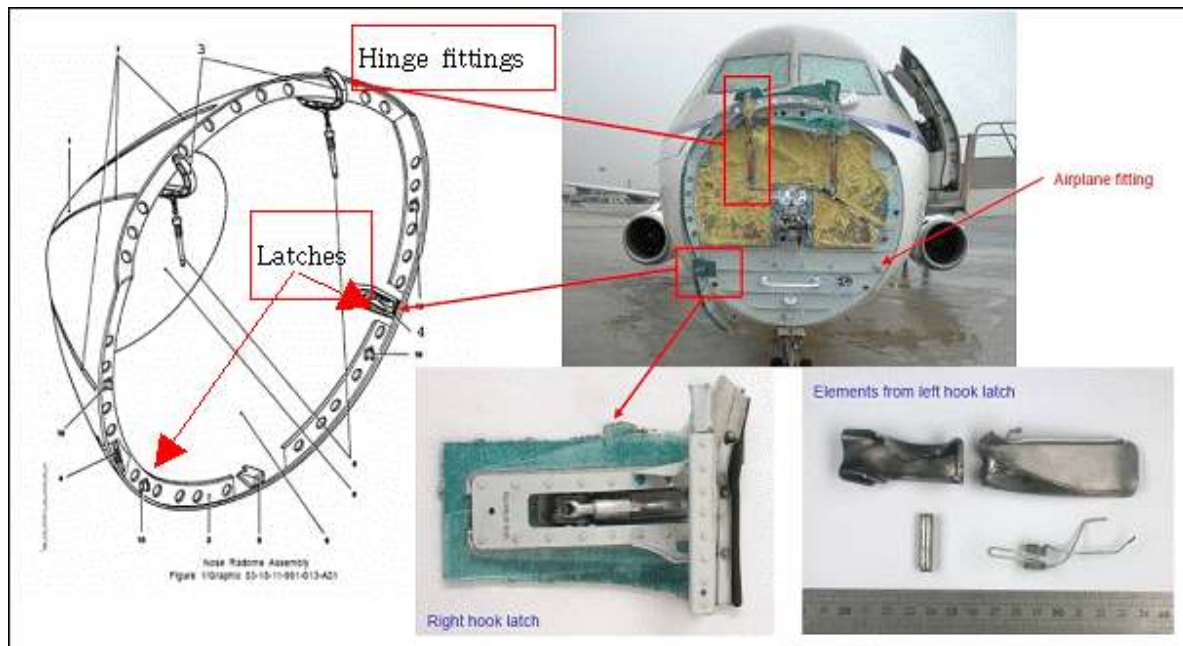
[Figure 21] Location of Latch Installed in the Aircraft and Damaged Pattern

[Figure 21] shows the location of parts installed in the aircraft and damaged pattern analyzed in the France BEA research lab.

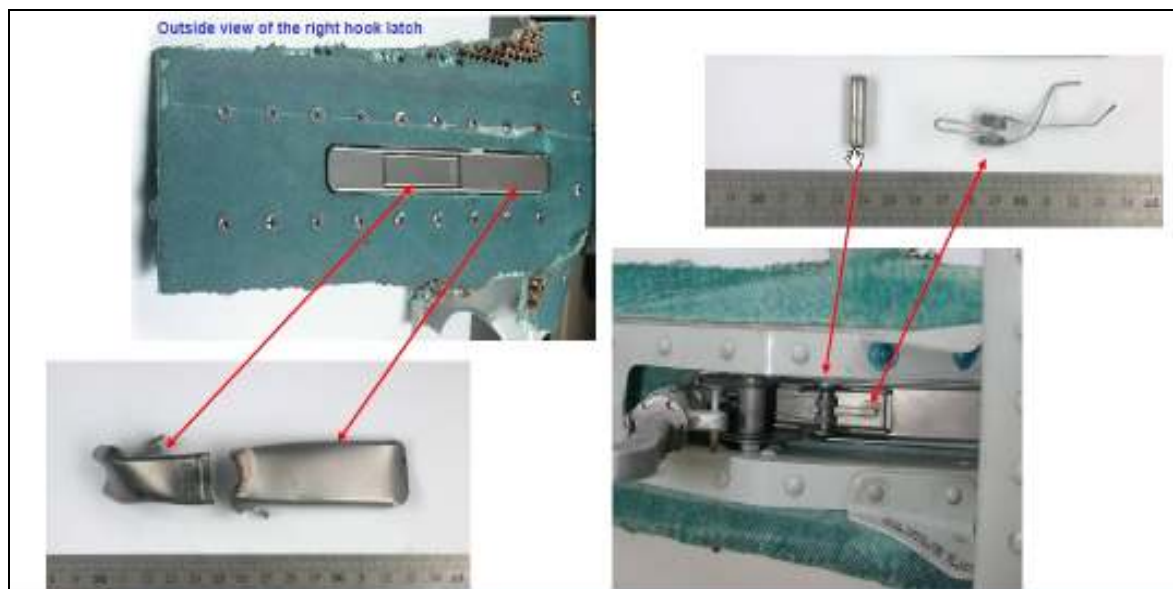
[Picture 20] Damaged Parts of the Left Hook Latch

[Picture 20] shows the damage parts from the left hook latch. The damaged part is the pushbutton marked as “PUSH,” the axle pushbutton spring and the rear part of the locking handle detached from pushbutton.

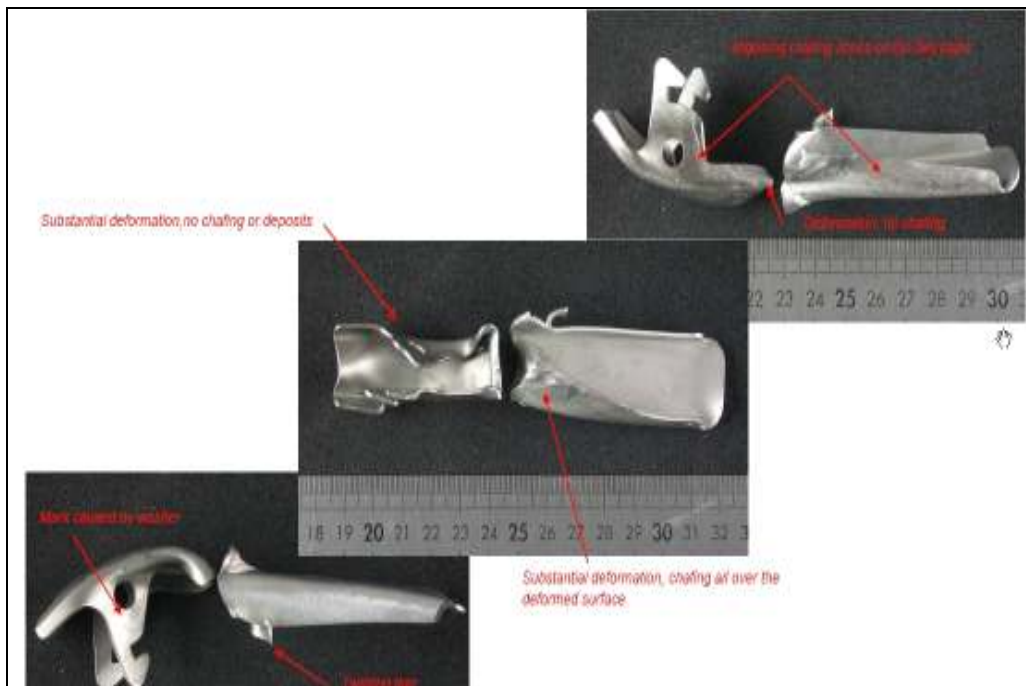
[Picture 21] Damage to the Left Handle

There were many deformation found in the left side and chafing was also found on the entire surface deformed. There were mark made by washer and twisting found as shown in the left lower picture.

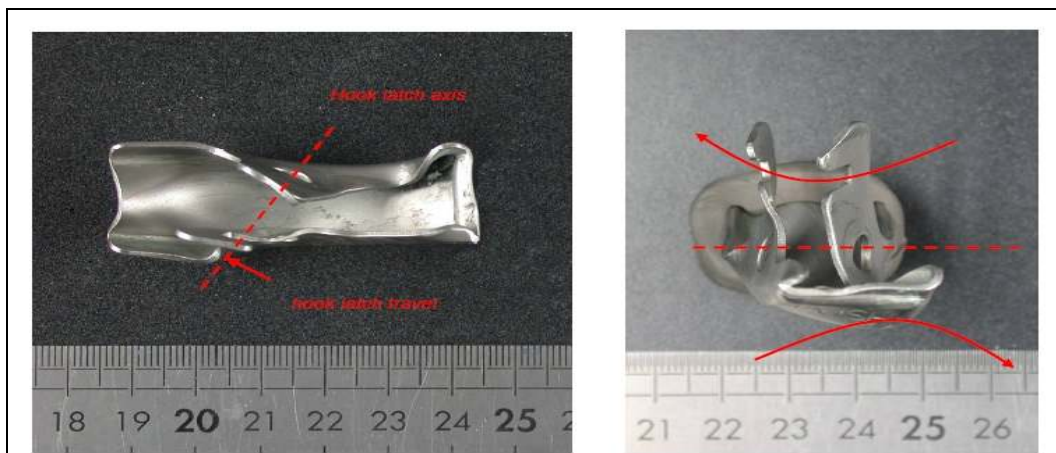
[Picture 22] Deformation of Pushbutton

The hook latch moves along its axle. The left picture on the [Figure 22] shows the deformed pushbutton. The reason of deformation was that the high energy applied to the pushbutton. The direction applied was the direction of bent arrow. As shown in [Picture 22], the indentation of hook latch was by spigots.

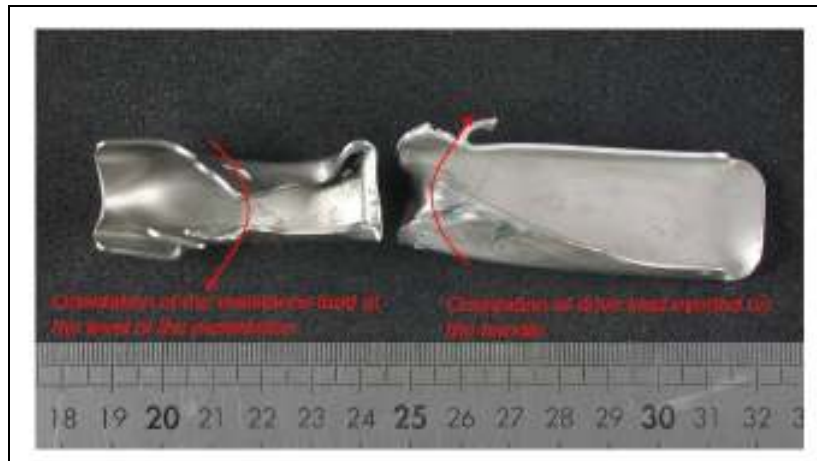
[Picture 23] Damage to the Left Handle and the Pushbutton

The left arrow shows the resisting direction applied horizontally to the pushbutton and the right arrow is the direction of pushing force applied to the handle. As shown in the [Picture 23], the force in a reversed direction was applied to the handle and the pushbutton. Such applied force made the rear part of the handle torn out as in the pushbutton.
