**REPORT
ON
ACCIDENT TO AIR INDIA EXPRESS BOEING 737-800
AIRCRAFT VT-AXV ON 22nd MAY 2010
AT MANGALORE**

**THE COURT
AIR MARSHAL BN GOKHALE, PVSM, AVSM, VM (Retd)
FORMER VICE CHIEF OF AIR STAFF, INDIAN AIR FORCE**

**GOVERNMENT OF INDIA
MINISTRY OF CIVIL AVIATION**

**NEW DELHI
31st OCTOBER, 2010**

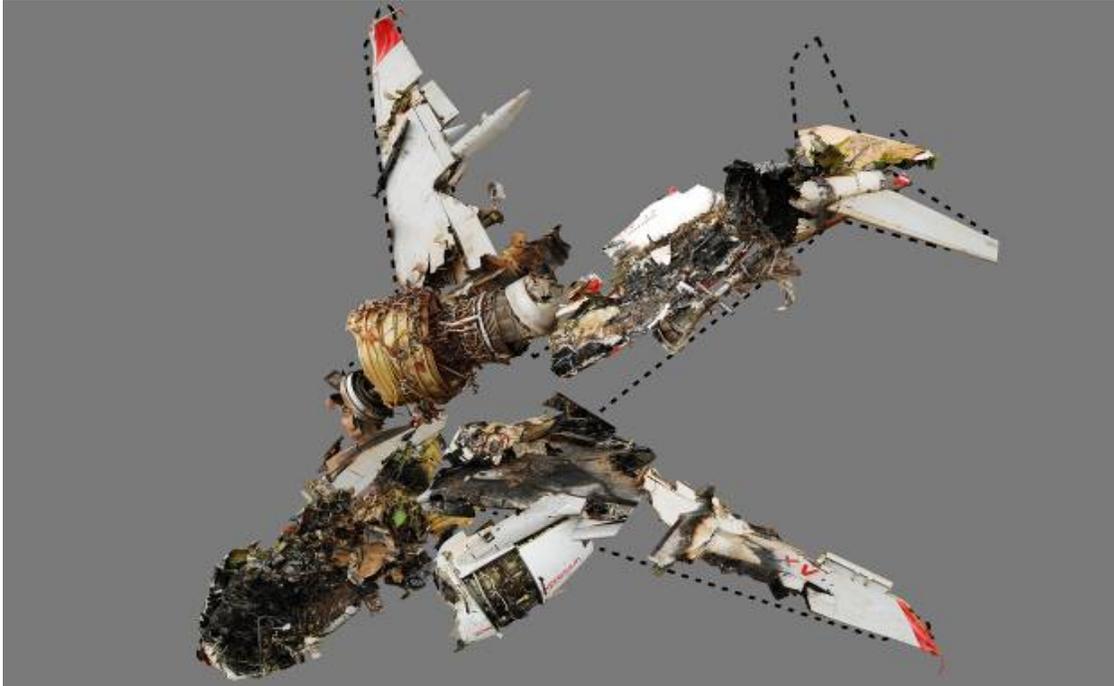
Photo 2: Photograph of the Re-arranged Wreckage

The entire wreckage from the crash site was later shifted to a secure area within the airport premises. For the ease of investigation, it was arranged in the shape of an actual aircraft as shown below: -

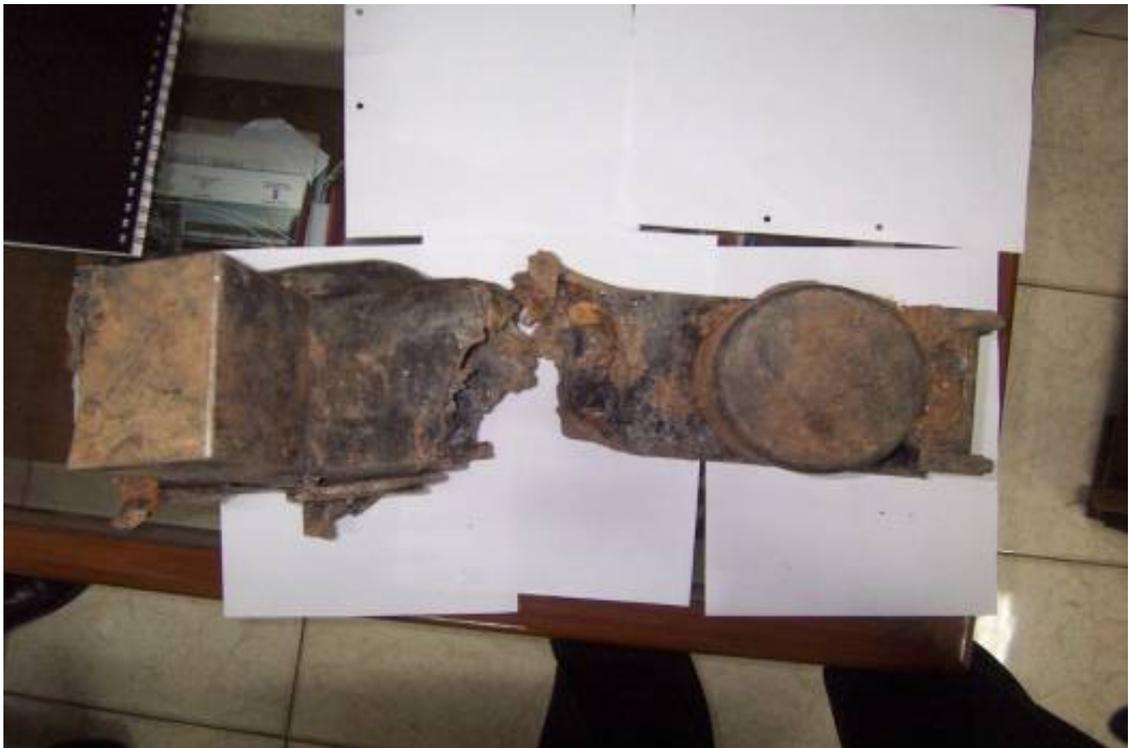
Photo 4: Digital Flight Data Recorder (In Damaged Condition)

The DFDR of accident aircraft was recovered from the crash site after 3 days i.e. on 25th May 2010. The DFDR had sustained substantial damage due to impact and post impact fire. The DFDR had broken into two pieces, one piece contained the Crash Survivable Memory Unit (CSMU) and other containing the connector as shown in the photograph below:-

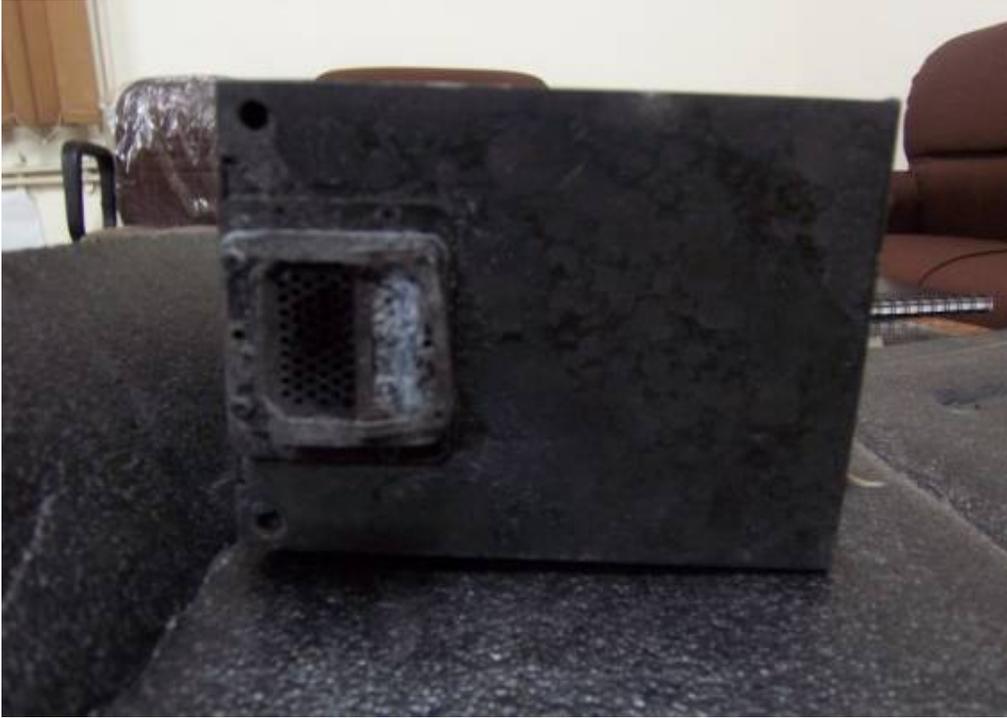
Photo 5: Connector of the CVR Damaged Due to Fire

The CVR had sustained significant heat and fire damage to the exterior as shown below:-

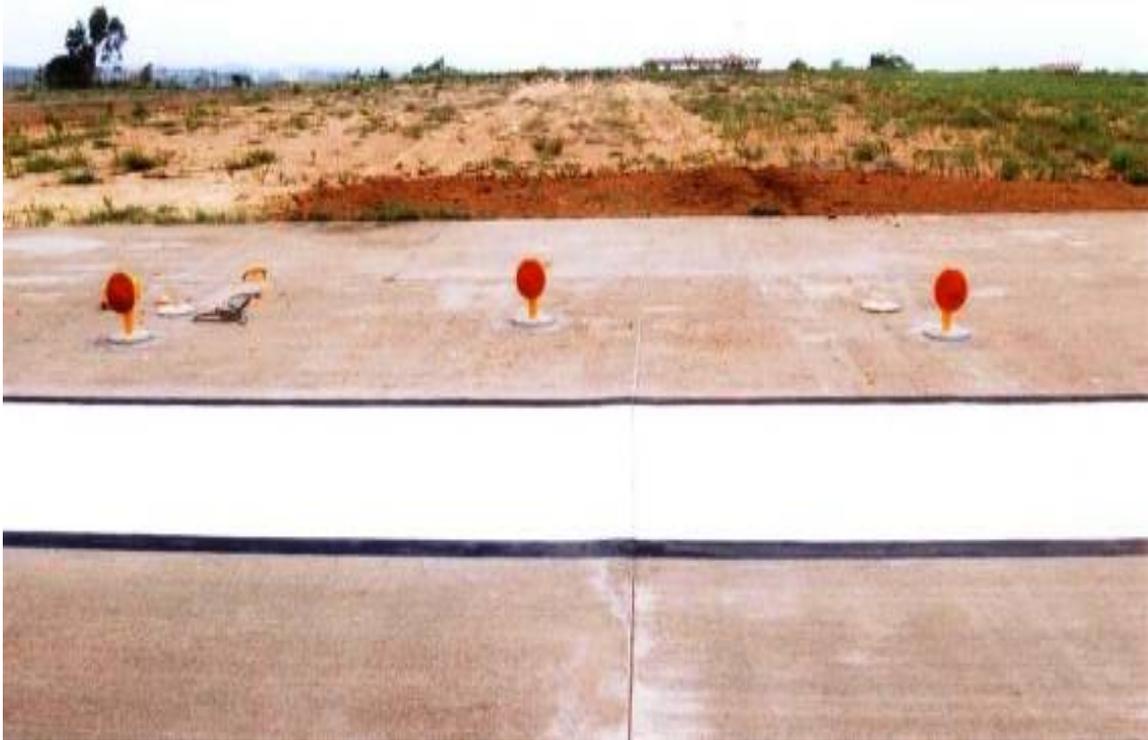
Photo 7: End of Runway 24 (Far View)

Thereafter, aircraft broke two runway edge lights towards the left of landing run (1st and third on left of centre line viewing from R/W 24). Then the aircraft overran the R/W 24 end and entered the Runway End Safety Area (RESA). It further broke five approach lights for R/W 06, in the RESA. In the RESA, wheel marks of all the three landing gears indicated that the aircraft was gradually turning towards the left. This is indicated in a rough Diagram 10, placed above.

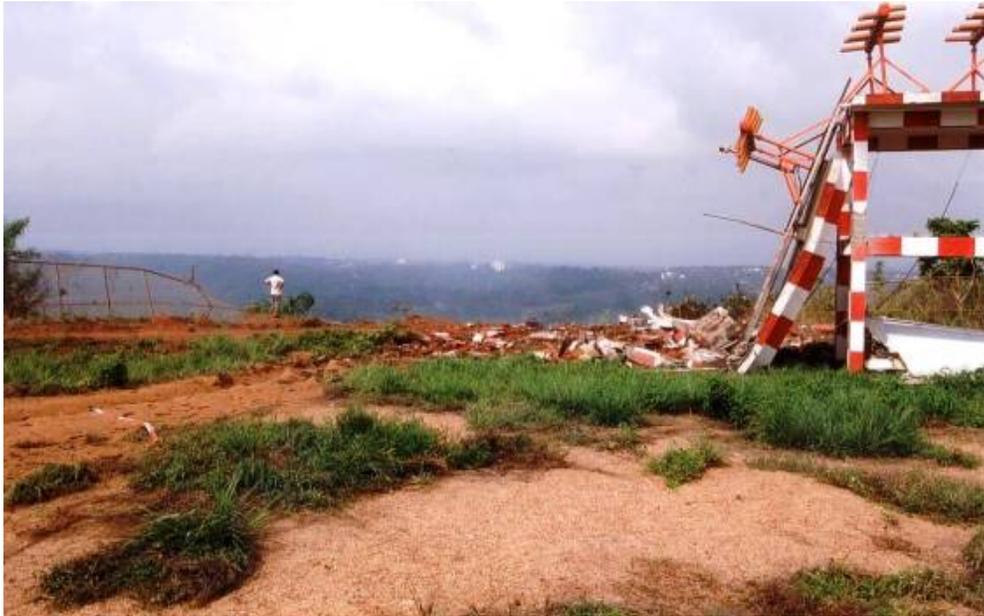
Photo 9: Broken ILS Mounting Structure Due to Impact of Wing

At a distance of 235 metres from R/W 24 end, the ILS localiser antenna had been mounted on a concrete structure. The out board portion of the right wing impacted this localiser mounting structure and got separated. The Right wing contacted two left pillars and the extreme left pillar collapsed. The second pillar from left, showed impact damage about 10 feet above ground. Outer portion of the right wing (WBL 616.75 to WBL 680.40) consisting of winglets was recovered at the localiser structure.

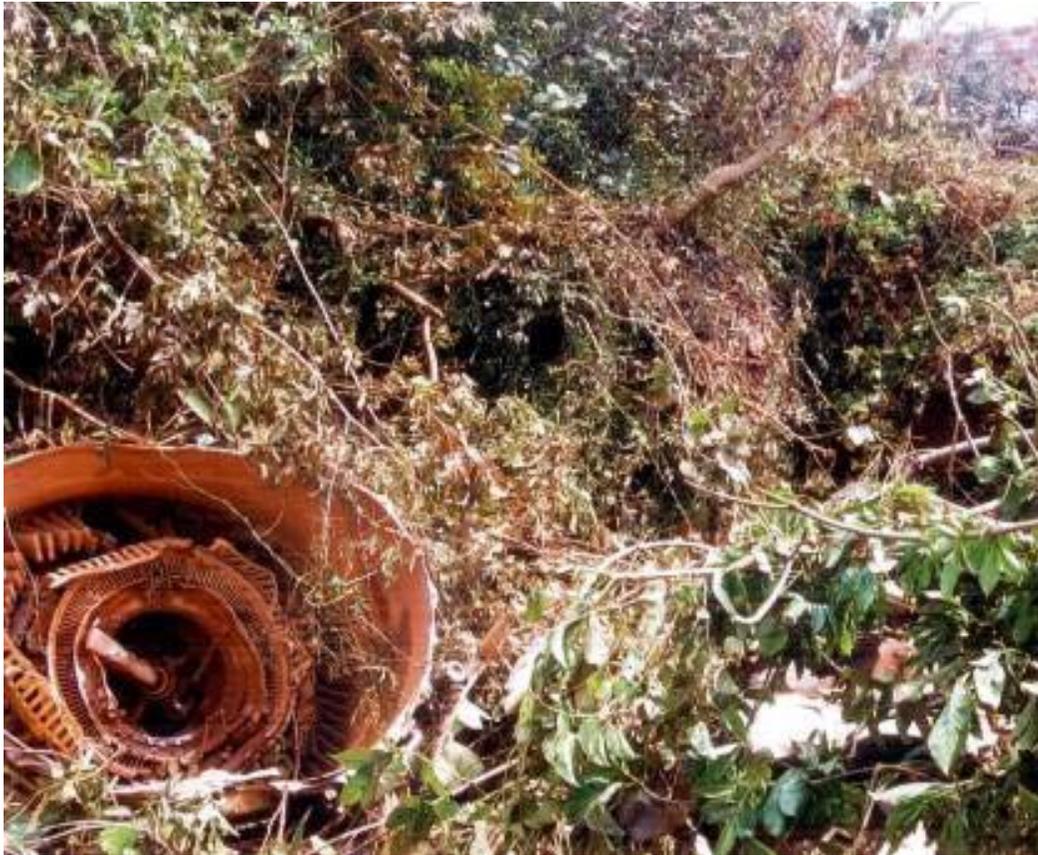
Photo 11: Right Engine lying on the Slope near End of the Airport Fencing

The aircraft then impacted the boundary fence and a portion of the Right wing (from WBL 71.24 to WBL 616.75) containing T/E Flap number 8, L/E Flaps and Slats, was found lying at the edge of the boundary. There were indications of fire visible in this area on the vegetation where the portion of the wing was found. Mangalore being a tabletop runway, the aircraft moved down along the slope of the hill after impacting the boundary fence. A portion of the Right wing, Right engine, Right main landing gear and few other structural parts separated from the aircraft in this area. Due to impact, component/parts of the Right engine also separated. Right engine fan frame, thrust reverser frame, core engine and associated components were recovered on the slope.

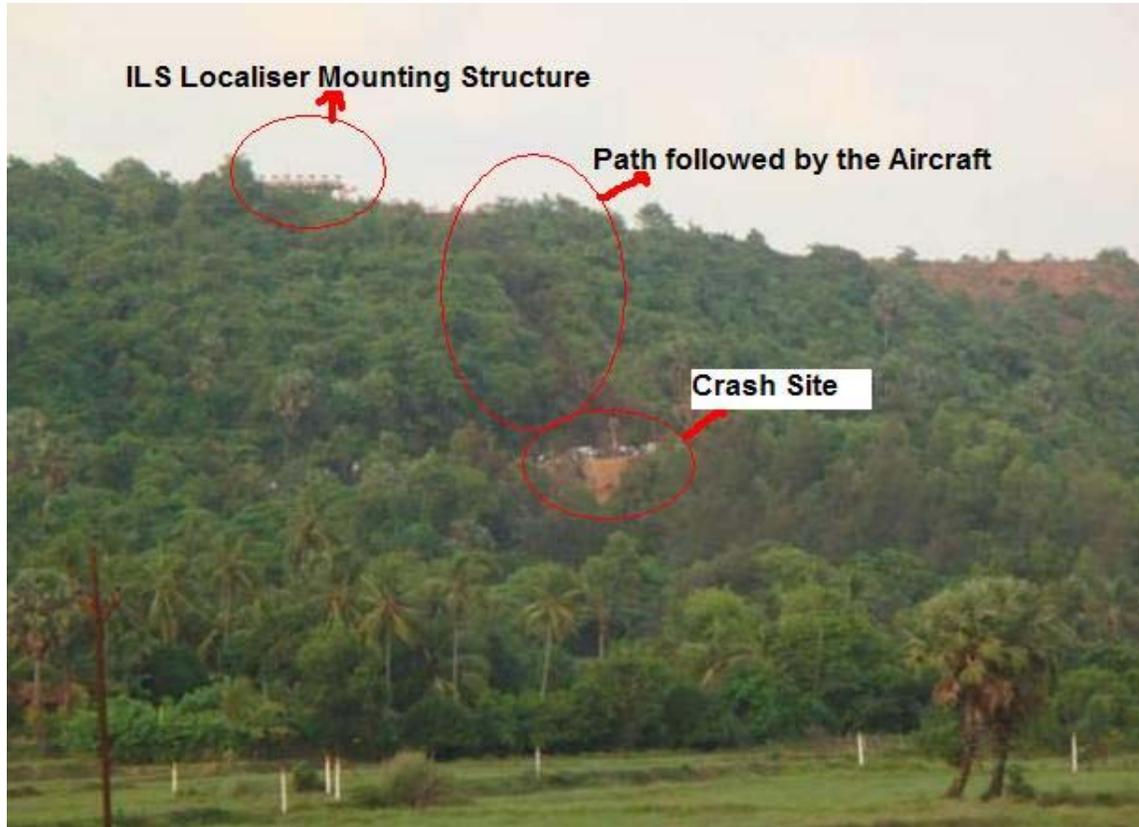
Photo 12: View of Path Followed by the Aircraft from Localiser Structure

At the end of the initial down-slope, there was a road followed by a gorge. The aircraft entered the gorge and separated into three main portions. The aircraft caught fire and a large portion of the aircraft was consumed in the fire. Due to impact and fire, the aircraft was destroyed.

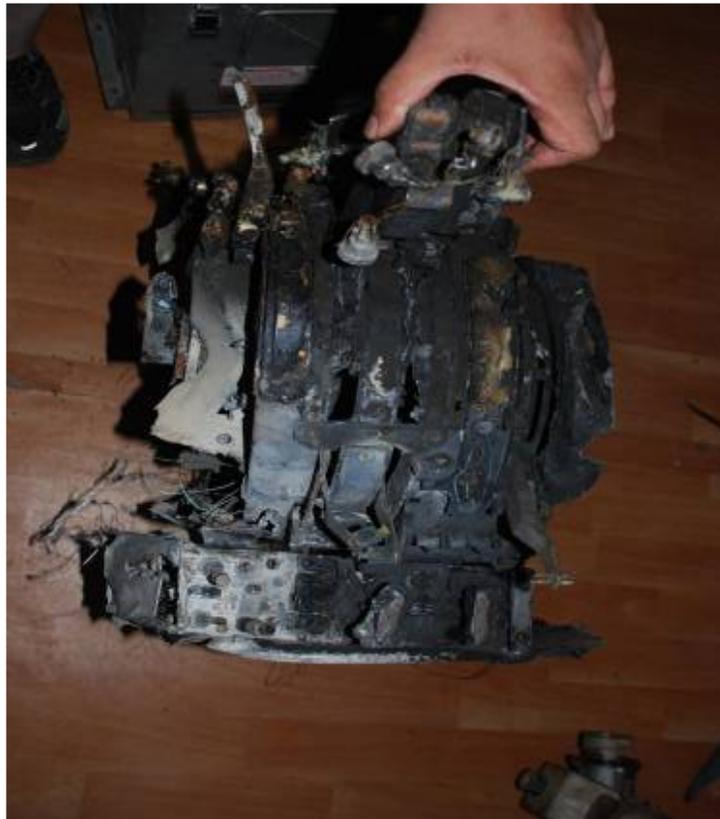
Photo 14: Control Stand

- Landing Gear Lever : Near Down Detent and Jammed
- Thrust Lever : Fully Forward
- Flaps : At Flap 40 detent
- Speedbrakes : Down Detent

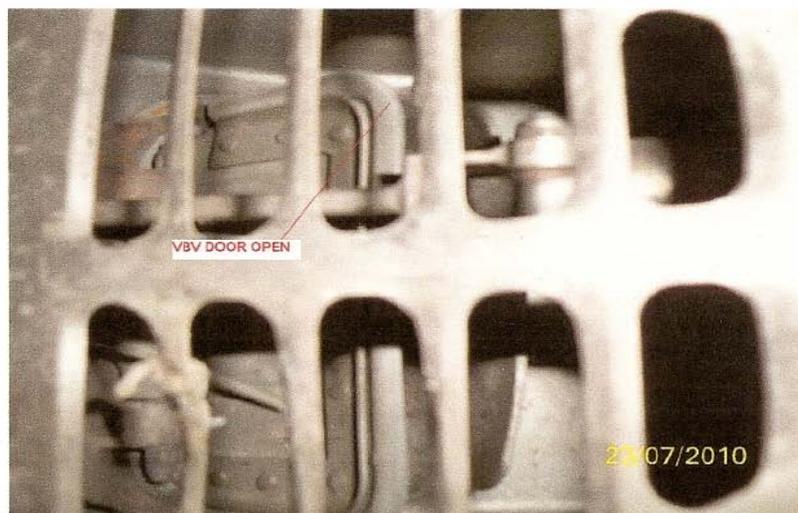
Variable Bleed Valve

1. Inlet cowl removed from the engine as instructed and engine installed on pedestals.
2. Inlet cowl found with impact damages at the forward end causing metal and composite material to liberate and enter into the gas path.
3. Fan frame and spinner cone found with deep dents.
4. All fan blades are found damaged. Some fan blades are observed torn with pieces missing.
5. The N1 and N2 spools of the engine could be rotated.
6. Exhaust nozzle and plug found with impact damages.
7. Variable bleed valves found fully open. Refer photograph below.

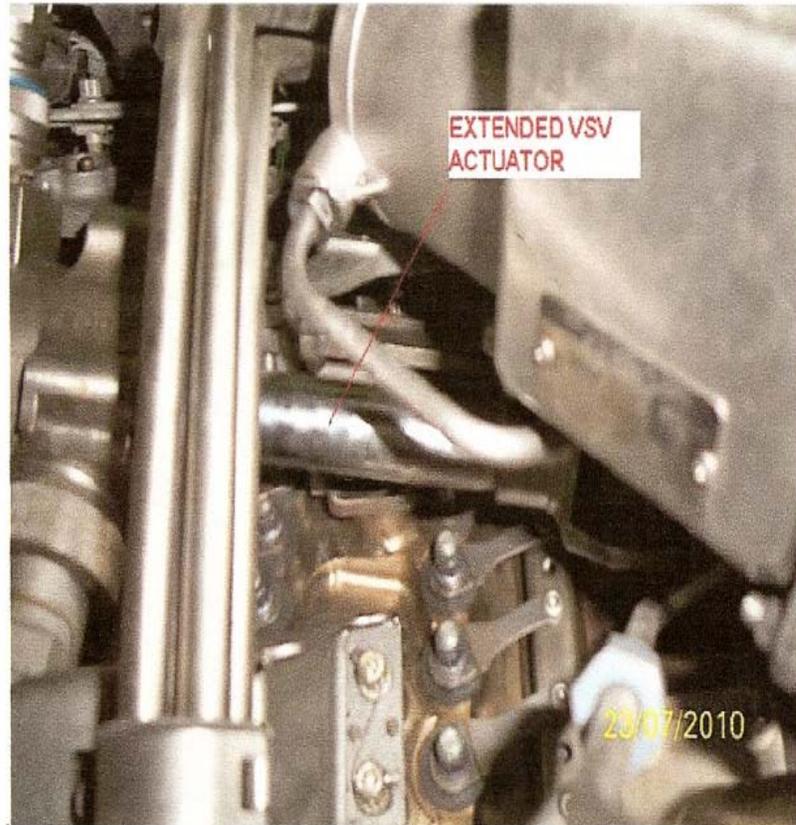
VSV Actuator.

8. Variable stator vane actuators found extended exposing approximately 3.500 inch of actuator piston rod. Refer photograph below.

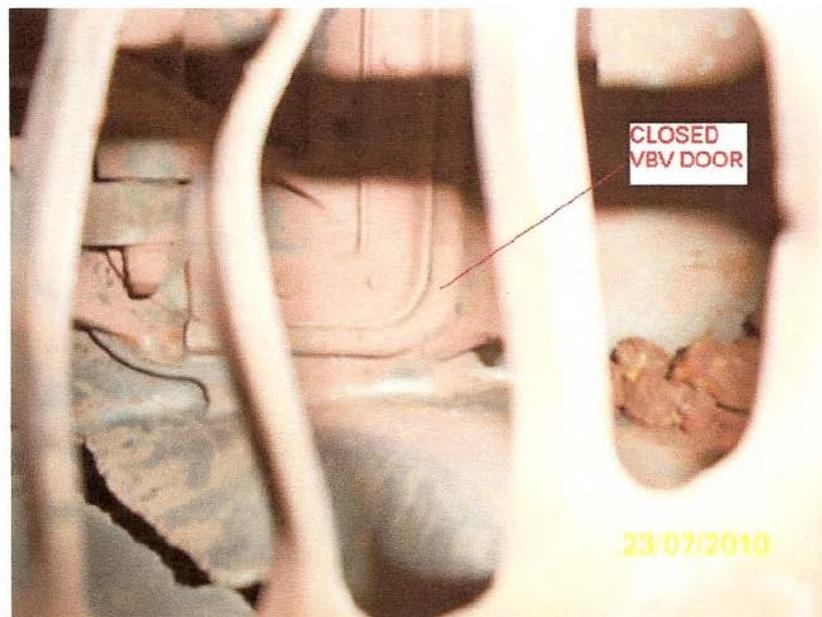
Variable Bleed Valve

1. Fan frame and turbine rear frame found distorted.
2. The forward and aft engine mounts found missing and thrust links found broken.
3. Fan frame observed twisted approx. 90 degree anti-clockwise looking from rear of the engine.
4. Low pressure turbine shaft found broken and the low pressure compressor with fan received as a separate disintegrated unit. All fan blades found sheared off near the root of the blade.
5. The N1 and N2 spool of the engine could not be rotated.
6. Accessory gear box and most of the accessories observed broken.
7. Variable bleed valve doors found closed, bleed ring area found totally distorted. Refer photograph below.

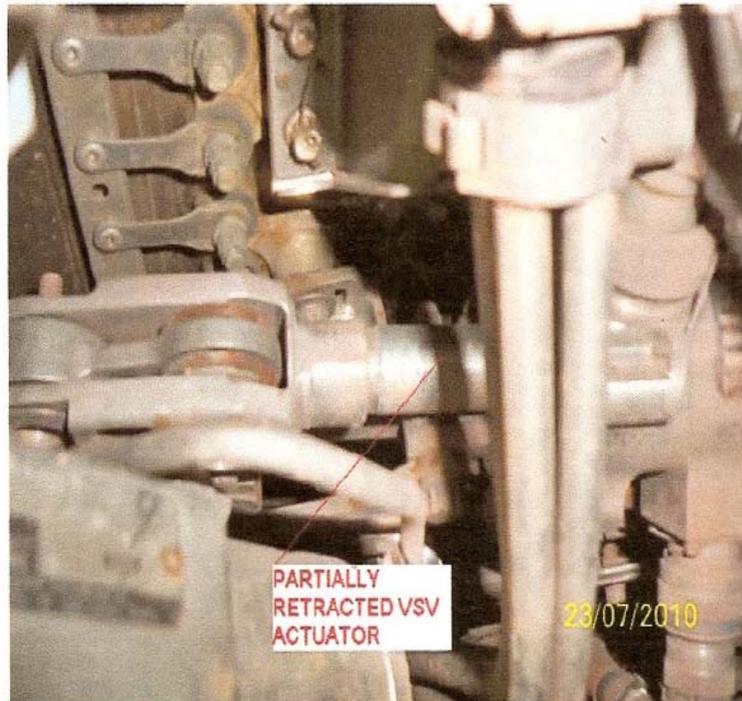
VSV Actuator.

8. Variable stator vane actuators found extended partially. Approximately 1.3 inch of actuator piston rod found extended. Refer photograph below.

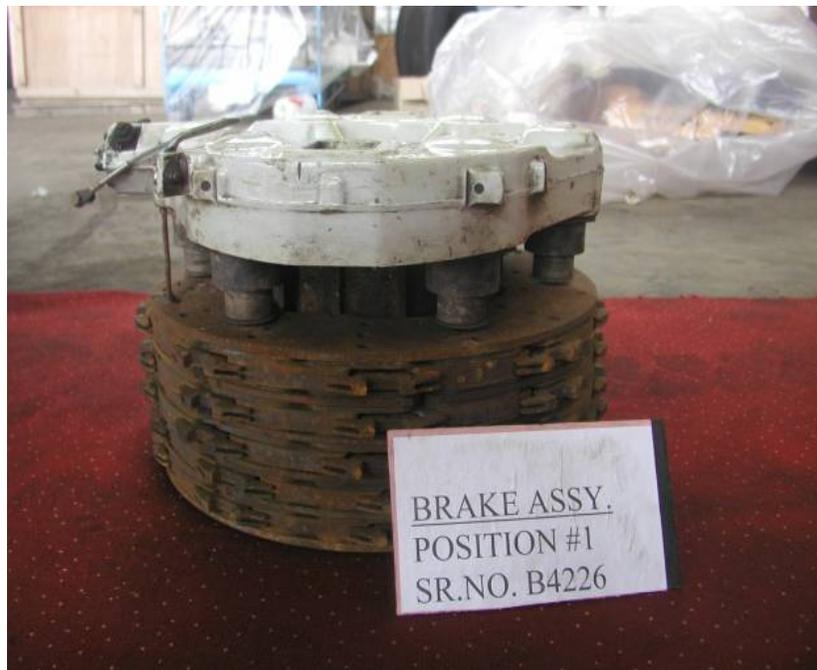
Photo 26: Brake Assembly Serial No B4226

Part No.	2612312-1	2612312-1	2612312-1	2612312-1
Brake Sr No.	B4226	B7423	B6221	B5382
Position	#1	#2	#3	#4
Installed on	12 th Sep 09	2 nd Sep 09	21 st Apr 10	2 nd Oct 09
Number of Landings	723	751	113	666
General Condition	No damage. (Rotors found free.)	No damage. (Rotors found free.)	No damage. (Rotors found free.)	Damage Observed on piston housing
Missing Parts	Nil	Nil	Nil	Qty. one indicator pin found missing
Hydraulic Leakage	No trace of hydraulic leakage	No trace of hydraulic leakage	No trace of hydraulic leakage	No trace of hydraulic leakage
Condition of Piston Housing	No damage observed	No damage observed	No damage observed	Damage observed at one location
Condition of Heat Stack	No damage observed	No damage observed	No damage observed	Found stuck in the wheel assembly S/N B10899
Indicator Pin	Both the pin in position	Both the pin in position. Out of which one found bent	Both the pin in position. Out of which one found bent	One pin in position and other found missing

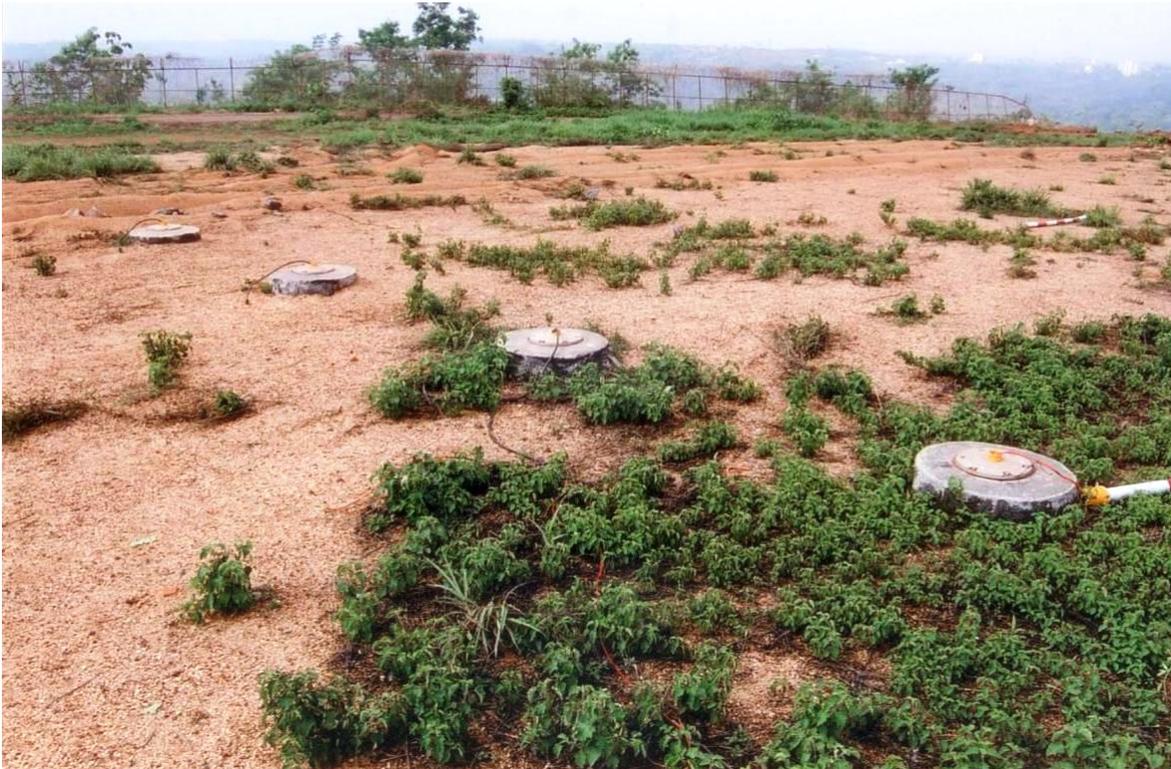
Photo 30: RESA for R/W 24 at Mangalore on the Day of Accident

Inspection of RESA at Mangalore had revealed that at the time of accident, localiser antenna and some temporary concrete platforms for ILS calibration were located within RESA. It also lacked regular maintenance. The RESA did not have adequate sand refilled as the concrete mounting structure of approach lights were protruding above the surface. Also, there were shrubs and vegetation in RESA as evident from the photograph shown below. Regular ploughing of this area would have prevented such growth.
