# **NATIONAL TRANSPORTATION SAFETY BOARD**

## **AIRCRAFT ACCIDENT REPORT**

**HORIZON AIR, INC.  
DEHAVILLAND DHC-8  
SEATTLE-TACOMA INTERNATIONAL AIRPORT  
SEATTLE, WASHINGTON  
APRIL 15, 1988**

NTSB/AAR-89/02

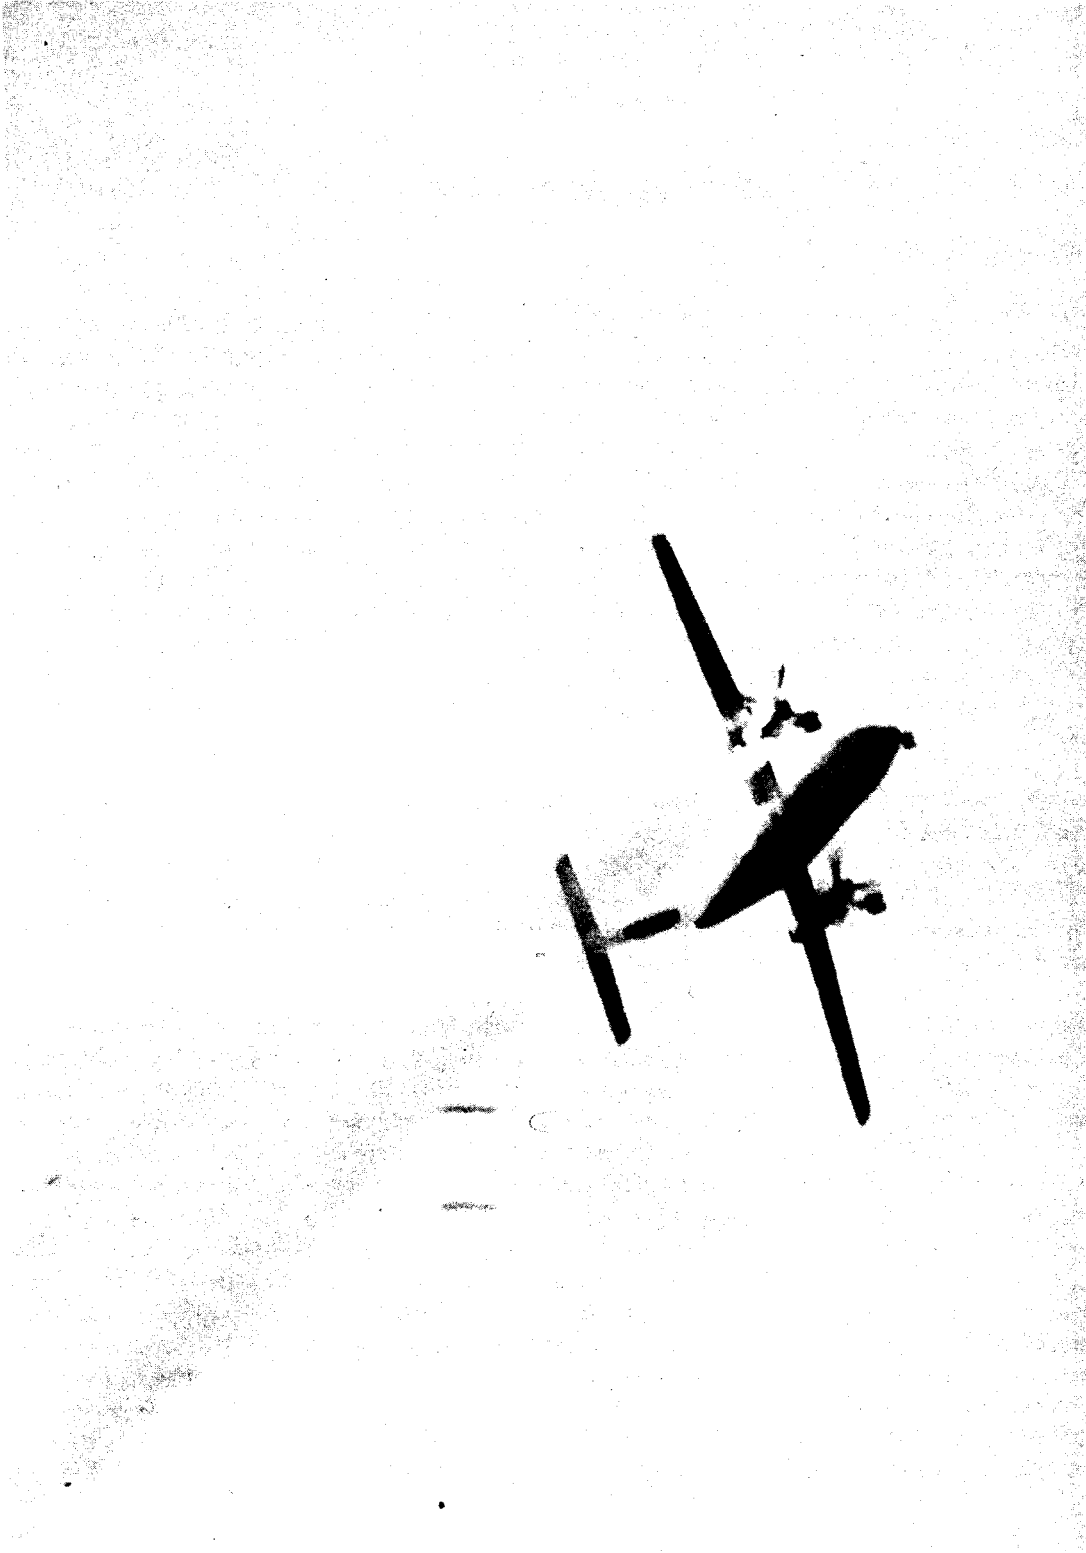
Figure 1.  $\omega$  photograph of N819PH on its final approach

The first officer stated that as he was scanning for traffic out the right side window during the turn to final approach, he observed a "flash" from the right engine. The first officer then observed that the center access panel on the left side of the right nacelle was missing and that an orange/yellow flame was in that area. The passenger in seat 9E also observed the fire and saw sections of engine cowl fall from the right nacelle. At 1831:03 the first officer stated, "We got a fire." Three seconds later the captain stated, "Max power. . .," and at 1831:09 he called for "15" of flaps. According to the FDR, the flaps began to move down shortly thereafter. After informing the captain of the fire, the first officer returned his attention to the engine instruments. The captain then retarded the right condition lever to the Start and Feather position and told the first officer to pull the fuel cutoff T-handle and fire the extinguisher bottles. After the first officer fired the extinguisher bottles and pulled the fuel cutoff T-handle, he observed that the fire was still burning and also that the green landing gear lights were no longer illuminated. (See figure 1.)

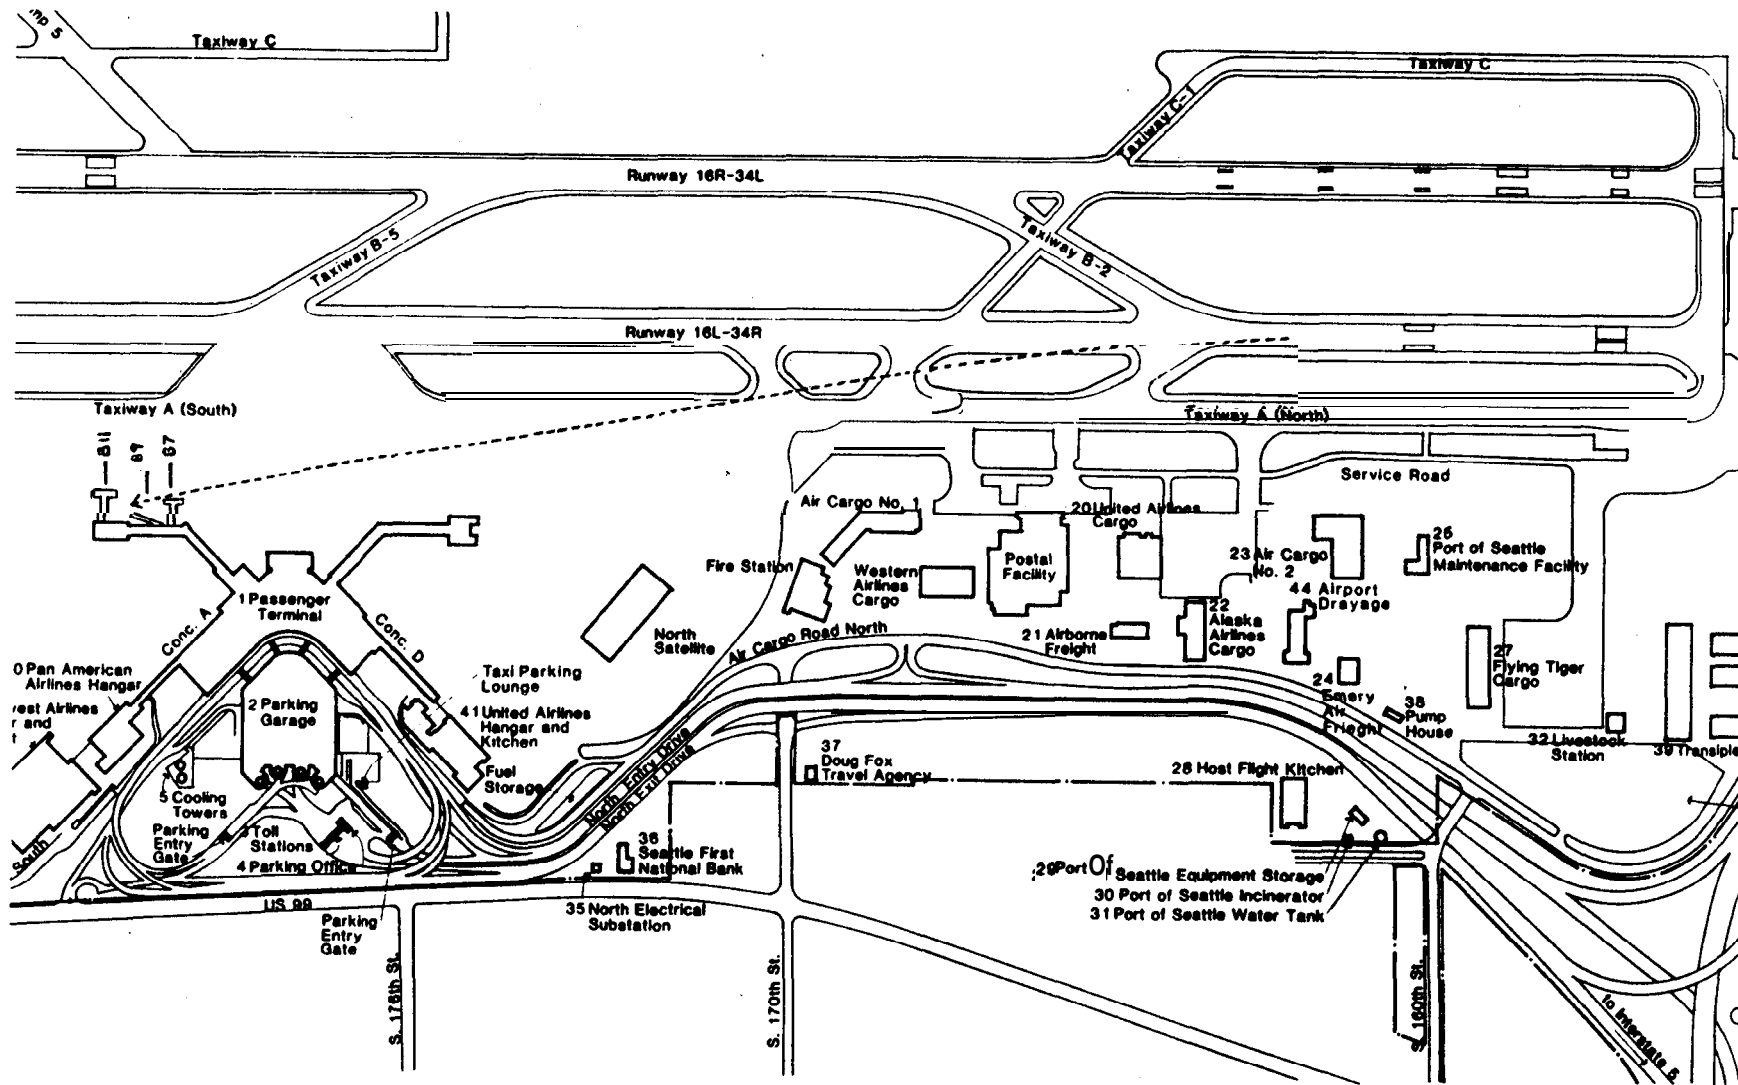
The first officer also tried his right rudder pedal, but it was already full right. He then noticed that the right brake pedal was already depressed and that the emergency brake was locked. He then advised the tower that the airplane was out of control and manually locked his and the captain's shoulder harnesses. As the airplane rolled onto the ramp pavement after crossing grass areas and taxiways on the airport, it struck and destroyed a frangible lighted runway designator sign. By this juncture, the airplane heading had changed another 2° to the left. Neither crewmember felt any deceleration. As the airplane entered the ramp area south of the tower, it struck jetway B7 damaging the outboard left wing. After striking the first jetway, the airplane struck jetway B9 causing the outboard left wing to separate from the airplane. The airplane struck and destroyed several baggage carts and pieces of ground equipment as it traversed the area between jetways B7 and B9 and came to rest against jetway B11 at 1832:31. (See figure 2.)

Figure 2. Diagram of the ground path of the airplane

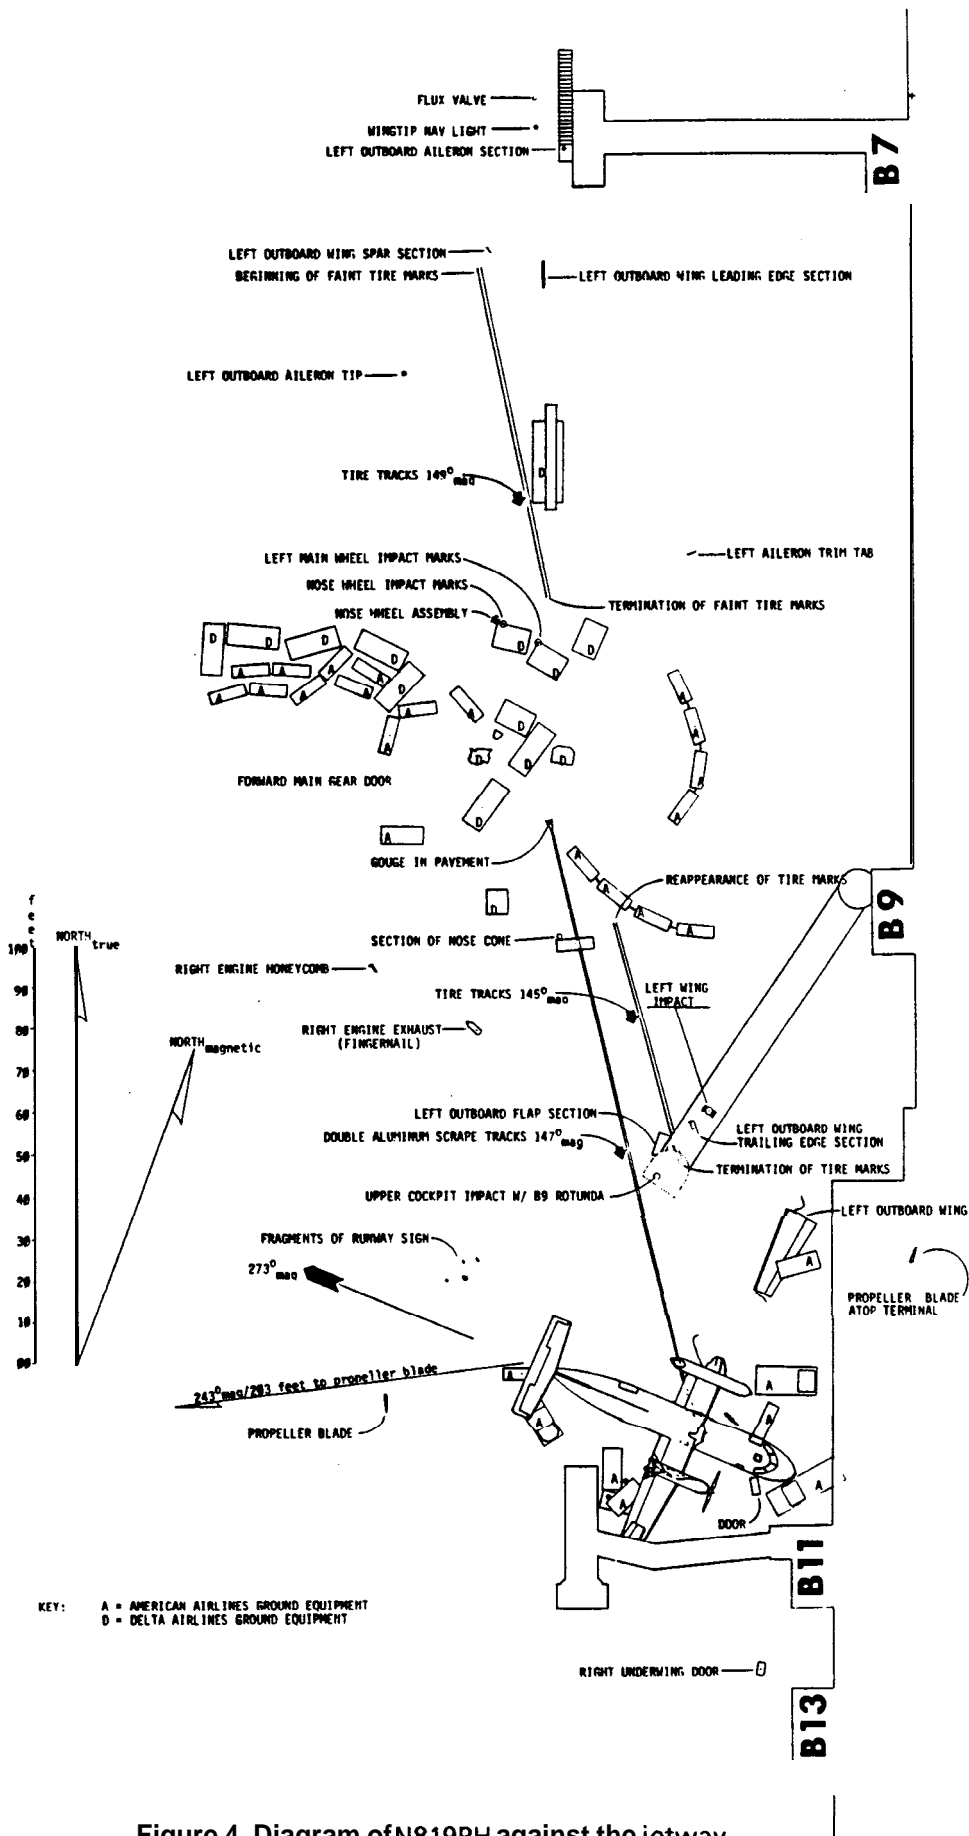
The right wing and right engine/engine nacelle sustained heavy fire damage. The aft portion of the nacelle was consumed by fire. The propeller was attached to the engine; however, one blade had separated and was recovered about 15 feet behind the left engine nacelle. (See figure 4.)

Figure 4. Diagram of N819PH against the jetway

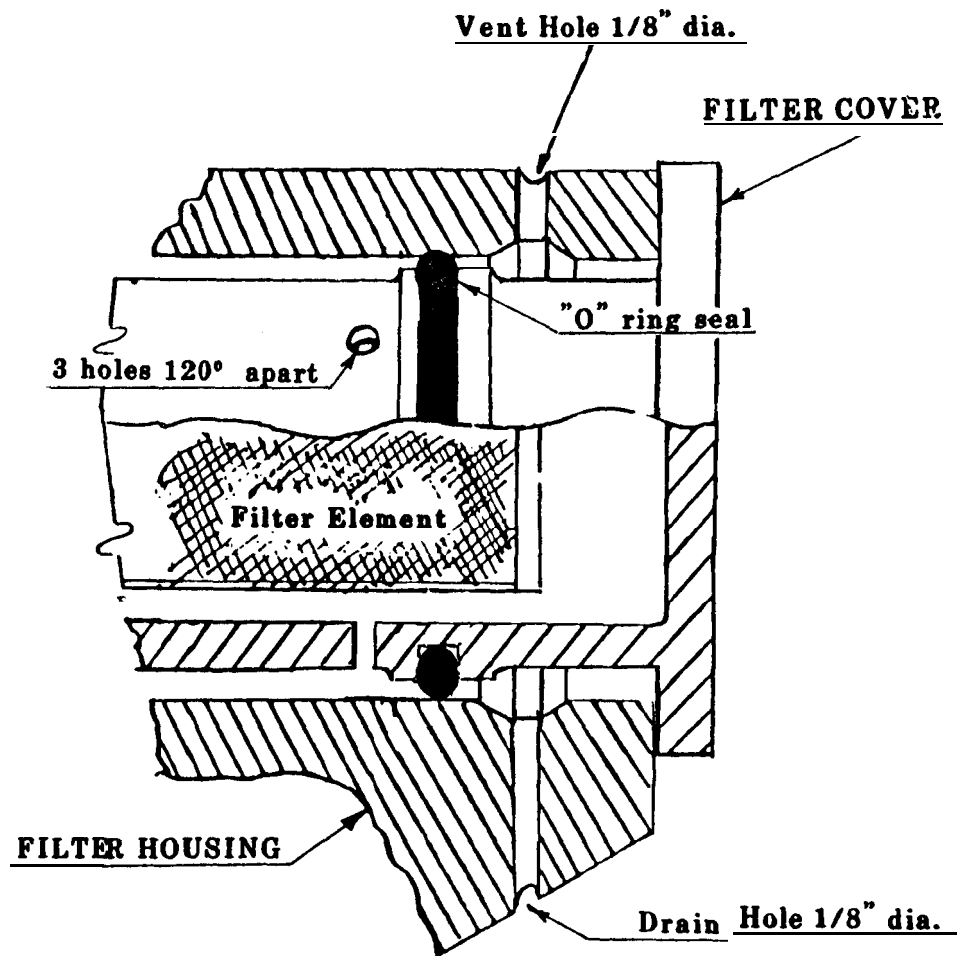
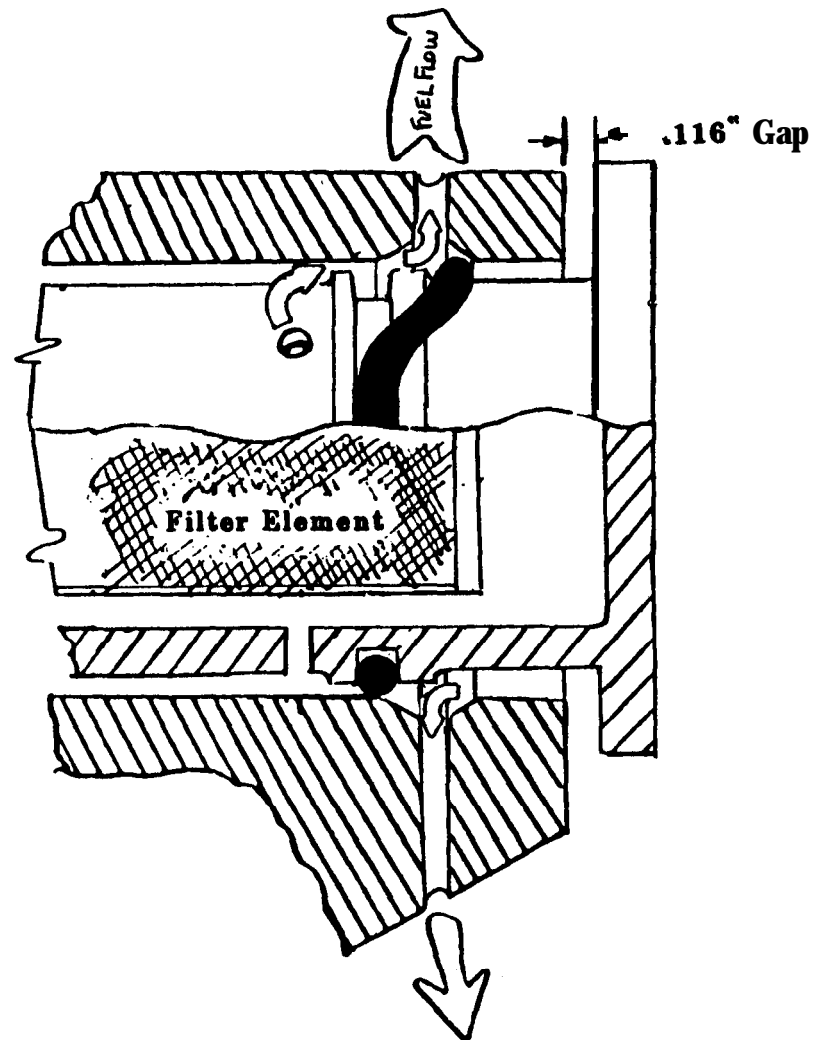
There was a 0.116-inch gap between the HMU high pressure fuel filter cover and the face of the housing. Fuel was observed leaking from the bottom of the gap 22 hours after the accident. The fuel filter cover on the left engine was examined, and the cover was noted to be bottomed against the filter housing; there was no gap. Specified torque on the fuel filter cover is 100 to 150 inch pounds.

Filter Assembly and O-Ring  
In Normal Position

Filter Assembly (with gapped cover)  
and O-Ring in Extruded Position

Figure 6. Cut-away diagram of a fuel filter housing

To remove the fuel filter cover required 80 in/lbs. breakaway and 40 in/lbs. running torque, which gradually decreased to a point where the cover could be removed by hand. A visual examination of the cover showed that the threads were in good condition. The o-ring was in one piece and in the proper position, but it exhibited some abrasion in the area where it had been forced out of its groove. It also exhibited a small cut in this area. When the pump was disassembled, it revealed that the power lever shaft seals exhibited considerable heat damage. The power lever portion of the HMU as installed in the airplane was in an area of moderate to heavy fire damage.

damaged condition, the o-ring still would have been identified as the fuel leak source, but without the radiographic proof, the fact that the o-ring had extruded over the filter weep hole would not have been discovered. Given the relatively small amount of damage to the o-ring, it would have been very difficult to explain the high volume of the fuel leak.

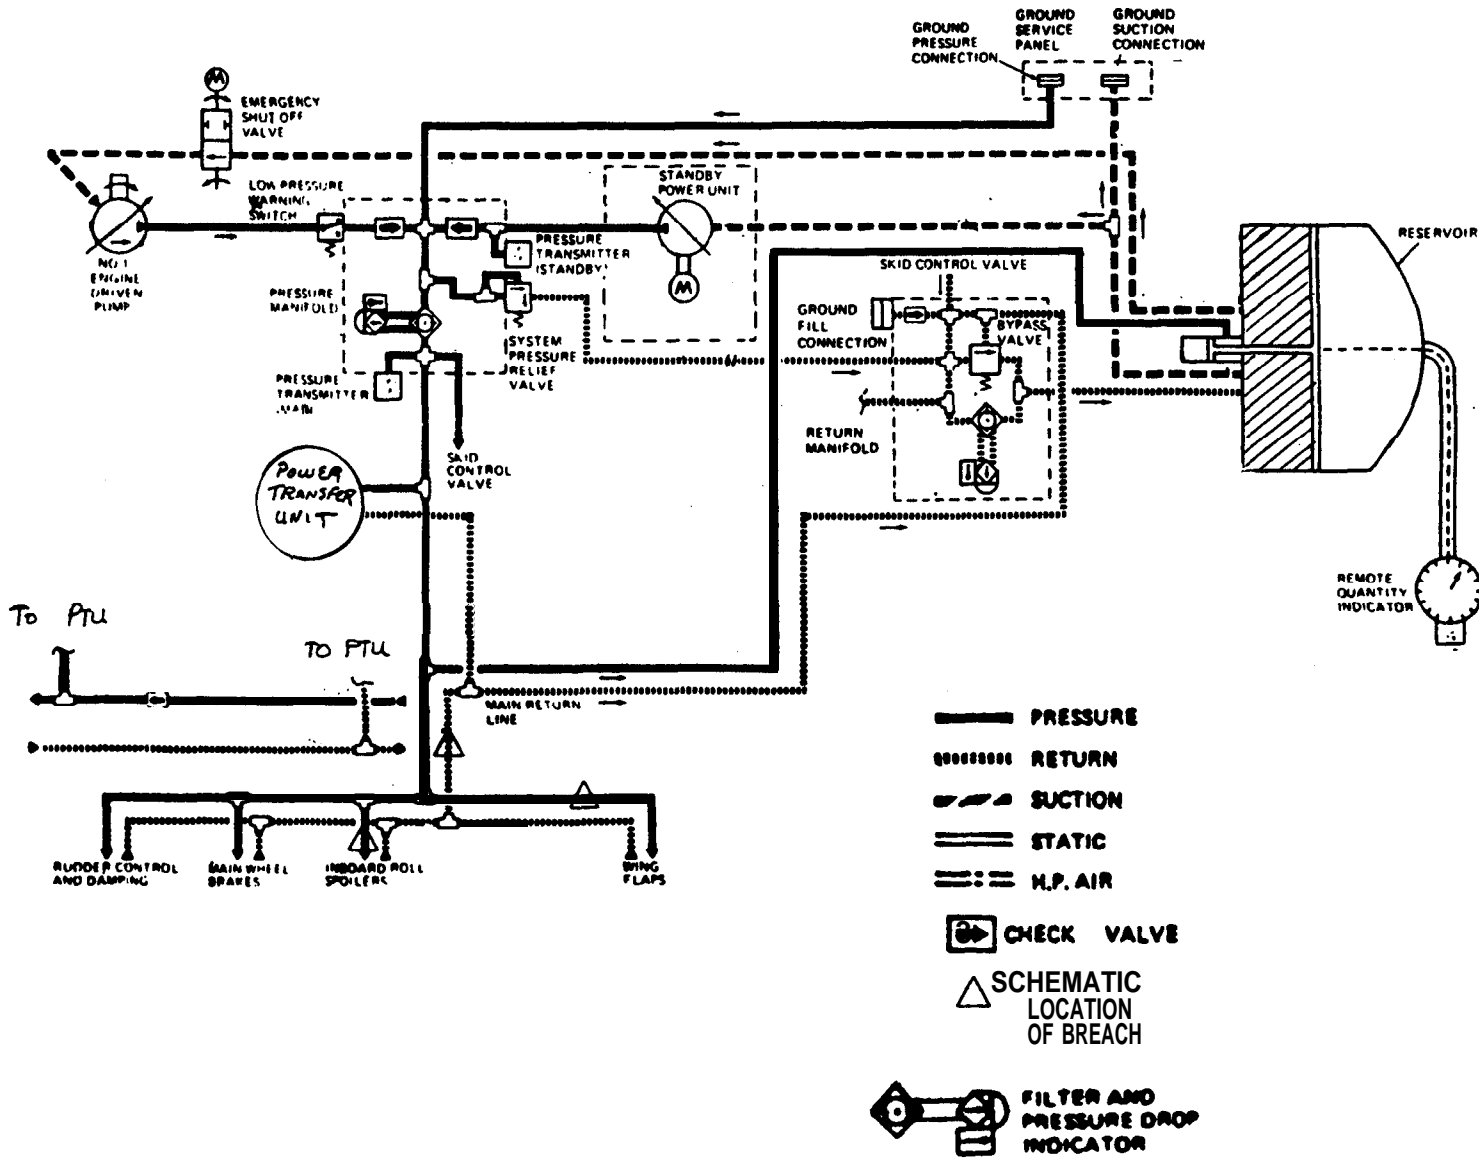
Three No. 1 (left) hydraulic pressure and fluid return lines in the right wing rear spar area of the right wheel well had been burned through by the fire. These fluid return lines included: one 1/4-inch diameter hydraulic pressure supply line to the right wing inboard roll spoilers; one 1/4-inch diameter lift dump pressure line; and one 3/8-inch diameter No. 1 hydraulic system return line. Also, the emergency/parking brake accumulator unit was found intact but both hydraulic lines to it were burned through. (See figure 8.) The destruction of these five hydraulic lines disabled both hydraulic systems.

Figure 8. Simplified schematic of the No. 1 hydraulic system
