TECHNICAL REPORT

Accident which occurred to aircraft McDonnell Douglas DC-9
and Boeing B-727-200, Registration EC-CGS
and EC-CFJ, in Madrid-Barajas
Airport, Spain

Date and time: December 7th, 1983
at 0839.29 hours.

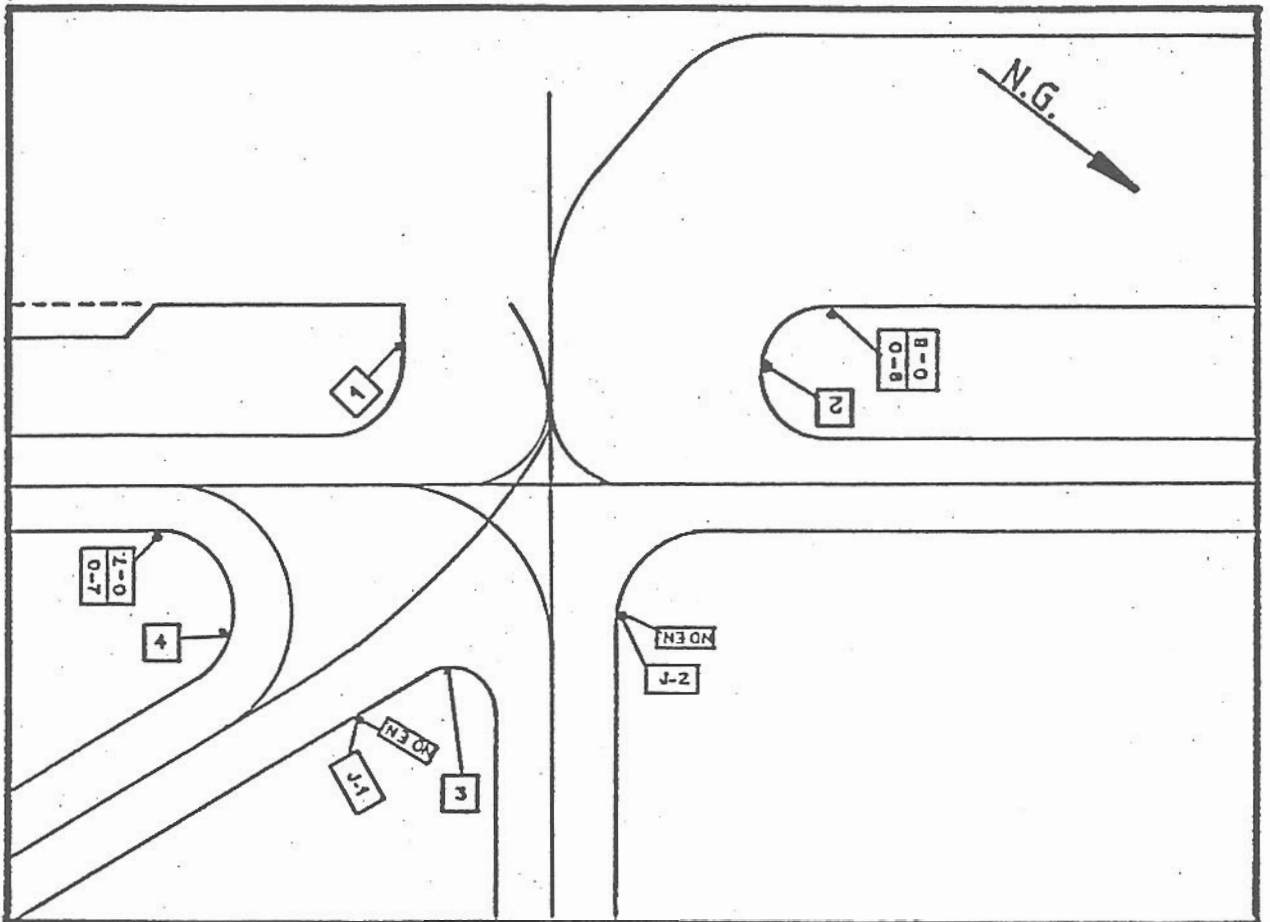
Marking and lighting of zone Gate J and access to J-1, J-2 and 0-7, 0-8.

The centerline sign from gate J joined the sign of taxiway O-8 centerline and the signs of exit taxiways J-1 and J-2 centerlines. To O-7 there was a discontinuity; also, close to O-7, this sign, old and discolored, did not leave J's centerline (its closest point was about 20 cm away), though it linked O-7 centerline. At the said "procedure for airplane movement at the Airport" an exit from J to O-7 had not been established, reason by which the taxiline of O-7 towards gate J was to be painted once the markers' position had been changed.

Taxiway O centerline sign was a double line and included centerline lights, edge lights and signals.

It must be noted that the area formed by gate J, taxiways J-1 and J-2, and taxi sectors O-7 and O-8 is quite large, reason by which some of the references established are fairly distant and their identification is difficult under reduced visibility conditions.

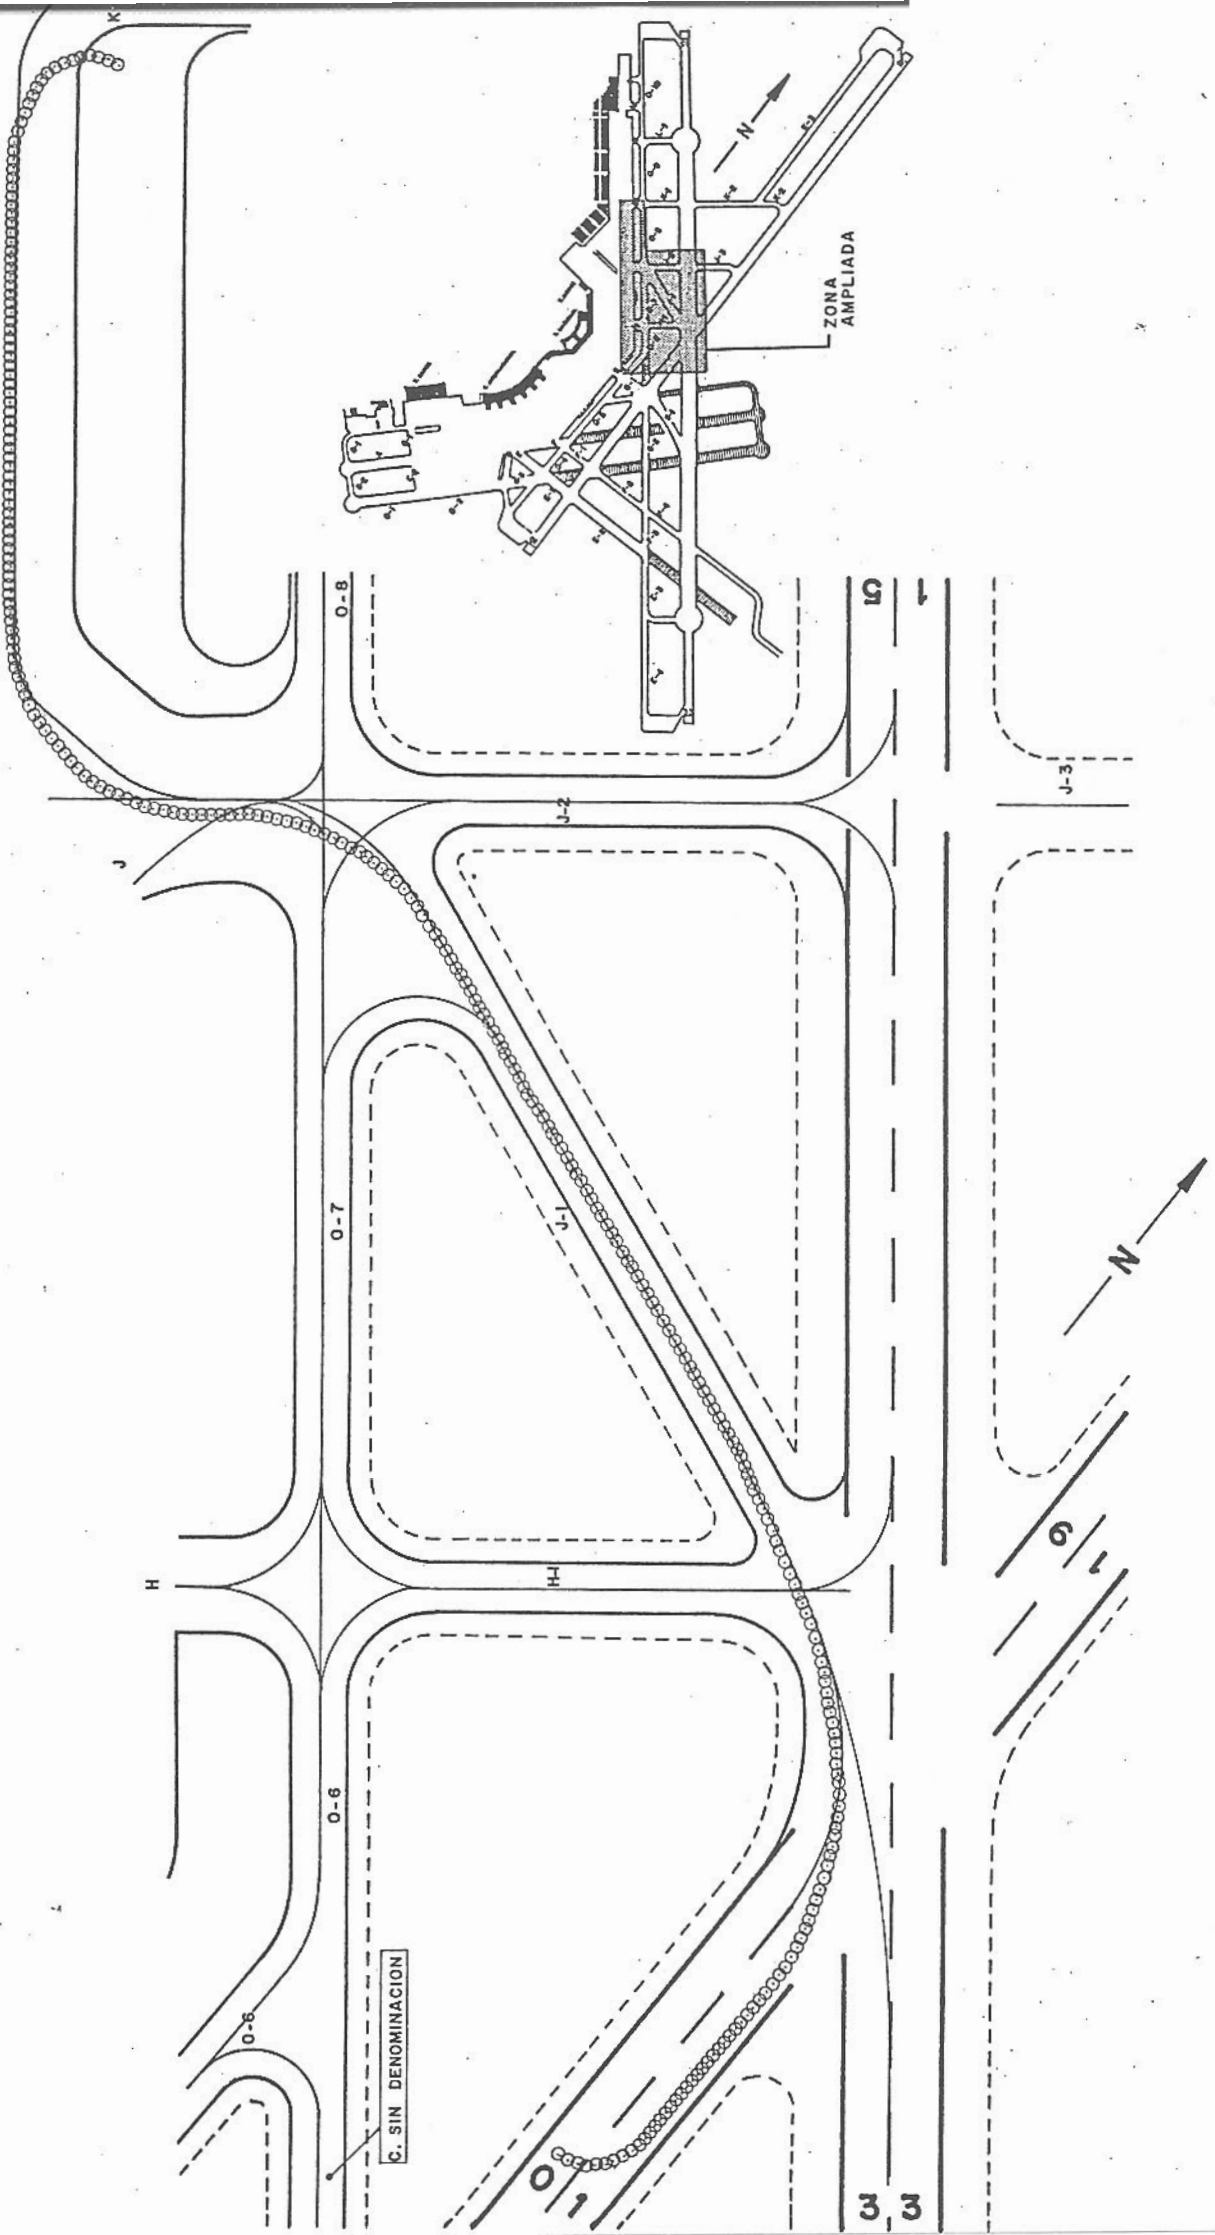
TRAYECTORIA SEGUIDA POR LA AERONAVE EC - CGS

In the study of the last turn the great corrections that were found in the direction angle and the correlation of time and heading support the theory that the Captain considered that they had entered in the runway by the taxi-way without denomination (continuation of O-7 and O-6), and that this turn was the faster action to leave the runway, seeking the space formed by G-1, G-3 and the no-denomination taxi-way.

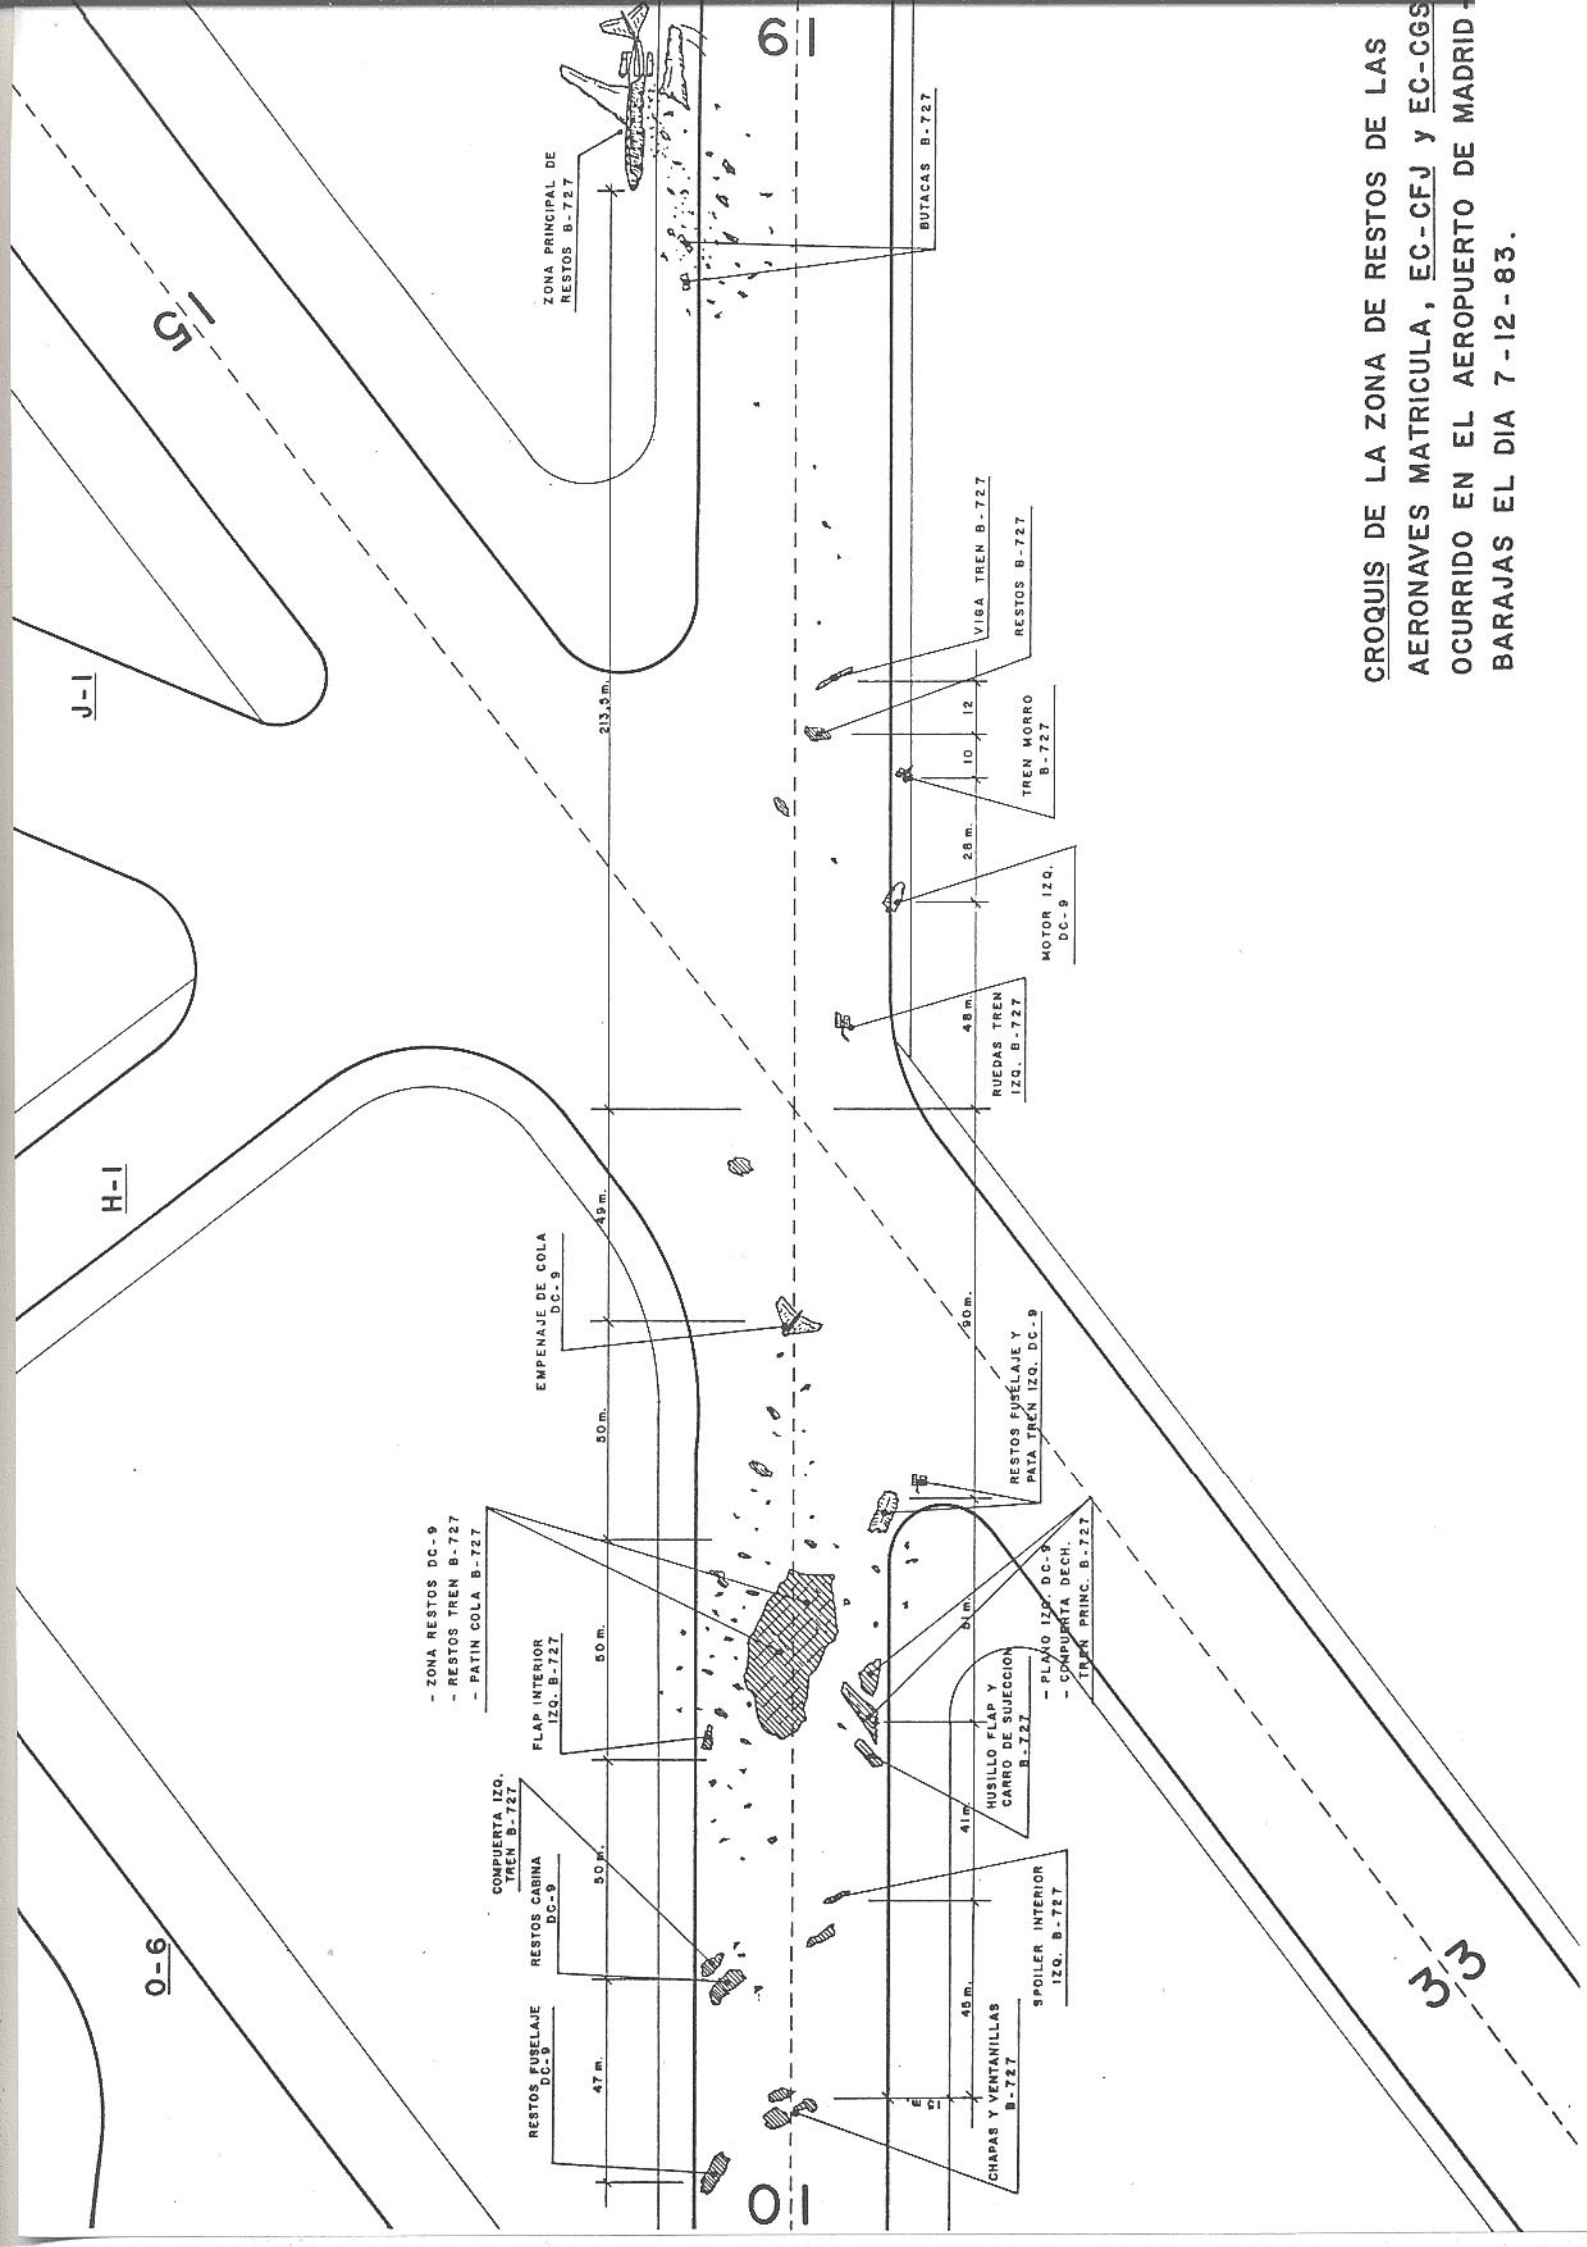
CROQUIS DE LA ZONA DE RESTOS DE LAS
 AERONAVES MATRICULA, EC-CFJ Y EC-CGS
 OCURRIDO EN EL AEROPUERTO DE MADRID
 BARAJAS EL DIA 7-12-83.

The main body of the remains of the DC-9 were found on the left half of runway 01, between 150 and 100 meters south of the intersection of the runways.

- ZONA RESTOS DC-9
 - RESTOS TREN B-727
 - PATIN COLA B-727
