**Aviation Safety Council
Taipei, Taiwan**

GE 791 Occurrence Investigation Report

**IN-FLIGHT ICING ENCOUNTER AND CRASH INTO THE SEA
TRANSASIA AIRWAYS FLIGHT 791
ATR72-200, B-22708
17 KILOMETERS SOUTHWEST OF MAKUNG CITY,
PENGHU ISLANDS, TAIWAN
DECEMBER 21, 2002**

ASC-AOR-05-04-001

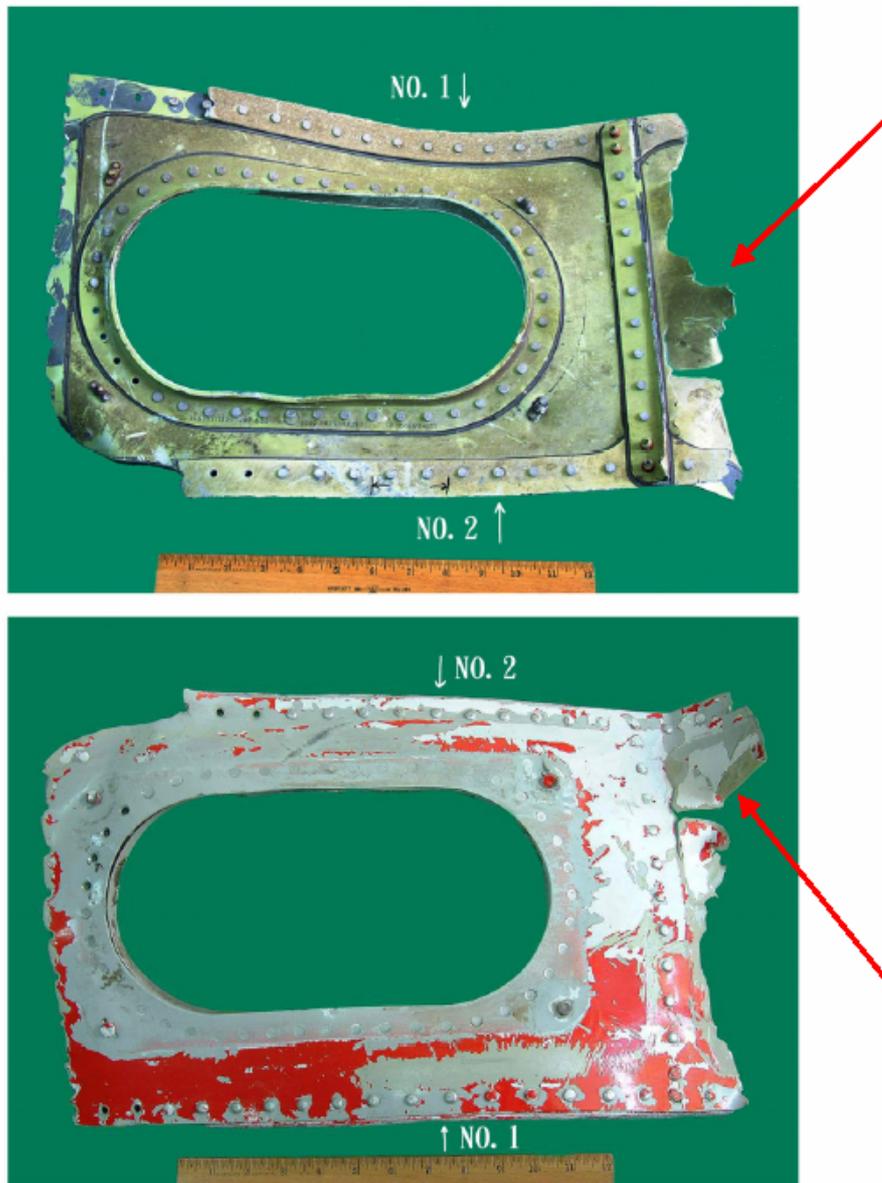
圖 1(a)、(b)分別為客艙窗戶結構損壞件之內面及外面的外觀觀察，其外圍輪廓斷面均呈現崎嶇不平的斷面形態，尤其是右邊斷面(編號 2 端朝上，從窗戶結構外面往裡瞧)呈現很大的變形及撕裂的破壞形態。

圖 1. 客艙窗戶結構破損件之外觀觀察。

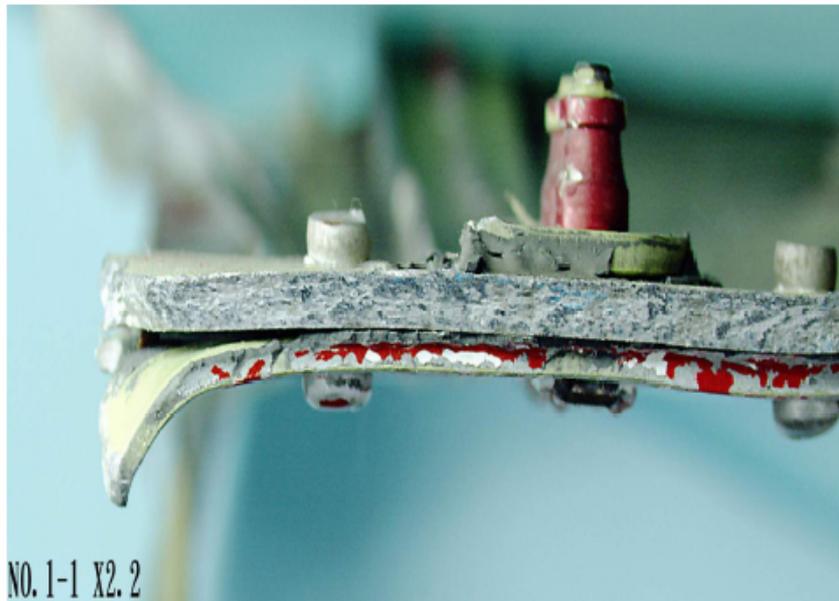
NO. 1-1 X2.2

如圖 2~圖 8 分別為斷面編號 1-1、1-2、1-3、1-4、1-5、1-6，及 1-7 之斷面巨觀觀察，斷面從頭到尾均呈現崎嶇不平的斷裂形態。而圖 9~圖 13 則分別為斷面編號 2-1、2-2、2-3、2-4，及 2-5 之斷面巨觀觀察，斷面從頭到尾也是呈現崎嶇不平的斷裂形態。至於破壞模式須由 SEM 確認。

圖 2. 客艙窗戶結構破損件編號 1-1 端斷面的巨觀觀察。(2.2X)

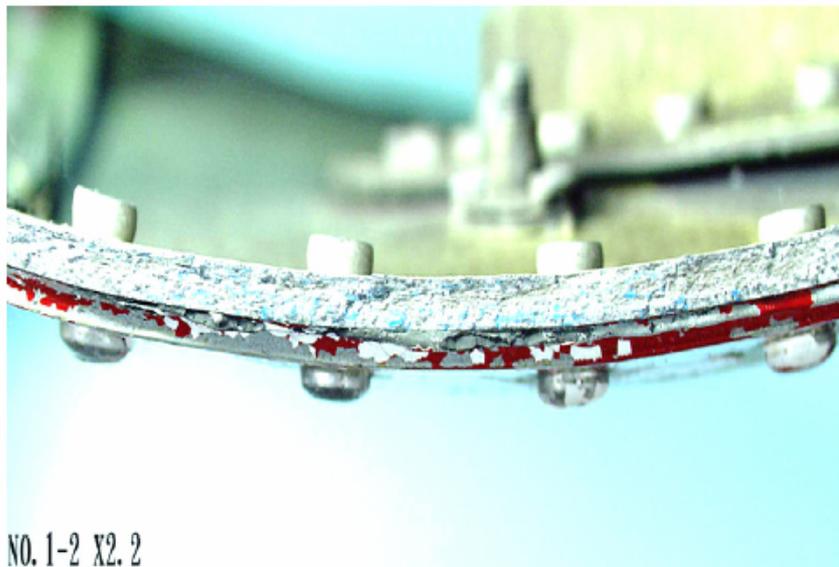
NO. 1-2 X2.2

圖 3. 客艙窗戶結構破損件編號 1-2 端斷面的巨觀觀察。(2.2X)

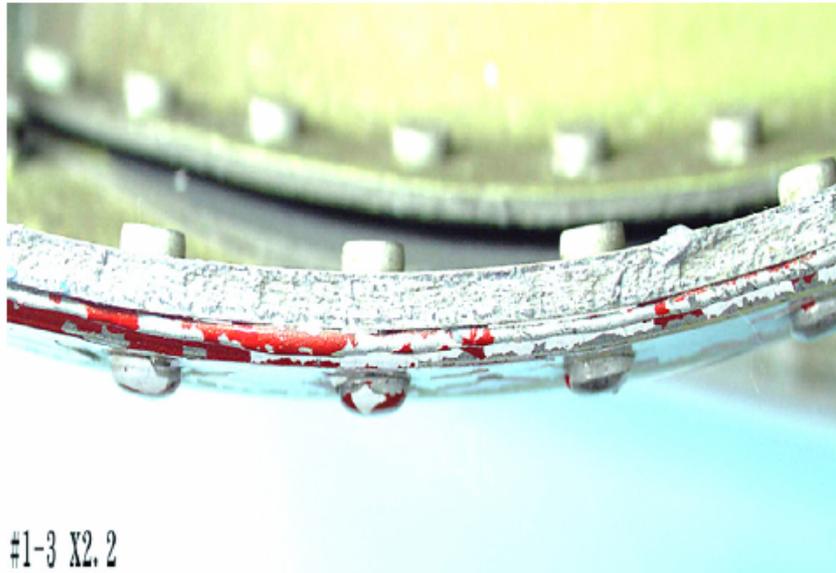
#1-3 X2.2

圖 4. 客艙窗戶結構破損件編號 1-3 端斷面的巨觀觀察。(2.2X)

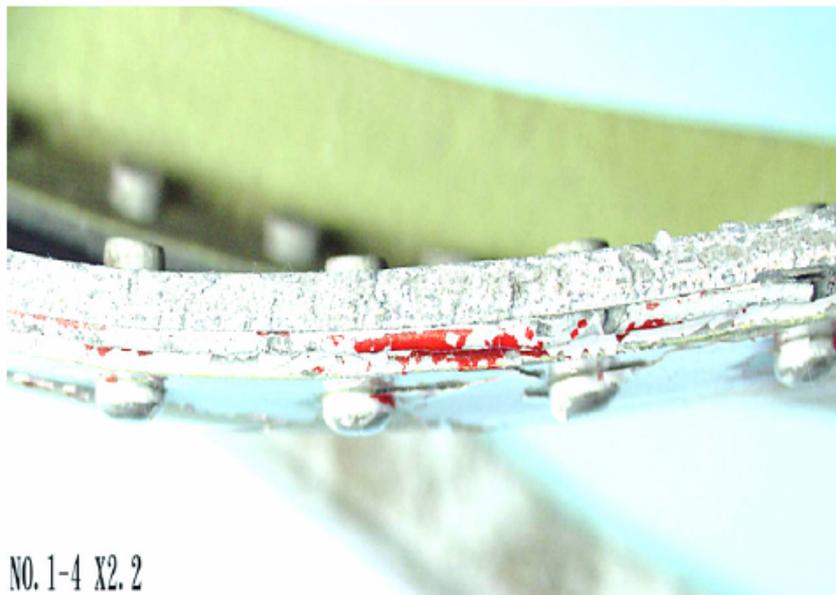
NO. 1-4 X2.2

圖 5. 客艙窗戶結構破損件編號 1-4 端斷面的巨觀觀察。(2.2X)

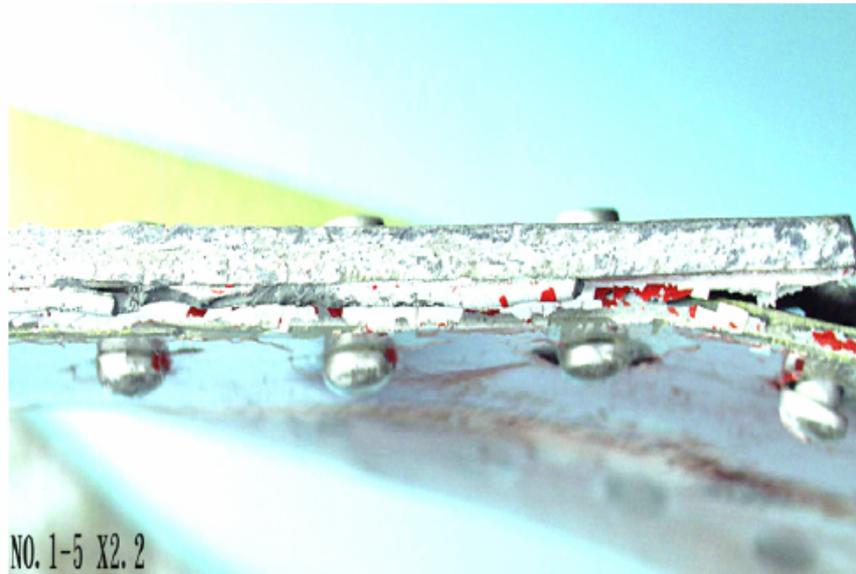
圖 6. 客艙窗戶結構破損件編號 1-5 端斷面的巨觀觀察。(2.2X)

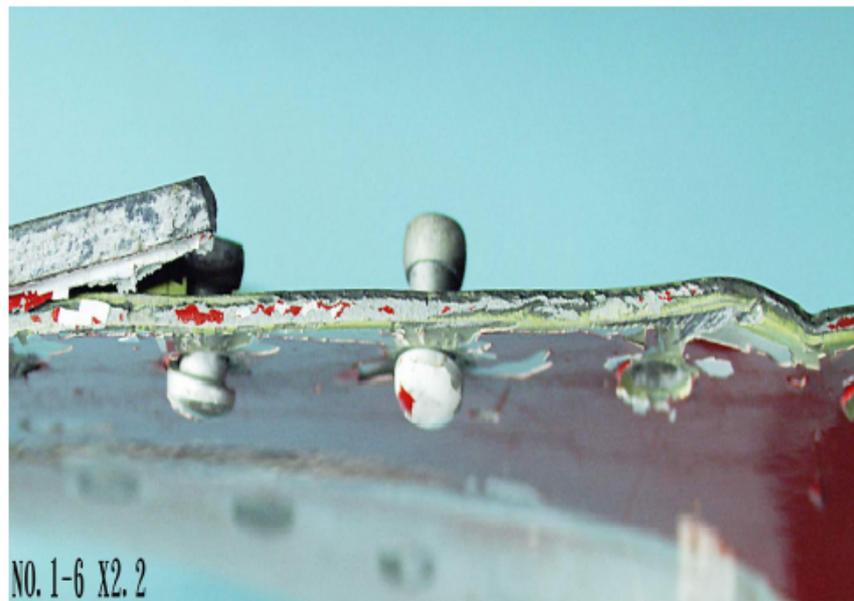
圖 7. 客艙窗戶結構破損件編號 1-6 端斷面的巨觀觀察。(2.2X)

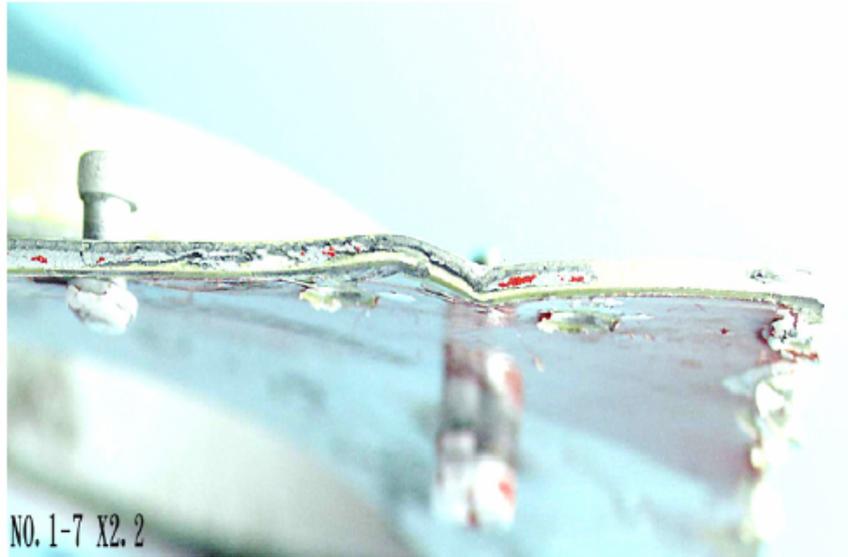
圖 8. 客艙窗戶結構破損件編號 1-7 端斷面的巨觀觀察。(2.2X)

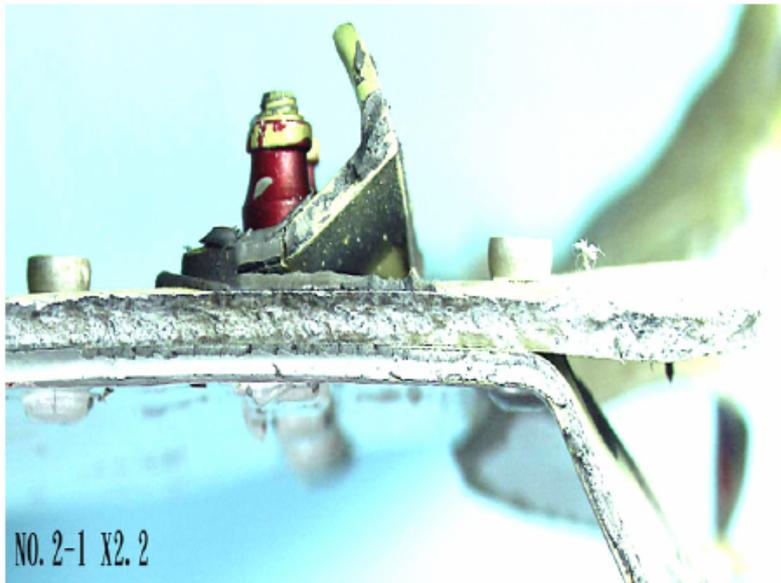
圖 9. 客艙窗戶結構破損件編號 2-1 端斷面的巨觀觀察。(2.2X)

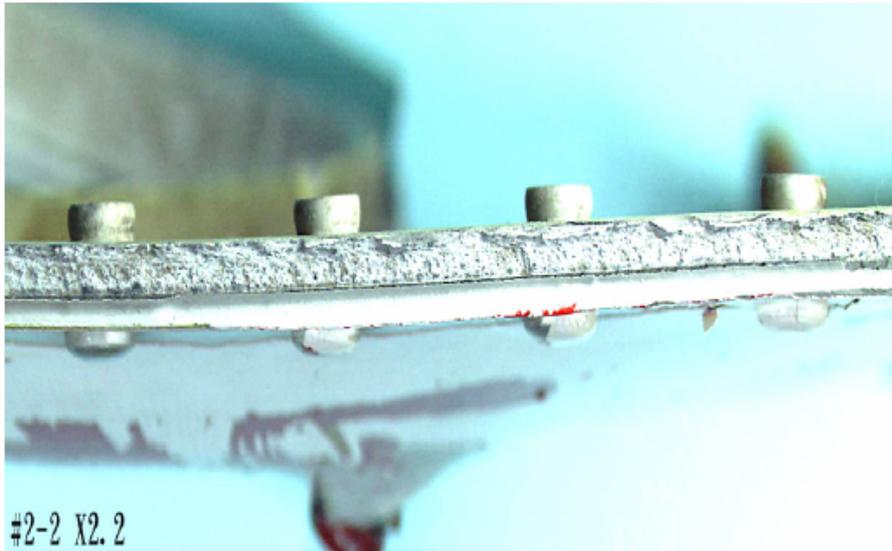
圖 10. 客艙窗戶結構破損件編號 2-2 端斷面的巨觀觀察。(2.2X)

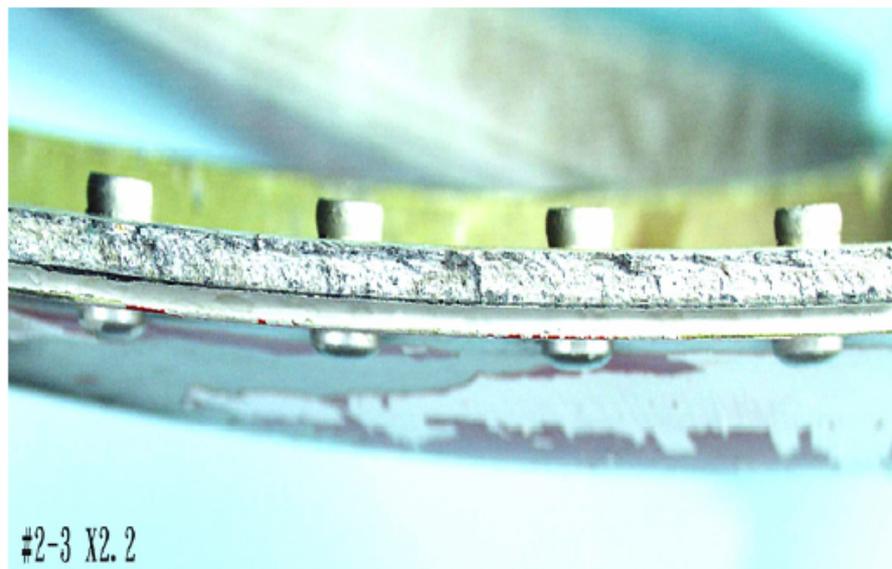
圖 11. 客艙窗戶結構破損件編號 2-3 端斷面的巨觀觀察。(2.2X)

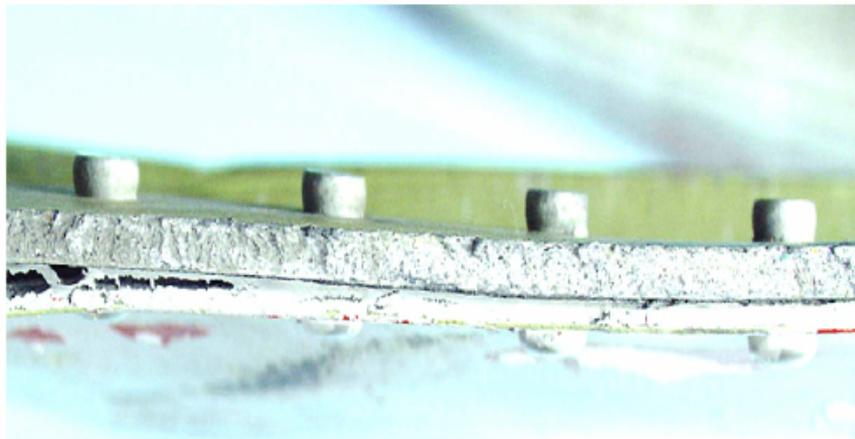
NO. 2-4 X2.2

圖 12. 客艙窗戶結構破損件編號 2-4 端斷面的巨觀觀察。(2.2X)

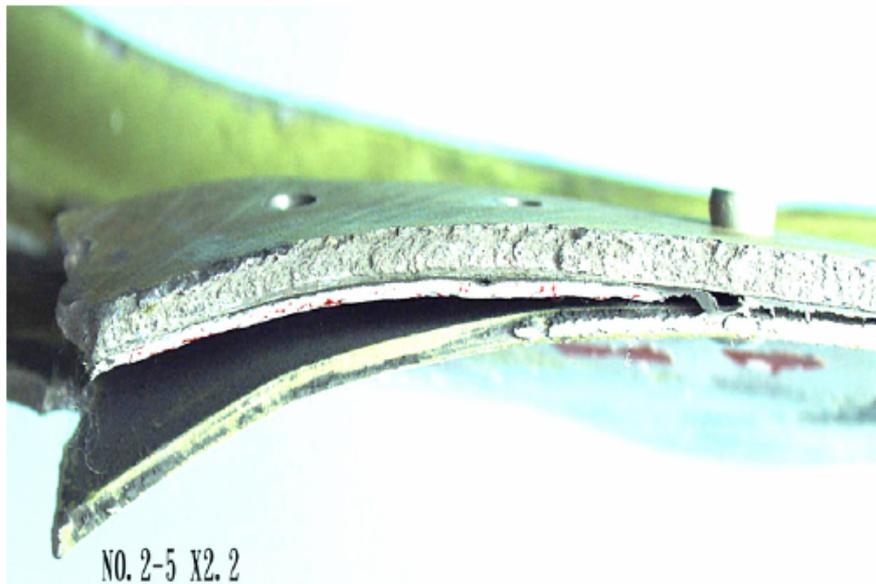
NO. 2-5 X2.2

圖 13. 客艙窗戶結構破損件編號 2-5 端斷面的巨觀觀察。(2.2X)

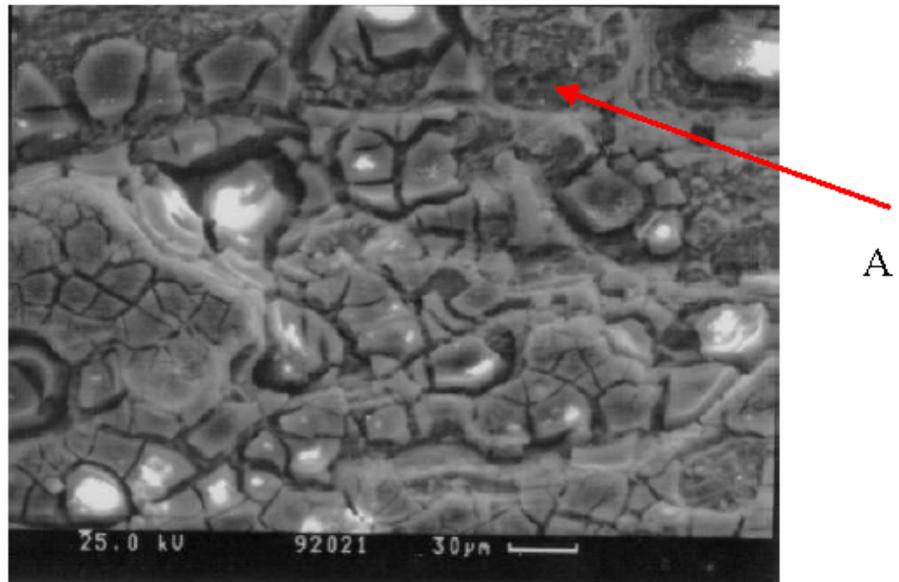
圖 14 為客艙窗戶結構破損件編號 2-3 端斷面的 SEM 照片，本破損件係由海中撈起所以表面已覆蓋壹層嚴重氧化物，不利 SEM 觀察。圖 15 為圖 14 上斷面 A 點區域的 SEM 觀察，明顯可見其凹渦組織(DIMPLE STRUCTURE)的痕跡，屬過負荷斷裂。

圖 14. 客艙窗戶結構破損件編號 2-3 端斷面的 SEM 觀察。(340X)
