NATIONAL
TRANSPORTATION
SAFETY
COMMITTEE

AIRCRAFT ACCIDENT REPORT

Garuda Indonesia Flight GA 880

Boeing B747-200 PK-GSD

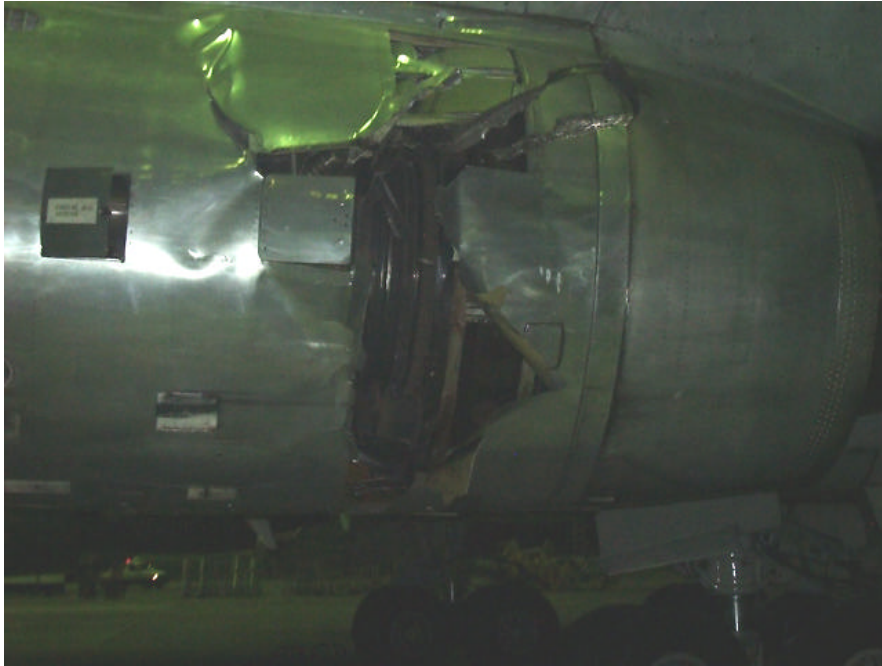
- Damages on outboard engine cowling and outer casing (see Figures A1, A2).
- Rupture on LPT casing, i.e. 5th and 6th stage outer airseal at 6 - 10 o'clock¹ position (see Figure B2).

Figure A1. Damage on Engine #2 casing (1)

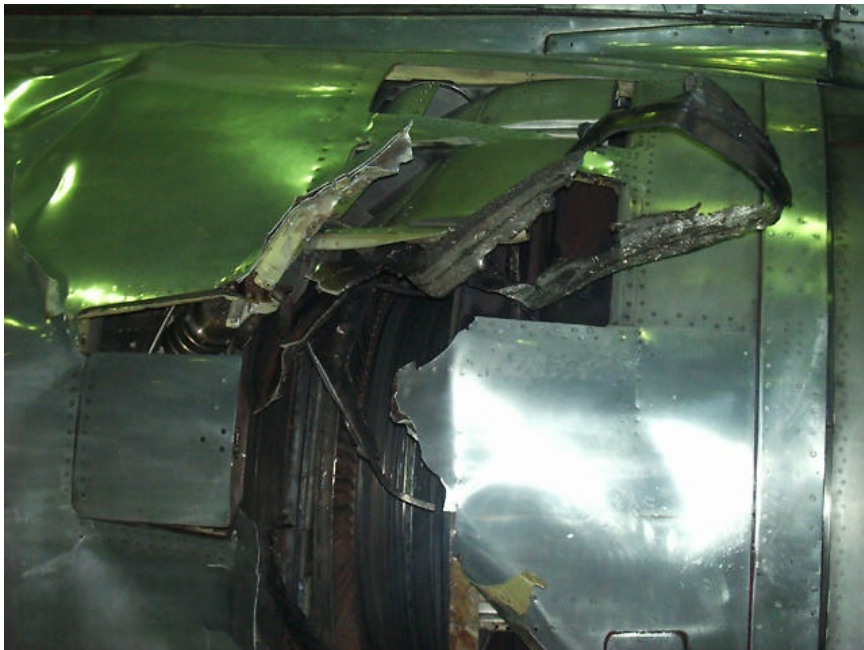
Figure A2. Damage on Engine #2 casing (2)

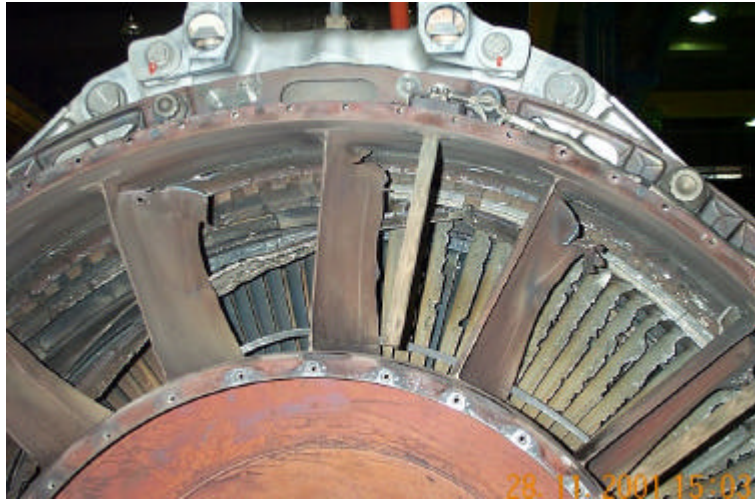
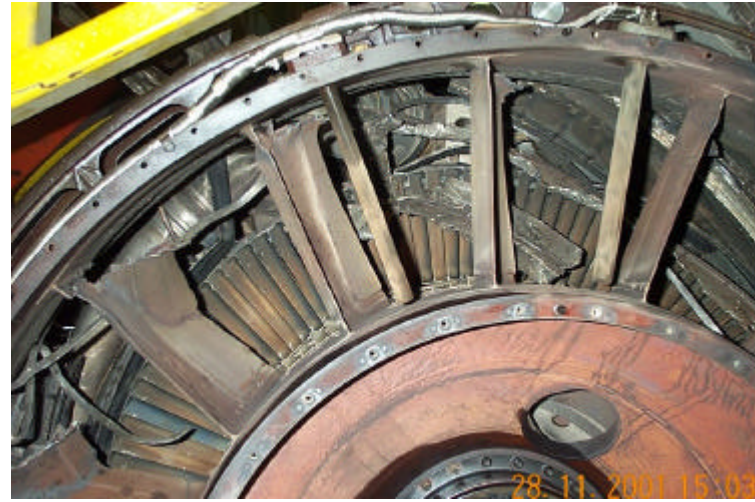
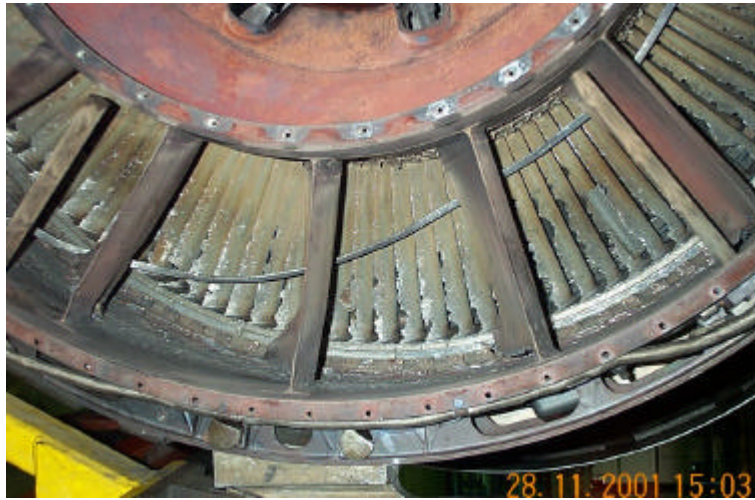
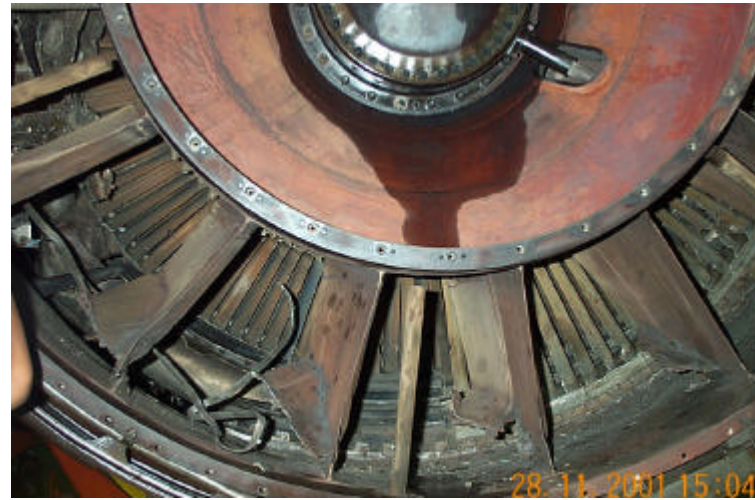
- Minor damages on the tailcone and flange bolt recess cavities.
- Severe impact damages on the turbine exhaust case and exhaust guide vanes (see Figures A3-A6).

Figure A3, A4, A5, A6. Engine #2 EGV

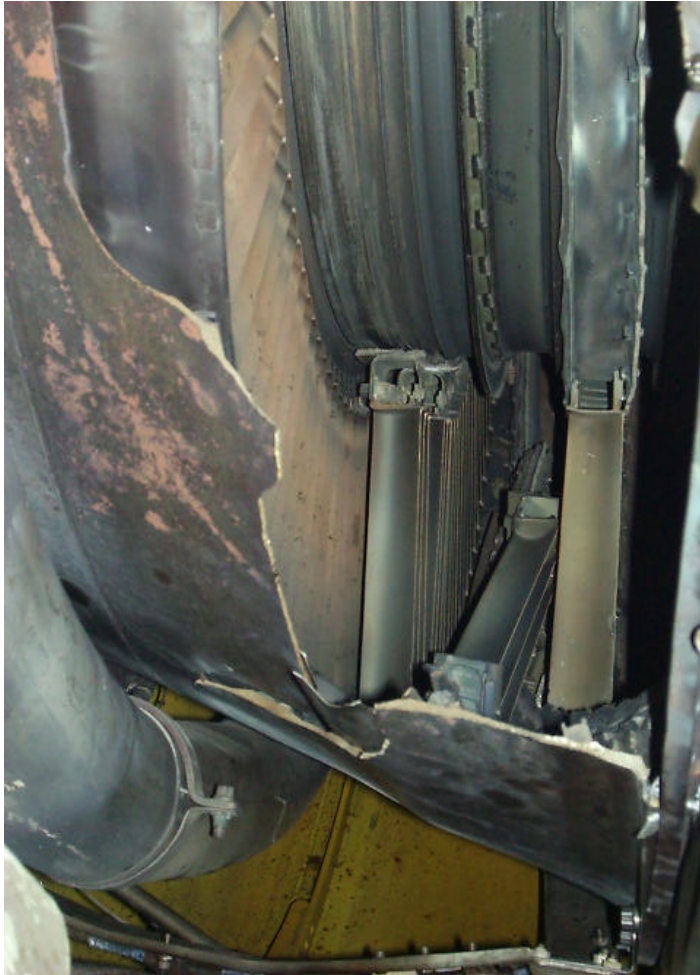
Figure A7. Engine #2 LPT Module, 5th and 6th stage (1)

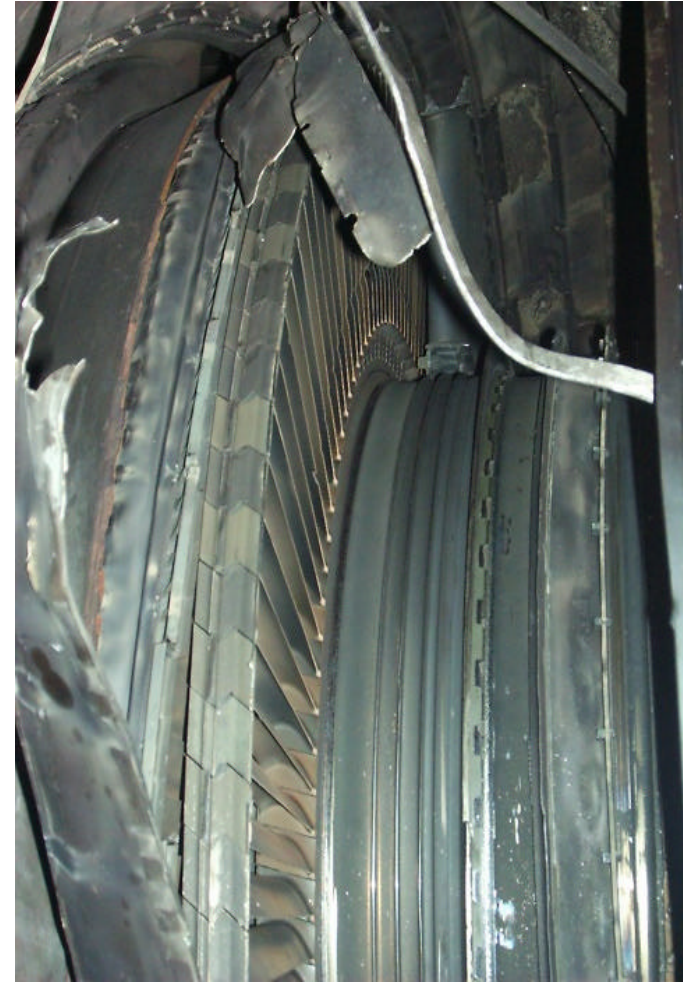
Figure A8. Engine #2 LPT Module, 5th and 6th stage (2)

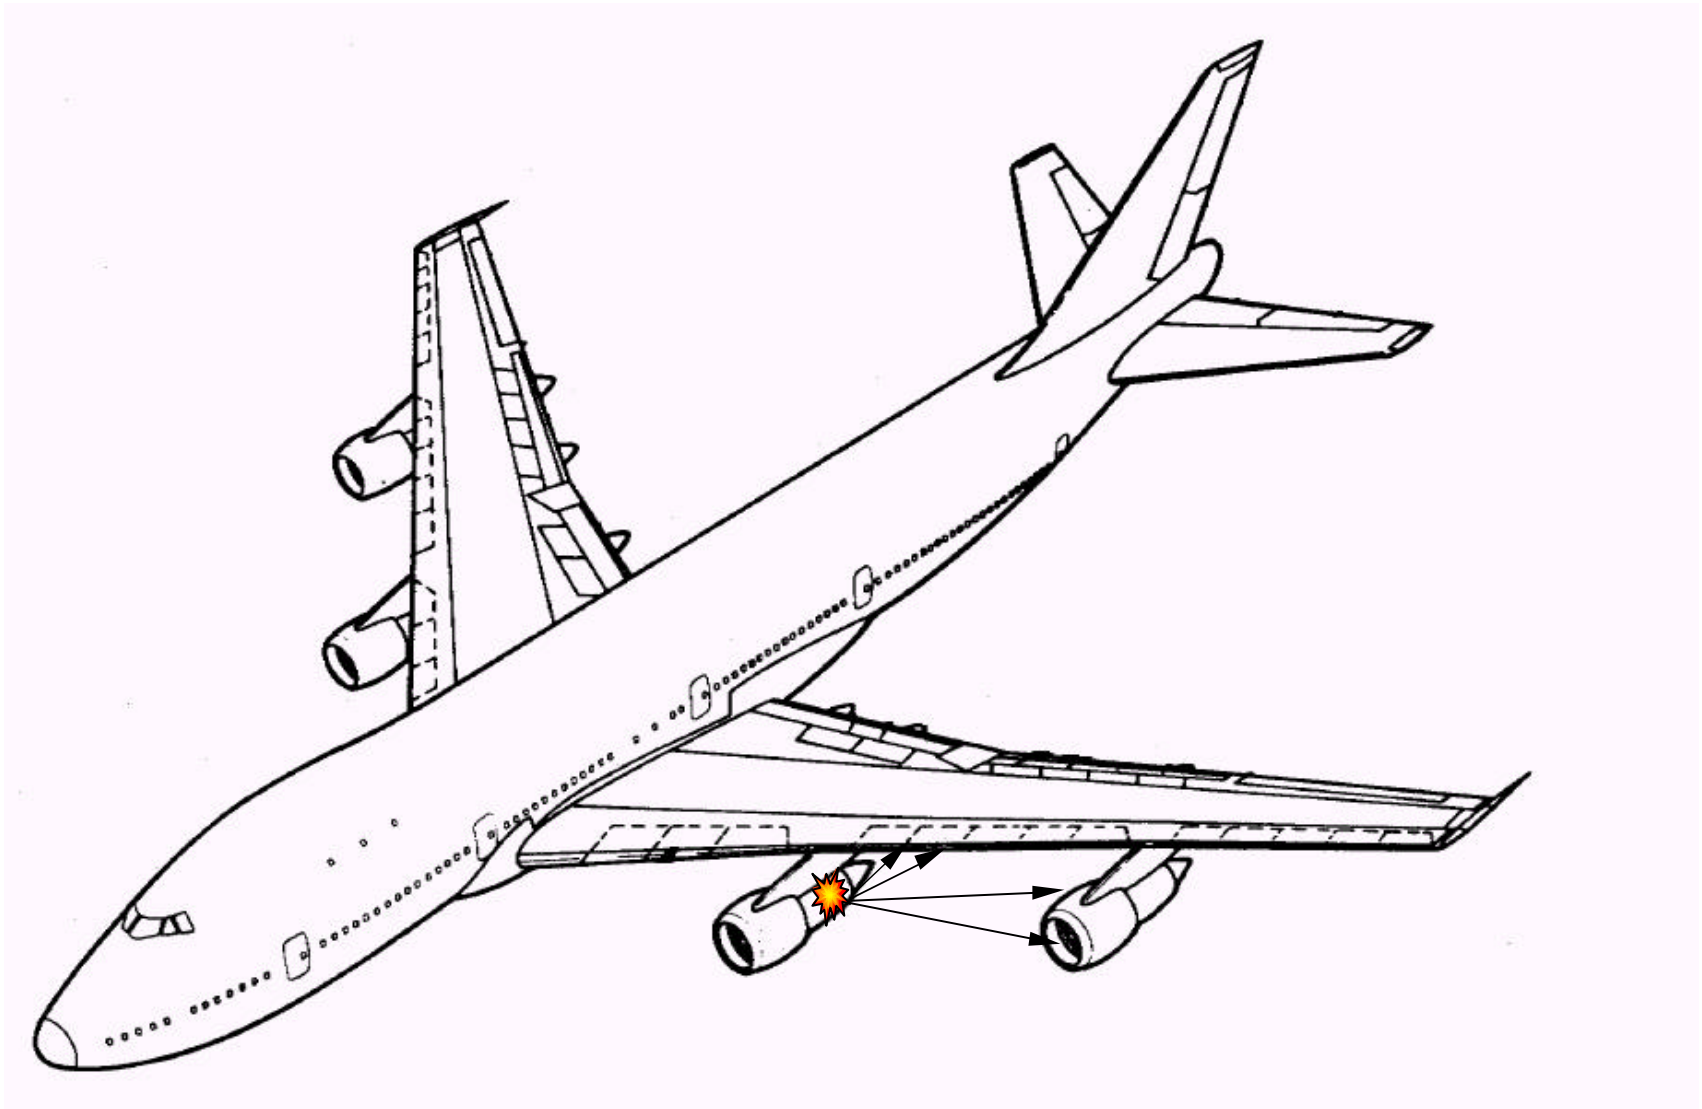
On-ground inspection revealed that an uncontained engine failure had occurred on the #2 engine low-pressure turbine, and the liberated debris had caused FOD on the #1 engine and airframe (see Figure A10).

Figure A10. Sketch of ejected debris path from engine #2

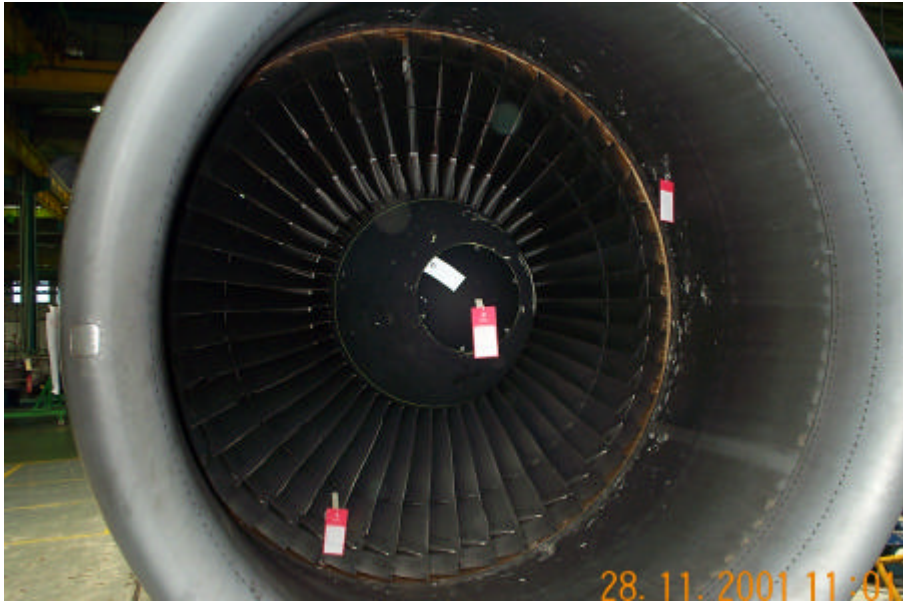
The #1 engine fan blades, spinner cone, side cowling and fan case had sustained damages (FOD) due to debris from the #2 engine (see Figures A11-A16).

Figure A11. FOD on Engine #1 fan (1) - tagged debris

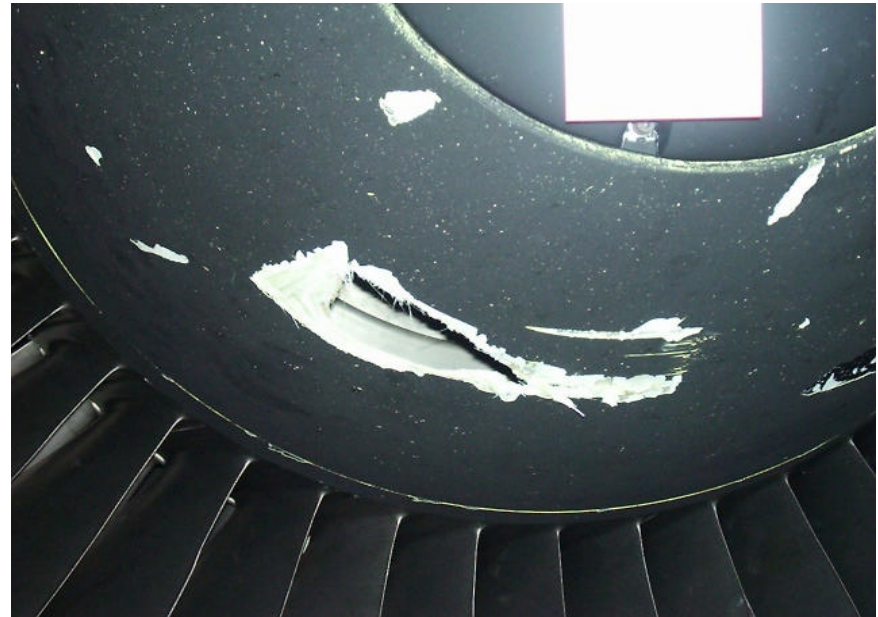
Figure A12. FOD on Engine #1 Fan (2)

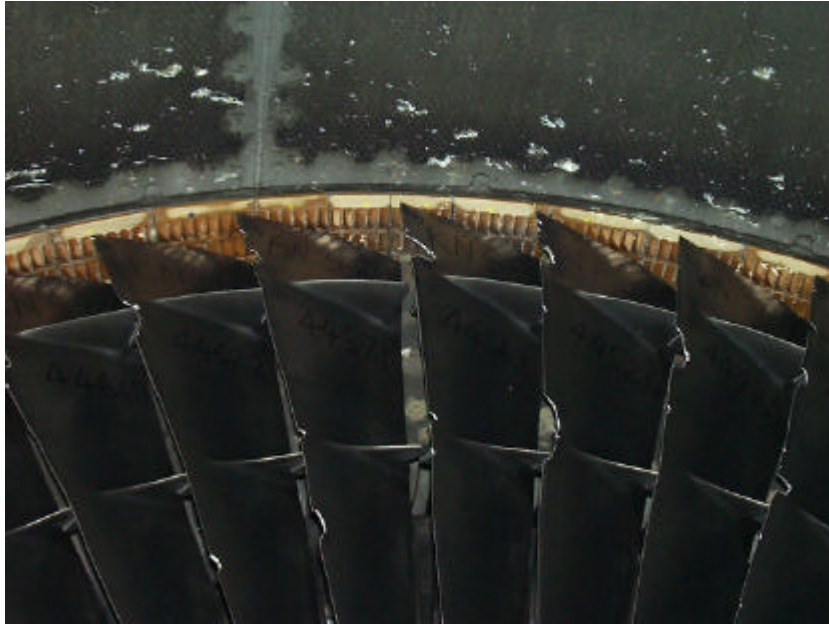
Figure A13. FOD on Engine #1 Fan/Fan Blades (2)

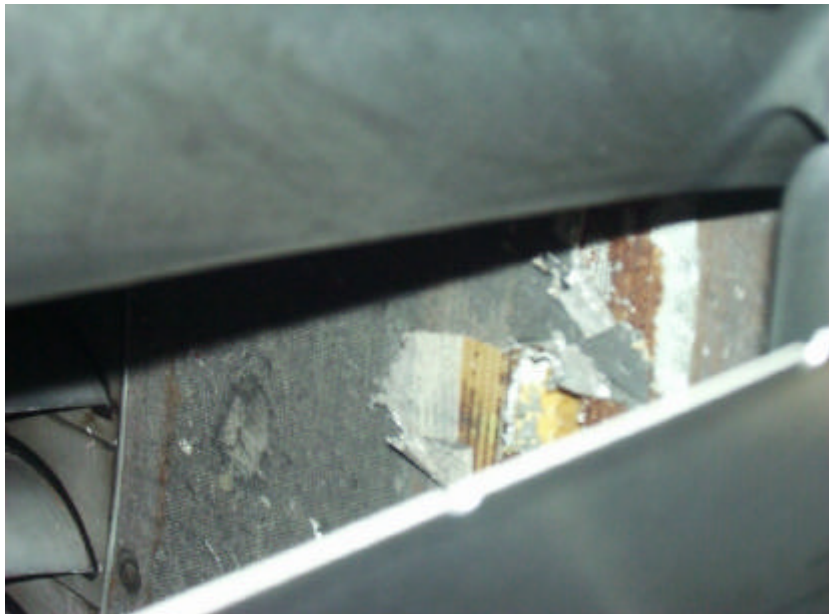
Figure A14. FOD on Engine #1 inner cowling

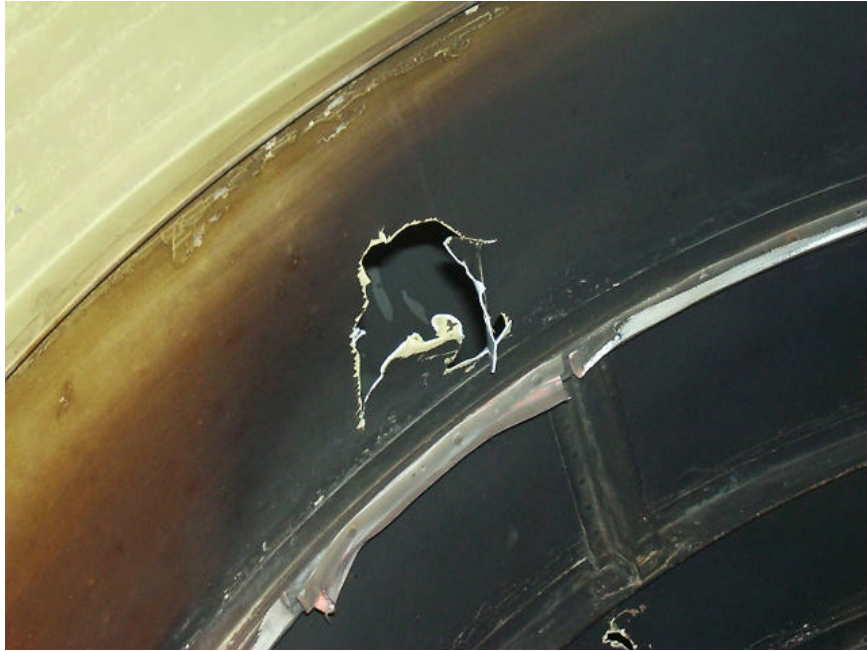
Figure A15. FOD on Engine #1 RH reverse cowl (1)

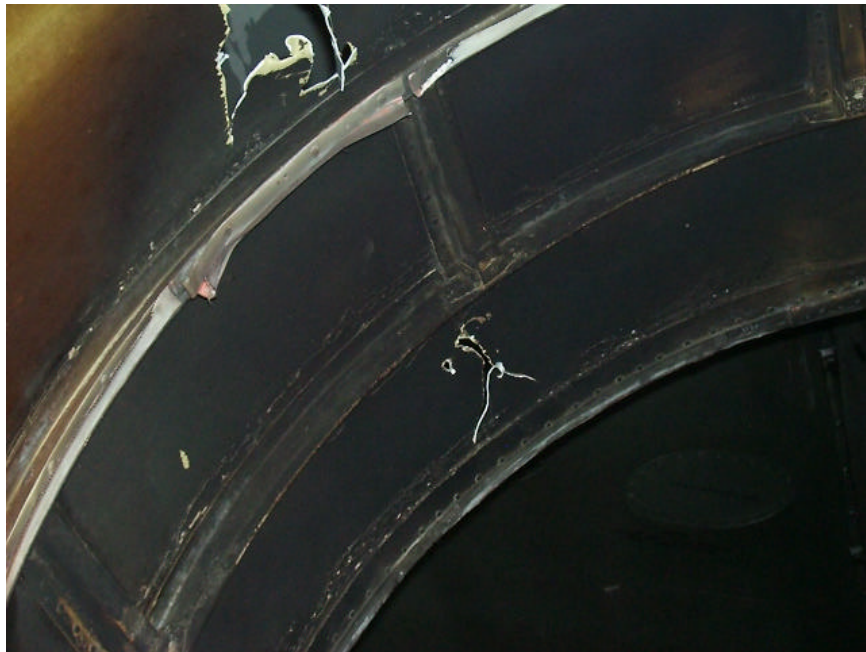
Figure A16. FOD on Engine #1 RH reverse cowl (2)

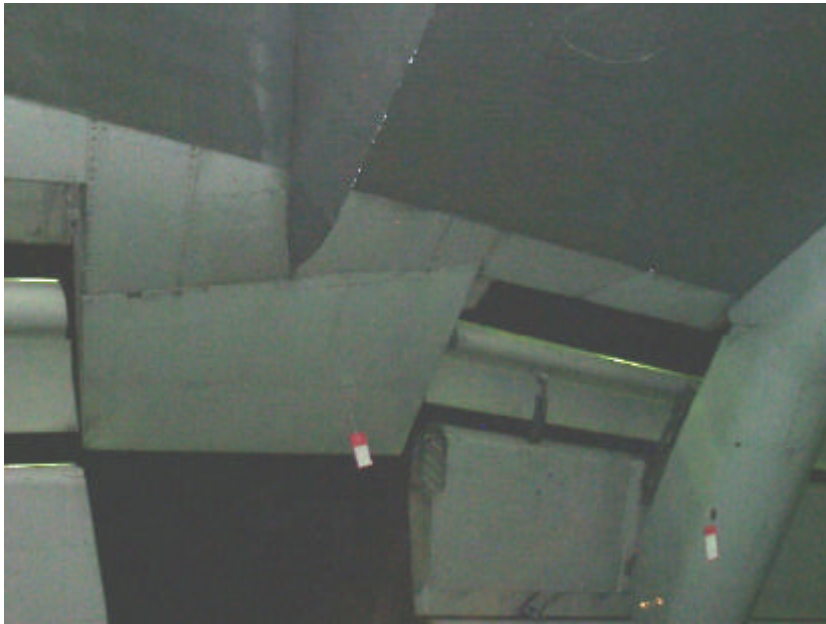
- Damages on lower surface of LH inboard aileron.
- Damages on LH inboard flap
- Damages on flap canoe #1 and #2.
- Damages on fix fairing near LH refueling panel.
- Damages on engine #1 pylon upper fairing.
- Skin scratches on engine #1 pylon RH side.
- Skin scratches on engine #1 hydraulic bay RH panel.

Figure A19. Damage on LH low speed aileron and flap track fairing - tagged debris

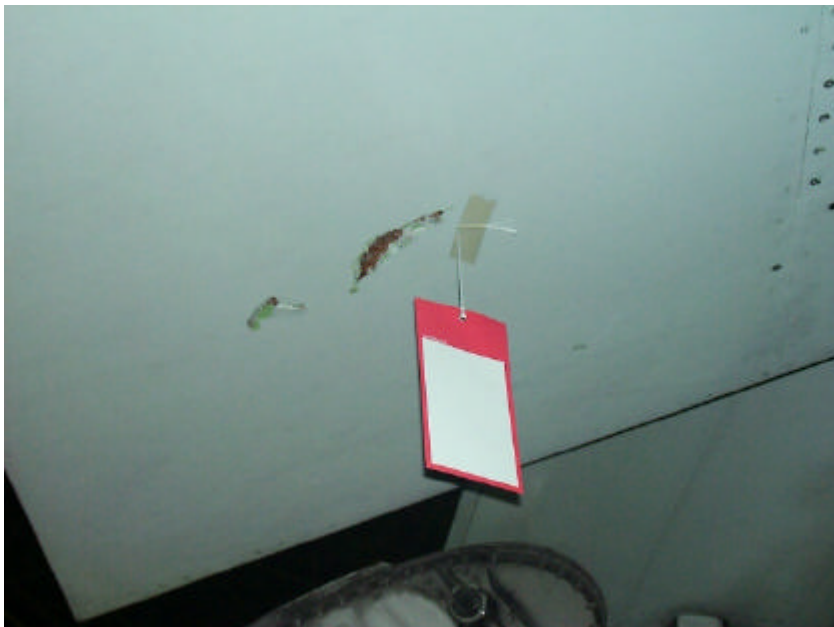
Figure A20. Damage on LH low speed aileron - tagged debris

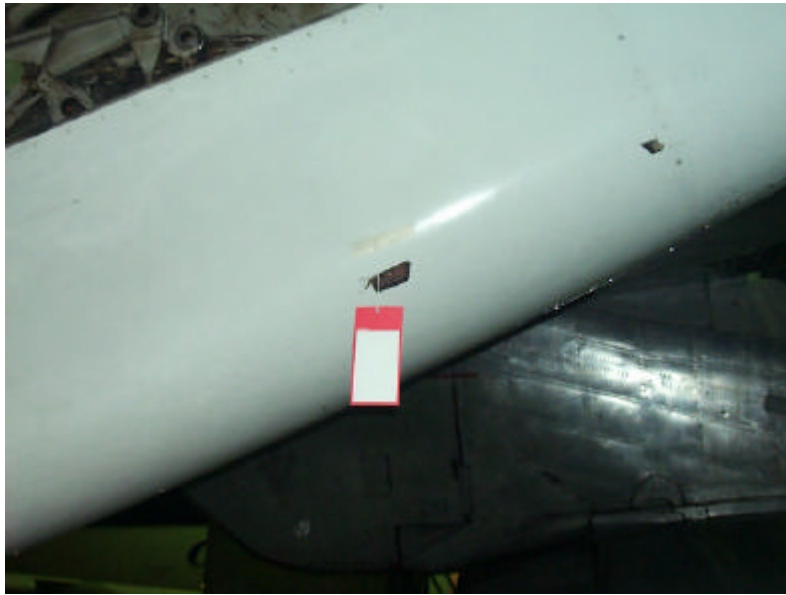
Figure A21. LH flap track fairing

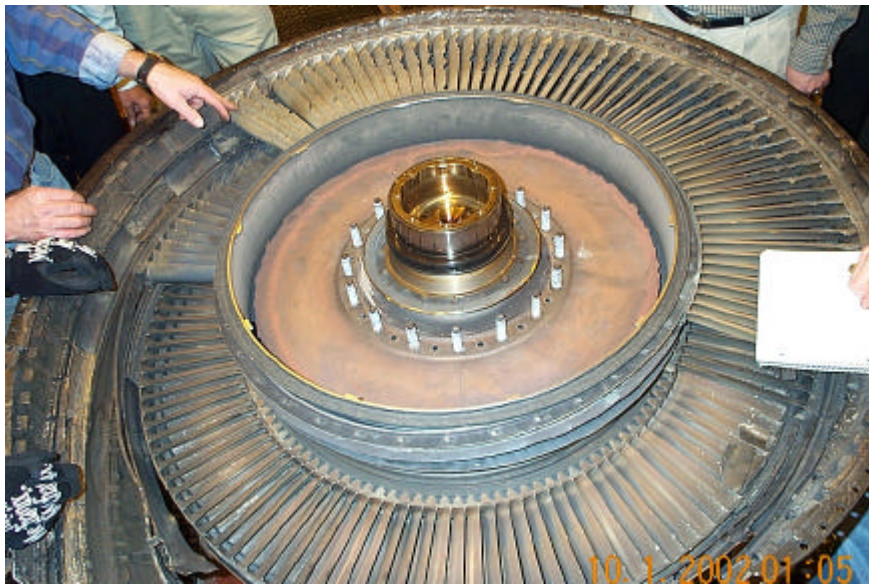
Figure B4. Engine #2 LPT Module - 5th stage disc revealed

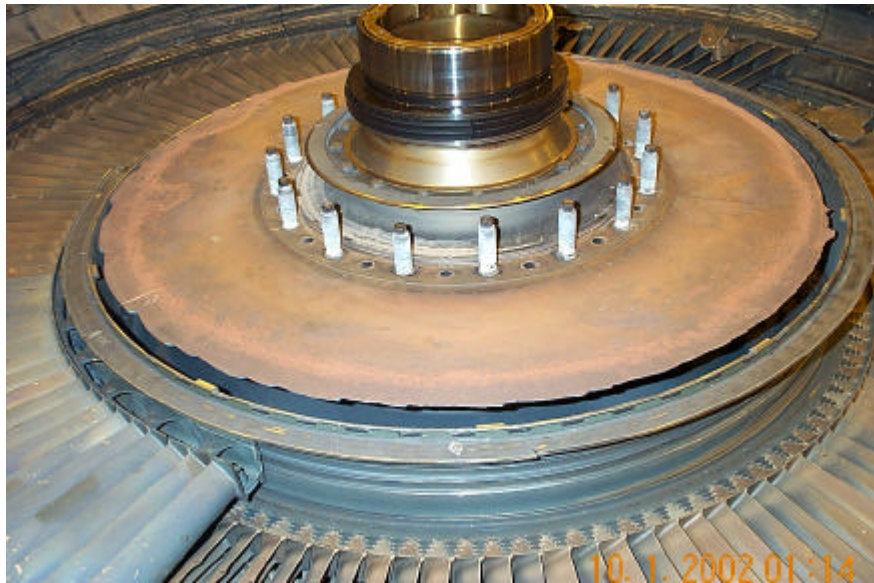
Figure B7. 5th stage disc web

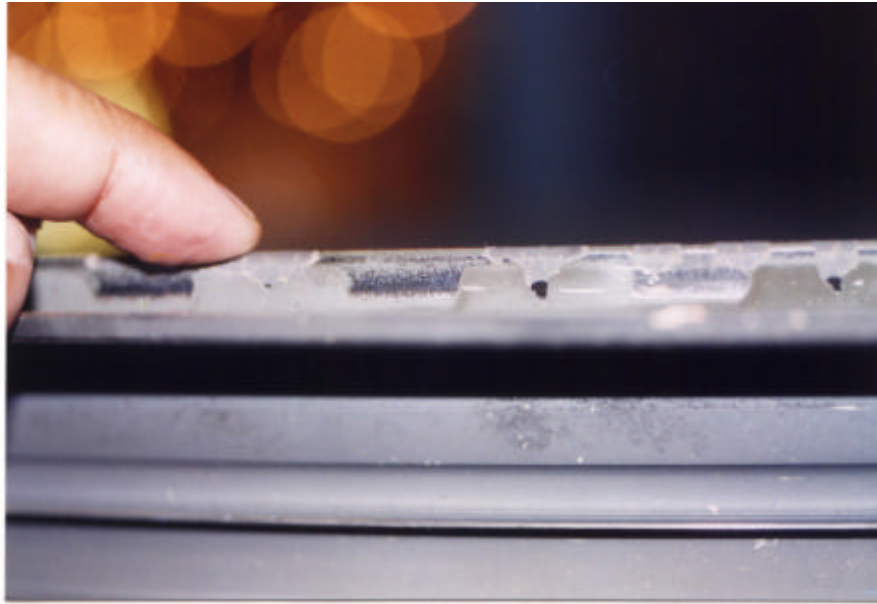
The engine tear down revealed the blockage of the cooling air holes of the 5th stage rotating airseal by plasma coating material. This blockage has a significant impact on the 5th stage disk lives and resulted in uncontained disk fracture.

The 5th airseal has 60 holes for the cooling air passage. During the teardown, fifty-six of the 60 (>90%) cooling holes were found blocked by plasma coating material. The four that were found partially blocked were exposed because of chipped coating (Fig. B9 and B10).

Figure B9. 5th stage inner airseal cooling air holes - three holes partially opened

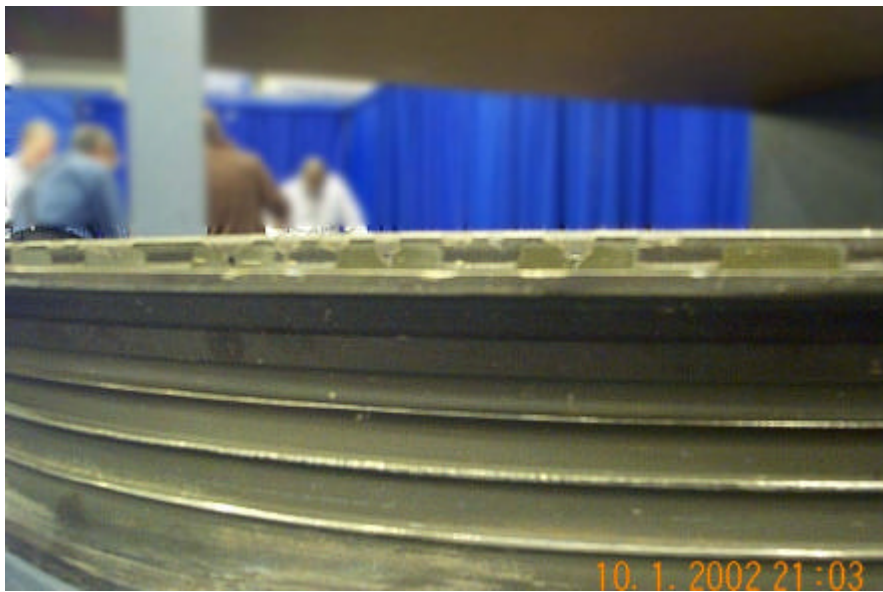
Figure B10. 5th stage inner airseal cooling air holes - blocked holes

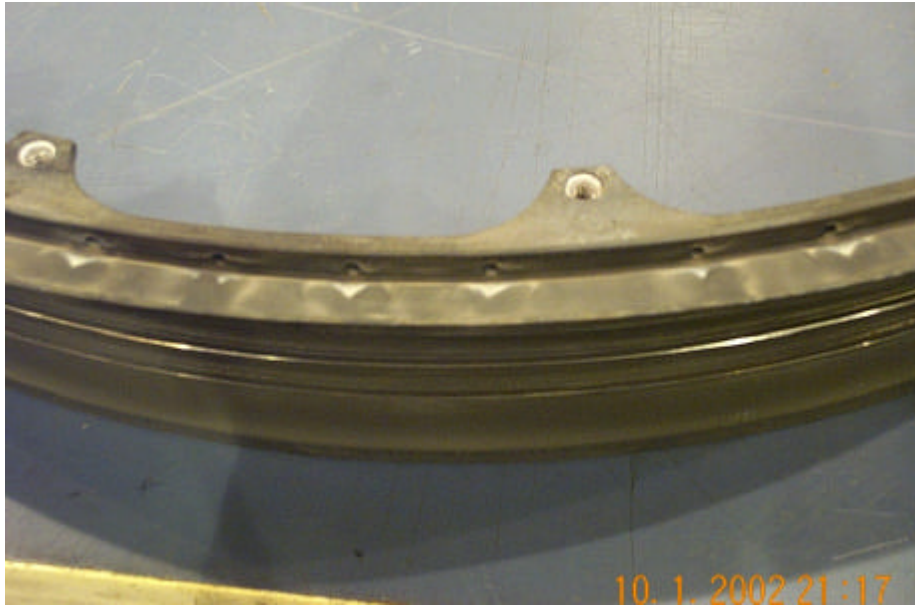
Figure B11. 4th stage inner airseal - discoloration due to cooling air passing through cooling air holes, not found on 5th stage inner airseal

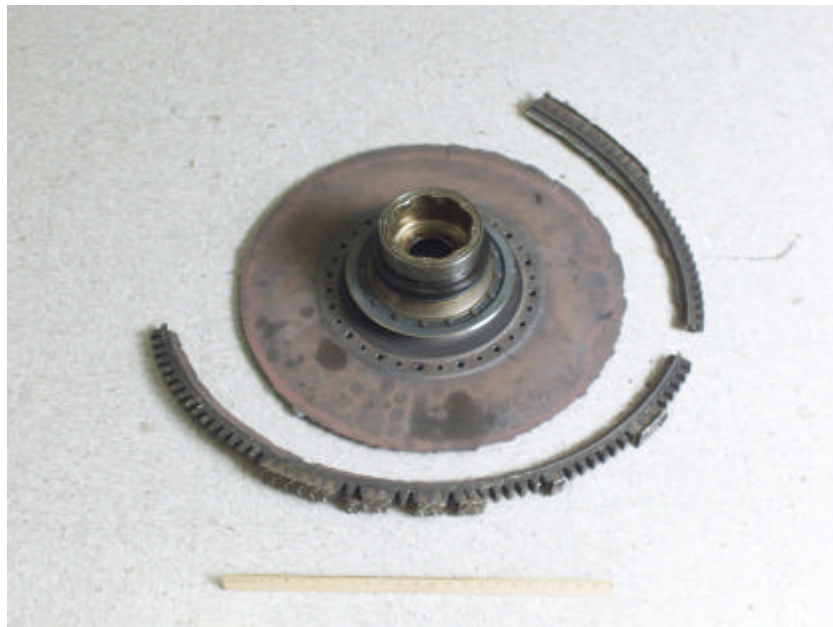
The rim of the disk was detached from the web (Fig. B12). The recovered rims consist of two broken pieces, which include 85 slots (out of 110 slots). These two pieces were recovered at Garuda Engine shop in Jakarta, and directly sent to NTSB Laboratory in Washington DC. The web of the disk shows different colors on both faces, the forward face has gray-blue color (Fig. C1), while the aft face has brown-red color (Fig. C2). The fracture surfaces of the disk show 90-degree plane on both faces connected by a 45-degree plane (Fig. C3, C4, C5 and C6).

Figure B12. 5th stage disc - web and two portions of recovered rims

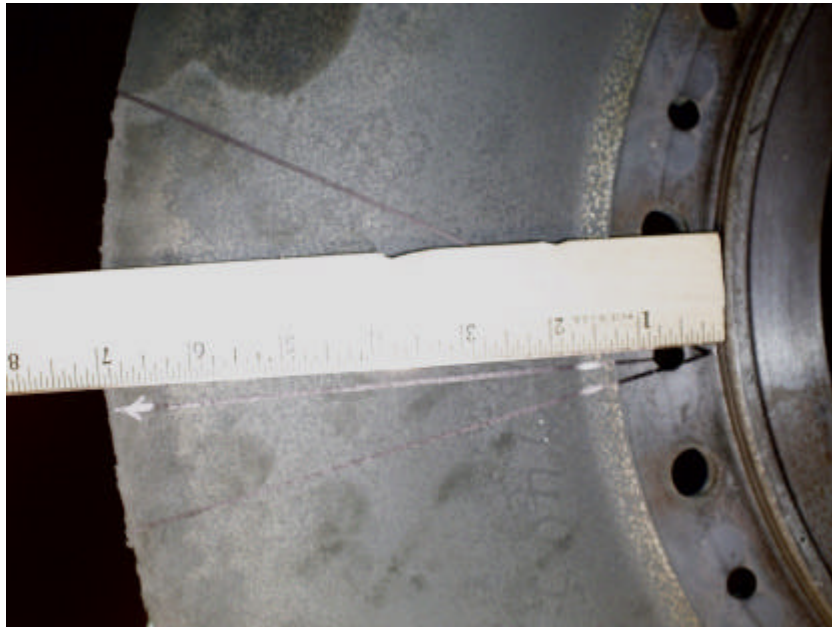
Overall visual inspection showed that the length of the 90° fracture surface is about 14 inches long on the forward face and 9.5 inches long on the aft face of the web. This type of fracture surface is located approximately 7 inches from the forward inner spacer snap diameter (or 13 inch radius from the disk centerline) or 0.5 inch from live rim. The 45° fracture surface occurred continuously circumferentially. This 45° fracture surface has a jagged form circumferentially (i.e. from 7 to 7.5 inches).

Figure C1. Location of fracture origin on 5th stage disc web, measured from bore - forward face

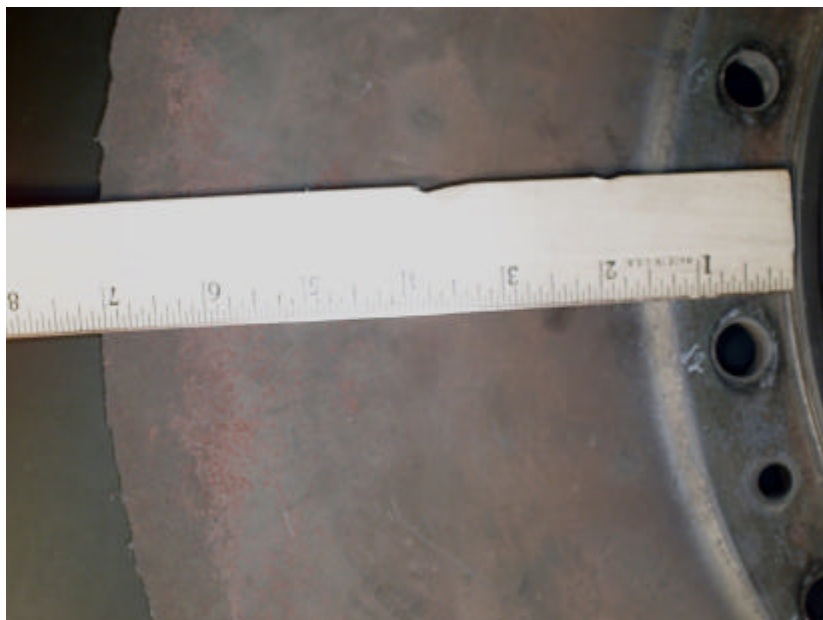
Figure C2. Location of fracture origin on 5th stage disc web, measured from bore - aft face

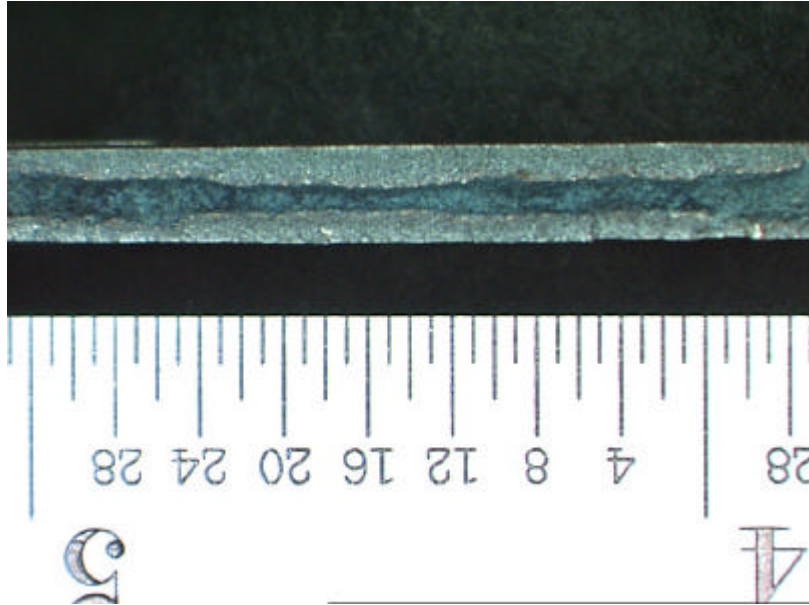
Figure C3. 5th stage disc web fracture origin surface (1)

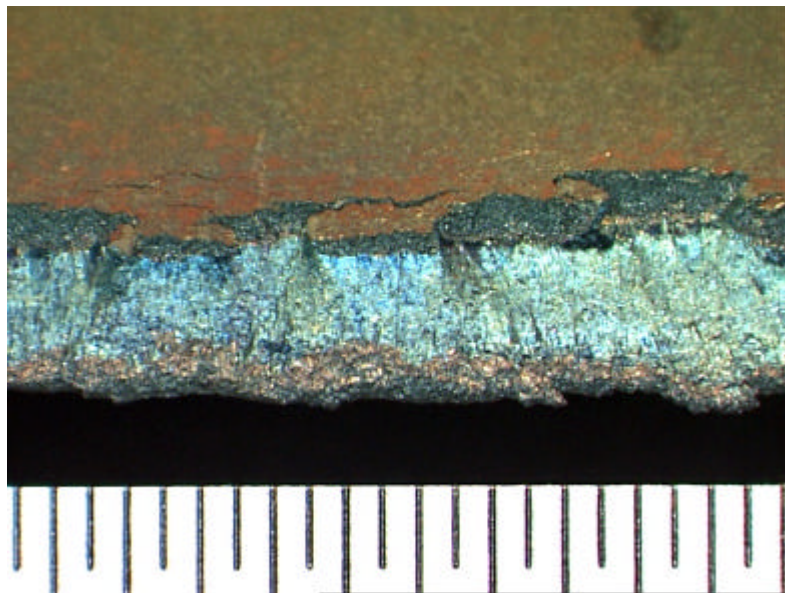
Figure C4. 5th stage disc web fracture origin surface (2)

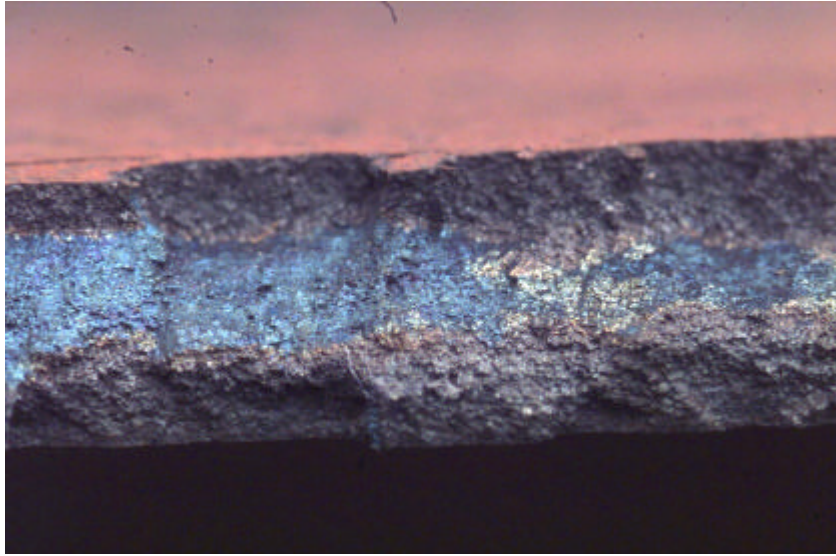
Figure C5. 5th stage disc web fracture origin surface (3)

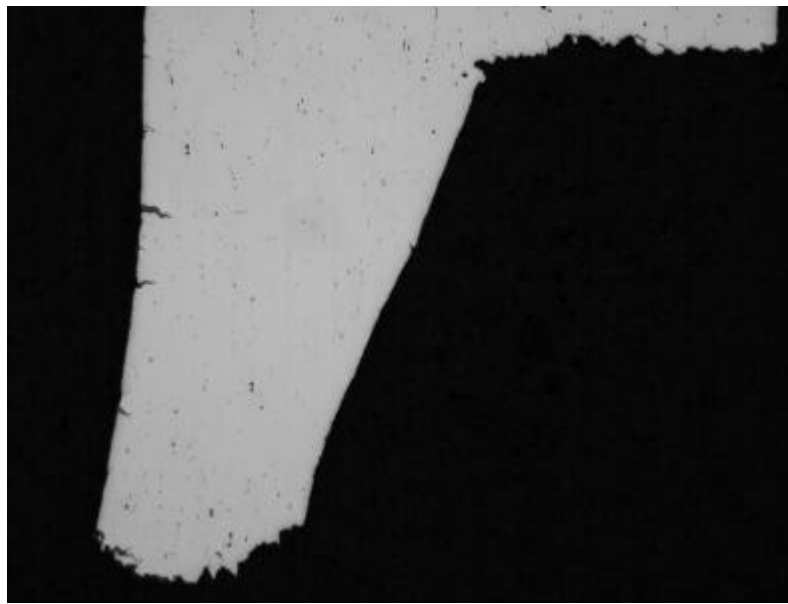
A sample for metallography was prepared on a section taken from the segment that has been observed by SEM. The un-etched surface shows the nature of the cracks and secondary cracks on the forward and aft side. More specifically, there were thicker oxide layers at the outer fracture and becomes thinner towards inner location. The intergranularity of the 90° fracture was also confirmed by the metallography examination. There were secondary cracks on the forward side and the aft side. These secondary cracks were “filled” with oxides.

Figure C6. Radial metallographic section through fracture origin showing forward and aft face of web. Forward face is on left side.

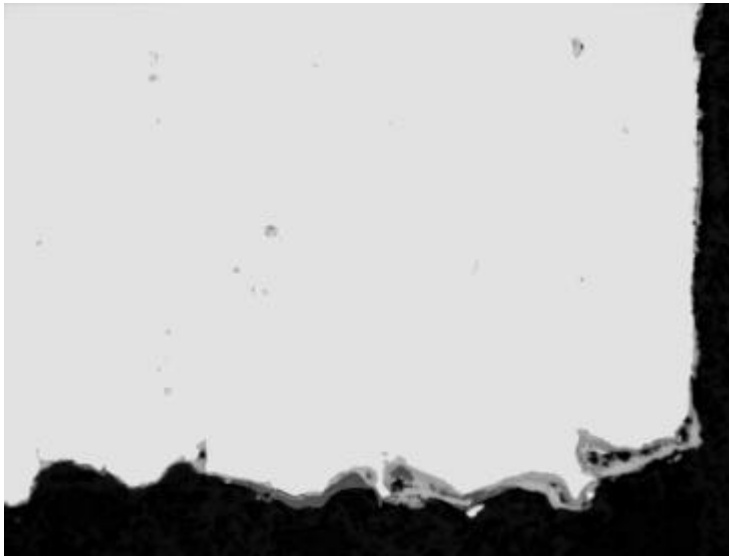
Figure C7. Fracture origin on aft face of web (aft face on right side)

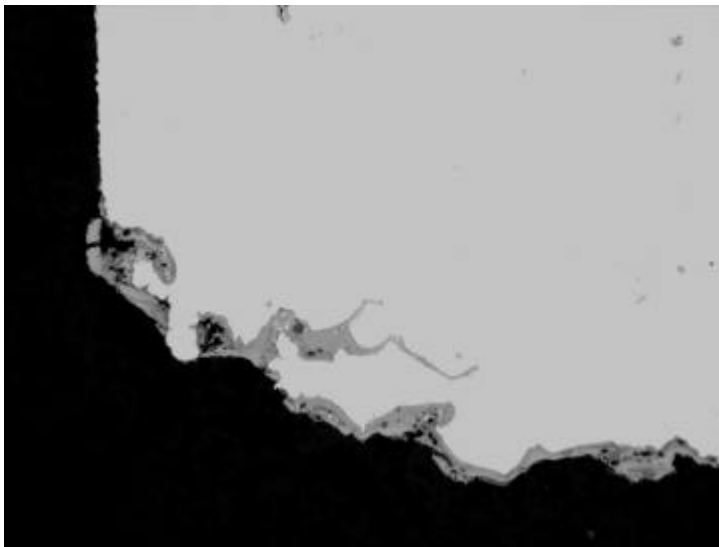
Figure C8. Fracture origin on forward face of web (forward face is on left side)

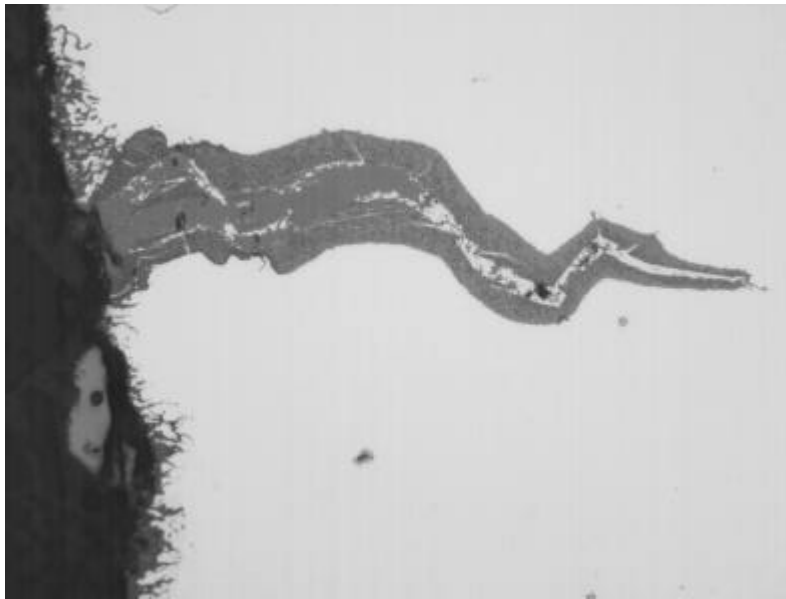
Figure C9. Secondary intergranular crack on forward face (left side)

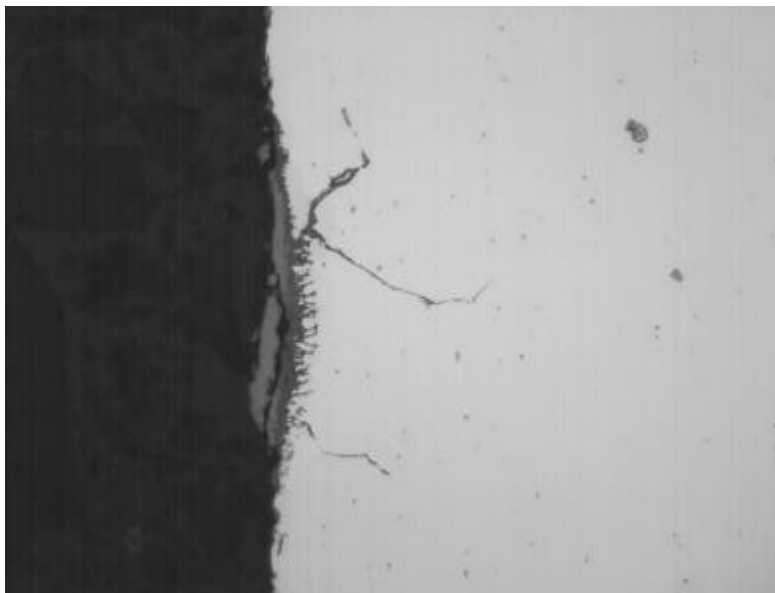
Figure C10. Secondary crack on forward face (left side)

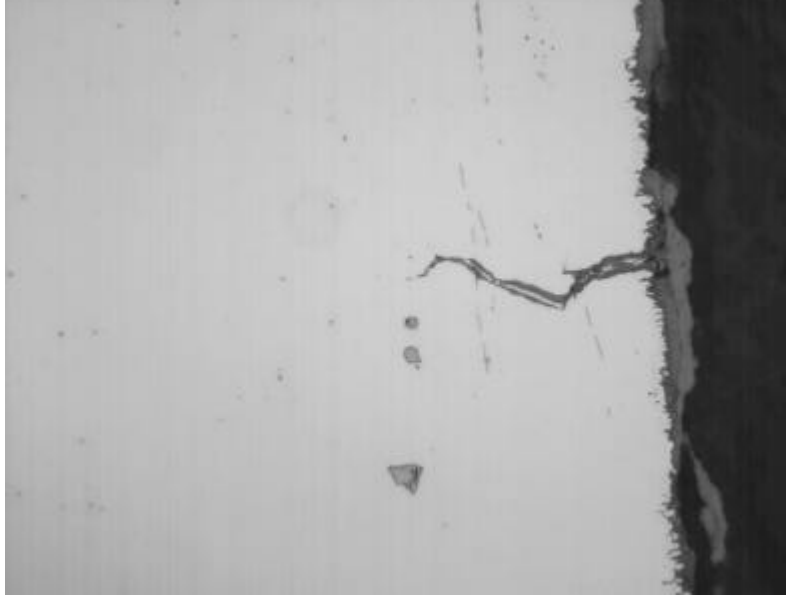
Figure C11. Secondary intergranular crack on aft face (right side)

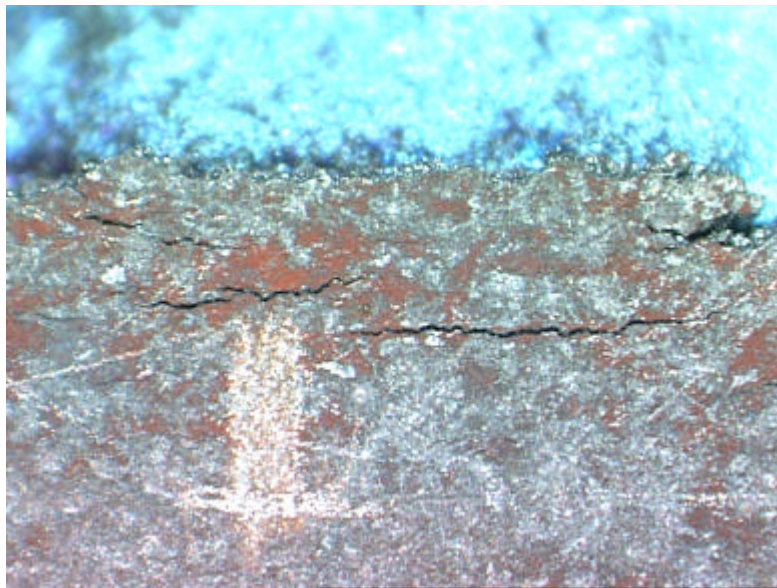
Figure C12. Secondary crack on aft face of web

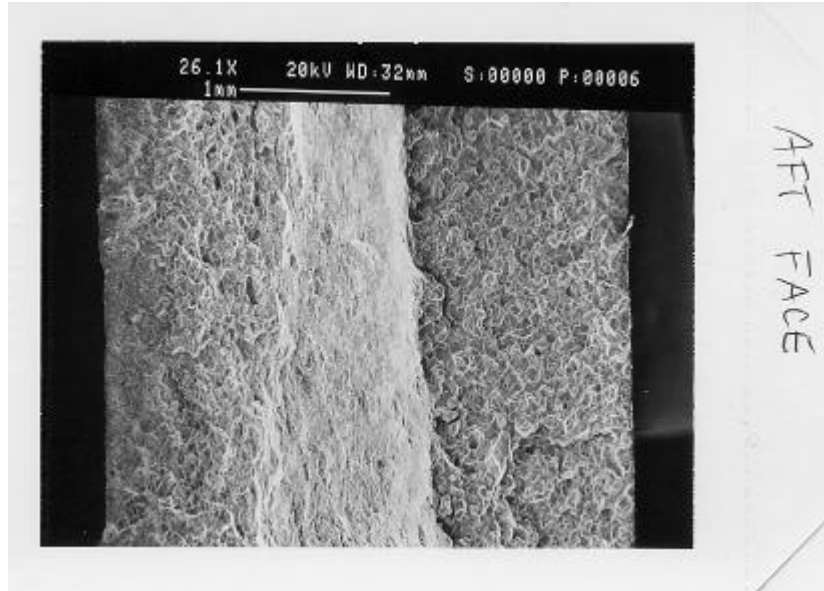
SEM examination was done on the fracture surface revealed the intergranular nature of the 90° fracture surface and smooth sheared surface of the 45° fracture surface (Fig. C13). On the 90° fracture surfaces the intergranular nature is more distinct at locations away from the disk face. Intergranular cracks were also observable at these locations. The less prominent intergranularity near the disk face is due to oxide formation (Fig. C16).

Figure C13. SEM Photo of fracture origin area

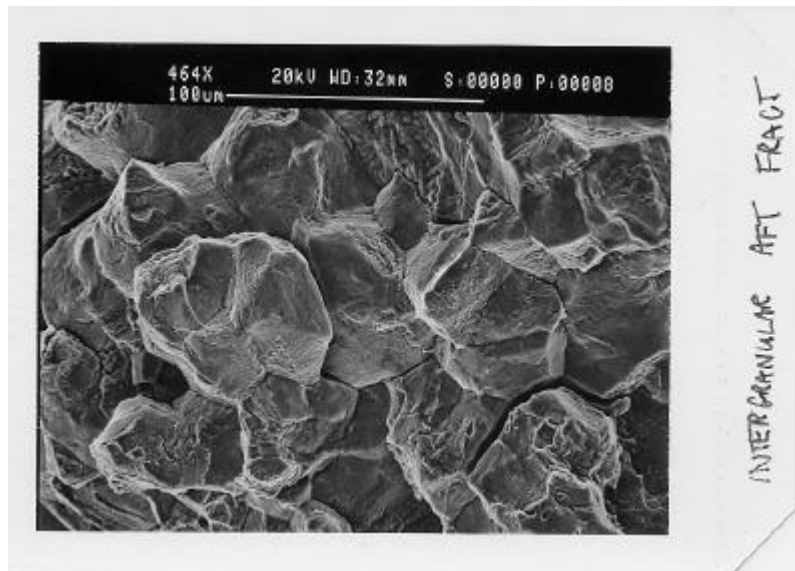
Figure C14. Intergranular fracture - aft face

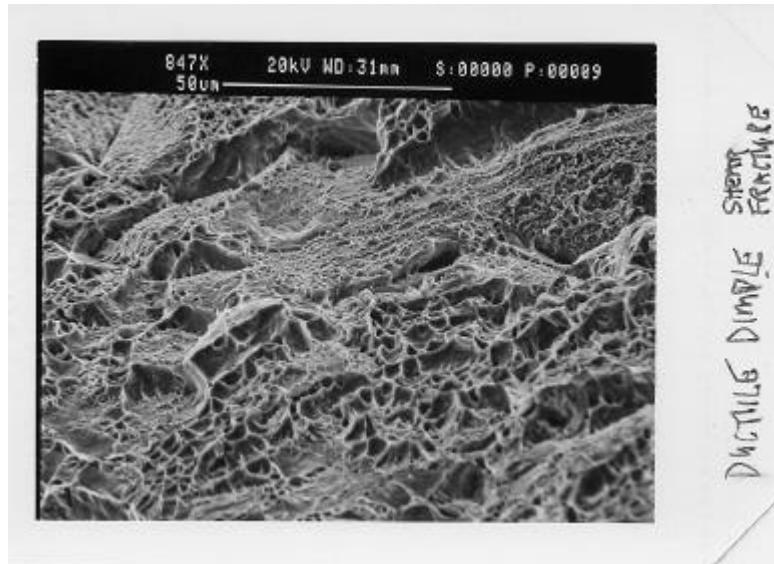
Dimples showing shear movement were observed on the 45° fracture surface (Fig. C15).

Figure C15. Ductile dimples indicating shear fracture in the middle section of the fracture origin surface

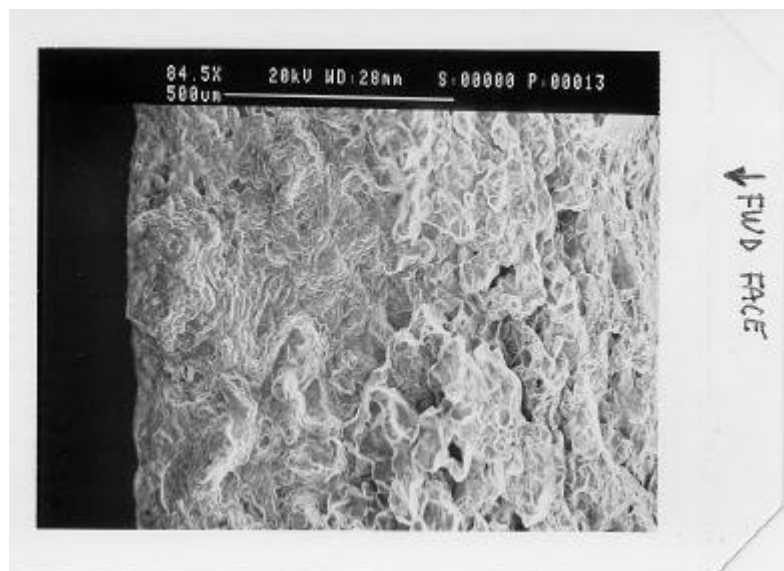
SEM observation on the face showed a circumferential intergranular crack (Fig. C16). Similar feature of fracture surface was observed in the secondary crack, due to oxide formation indicating longer exposure to gases.

Figure C16. Severely oxidized intergranular fracture on left side (forward face)
