NATIONAL
TRANSPORTATION
SAFETY
COMMITTEE

AIRCRAFT ACCIDENT REPORT

Garuda Indonesia Flight GA 880

Boeing B747-200 PK-GSD

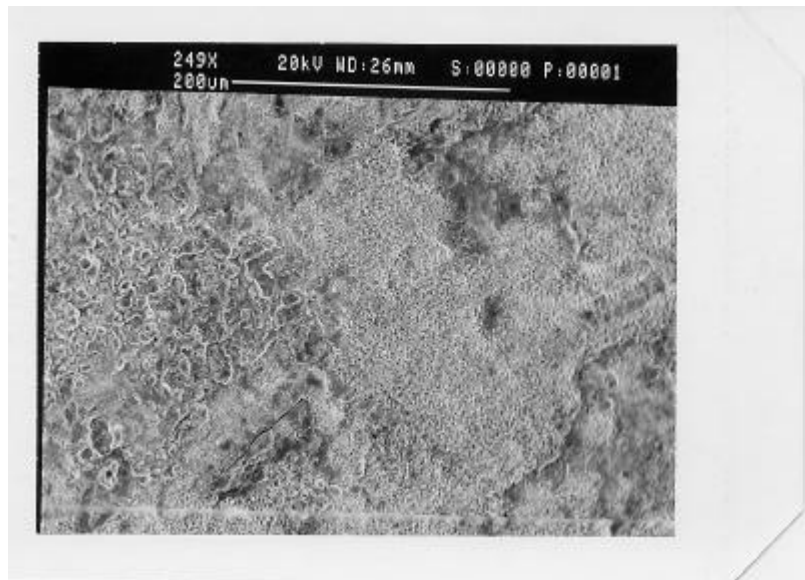
Figure C17. Close up of aft face showing oxidized surface (red oxide appears as fine feature)

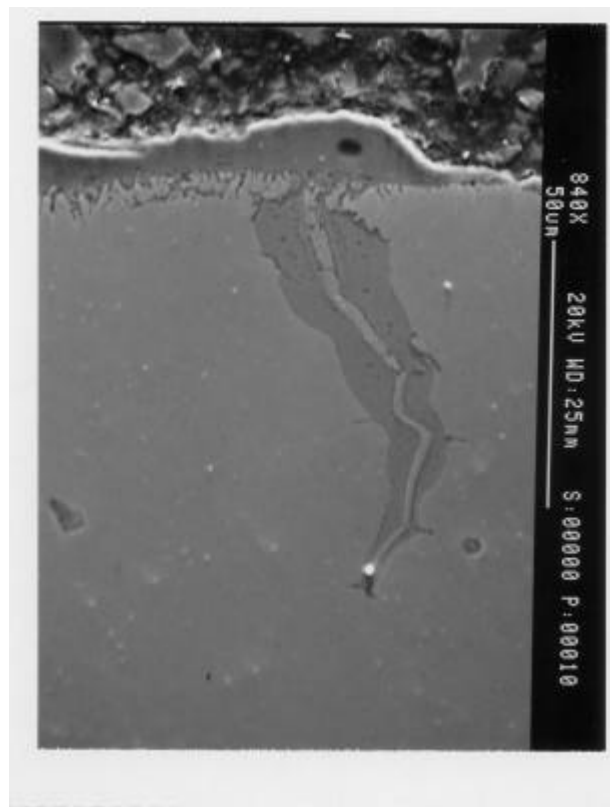
Figure C18. SEM photo of secondary intergranular crack (forward face)

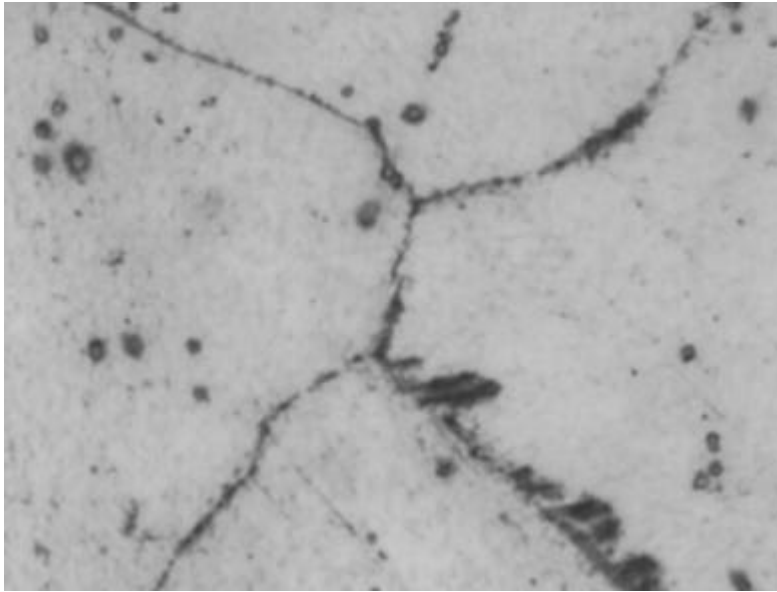
The grain size of the section near the fracture surface was found to be 6 ASTM Grain Size.

Higher magnification (1000x) reveals that the grain boundaries consist of small discrete carbide precipitates. There are no detrimental phases/features observed at the grain boundaries, such as:

Figure C19. Microstructure next to fracture origin area

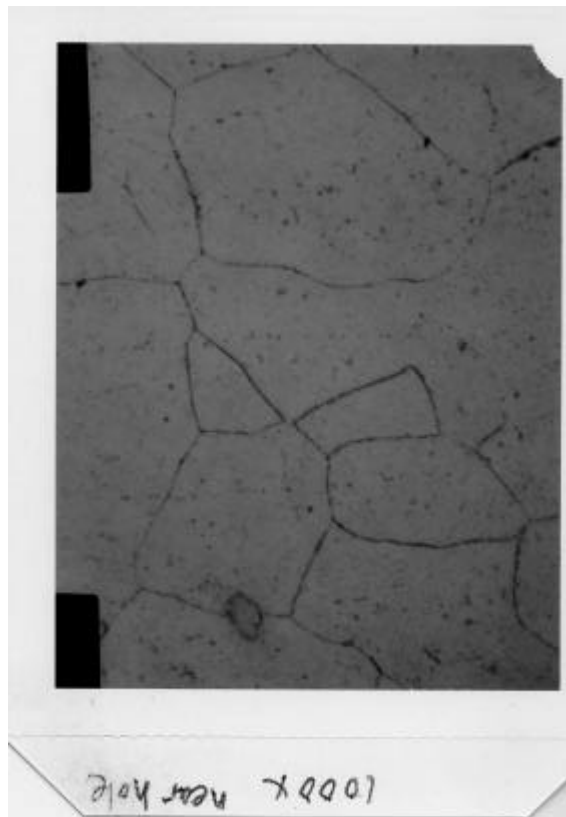
Figure C20. Microstructure next to hole area

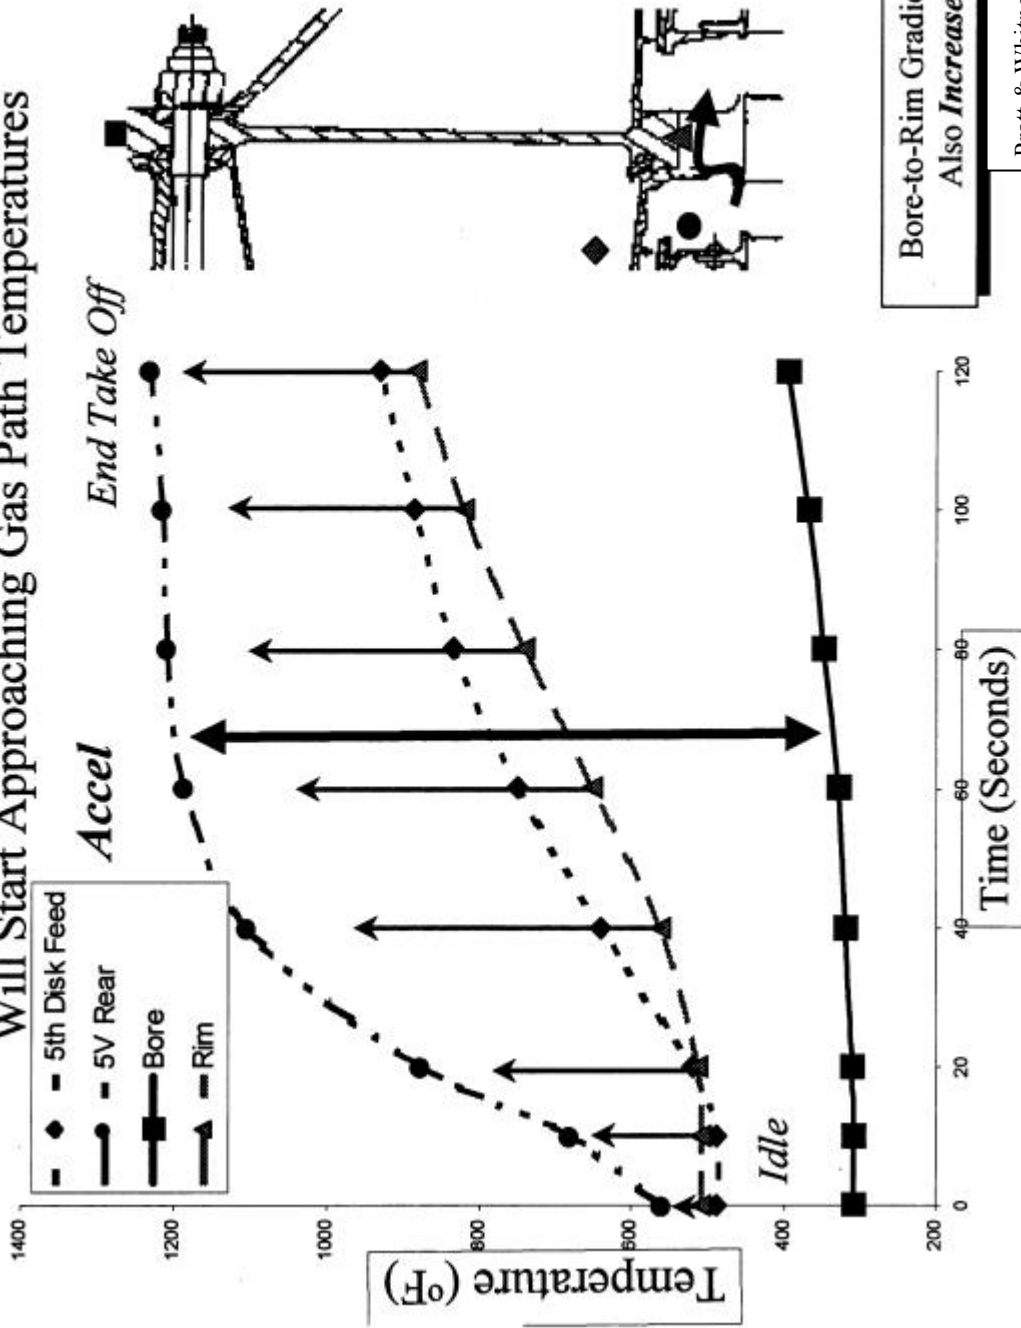
When the Live Rim Cooling Air is Blocked, Live Rim Temperatures Will Start Approaching Gas Path Temperatures

Bore-to-Rim Gradient Will Also *Increase* !!

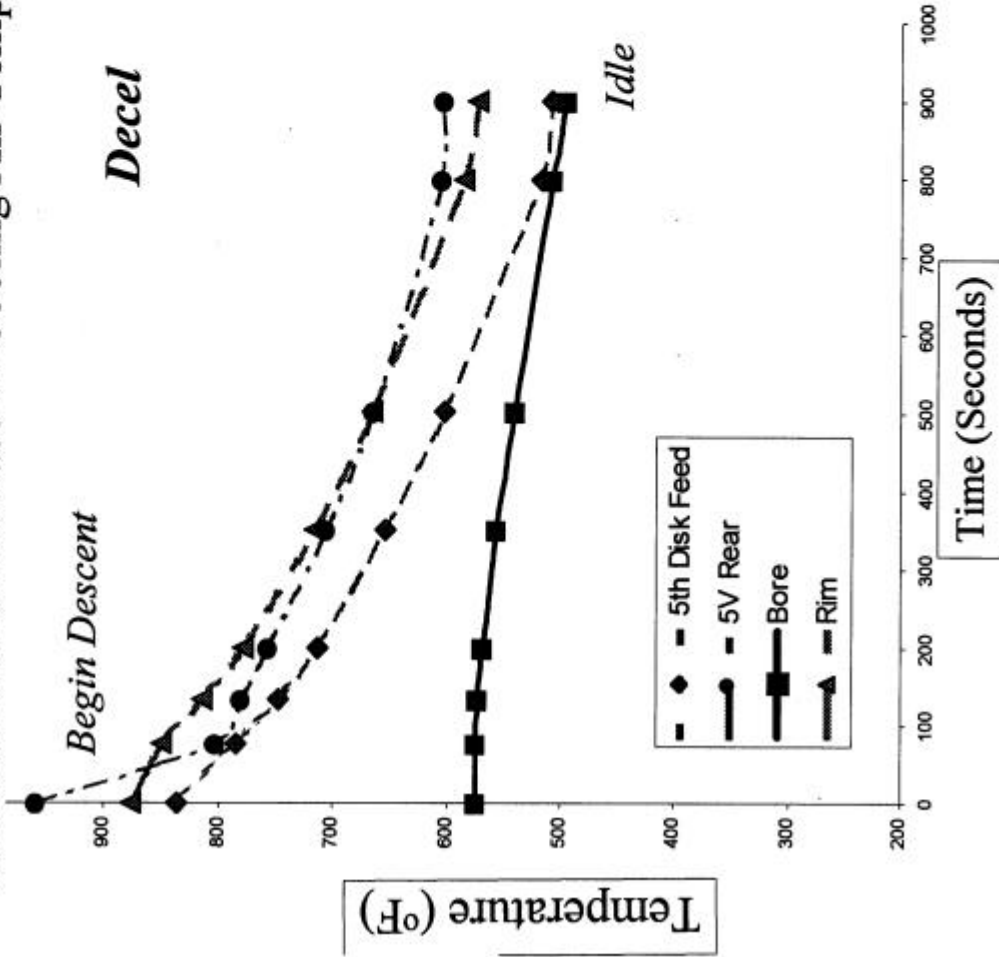
When the Live Rim Cooling Air is Blocked, Live Rim Temperatures will Increase Due to Increase in Cooling Air Temp – Not as Severe as Accel

Bore-to-Rim Gradient Will Also *Increase* !!

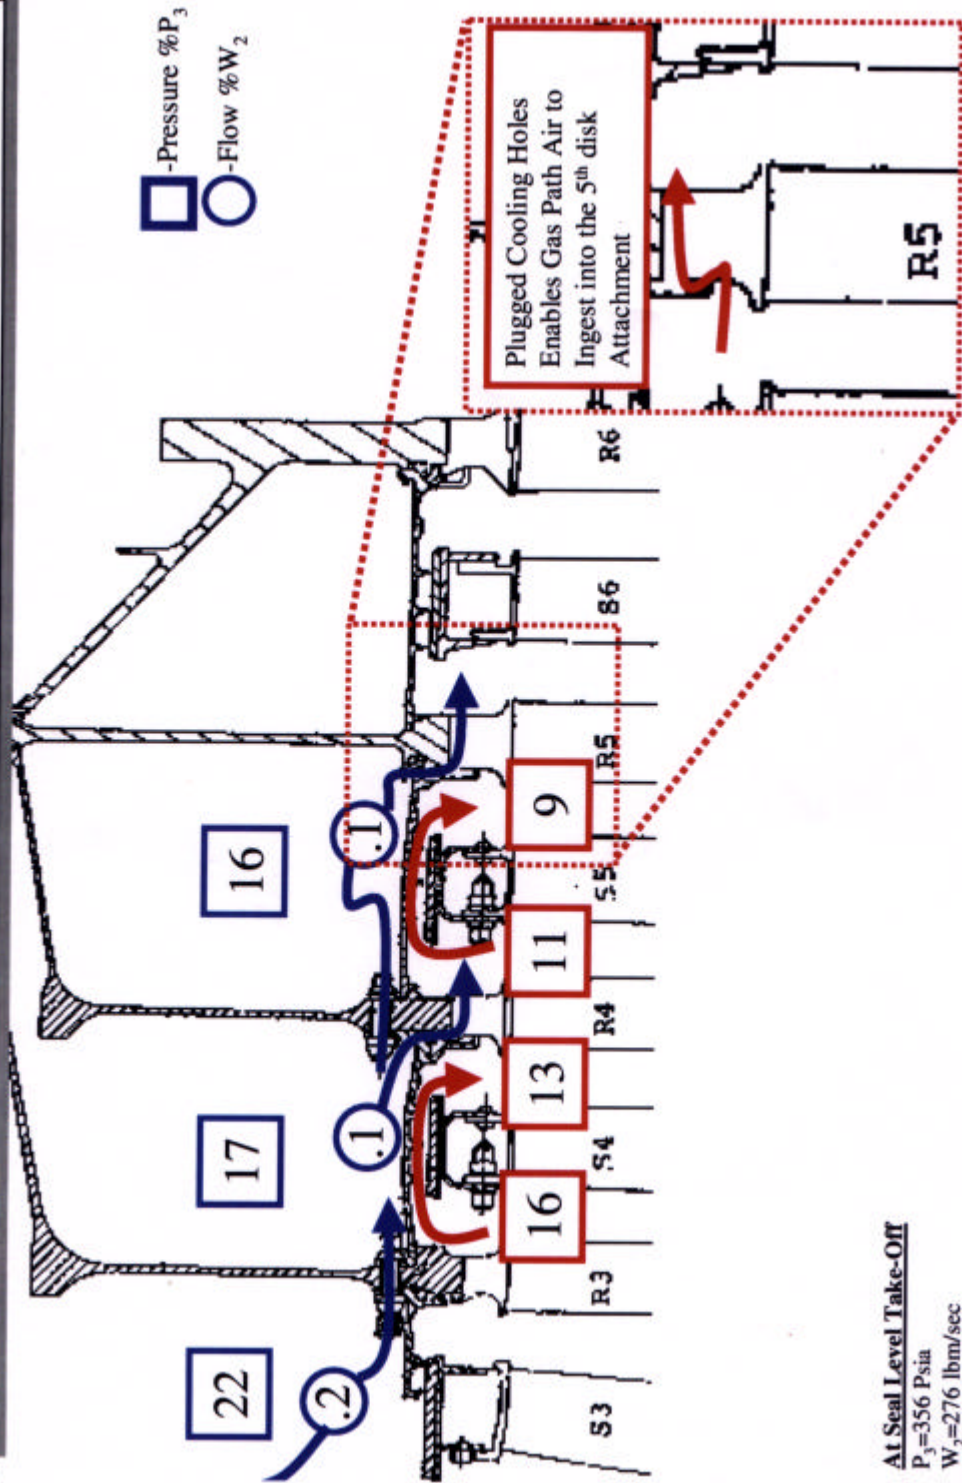
Plugging 4-5 Inner Air Seal Cooling Holes Will Increase Live Rim Temperatures at 5th disk

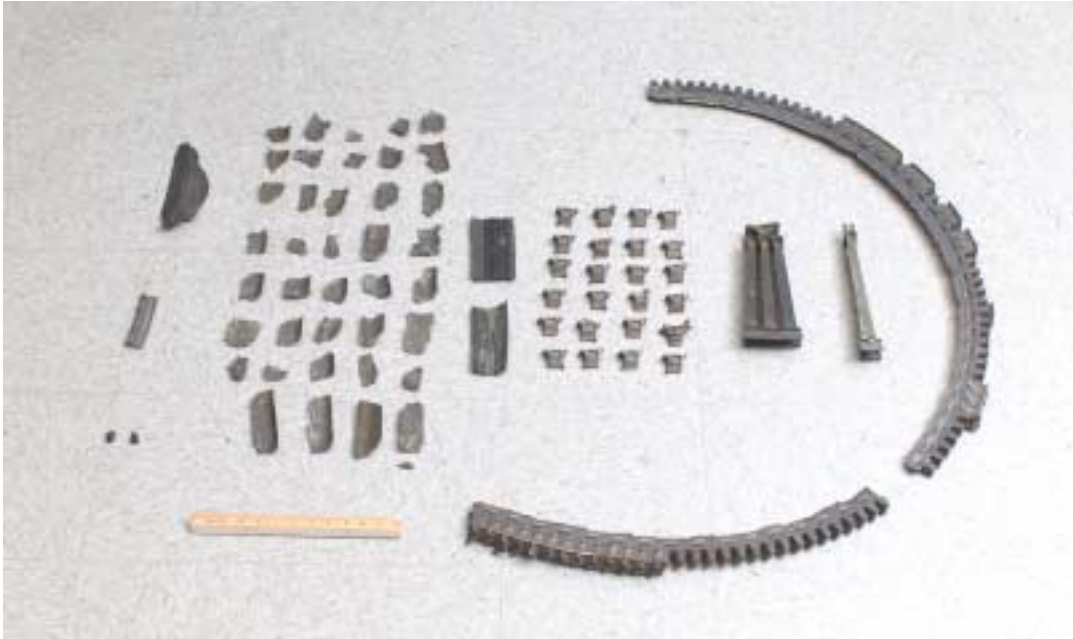
Figure 1. As-received portions of the 5th stage LPT disk showing two pieces of the rim (right side of photograph), and several pieces of vane and blades.

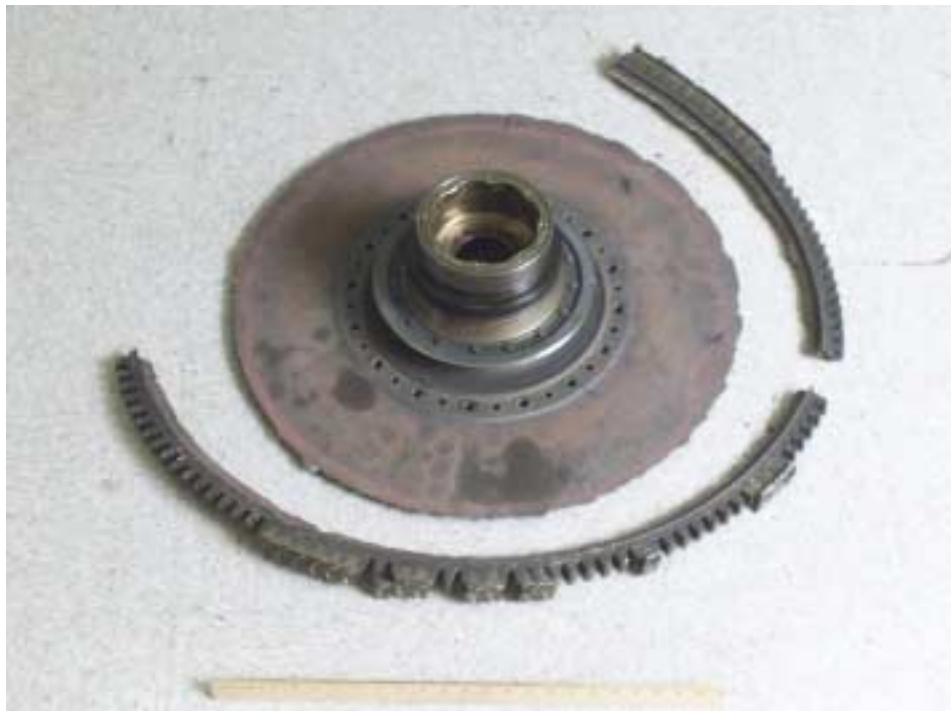
Figure 2. As-received disk that fractured all around the web. The two rim pieces were positioned next to the web portion as if intact.

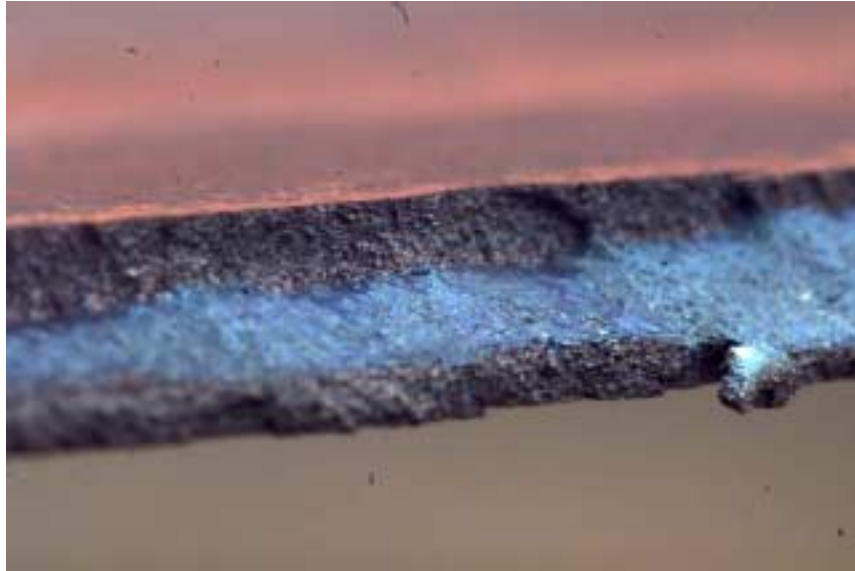
Figure 3. Optical photograph of a portion of the web fracture face. The flat fracture regions adjacent to each face of the web (appear gray-dark blue) are connected by a slant fracture (blue). The aft face of the web appears red-brown and is located on the upper side of the photograph. Photograph taken by P&W after disassembly of the disk.

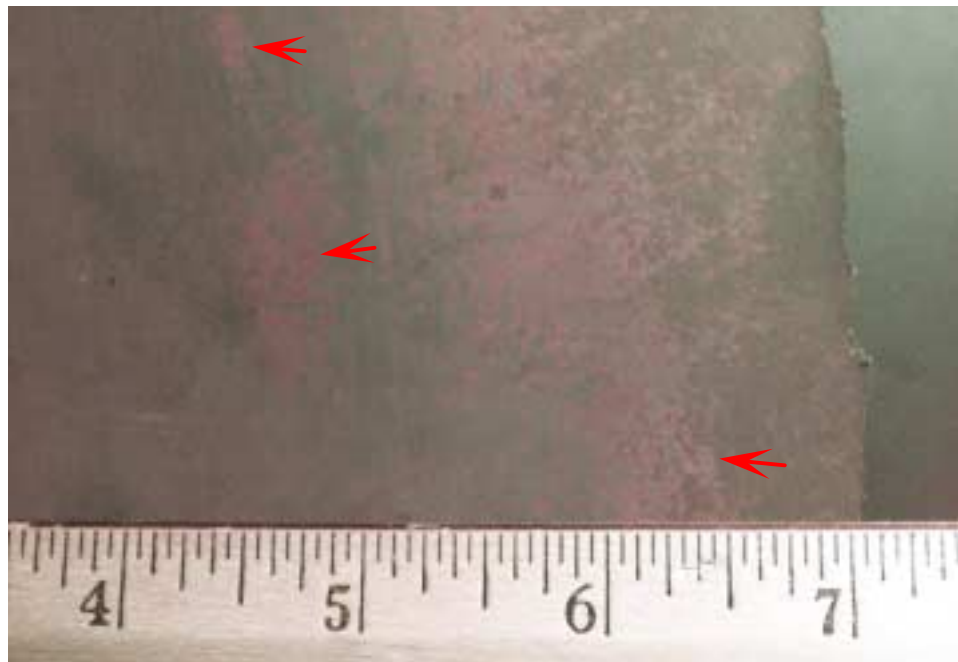
Figure 4. Area of the aft face of the web with some of the red-brown deposits indicated by unmarked arrows.

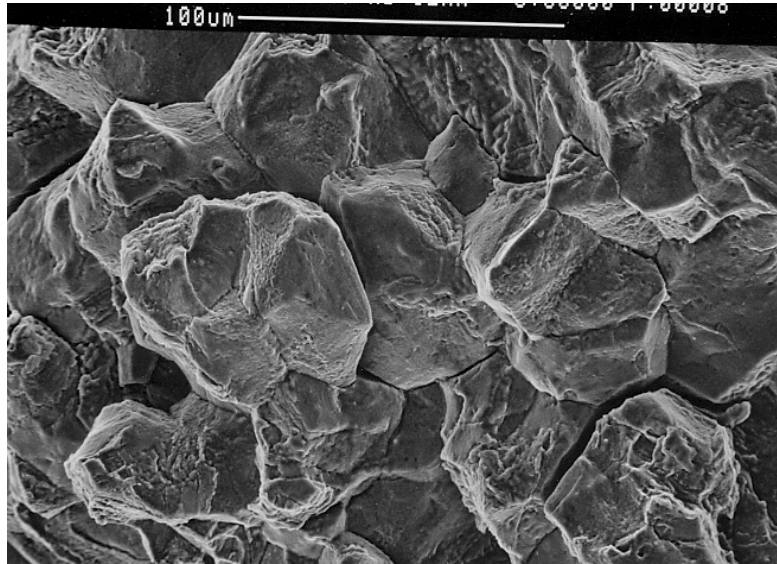
Figure 5. Scanning electron microscope photograph of typical intergranular fracture features that were found on the web portion of the disk. This photograph was taken on the flat fracture region that was located adjacent to the aft face of the web.

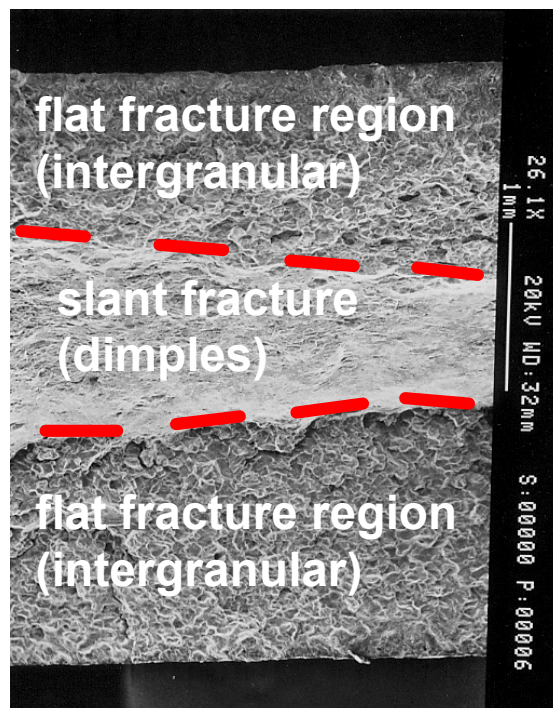
Figure 6. Scanning electron microscope (SEM) photograph of the fracture face located on the web portion of the disk. Flat fracture regions were situated adjacent to the forward and aft faces of the web. Aft face of the web is on the bottom side of photograph.

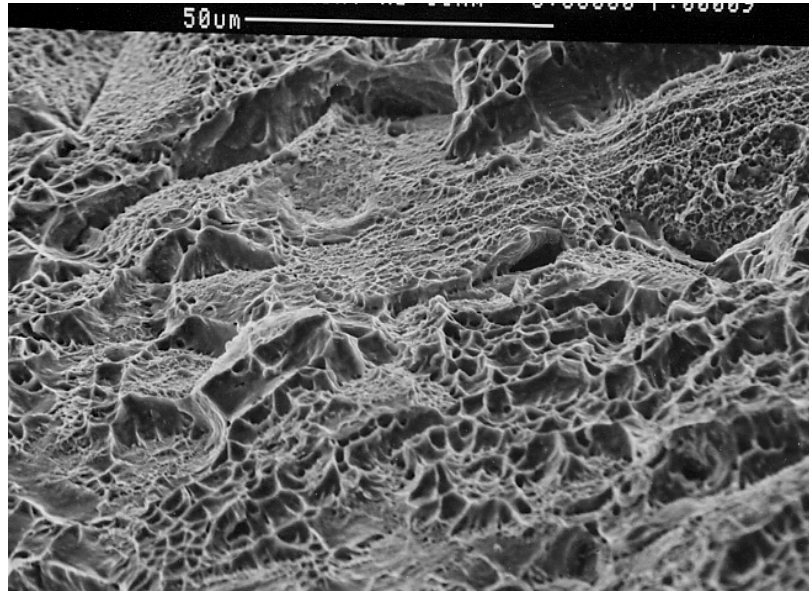
Figure 7. SEM photograph of typical ductile dimple features on the slant fracture.

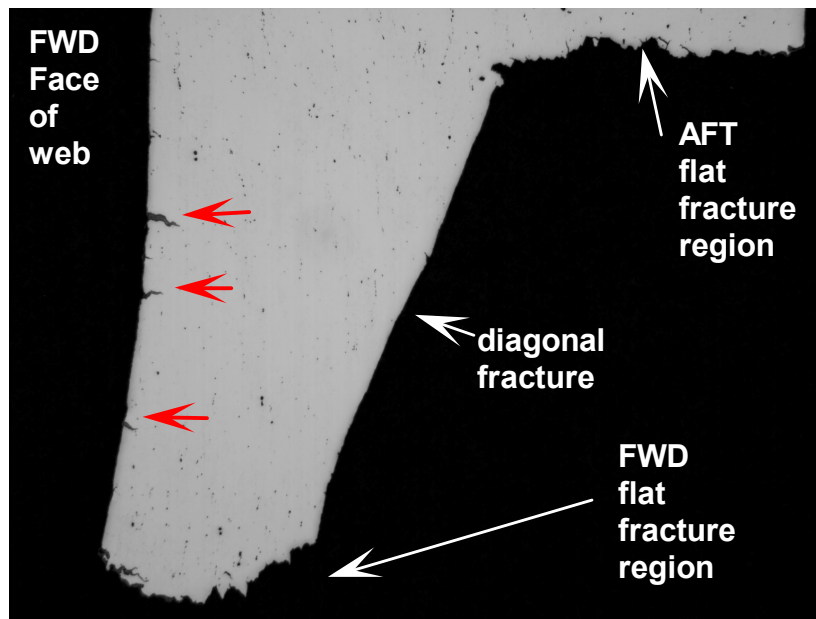
Figure 8. Metallurgical section radially through the fracture. The flat fracture regions on the forward and aft face of the web are connected by a diagonal (shear) fracture. Arrows indicate location of secondary cracks on the forward face of the web.

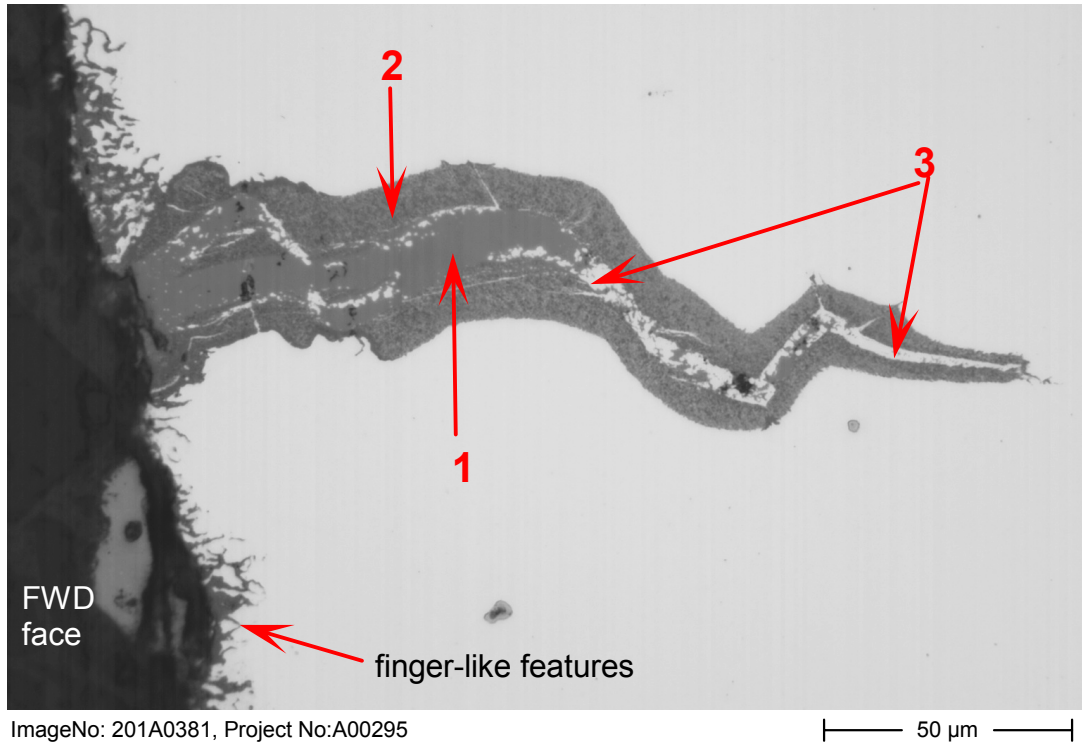
Figure 9. Polished section showing a crack that emanated from the forward face of the web. The crack is filled with three types of oxides, labelled "1" through "3".

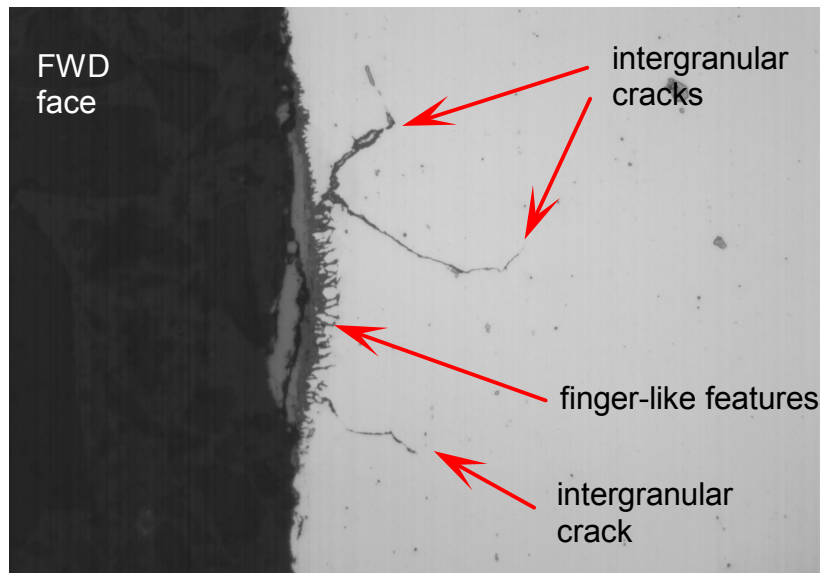
Figure 10. Portion of a polished section showing another crack that emanated from the forward face of the web. The crack is filled with oxides and it propagating along the grain boundaries.
