**AERONAUTICAL ACCIDENT INVESTIGATION
AND PREVENTION CENTER**

**FINAL REPORT
A-00X/CENIPA/2008**

ACFT REGISTRATION: PR-GTD and N600XL

MODELS: B-737 8EH and EMB-135 BJ LEGACY

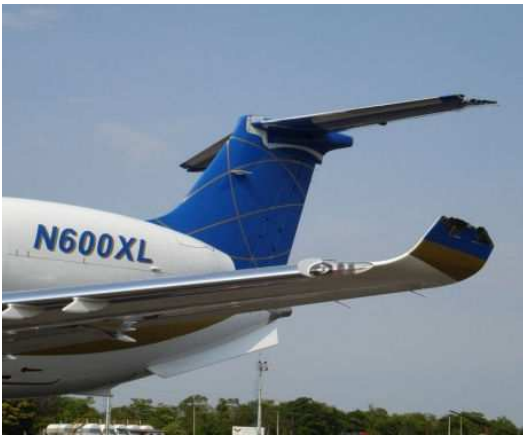
Figure 1

On the occasion, an external inspection was made so as to observe the structural damage sustained by the N600XL airplane. In summary, the following damages were seen: break of the left wing winglet (Figure 1), varied deformations on the left wing and a cut on the fairing of the left tip of the horizontal stabilizer, both on the left side (Figure 2).

Damaged tail and winglet, N600XL

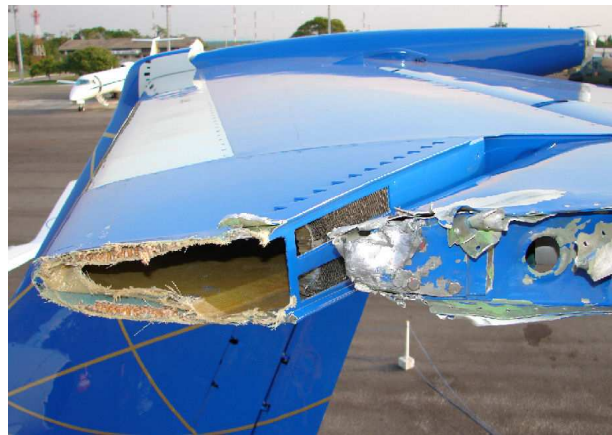
Figure 2

Damaged horizontal stabilizer, N600XL

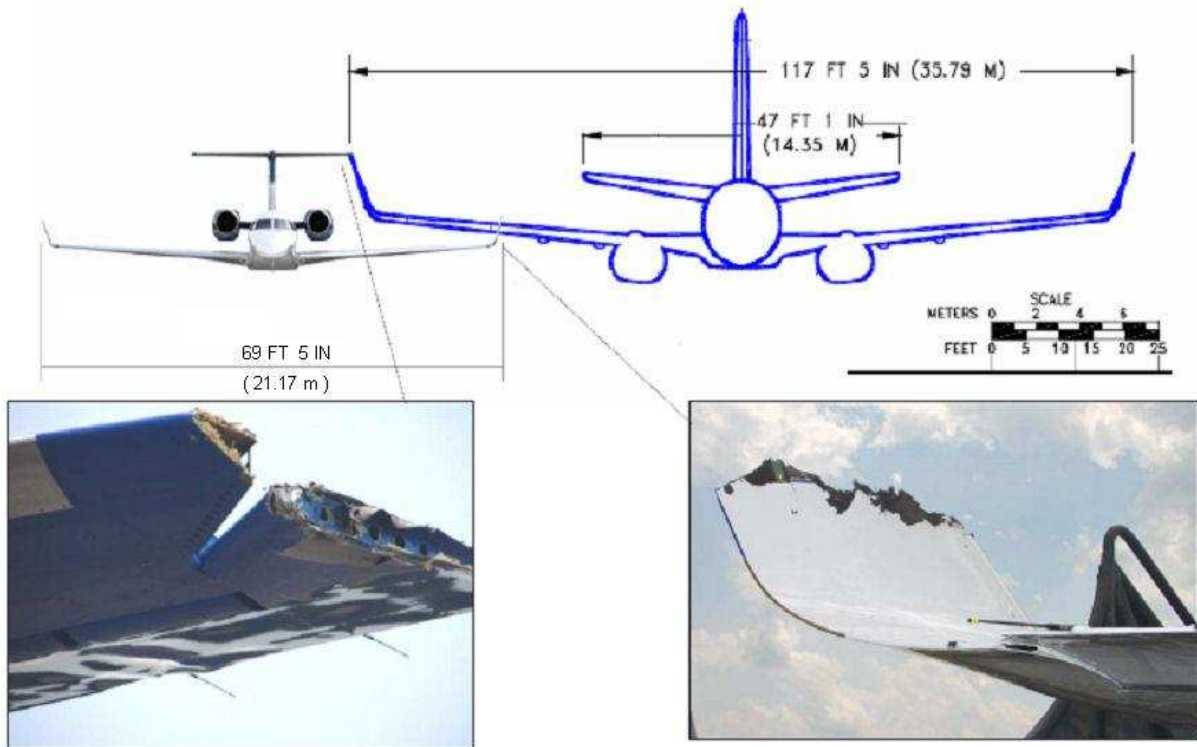
Figure 3

The evaluation of the damages sustained by the N600XL and PR-GTD airplanes allowed the elaboration of a representation of the probable relative position of the two aircraft at the moment of the collision, as shown in figure 3.

Geometry of the collision between the Legacy-600 N600XL and the 737-8EH PR-GTD

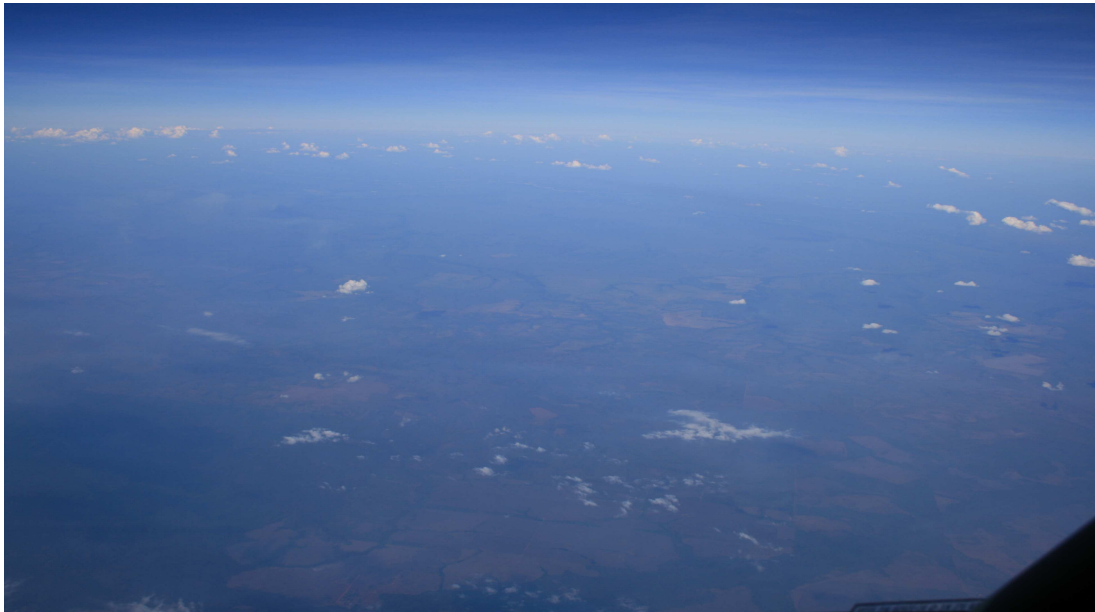
“Through the analysis of the documents, it is observed that there was no formation of significant clouds at the probable location of the collision, the wind was normal for the flight level, and there were not turbulence, icing or other significant phenomena.

After the analysis, it was possible to conclude that the meteorological conditions along the route were not contributing factors to the accident with the aircraft in question.”

Figure 9 – Photo of the weather conditions along the route of the N600XL

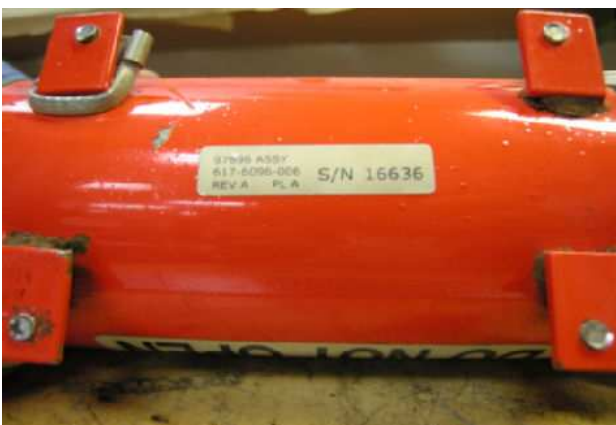
Figure 19: SSCVR protected cylinder, PR-GTD

The direct impact of the SSVR unit against a tree trunk or branch was sufficient for the protected cylinder containing the data (Figure 19) to detach from the rest of the set (Figure 20).

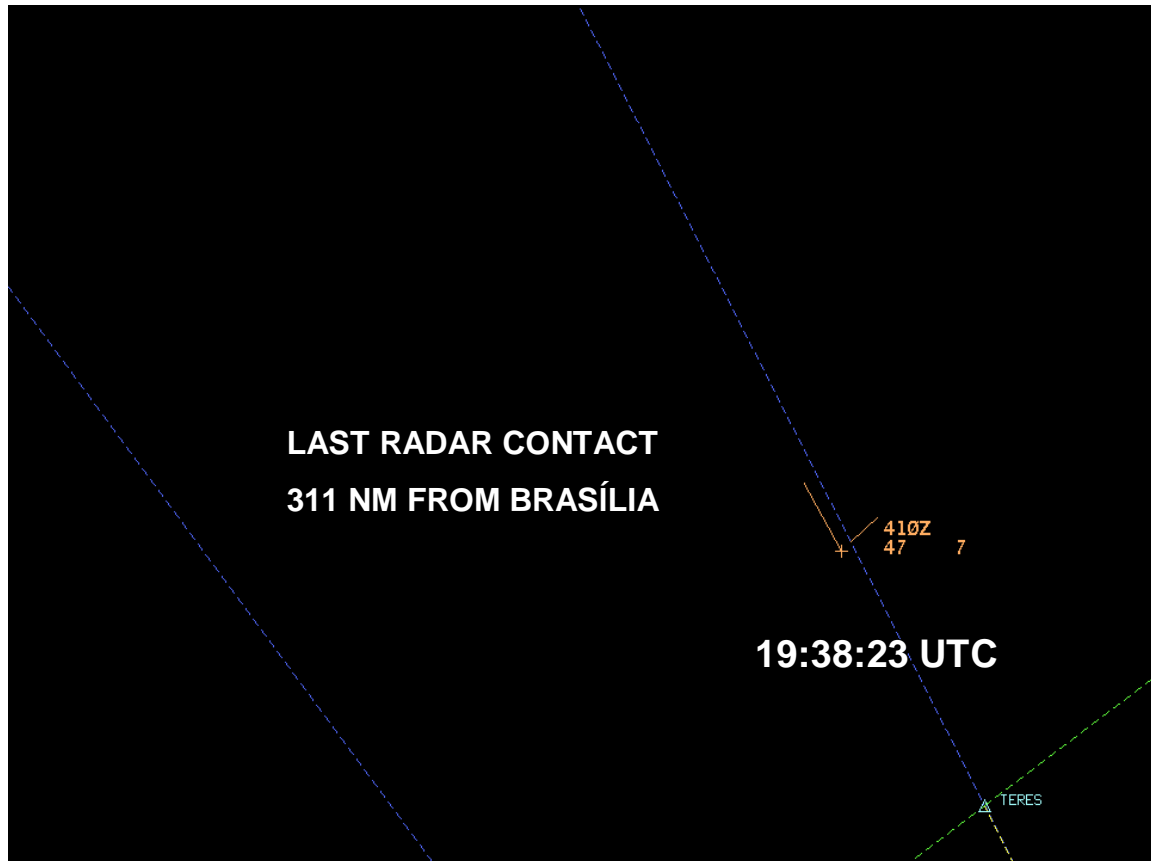
Figure 65

At 1938:23 UTC, the primary radar contact was lost, when the aircraft was at 311 NM. If the transponder had been transmitting, the secondary radar coverage would have been available to the controllers.

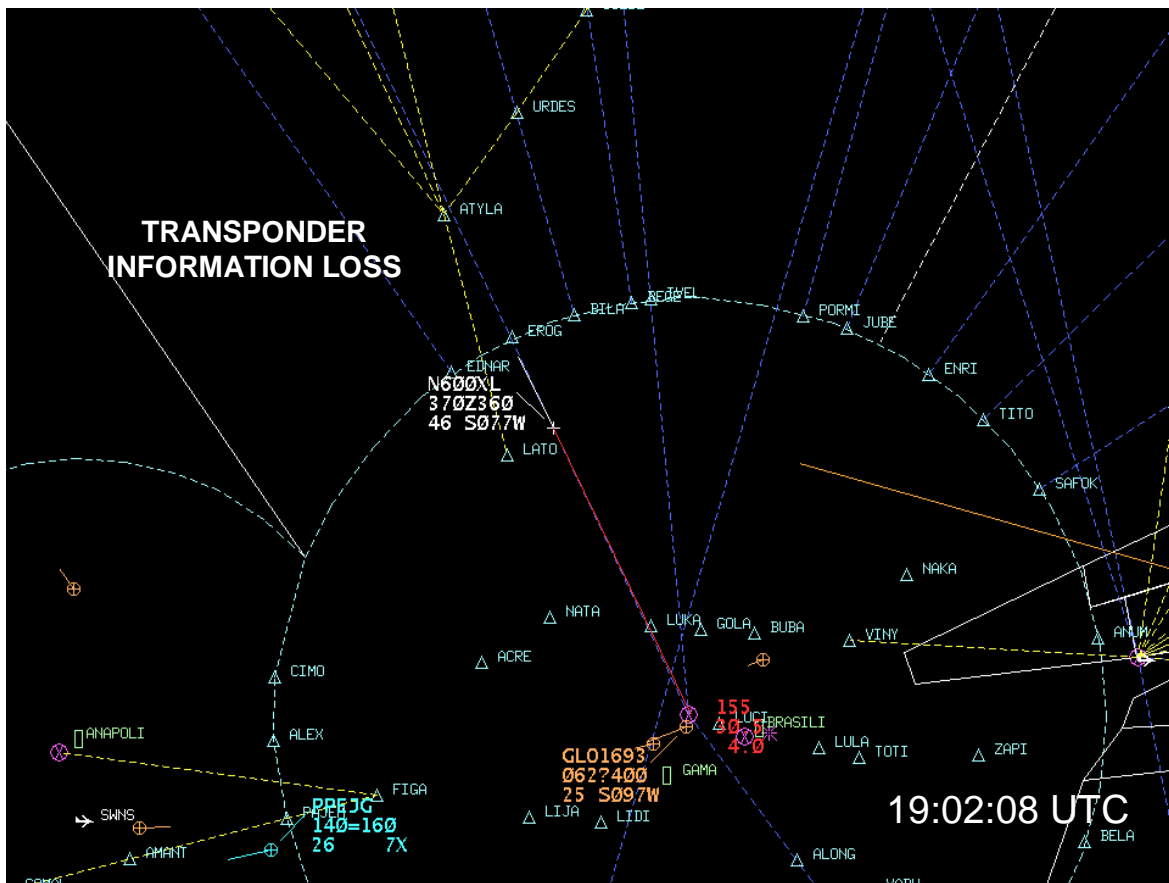
Figure 73 depicts the change in the presentation of the N600XL data block, with the addition of the letter Z after the aircraft measured altitude.

Figure 73 – Presentation of the N600XL data block, after the transponder transmission discontinuance.
