*Accident
on 24 March 2001
at Saint-Barthélemy (971)
to the DHC-6-300
registered F-OGES
operated by Caraïbes Air Transport*

REPORT
f-es010324a

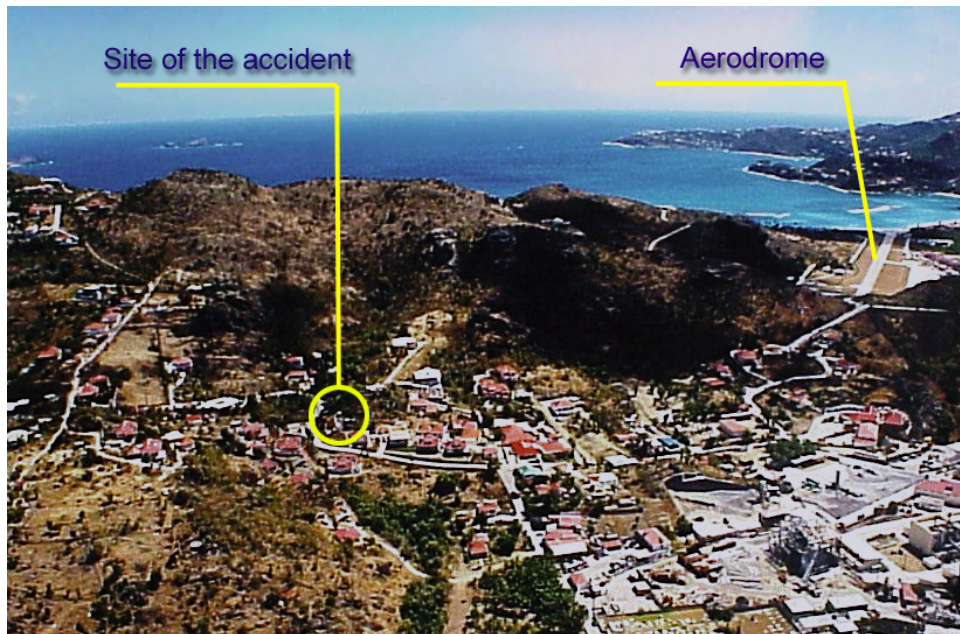
Aerial view of the site and the aerodrome

The accident occurred north-west of the aerodrome, on the west slope of the La Tourmente pass, at around six hundred metres from the threshold of runway 10.

The aircraft struck the ground right next to a dwelling located along the Corossol road, on a steep, hard piece of land planted with trees and bushes. The wreckage was spread over an area of around nine hundred square metres.

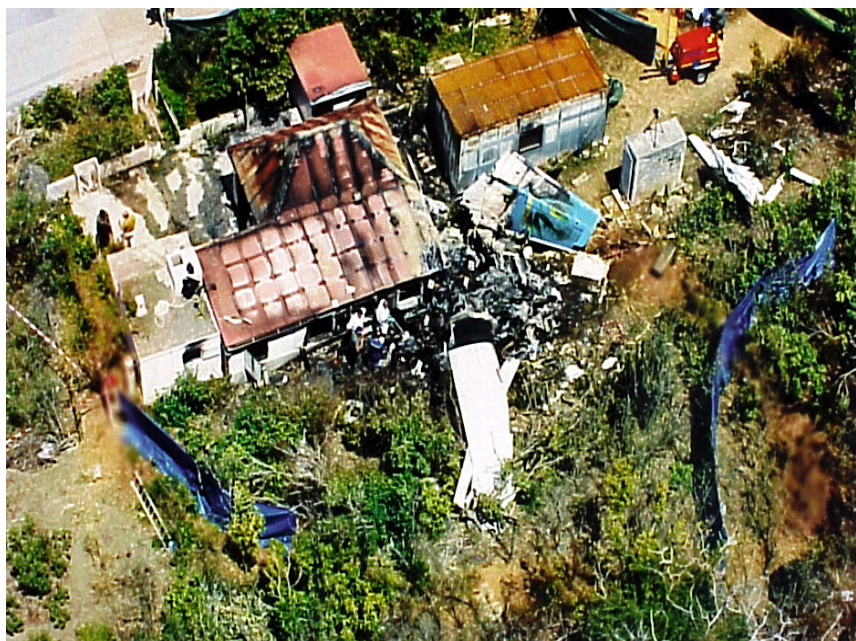
On either side, and in immediate proximity to the area of fire, the main wreckage found was the aircraft's two wings and tail assembly. Not much affected by the fire, they were separated from the fuselage and exhibited significant compression deformations. There were no traces of a bird strike. The rupture marks on the flaps show a symmetrical extension of 37.5% on impact.

No signs of anomalies in relation to the integrity of the controls and mechanical linkages were found.

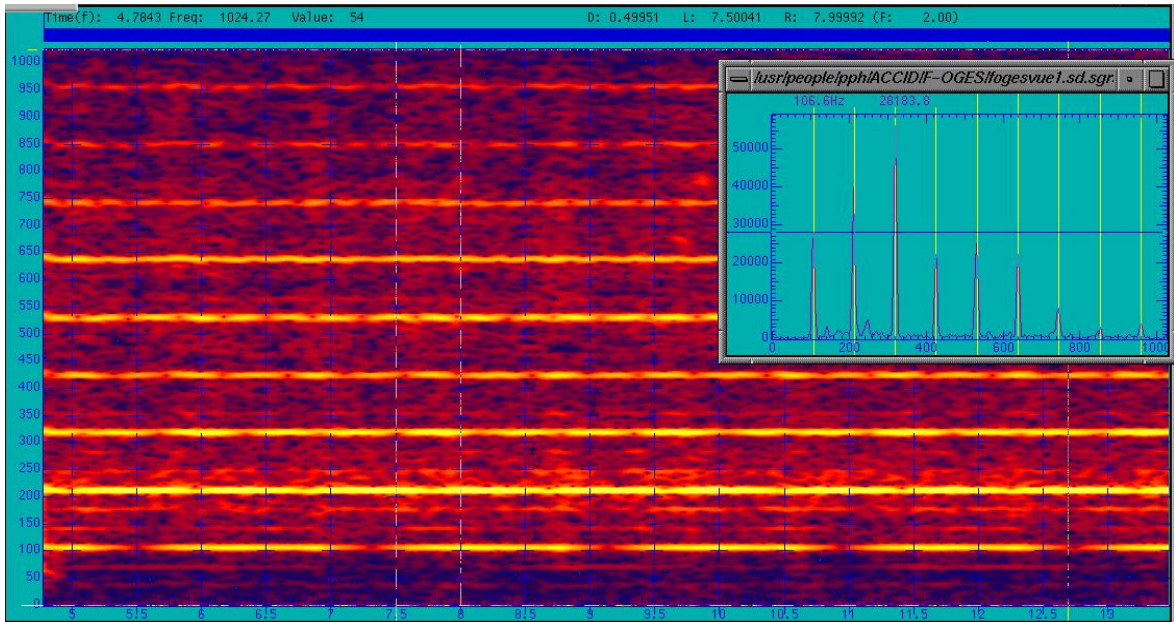
Spectral analysis of the soundtrack on take-off

Take-off: the fundamental frequency measured on the soundtrack was 106 Hz with eight to ten visible harmonics. The propeller rotation speed deduced from this was 2,120 RPM (in this phase of flight the manufacturer specifies a rotation speed of around 2,110 RPM). The absence of a double peak shows that the propellers were turning at the same airspeed.

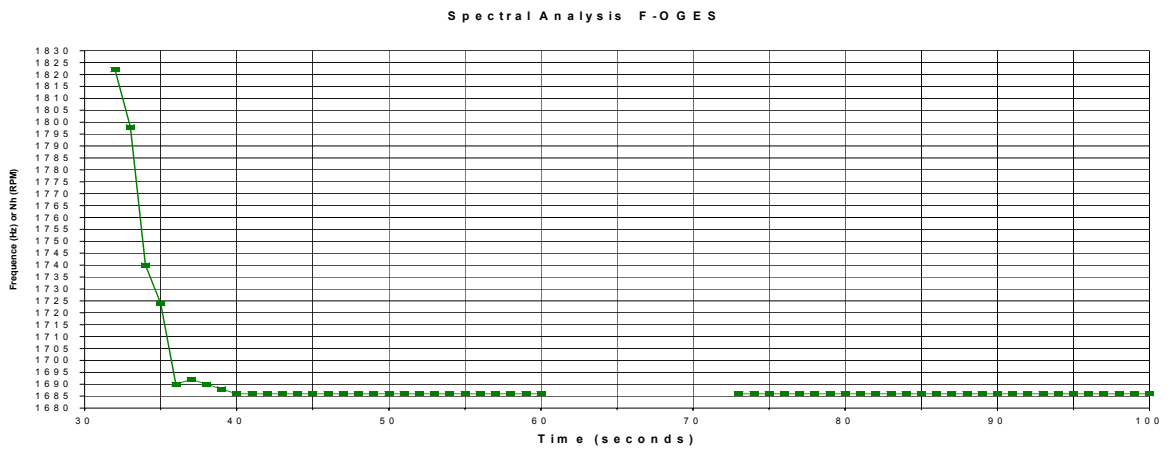
Propeller speed in cruise

Cruise: the sound signal indicates a slowing down of the propeller rotation speed from 1,825 to 1,690 RPM in five seconds, then stabilization at 1,685 RPM. This figure corresponds to the cruising speed specified by the manufacturer. Again, the absence of a double peak shows that the propellers were synchronized.

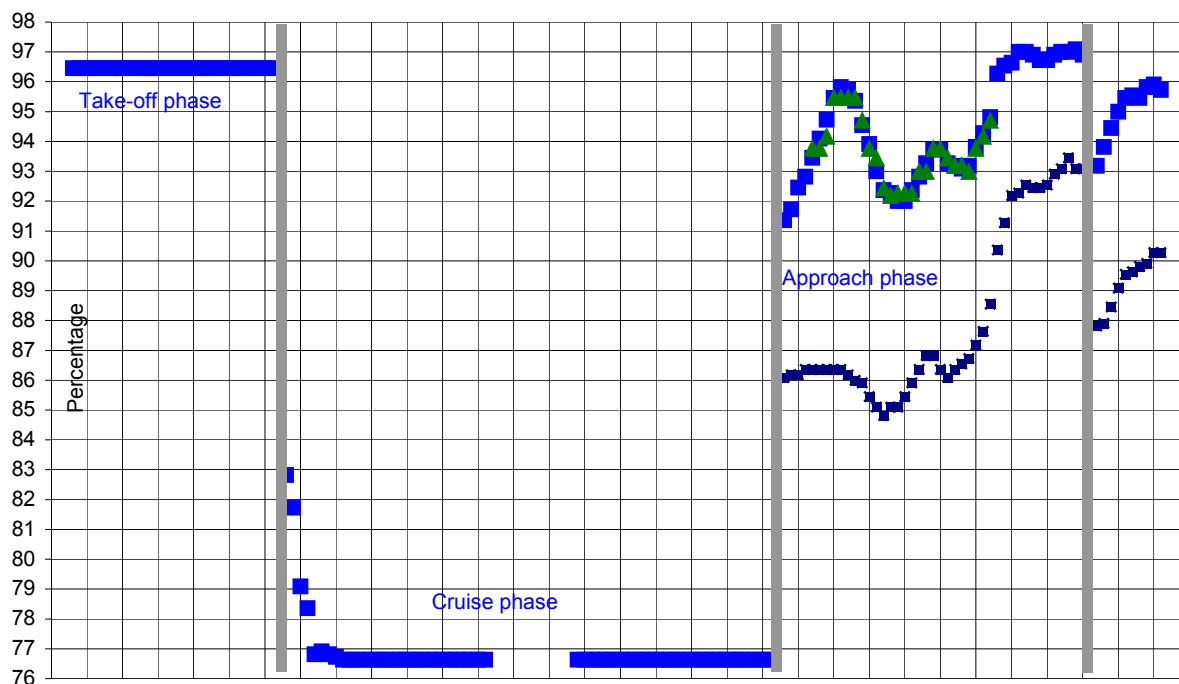
The rotation speeds of the propellers during flight TX 1501, expressed as a percentage of the reference rotation speed as defined by the manufacturer, are represented on the following graph. The discontinuities between the points correspond to the ends of each recording.

The asymmetry between the two propellers during the approach phase was around 9%, which is consistent with normal use (see following). An increase in RPM of the order of 6% to 8% was also noted.

In conclusion, examination of the film found in the wreckage did not bring to light any malfunctions or anomalies for that part of the flight which was recorded.

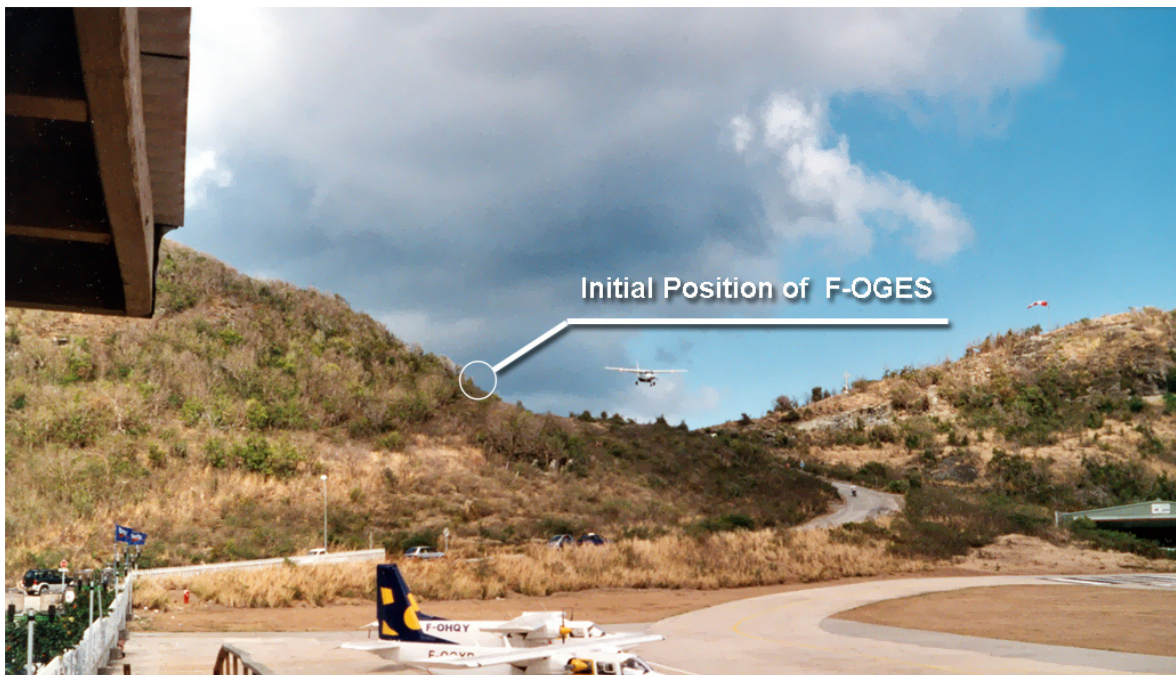
The photo shows an airplane belonging to another airline on passing the pass. The circle indicates the initial position of F-OGES during its turn to the left.
