# CIVIL AVIATION ACCIDENT REPORT

No, FMA/AIPB/424

FINAL REPORT ON THE ACCIDENT TO  
SOSOLISO AIRLINES DC 9-32 AIRCRAFT  
REGISTERED 5N - BFD AT PORT HARCOURT-  
INTERNATIONAL AIRPORT ON 10TH DECEMBER  
2005

JULY 2006

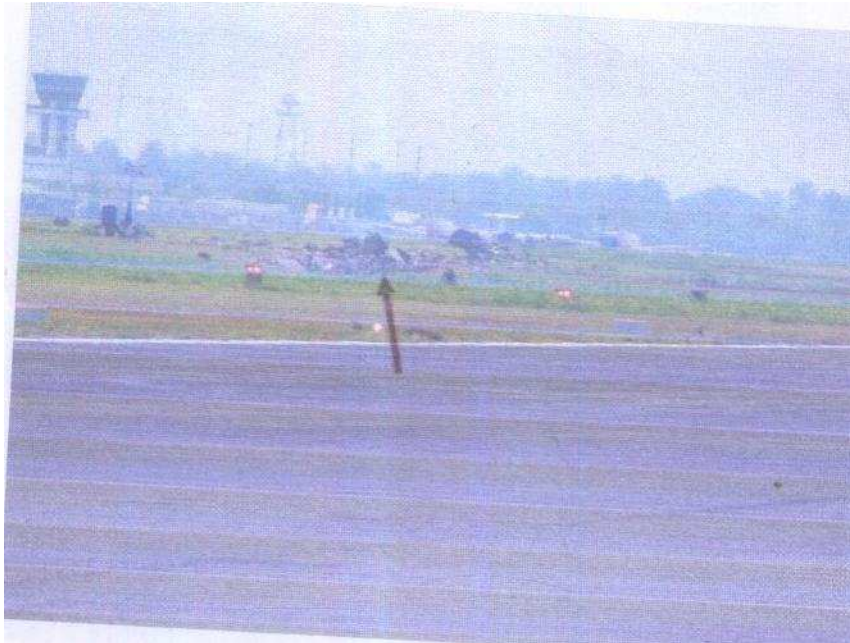
#### APPENDIX 5.2

Photograph showing the first impact of the aircraft; having the runway to the right.

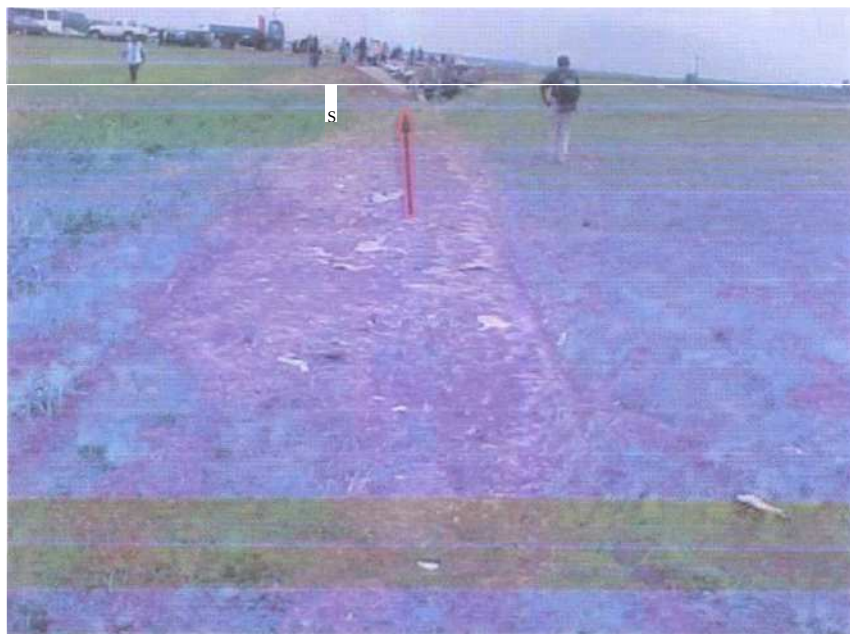
APPENDIX 53

Mr. Dennis Jones of NTSR, USA assessing the impact/wreckage of the aircraft

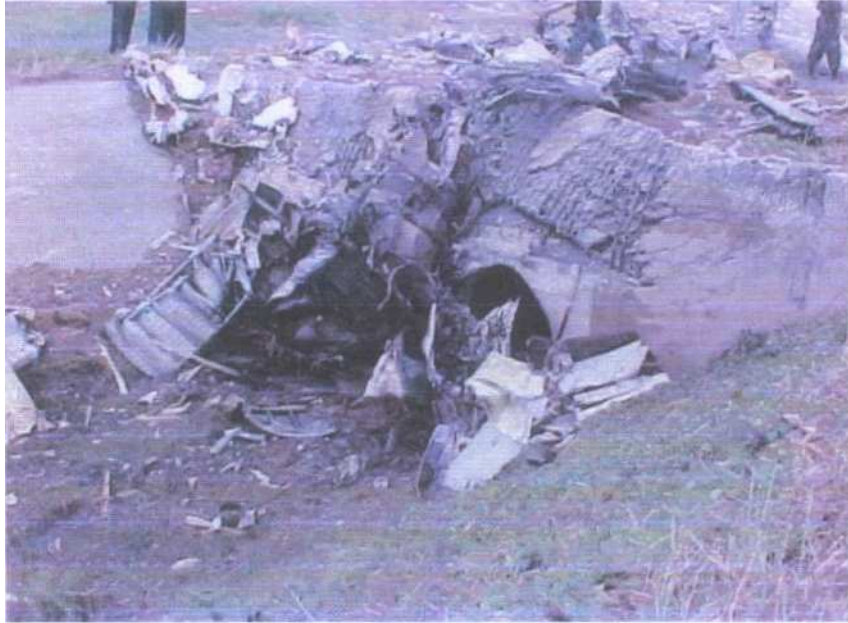
APPENDIX 5\*4

The exposed concrete drainage culvert located at about 70m to the left of runway 21 edge and 540m from the threshold portends serious danger to aircraft during landing and takeoff. The aircraft impacted heavily with the drainage culvert, which resulted into its disintegration and fire outbreak. The first physical evidence of fire was observed at about 200m from the culvert.

- (xviii) The exposed concrete drainage structure is badly located and poses a real danger to aircraft landing on Runway 21.
- (xix) The aircraft disintegrated and caught fire along its path spanning over 790m. The cockpit section with the forward fuselage was found at a further 330m from the rest of the wreckage trail on the taxiway giving a total wreckage distance of 1 120m.

Photograph showing heavy impact with concrete drainage culvert

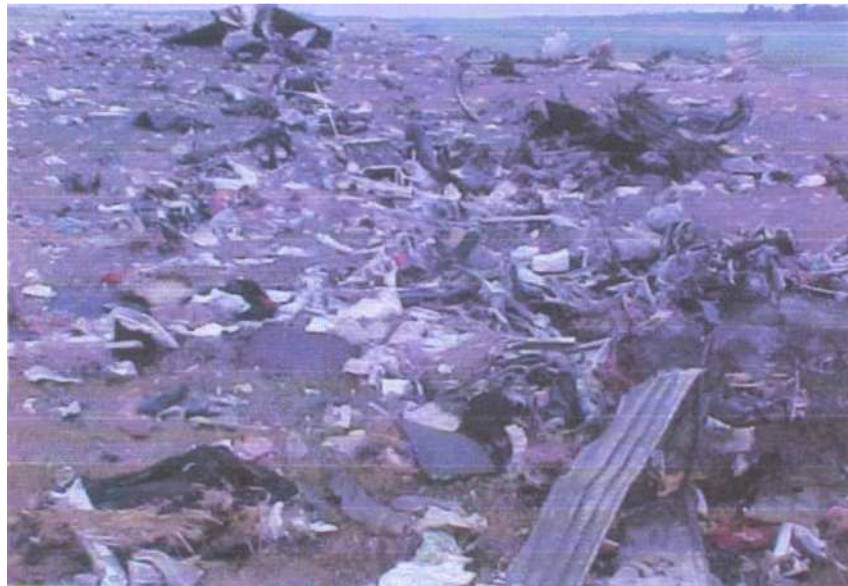
Part of the wreckage trail of the aircraft

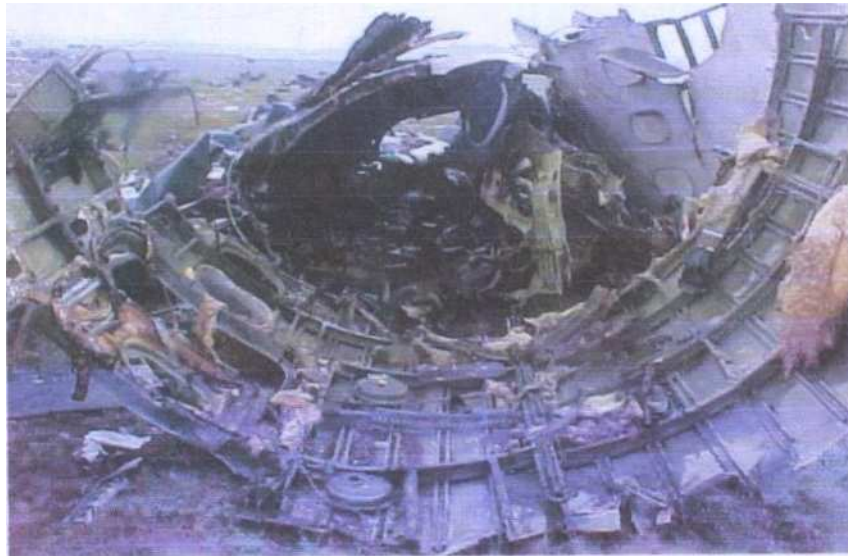
APPENDIX 5.6

Part of the aft fuselage of the aircraft

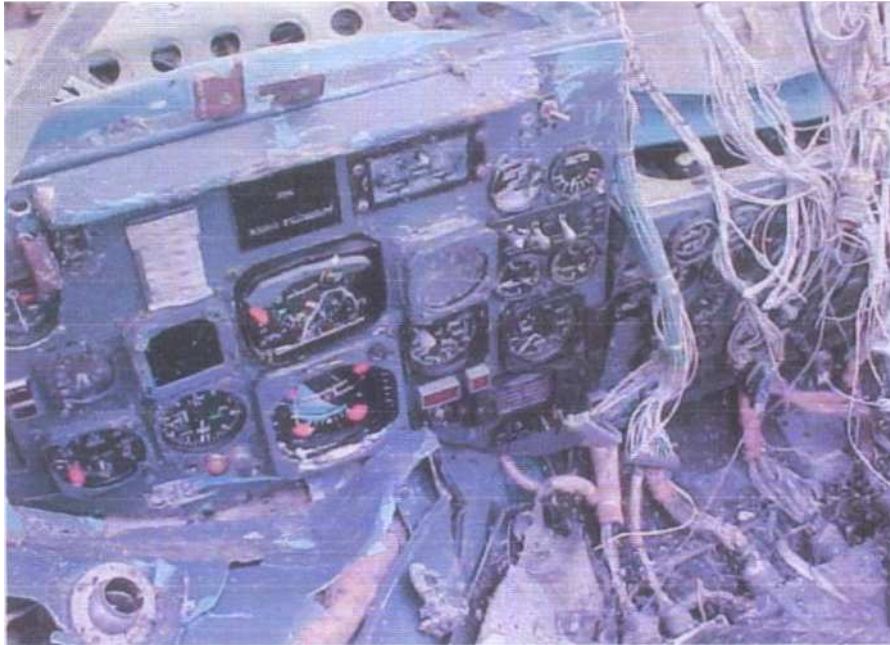
## APPENDIX 5.8

Photograph showing the Instrument panel found on taxiway, 330m away from the rest of the wreckage

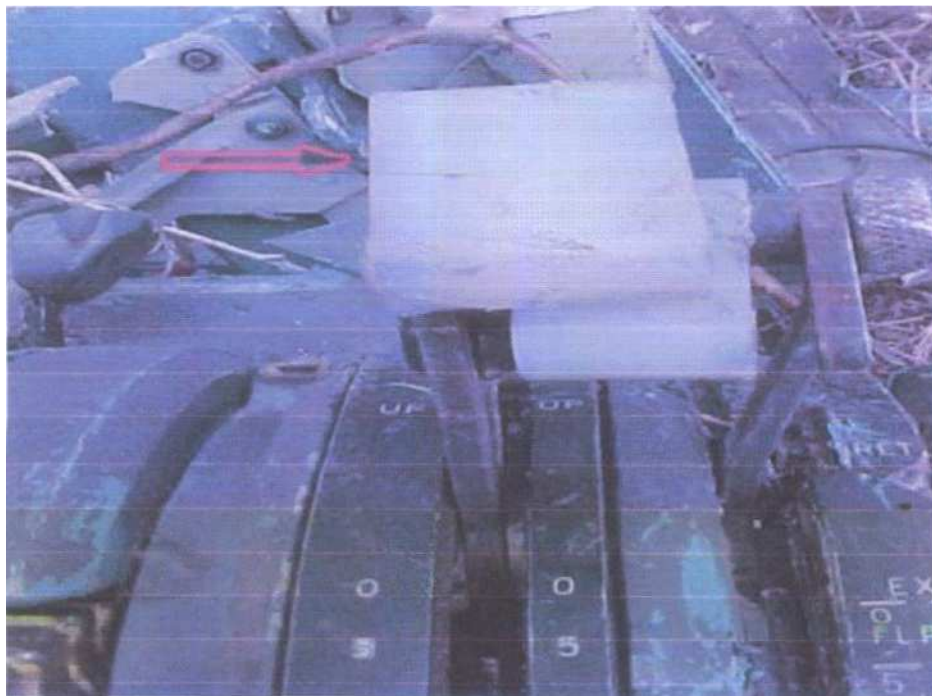
## APPENDIX 5.9

Arrow showing the Flap lever at up position

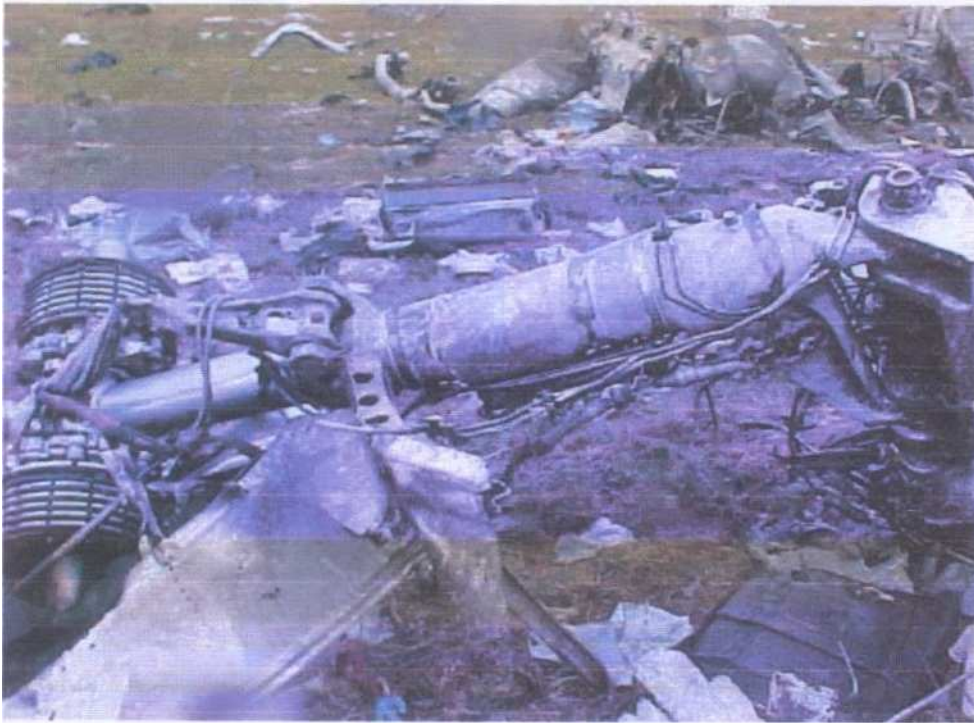
Picture showing a main landing gear APPENDIX 5.14

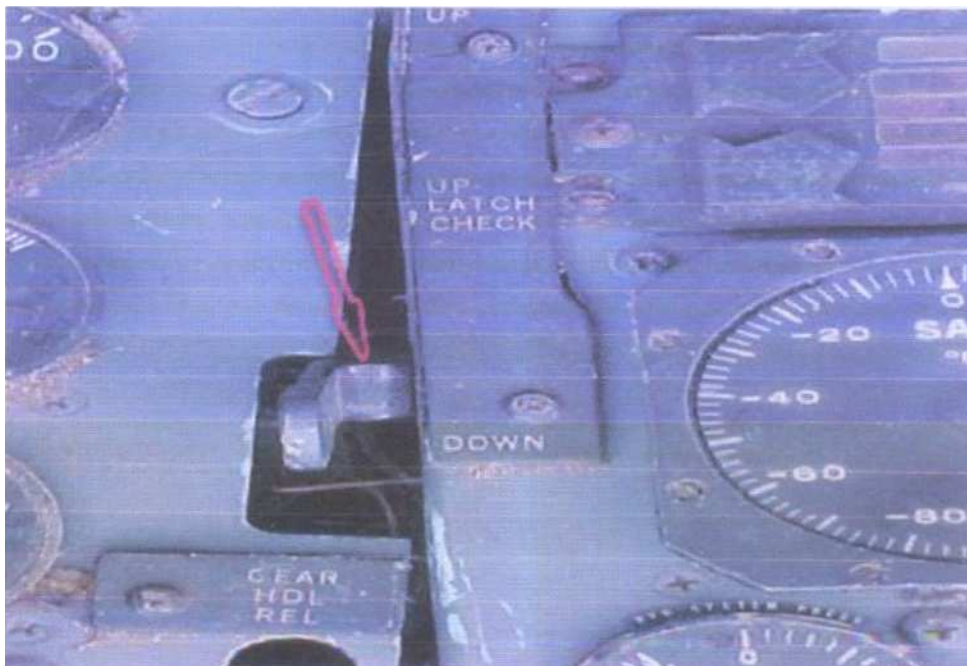
Arrow showing the position of the landing gear lever

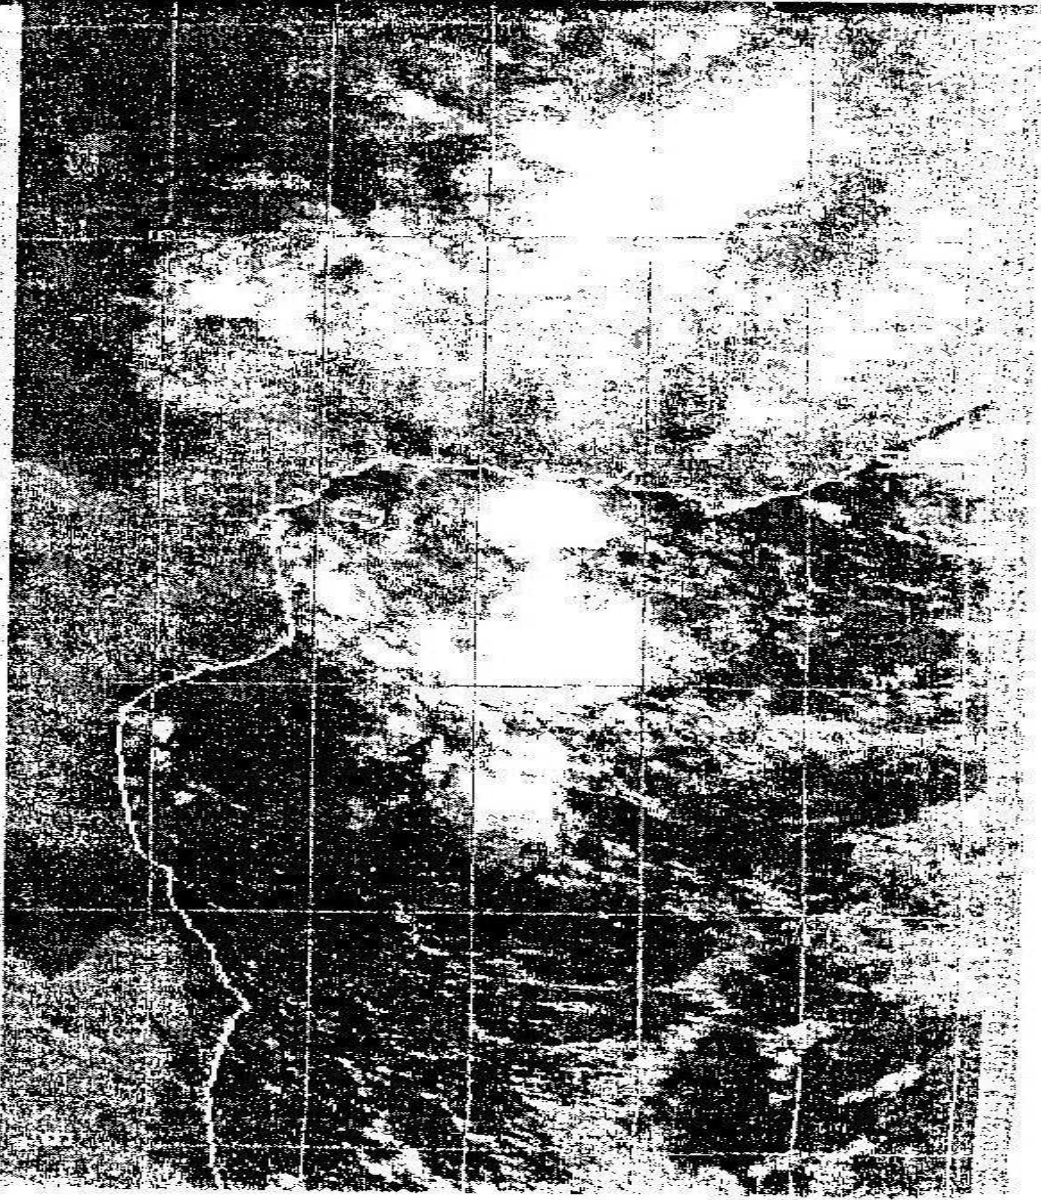
A developing sea breeze front (SBF) along the southern coast of Nigeria is apparent in the visible satellite imagery at 1000 UTC. It appears as a fine white line parallel to the coast moving inland (northward), which consists of cumulus clouds along the leading edge of the front. A convective cell fires ESE of the accident site (PHG) along the SBF between 0930 and 1030 UTC and quickly dissipates by 1100 UTC. This collapsing cell sends an outflow boundary north and westward. At the intersection of the outflow boundary and the SBF, a new convective cell fires at 1200 UTC just ESE of the accident site. The new cell continues to develop and was just several miles east and south PHG at 1300 UTC. The SBF, possibly reinforced by thunderstorm outflow, was intersecting PHG at 1300 UTC. New convective development was apparent along the boundary between 1230 and 1300 UTC. It is likely that this northward propagating boundary brought a sudden increase in southerly winds as it passed through PHG.
