C I V I L A E R O N A U T I C S B O A R D  
A I R C R A F T A C C I D E N T R E P O R T

UNITED AIR LINES, INC., VICKERS-ARMSTRONGS VISCOUNT, N 7430,  
NEAR ELLICOTT CITY, MARYLAND, NOVEMBER 23, 1962

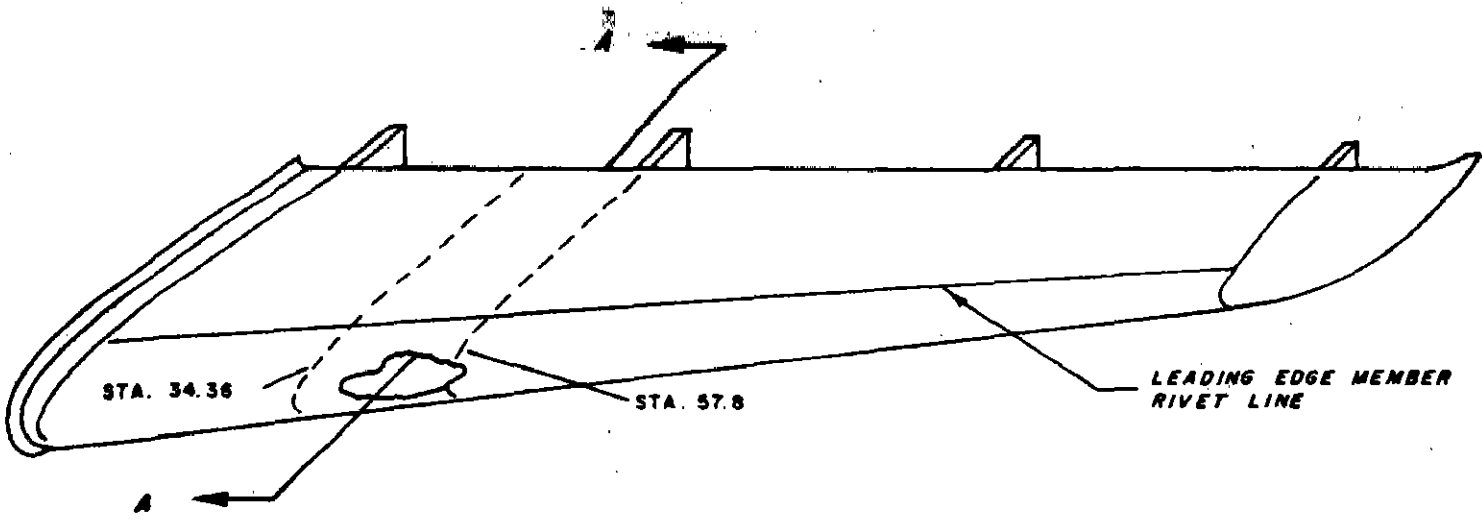
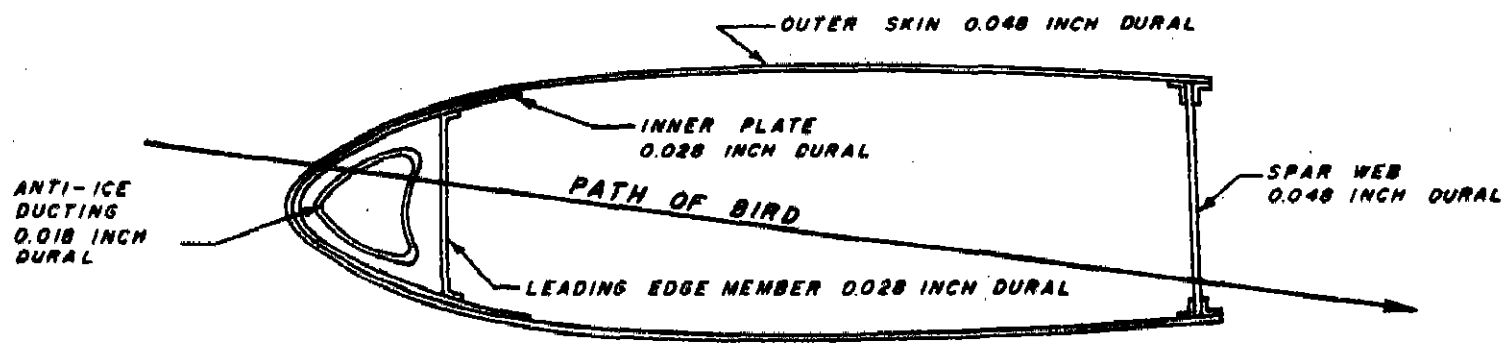
LEFT HORIZONTAL STABILIZER

Bird remains were found on both horizontal stabilizers, indicating two distinct bird strikes on these surfaces. Superficial damage occurred on the right horizontal stabilizer, 22 inches outboard of the fuselage. This strike was a glancing blow and did not result in penetration. The other strike was on the left horizontal stabilizer, approximately 49 inches outboard of the fuselage. <sup>3/</sup> In this instance the bird penetrated the leading edge and passed through the leading edge member. Continuing aft the bird fractured the spar web, partially separating it from the top and bottom caps, and then made final contact with the lower leading edge of the elevator, which resulted in denting but no penetration.

The left horizontal stabilizer and elevator failed along a chord plane generally following the travel of the bird through the structure. The direction of failure was downward and slightly aft. In addition to this failure, the right horizontal stabilizer and elevator separated downward and aft approximately 57 inches from the fuselage. Subsequently, the weakened inboard portion of this horizontal stabilizer also failed.

In contrast to this, the bird strike on the left horizontal stabilizer was concentrated nearly at the most forward point of the leading edge. At this point the angle between the line of force and the stabilizer skin resulted in penetration. The damage sustained in this instance weakened the structure so that the normal down load initiated immediate failure of the horizontal stabilizer and elevator along a chord plane directly aft of the initial impact point. As these parts failed downward and slightly aft, a violent instantaneous nose-down pitching moment was generated. During the left horizontal stabilizer failure sequence, the elevators were displaced beyond their limit, trailing edge upward, thus imposing a severe down load on the right horizontal stabilizer which also failed downward. As the outboard 11 feet of the right horizontal stabilizer and elevator were in the process of separation they weakened the structure of the remaining inboard stabilizer section, which subsequently separated prior to impact. This breakup rendered the aircraft uncontrollable.
