File No. 1-0002

**AIRCRAFT ACCIDENT REPORT**

**PARADISE AIRLINES, INC.**  
**Lockheed Constellation,**  
**L-049, N 86504**  
**near Zephyr Cove, Nevada**  
**March 1, 1964**

**CIVIL AERONAUTICS BOARD**  
**WASHINGTON, D.C. 20428**

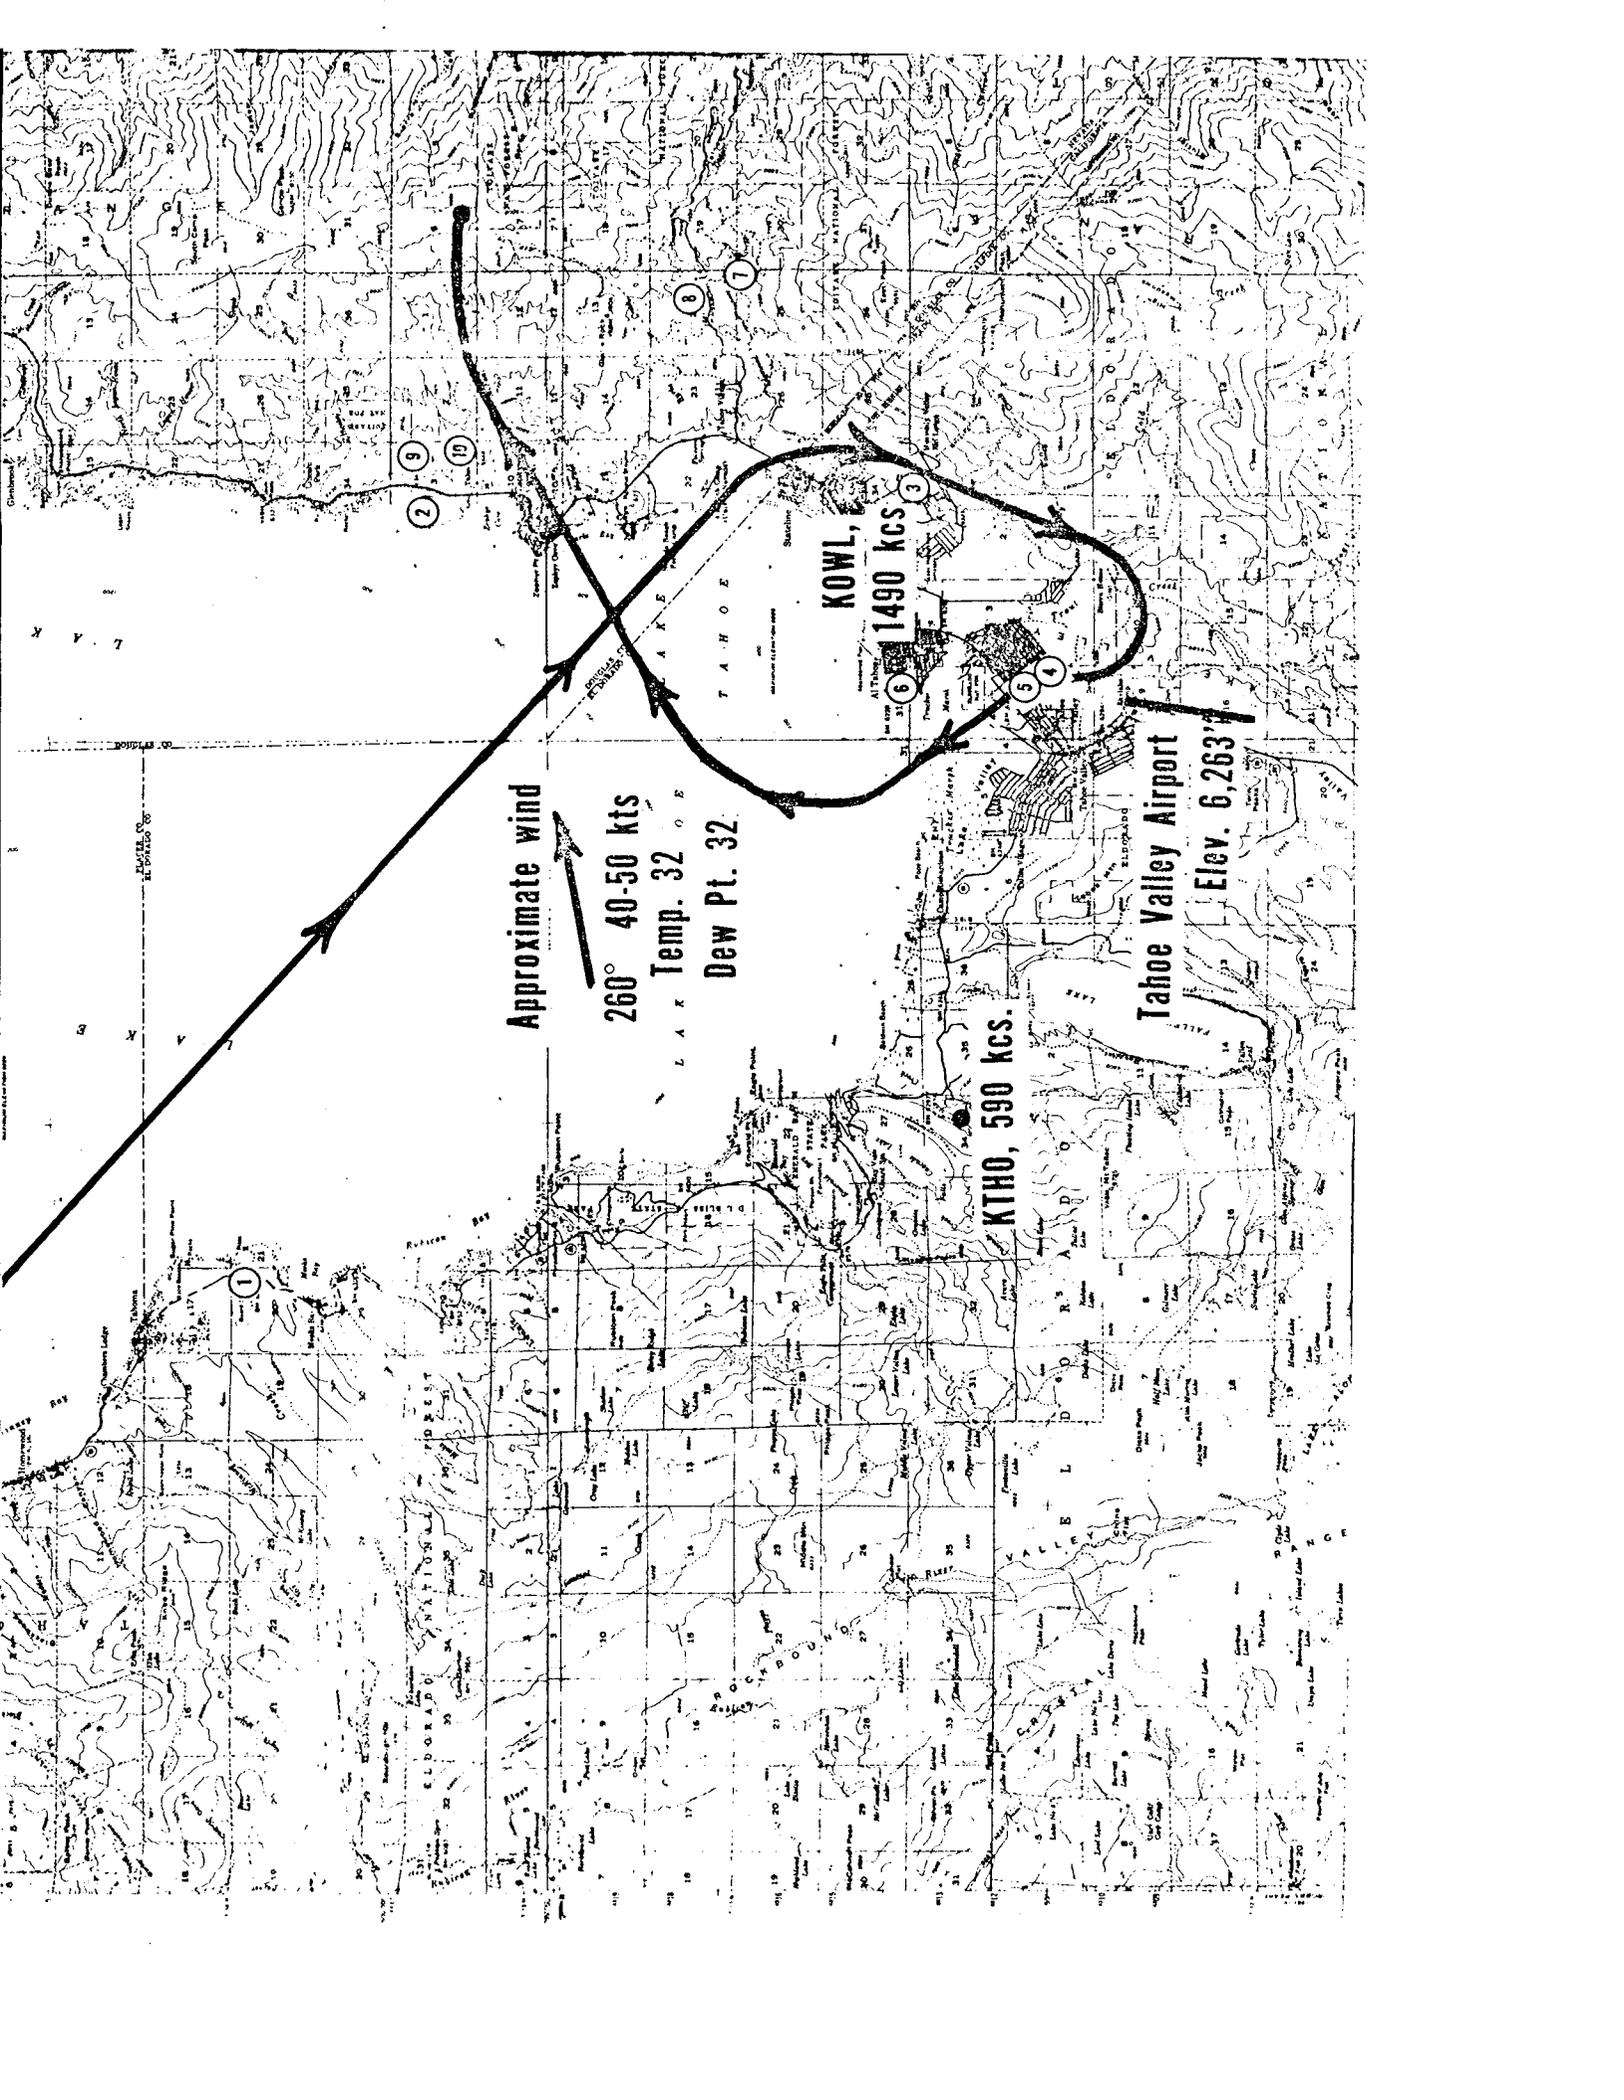
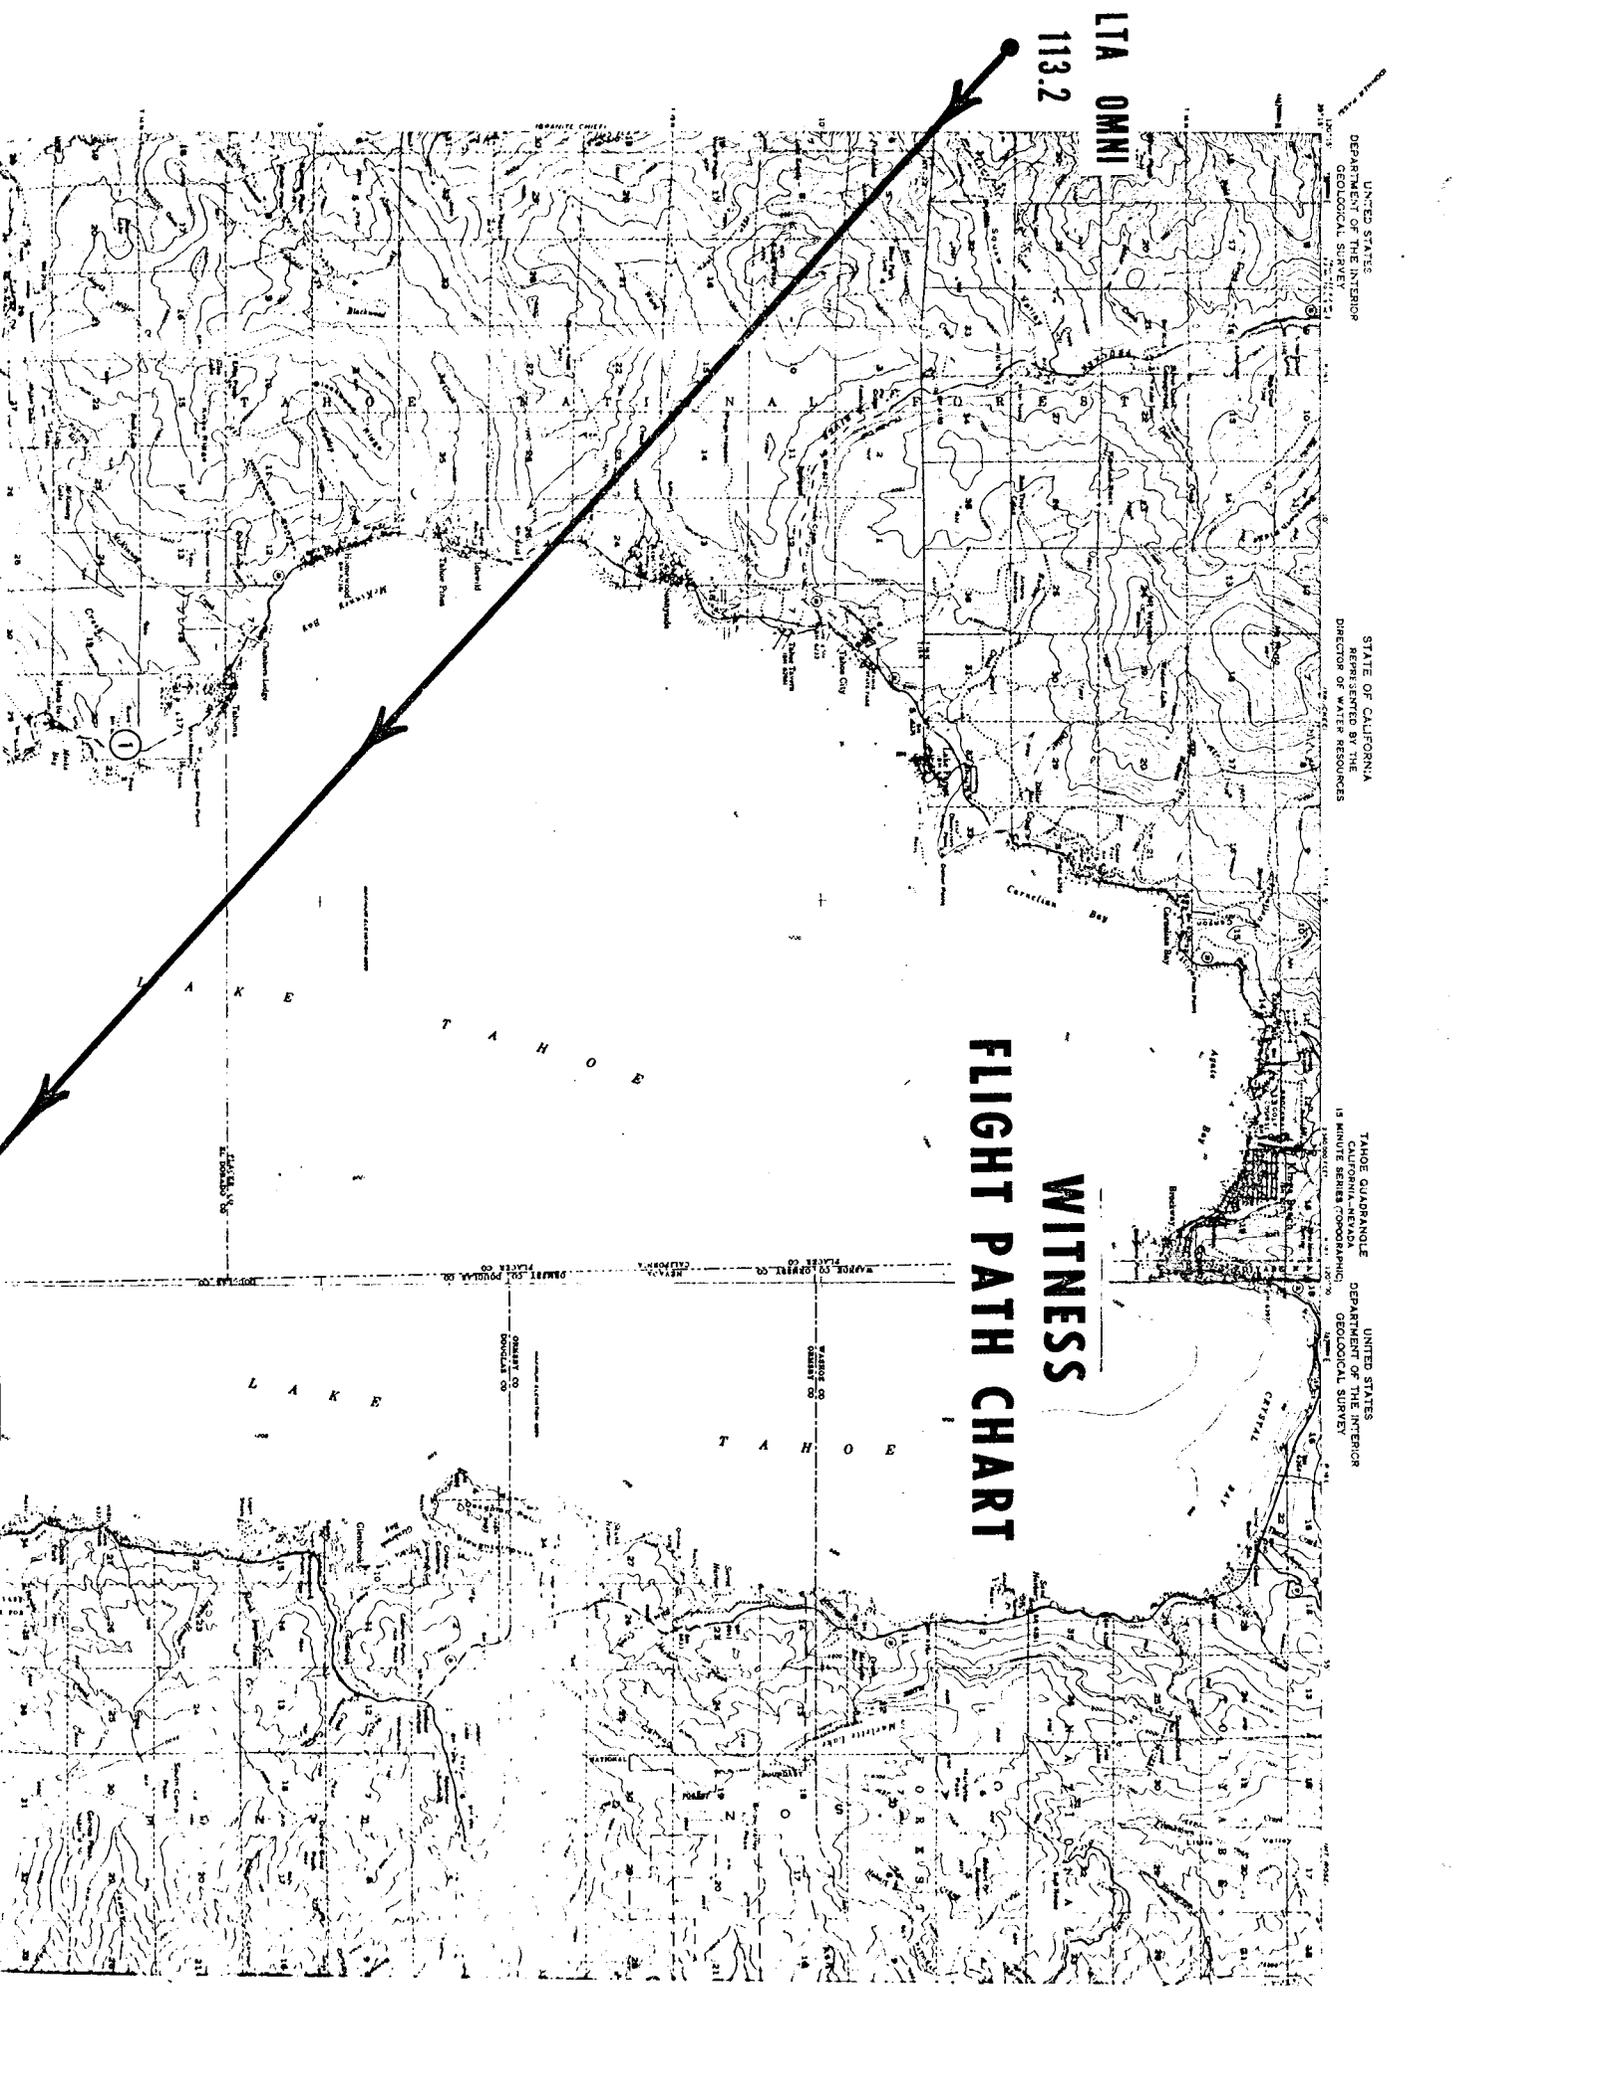
# WITNESS FLIGHT PATH CHART

A witness on the west shore of Lake Tahoe (See Attachment No. 1) heard, but did not see, an aircraft proceeding over the lake between 1100 and 1130. The weather in his vicinity was inclement with visibility ranging from zero to one-fourth mile in blowing snow. A witness on the east shore also heard, but did not see, an aircraft southbound over the lake at about the same time.

When the crew decided to abandon the approach, they took up a heading which they must have known would take them towards the high terrain east of the lake. (See Attachment No. 1.) It is very likely that from their position over the Tahoe VOR they were able to observe the VFR conditions that existed east of Lake Tahoe on the leeward side of the mountains. Additionally, it is assumed that the first officer was aware of the existence of Daggett Pass and considered it an access to VFR conditions beyond the pass. It is further assumed that he knew an altitude of 9,000 feet would provide about 1,500 feet terrain clearance through the center of the pass. Further, an easterly heading from the south end of the lake would take the aircraft through the pass which is several miles wide.
