REPORT ON
ADC'S FLT. No. O86 CRASH
NOVEMBER 7, 1996

ADC FLIGHT 086 BOEING 727

5N-BBG WHICH CRASHED AT EJIRIN,

VOLUME 1

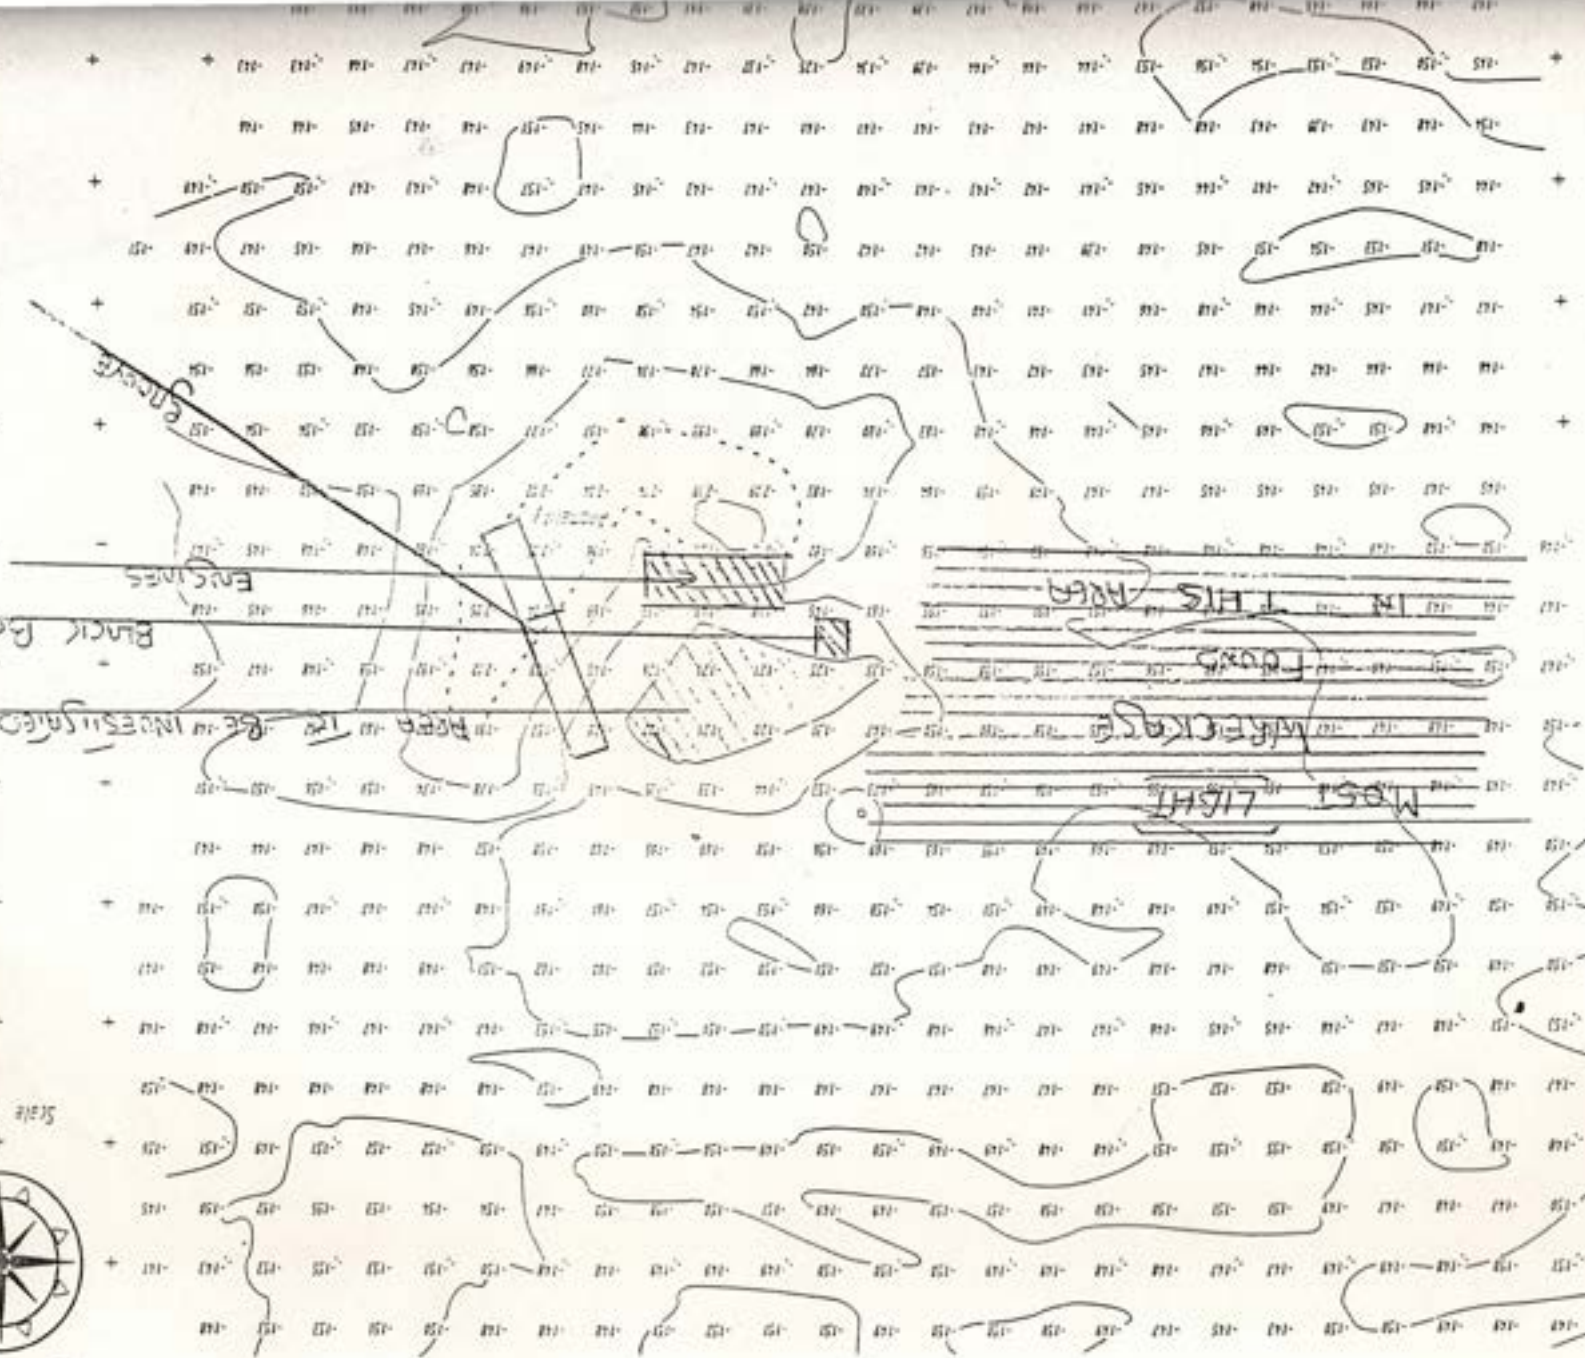
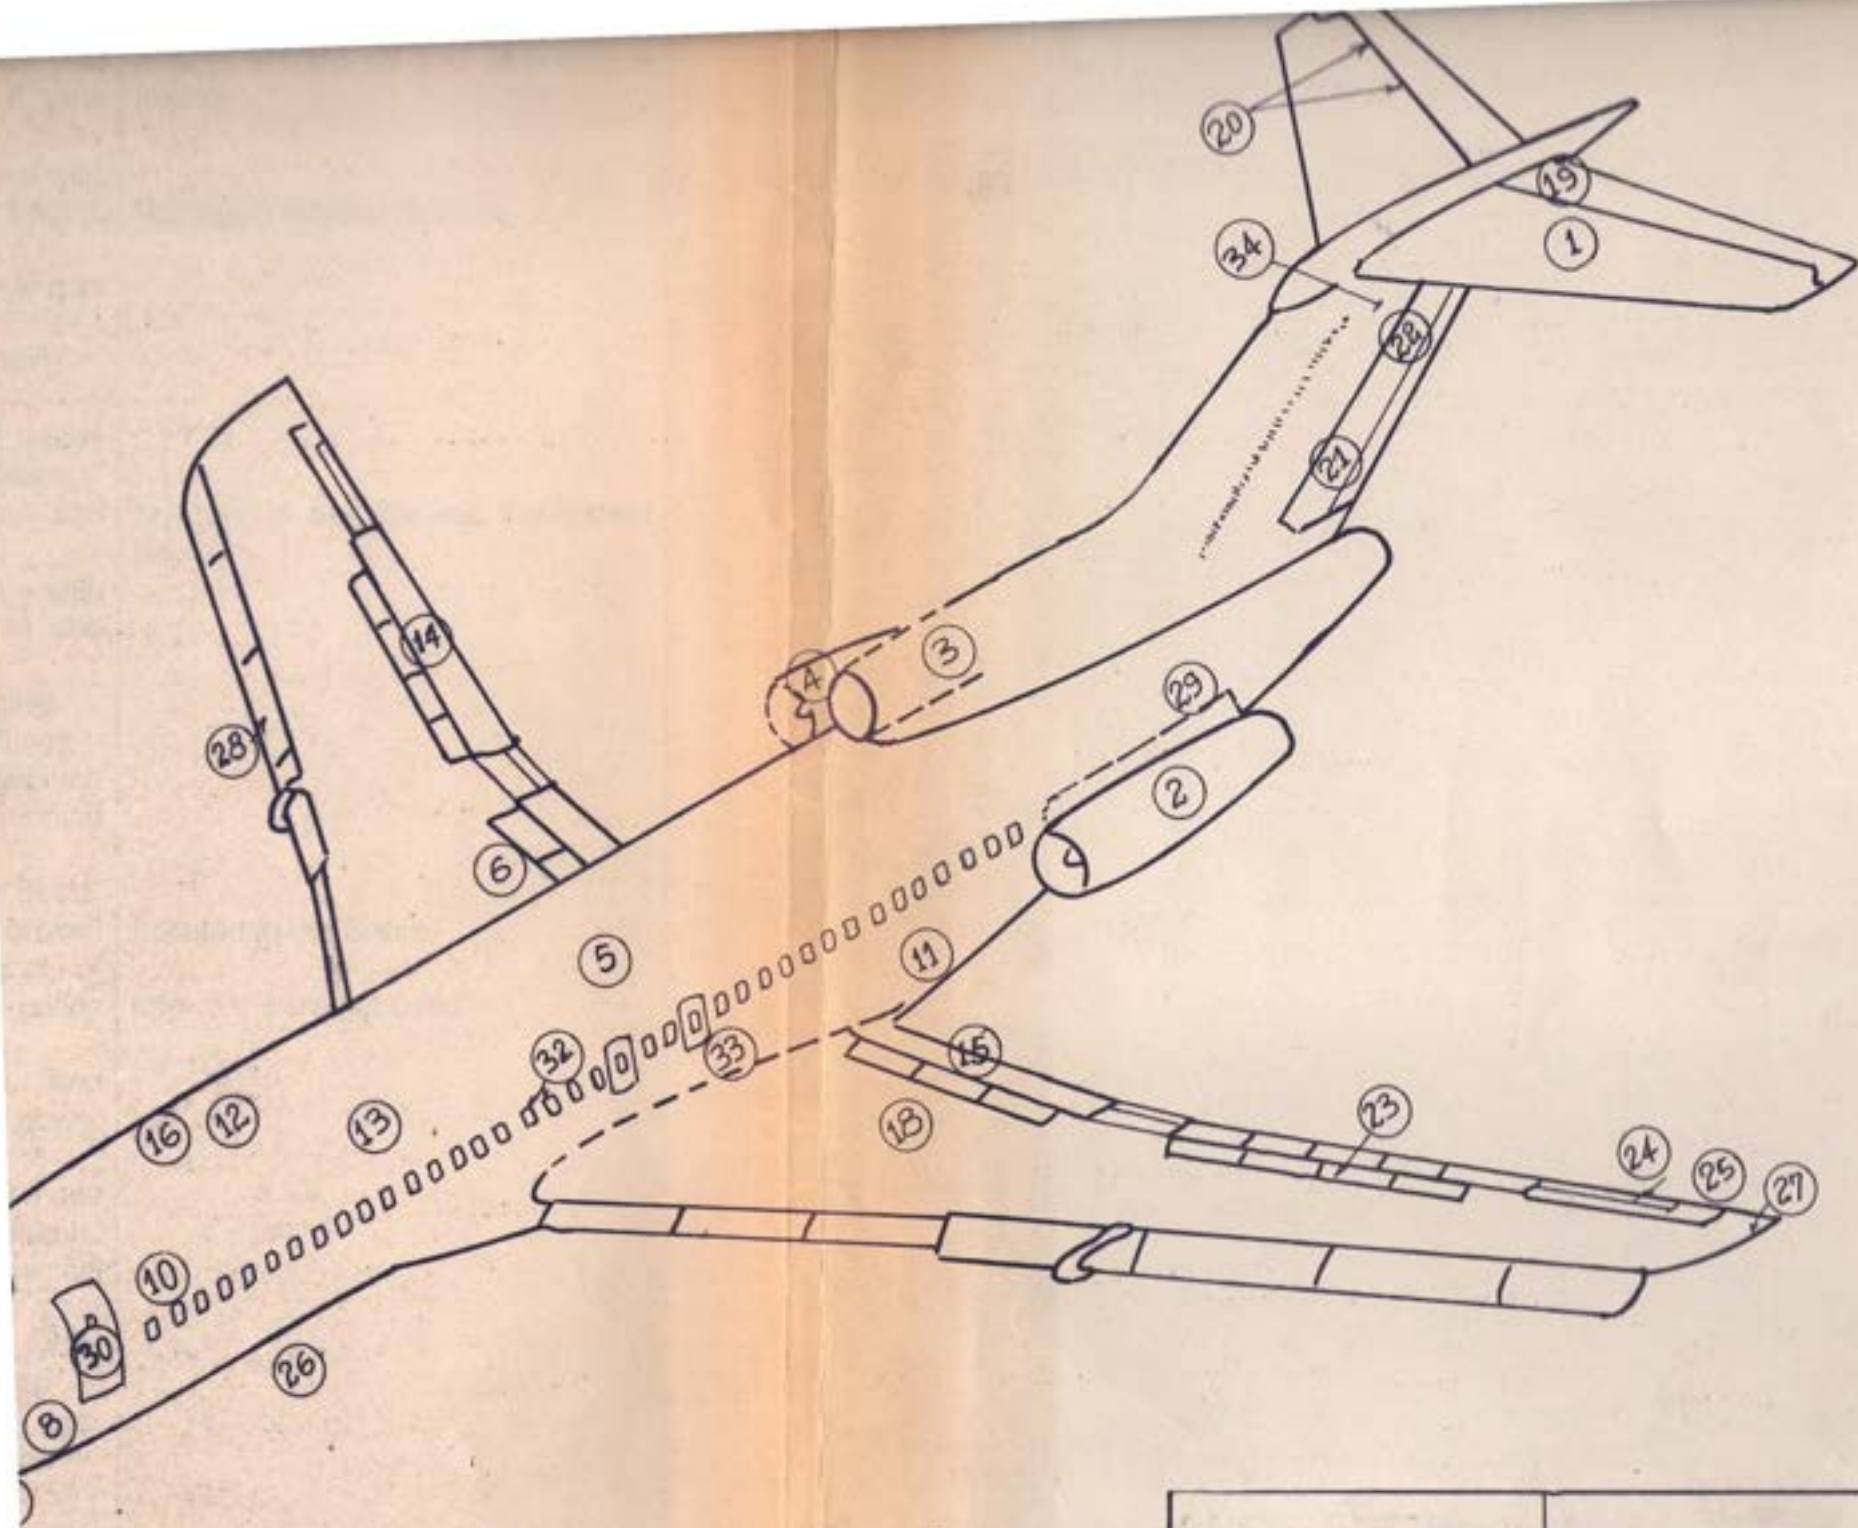
ITEM	WRECKAGE DISTRIBUTION CHART	REMARK
1.	Part of the left horizontal stabilizer	Contain marks indicating some robbing of internal components
2.	Damaged No. 1 Engine turbine disc assembly and pieces of Engine compressor disc and blades	Blades sheard off and liberated at impact

3.	Damaged No. 2 Engine turbine disc assembly and pieces of Engine compressor disc and blades	Damaged beyond Repairs
4.	Damaged No. 3 Engine Turbine disc assembly

5.	Damaged APU Electrical starter	
6.	Broken Rear Spar	
7.	Shattered cockpit window panes and cockpit windshield attachment	
8.	Damaged ATC Transponder and Damaged DME Interrogator	Located in the Electric Equipment Racks

9.	Damaged ACARs control unit, Damaged F/E's control panel and Pilot's seat foam	
10.	Punctured portable oxygen bottle	
11.	Broken Hydraulic lines and fittings

12.	Broken pieces of air-conditioning bay door, ground air-conditioning cart receptacle	
13.	Broken pieces of cabin seats, broken pieces of seat tracks, broken pieces of seat belt, large quantity of torned life vests, damaged galley components and oven timer	Located in the Cabin Life vest were not used
14 &	Flap tracks, Flap drives and carriages and damaged flap power unit

15.		
17&	Broken pieces of main and hose gear struts, Rear spar attachments, damaged Landing gear mechanical door linkages, broken main gear working beams, shattered tyres, broken wheel drums, pieces of brake stators/rotors, Landing gear support struts and Accumulator

20.	Damaged elevator balance	
34.	Damaged elevator feel Computer	
21&	Damaged rudder power control unit	The upper and lower Rudder power control units are mounted in vertical fin structure

22.		
23.	Damaged hydraulic spoiler actuators

<p>25.</p> <p>26.</p> <p>27.</p> <p>28.</p> <p>29.</p> <p>30.</p> <p>31.</p> <p>32.</p> <p>32.</p>	<p>Aileron control rods, damaged Aileron power control unit and damaged Aileron control</p> <p>Fragmented pieces of fuselage skin and broken pieces of stringers</p> <p>Damaged fuel shut off valve, pieces of fuel supply line and valves, damaged fuel Boost pump access panel and damaged Boost pump</p> <p>Broken pieces of anti-ice ducts and damaged anti-ice valves</p> <p>Broken pieces of pneumatic pipes and valves</p> <p>Part of the passenger's door</p> <p>Part of the toilet draining panel</p> <p>Broken pieces of cabin windows</p> <p>Broken cabin emergency exit window</p>	<p>Aileron power control units is mounted in the left wheel well. Aileron control valve is located in the wheel well</p>
--	--	--
