NATIONAL TRANSPORTATION SAFETY BOARD

AIRCRAFT ACCIDENT REPORT

CONTINENTAL AIR LINES, INC.,
McDONNELL-DOUGLAS DC-10-10, #68045
LOS ANGELES, CALIFORNIA
MARCH 1, 1978

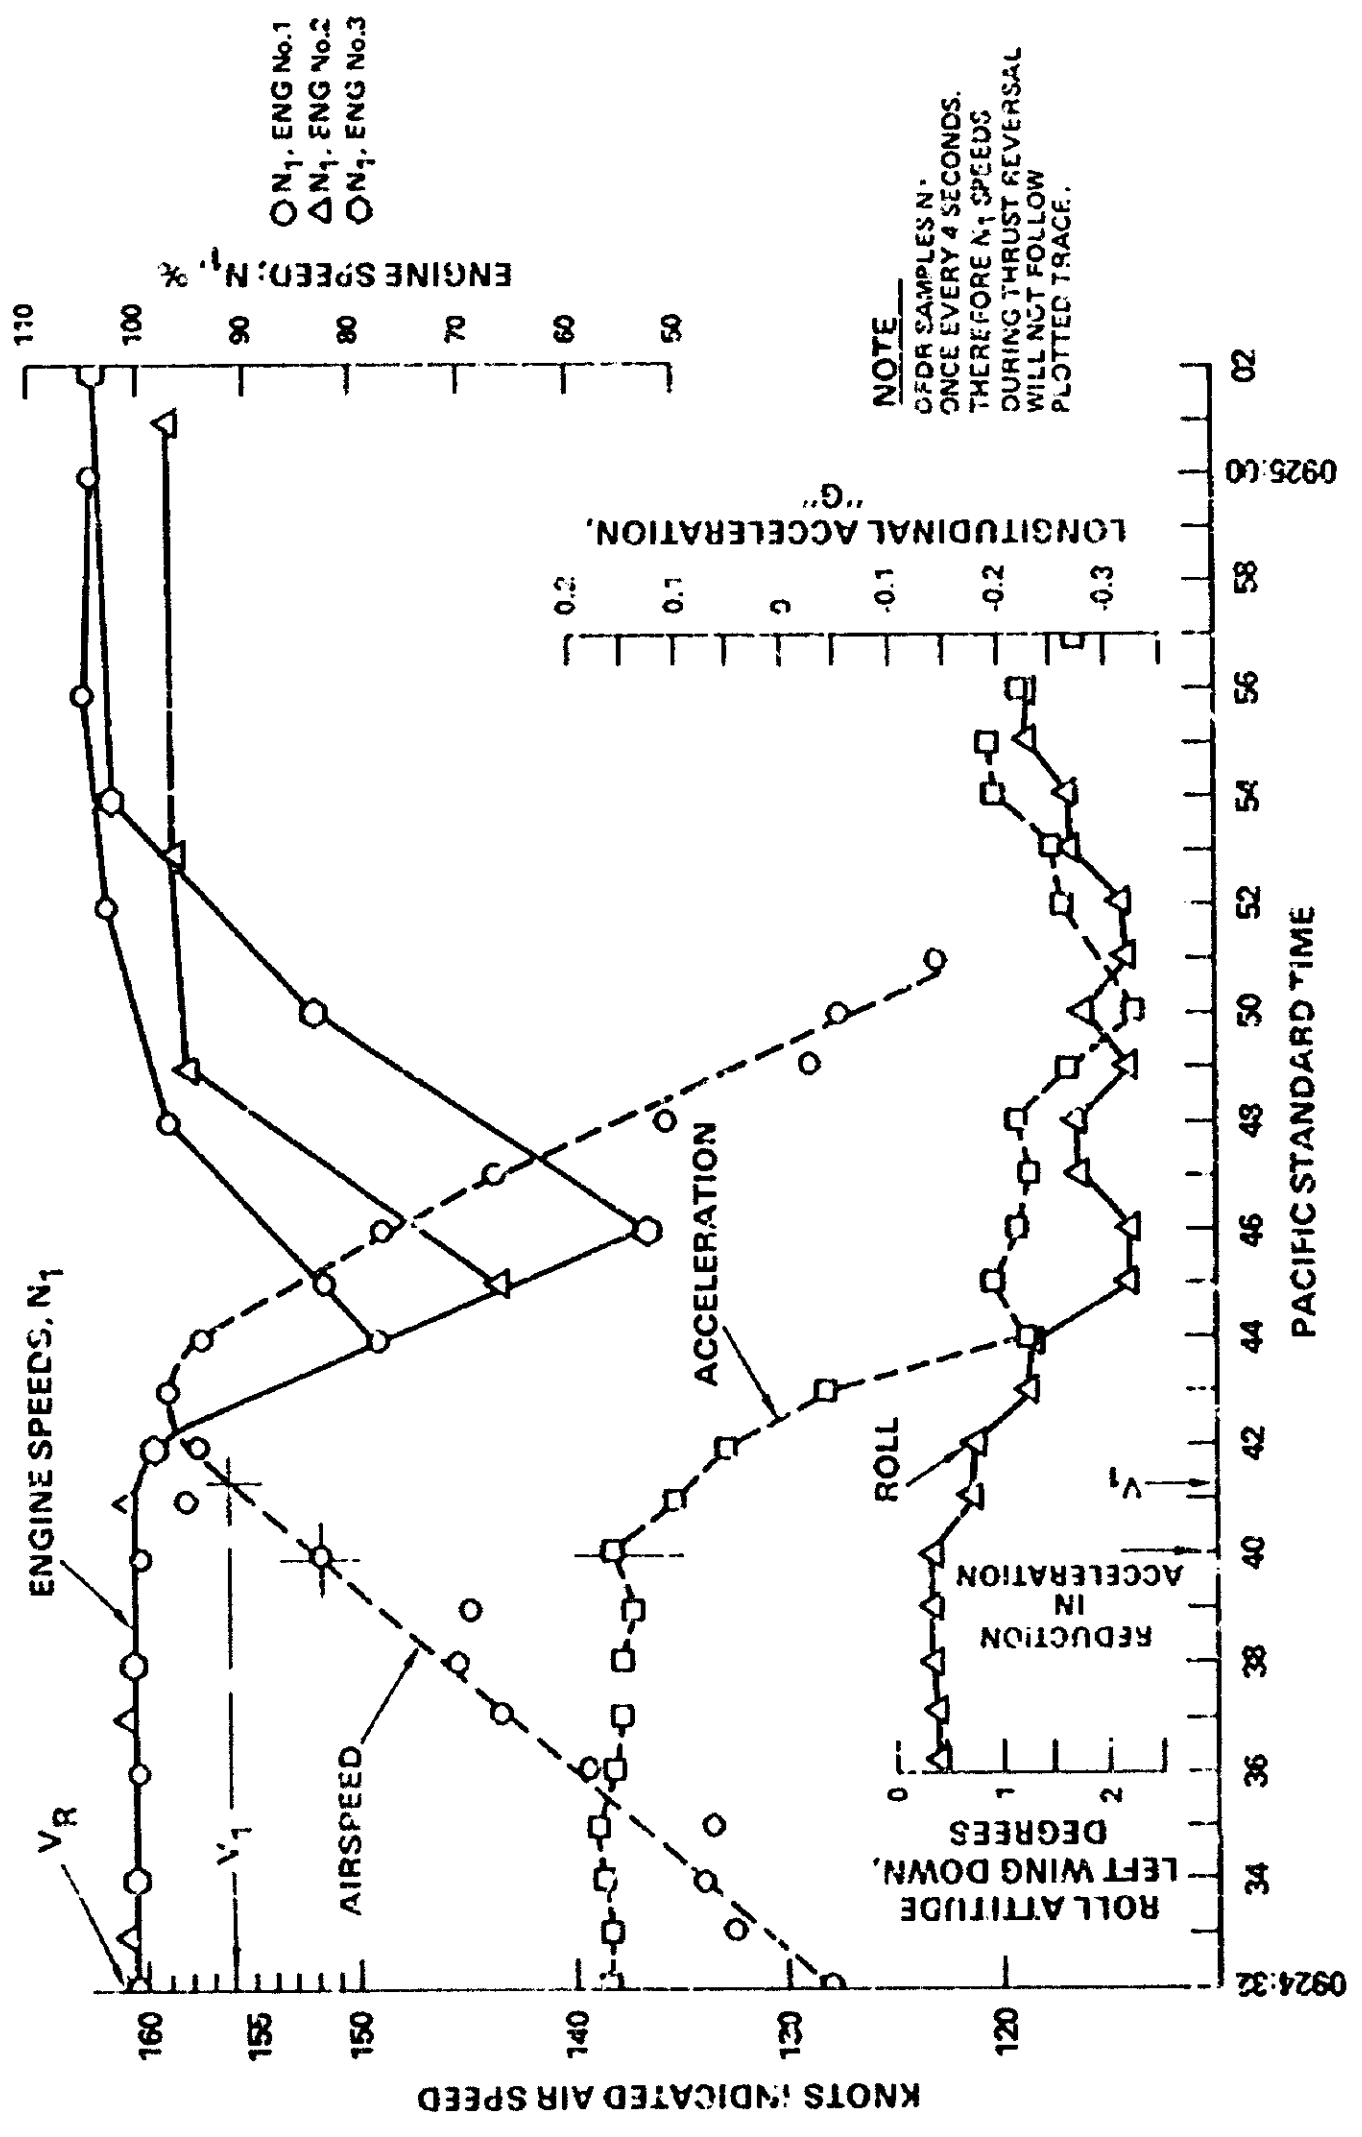
Figure 2. Aircraft performance before, after NTO initiation.

The DFDR data showed that the takeoff roll began from a static position on runway 6R at 0923:54. (See figure 2.) The wing flaps were set at 5°. Takeoff thrust was established at 101-percent N_1 on all engines as the aircraft accelerated through 37 kns. At 152 kns, 46 sec into the takeoff roll and 4 kns below V_1 , the longitudinal accelerometer began recording a marked decrease in the aircraft's acceleration although takeoff thrust was being maintained on all engines. No indications of tire failure were evidenced below 152 kns by the DFDR. At 152 kns, the DFDR roll attitude parameter began to record a gradual lowering of the left wing. V_1 speed, 156 kns, was reached 1.2 sec later, or 47.2 sec after the start of the takeoff roll. Engine thrust began to be reduced less than 0.5 sec after V_1 speed. A maximum speed of 159 kns, 2 kns below V_R , was recorded 1.8 sec after V_1 and 0.5 sec after longitudinal acceleration had changed from positive (acceleration) to negative (deceleration) values. Thrust reversers unlocked while the airspeed was decelerating through 157 kns at a peak deceleration rate of $-0.23g$. About 1.2 sec later, the thrust reversers were deployed at 152 kns as the engines were spooling down for thrust reversal and as the left wing reached its maximum down attitude of 2.1°. The engines began to spool up for thrust reversal 4.8 sec after V_1 ; maximum reverse thrust values were attained in 3 sec on the center engine, in 6 sec on the left engine, and in 8 sec on the right engine. Aircraft heading began to deviate to the right of the runway centerline as full reverse thrust was being attained. The heading reached 079°, the maximum deviation from the centerline, as the aircraft's speed decelerated through 58 kns.

A peak vertical acceleration value of 1.22g was recorded 20.8 sec after V_1 indicating the end of the runway. The airspeed at this time was decelerating through 68 kns with reverse thrust being maintained at 104- to 105-percent N_1 speed on the wing engines and at 100-percent N_1 speed on the center engine. Three sec later, the aircraft heading began a rapid turn to the left simultaneous with a sudden 10° lowering of the left wing. The left engine speed also decreased suddenly. Peak engine speeds for the center and right engines were recorded 1 sec later. Engine speeds began to decrease on the center and right engines at airspeeds of 57 kns and 30 kns, respectively. The last recorded airspeed was 30 kns.

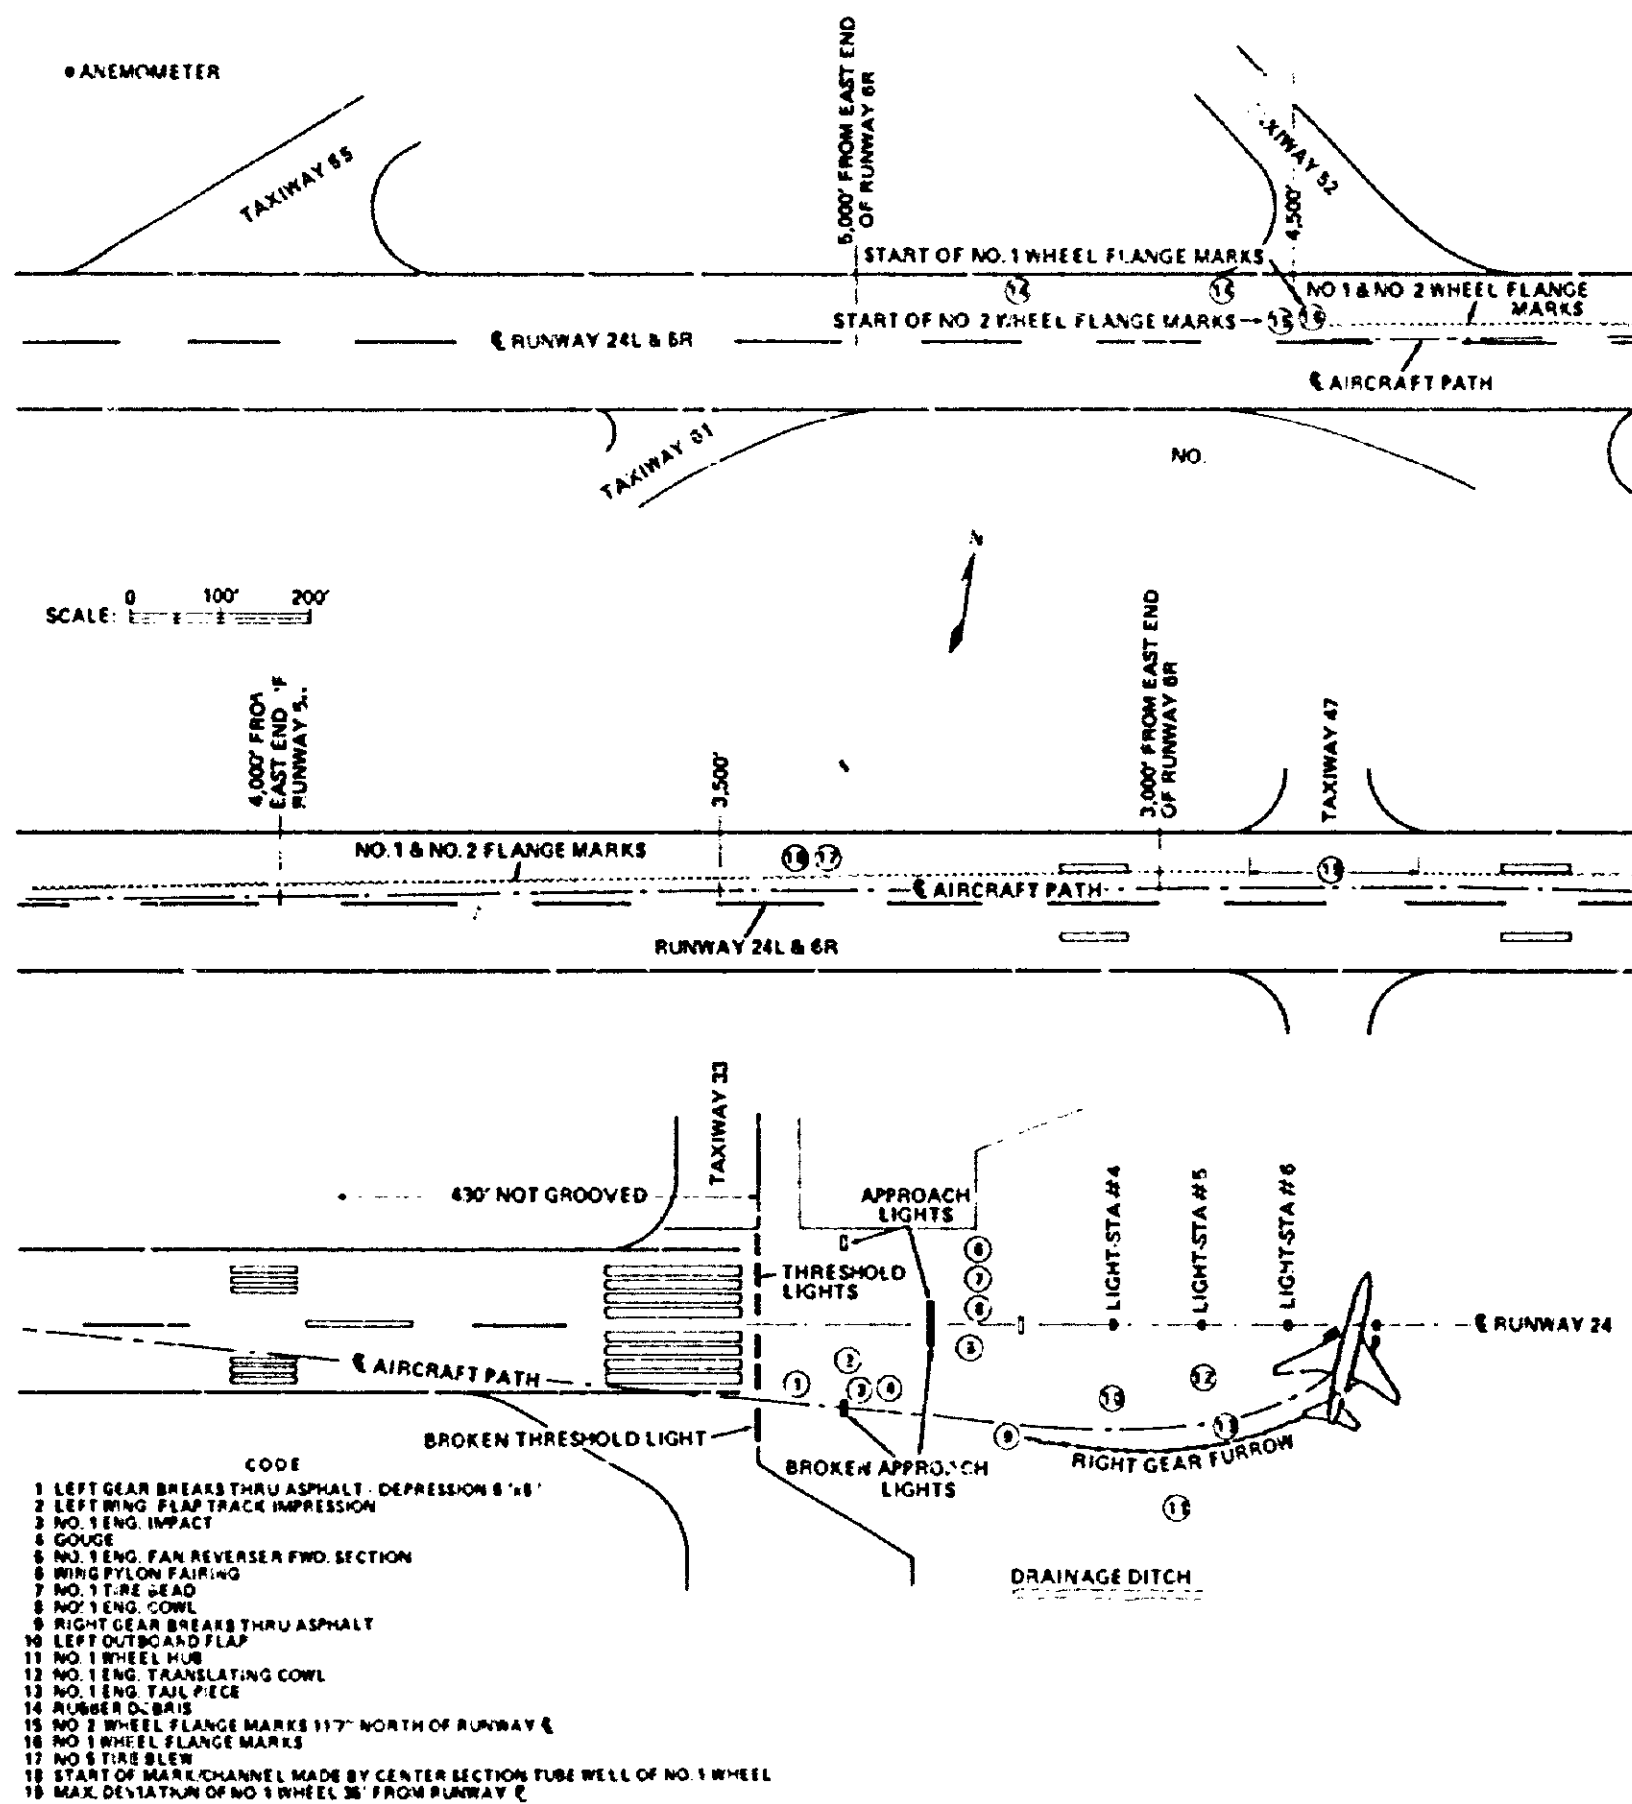
Figure 3. Aircraft wreckage distribution chart.

About 100 ft after the aircraft left the runway surface, the remains of the left main landing gear wheel and tire assemblies broke through the tarmac surface of the nonload-bearing area and the landing gear structure failed aft. The left-main landing gear strut was found trailing behind the wing; the lower end of the strut was supported by the No. 1 wheel and two brake assemblies, which were resting on the ground. The upper end of the strut was not deformed and was connected to the main landing gear support fitting. The support fitting was not connected structurally to the wing box. Extensions of the wing upper skin, upper doubler, lower skin, and lower doubler aft of the wing rear spar connecting the gear support fitting to the wing box had failed. The upper skin had torn off along the rear spar. The lower skin had torn off aft of the rear spar. The lower doubler was torn off aft of the skin fracture.

The upper and lower auxiliary spar was torn off at the flap hinge fitting. Major fasteners connecting the support fitting to the wing box failed, except for the lower outboard 1 1/2-in.-diameter bolt connecting the support fitting to the wing box internal bulkhead, directly forward of the support fitting.

A trapezoidal portion of the wing rear spar web (about 3 1/2 sq ft) remained attached to the landing support fitting. This opened up the No. 1 fuel tank. The rear spar shear web and doubler had failed. A length of the vertical tang of the rear spar lower cap and a portion of the lower outboard cap of the wing chordwise internal bulkhead also remained attached to the landing gear support fitting. The wing bulkhead upper 1-in. bolts failed 1 in. aft of the rear spar web. The lower inboard 1 1/2-in.-diameter bolt was missing from its hole. A portion of the lower bulkhead cap remained on the lower outboard 1 1/2-in.-diameter bolt. A section of the rear spar web and vertical tang of the lower cap had broken loose at the outboard end of the landing gear fitting, which created a 1-sq-ft hole in the aft wall of the left compartment of the No. 2 fuel tank.

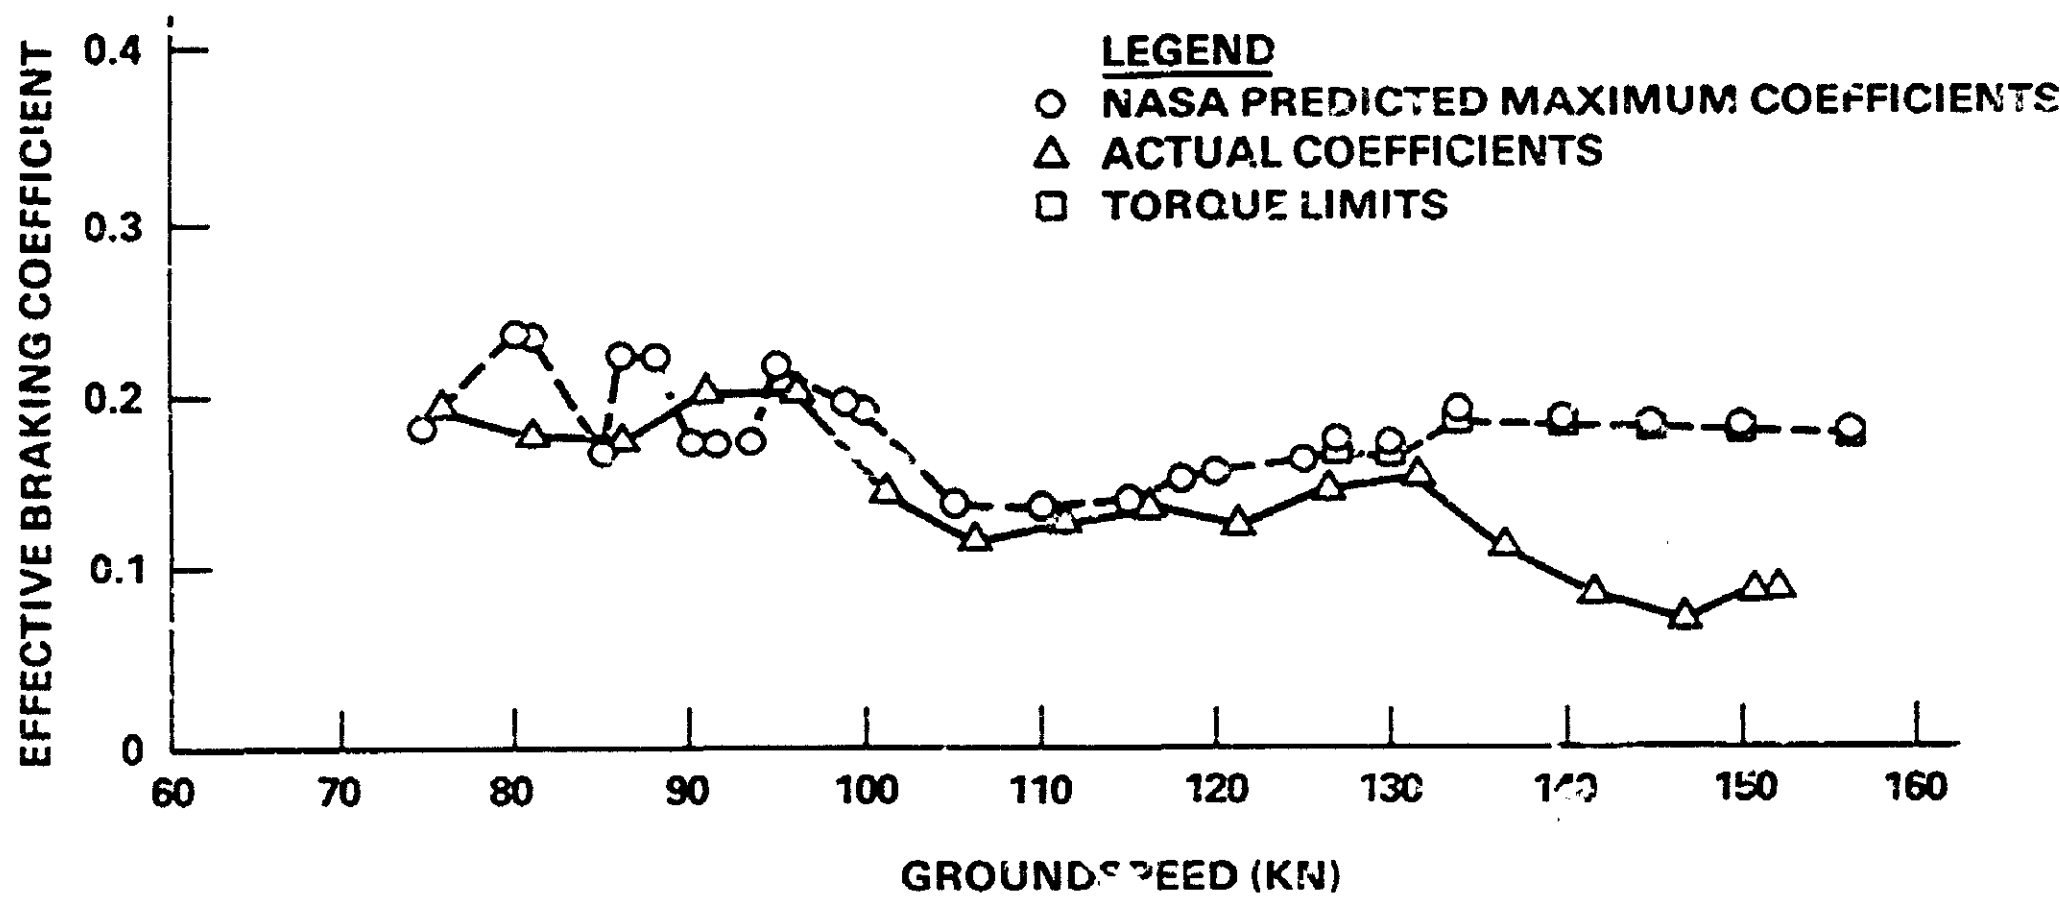
Figure 4. Comparison of actual and predicted maximum braking capabilities.

The effective tire to pavement frictional coefficients available to the failed left main landing gear tires and wheels during deceleration from 156 kns to 74 kns were 42 percent less than those available to the four unfailed right main landing gear tires over the same speed range. Douglas Aircraft Company estimated that the surface contaminants increased the aircraft stopping distance by 300 to 400 ft. By similar analyses, an uncontaminated, wet, and grooved surface was estimated to provide at least a 2,000-ft stopping distance advantage over an ungrooved, clean surface. NASA analysis confirmed these calculations.

The actual rejected takeoff braking performance for the Continental DC-10 was calculated using D_rDR data and aerodynamic data. These calculations produced a relationship between effective tire-to-pavement frictional coefficients and aircraft groundspeed. When these results were compared to the NASA-predicted maximum braking coefficients over the same speed range, substantial differences were found in the 153 kns to 132 kns groundspeed range, during which the aircraft traveled about 1,200 ft in the initial portion of the takeoff. For groundspeeds between 132 kns and 68 kns (the end of runway speed), the Douglas and NASA braking values substantially agreed, indicating that maximum braking was being achieved over the last 2,250 ft of runway. (See figure 4.) Three possible reasons for the disagreement above 132 kns are: (1) The values predicted by NASA could have been excessive, (2) temporary loss or delay in antiskid system operation, and (3) the crew could have applied less than maximum brake pressure. If the predicted braking levels above 132 kns had been achieved, the aircraft might have stopped intact about 200 ft beyond the departure end of the runway. The Safety Board was not able to quantify the actual amount of braking effort applied by the crew or to accurately determine why the full braking values predicted by the NASA theory were not achieved.
