NATIONAL TRANSPORTATION SAFETY BOARD

# AIRCRAFT ACCIDENT REPORT

ALLEGHENY AIRLINES, INC.

CONVAIR 580, N5802

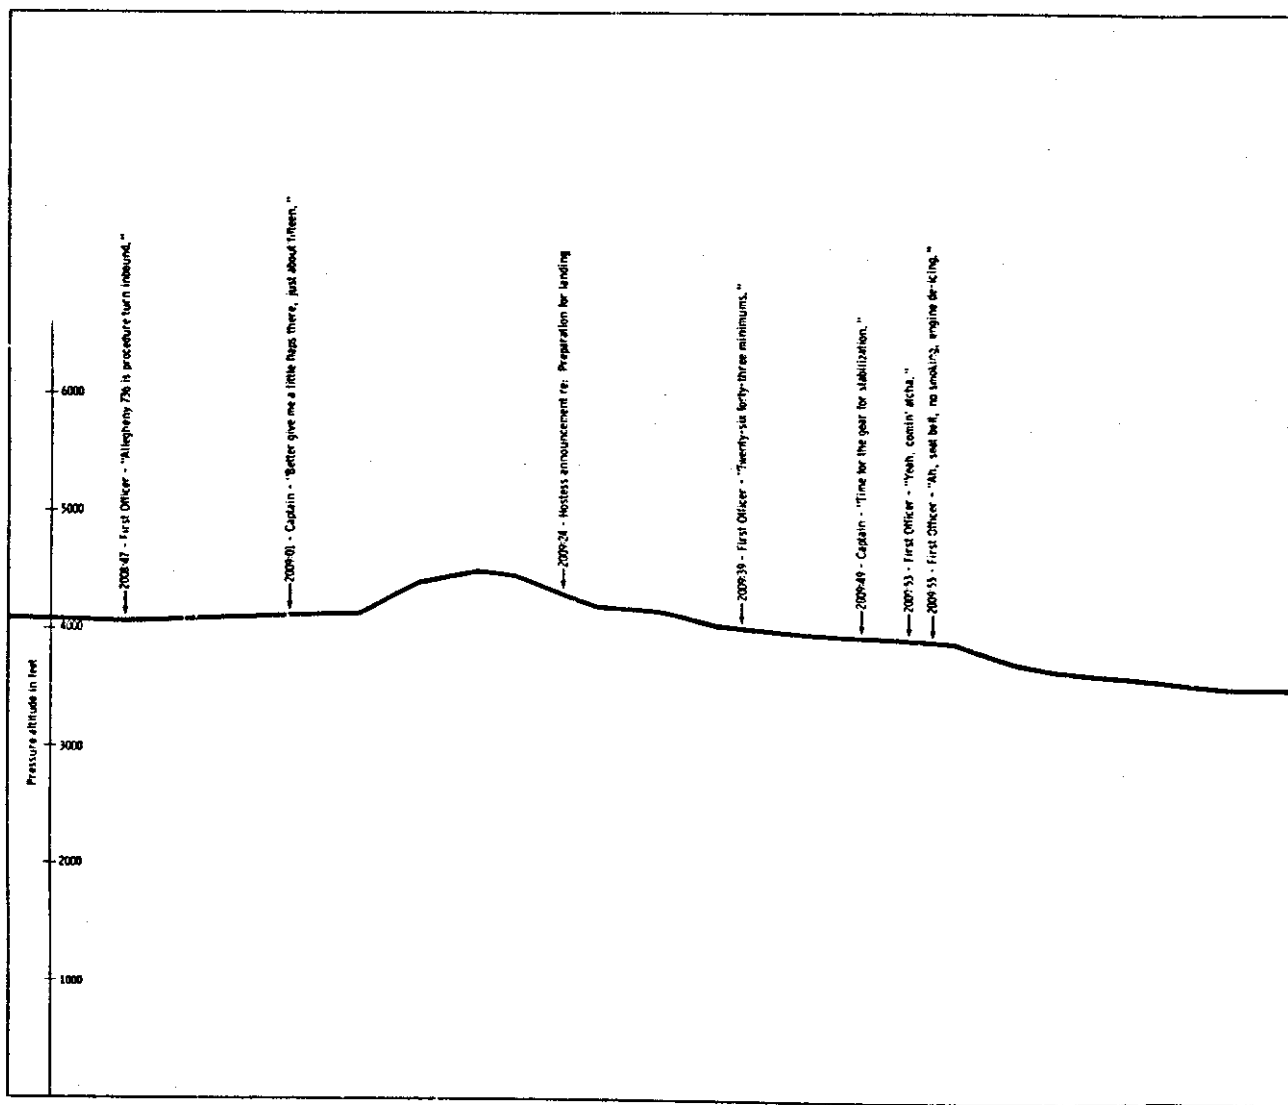
Time span of landing light first observation before impact according to surviving hostess and passenger.

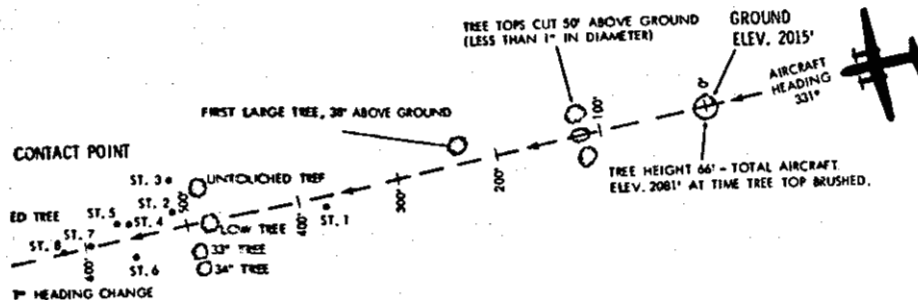
DISTRIBUTION OF WRECKAGE (PLAN VIEW)

were broken tree branches 66 feet above the ground. The ground elevation at the base of this tree was 2,015 feet. From this point, the swath cut by the aircraft through the tree branches followed a general heading of 331° magnetic, with a downward slope of 2° for 230 feet. Evidence indicated that at this point, the right wing of the aircraft, outboard of the engine, struck a large tree 38 feet above its base, the elevation of which was 2,035 feet. The downward slope of the swath cut by the aircraft thereafter increased to 4° until the first ground impact at a point 800 feet from the initial tree contact. The heading of the swath remained 331° until reaching a point 715 feet from initial tree impact, after which the heading changed to 342'. The major portion of the aircraft came to rest, inverted, 1,053 feet from the point of initial impact. The elevation at the main wreckage area was 2,040 feet. 8/

The aircraft came to rest in an inverted position with the top portion of the fuselage structure torn away. More specifically, the damage to the upper fuselage began just below the windshield and extended aft in a diagonal plane to the top of the fuselage at the rear cabin door.
