# AIRCRAFT ACCIDENT REPORT

BOEING 707-331B, N8734

IN THE IONIAN SEA

REPORT NUMBER: NTSB-AAR-75-7

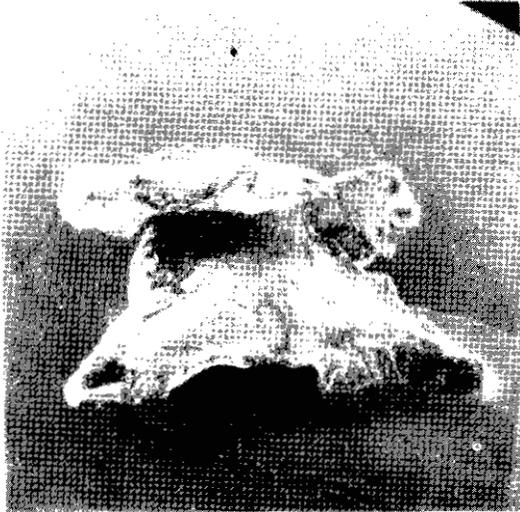
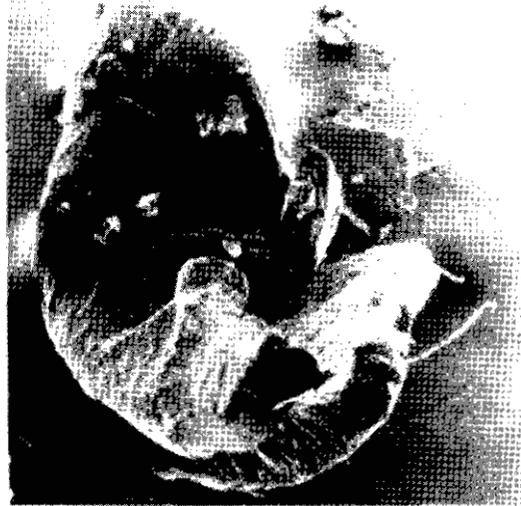
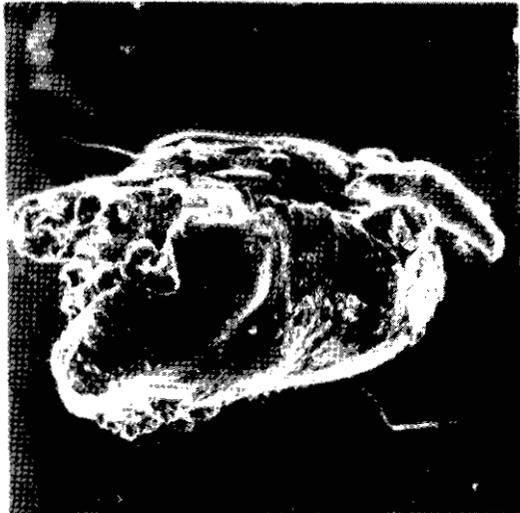
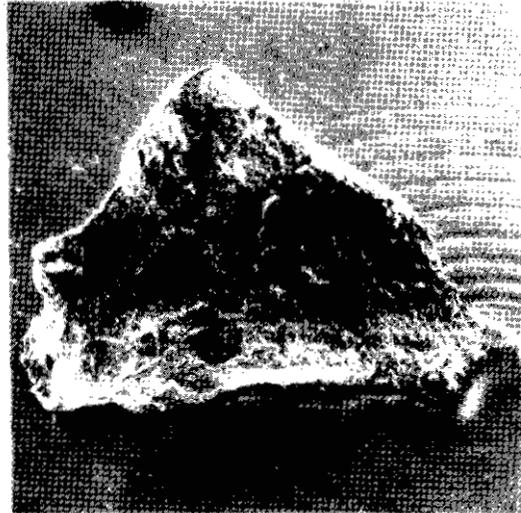
FIG 3 ALUMINIUM ALLOY FRAGMENTS

Exhibits A, E, G, and H are aluminum alloy fragments that were examined optically and in the electron scanning microscope. They showed rolled back edges, engraving, and spalling ('Figure 3). These are all features typical of explosively formed fragments. The deformation of fragments E and H was extensive and "wrap around" features comparable

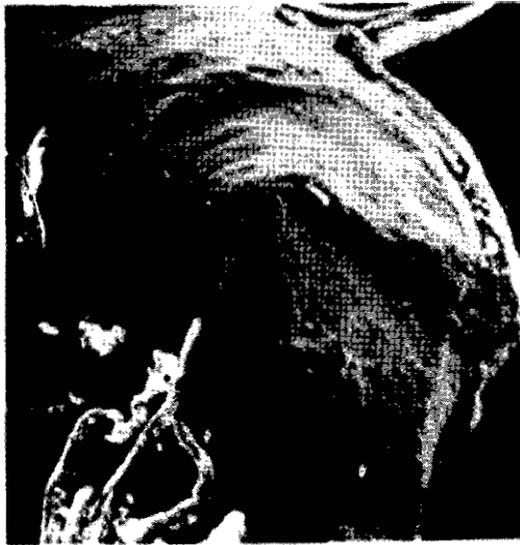
FIG 4 FRAGMENTS FROM TWA 707 & COMET G-ARCO AIRCRAFT

with those found on the fragments extracted from the Comet seat cushions were found (Figure 4). There were few signs of conventional microvoid rupture in these fragments, and an explosion is the only phenomenon known which can produce the observed surface features.

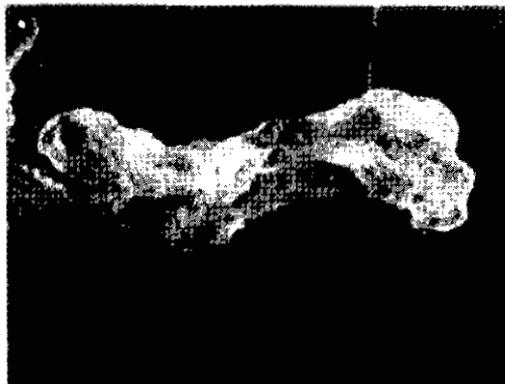
FIG 3 ZINC ALLOY FRAGMENT ARC/I x 15

Exhibit ARC/1 is a zinc alloy fragment. It is severely distorted but salt water corrosion has obliterated any surface rupture features (Figure 5). Exhibit I, an iron fragment, is also corroded but the fragment deformation and polyurethane bonded to it are again similar to that found in the Comet inquiry (Figure 6), indicating that the particle had been hot and was derived from an explosive source. Both these fragments are foreign to the aircraft structure.

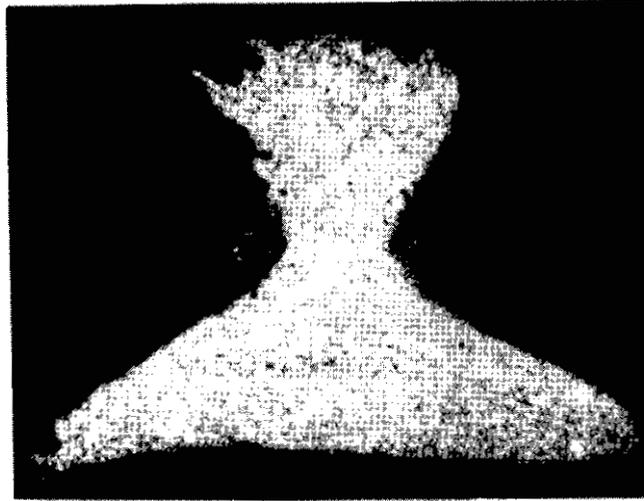
FIG 7 METALLURGICAL SECTION OF FRAGMENT I x 75

Exhibit I was polished and etched. The micro-structure is that of a low carbon iron with a grain size between 15 and 20 microns (Figure 7). This is considerably finer than that found in commercially available material and is the product of a heavily cold worked structure, recrystallizing rapidly at a high temperature but with grain growth inhibited. This structure is expected in an iron fragment which has undergone extensive deformation and heating at the source of an explosion, followed by drastic cooling on impact with suitcase. Similar structures have been produced in tests at RARDE when high explosives were detonated against iron plates. The similarities between the structure of fragment I with the structures obtained in controlled explosive trials can be seen in Figure 8. Evidence of explosive deformation is apparent in the micro-structure of the strained steel case hinge (Figure 9). The strain in the hinge was small, but deformation twins were found in a portion of the grains. These twins are effective signature of an explosive shock passing through the hinge. Twinned structures were found in the Comet fragments, though the density in these was considerably higher because the fragments suffered greater strain.

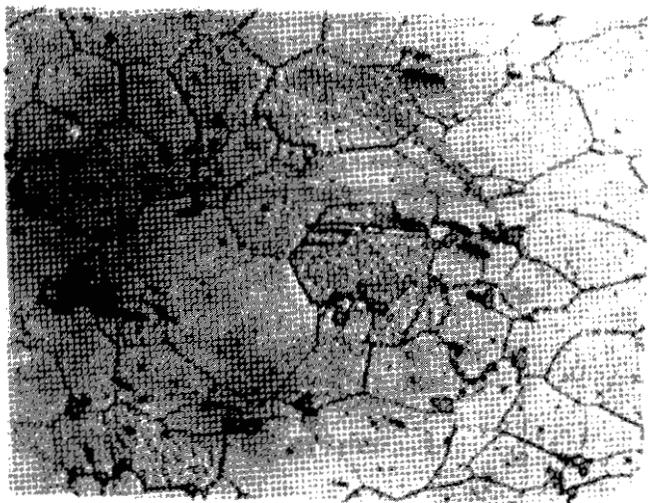
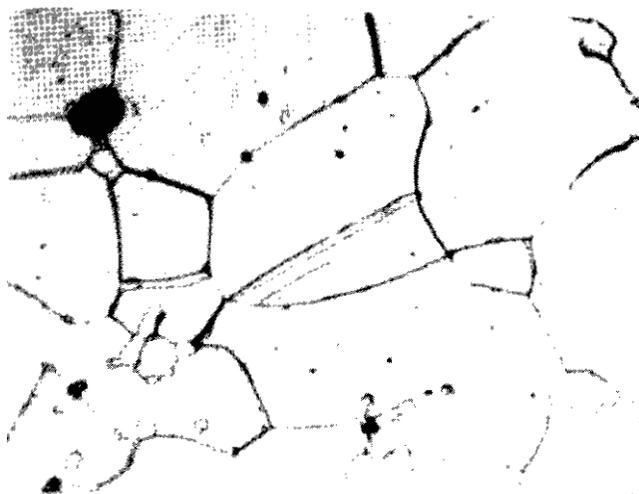
FIG · METALLURGICAL SECTION OF DAMAGED HINGE

microstructure of the piece of metal hinge designated as specimen Q19A, it was concluded that the objects from which these metal parts originated were damaged as a result of exposure to the detonation of a high order explosive. <sup>11</sup>
