1. Report No. NTSB-AAR-75-7	2. Government Accession No.	PB 241 705	
4. Title and Subtitle Aircraft Accident Report - Trans World Airlines, Inc., Boeing 707-331B, N8734, in the Ionian Sea, September 8, 1974.		5. Report Date March 26, 1975	6. Performing Organization Code

# AIRCRAFT ACCIDENT REPORT

TRANS WORLD AIRLINES, INC.

BOEING 707-331B, N8734

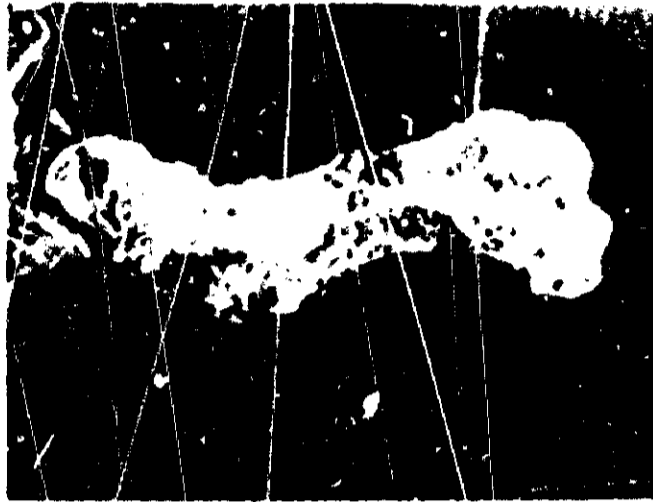
FIG. 1 ZINC ALLOY FRAGMENT AREA 1115

Exhibit ARC/1 is a zinc alloy fragment. It is severely distorted but salt water corrosion has obliterated any surface rupture features (Figure 5). Exhibit I, an iron fragment, is also corroded but the fragment deformation and polyurethane bonded to it are again similar to that found in the Comet inquiry (Figure 6), indicating that the particle had been hot and was derived from an explosive source. Both these fragments are foreign to the aircraft structure.

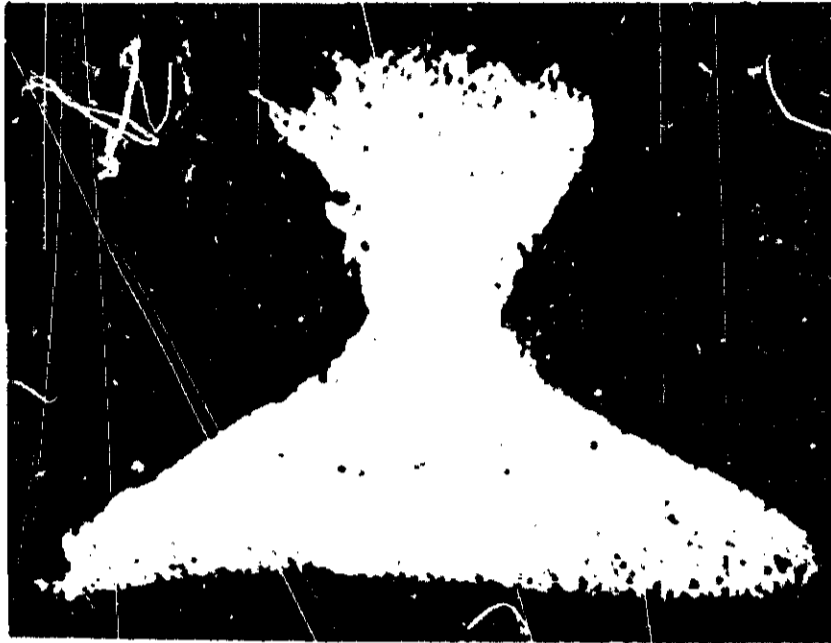
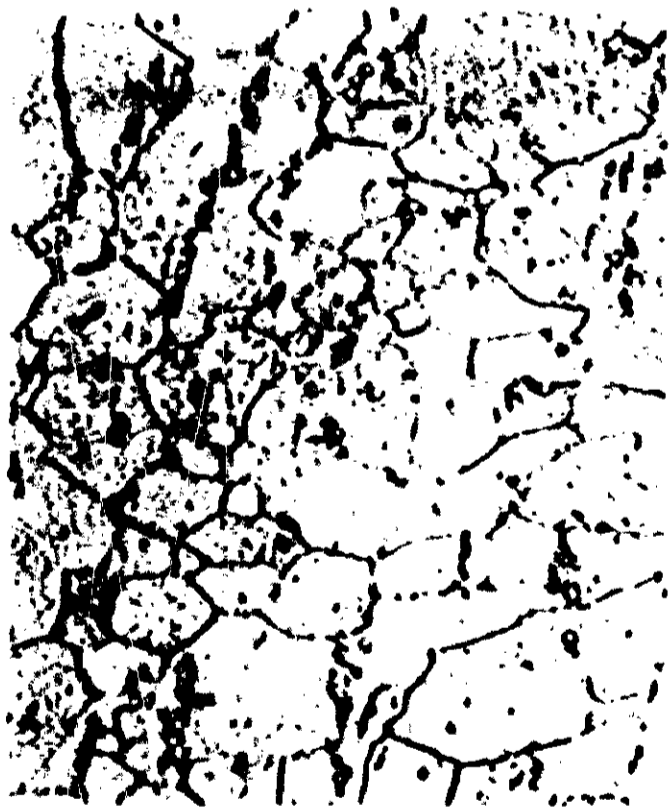
FIG METALLURGICAL SECTION OF FRAGMENT I x 75

Exhibit I was polished and etched. The micro-structure is that of a low carbon iron with a grain size between 15 and 20 microns (Figure 7). This is considerably finer than that found in commercially available material and is the product of a heavily cold worked structure, recrystallizing rapidly at a high temperature but with grain growth inhibited. This structure is expected in an iron fragment which has undergone extensive deformation and heating at the source of an explosion, followed by drastic cooling on impact with suitcase. Similar structures have been produced in tests at RARDE when high explosives were detonated against iron plates. The similarities between the structure of fragment I with the structures obtained in controlled explosive trials can be seen in Figure 8. Evidence of explosive deformation is apparent in the micro-structure of the strained steel case hinge (Figure 9). The strain in the hinge was small, but deformation twins were found in a portion of the grains. These twins are effective signature of an explosive shock passing through the hinge. Twinned structures were found in the Comet fragments, though the density in these was considerably higher because the fragments suffered greater strain.
