NATIONAL TRANSPORTATION SAFETY BOARD
Washington, D. C. 20591

AIRCRAFT ACCIDENT REPORT

MARTIN 404, N464M
8 STATUTE MILES WEST OF
SILVER PLUME, COLORADO
OCTOBER 2, 1970

REPORT NUMBER: NTSB-AAR-71-4

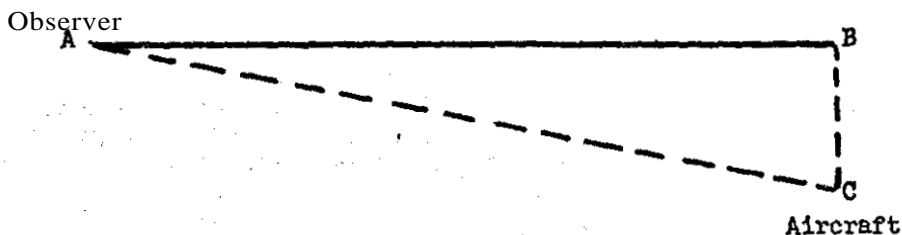
Diagrammatically:

- (1) Two witnesses who observed the aircraft from above at Loveland Pass provided a sight line with a depression angle of $4-1/4^\circ$ as measured by an Abney level. The aircraft was first observed when it was east of Dry Gulch. The distance was approximately 12,000 feet.

Angle A = $4-1/4^\circ$
Line AC = 12,000

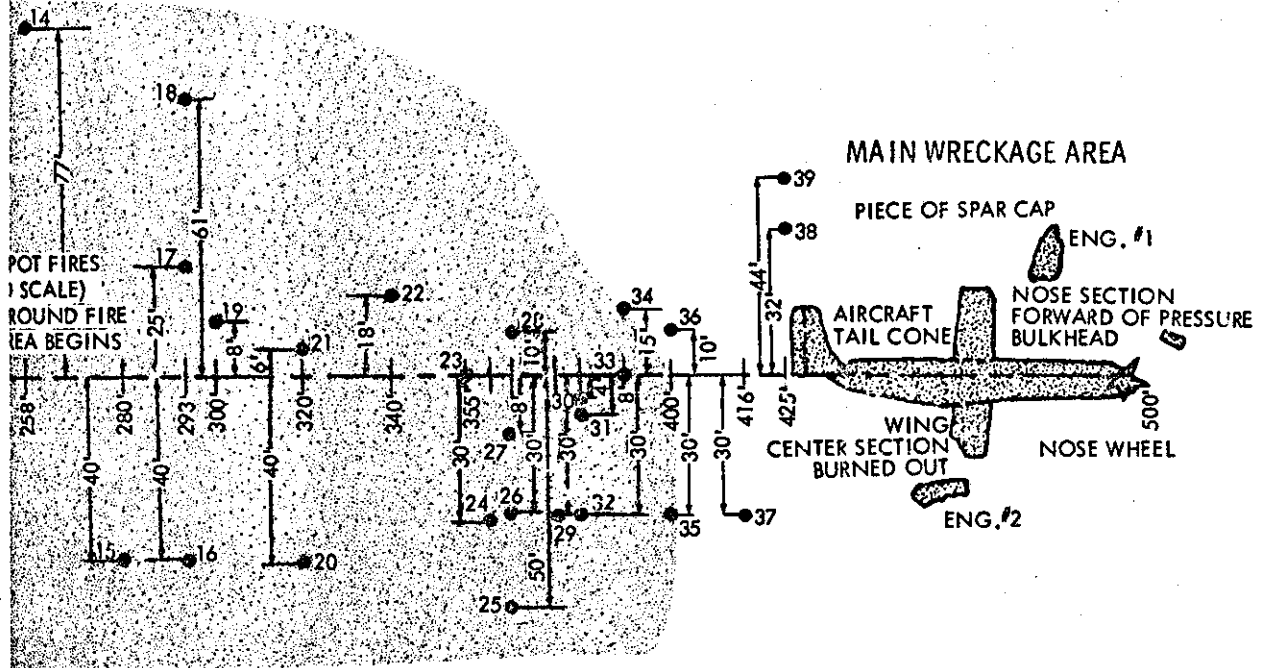
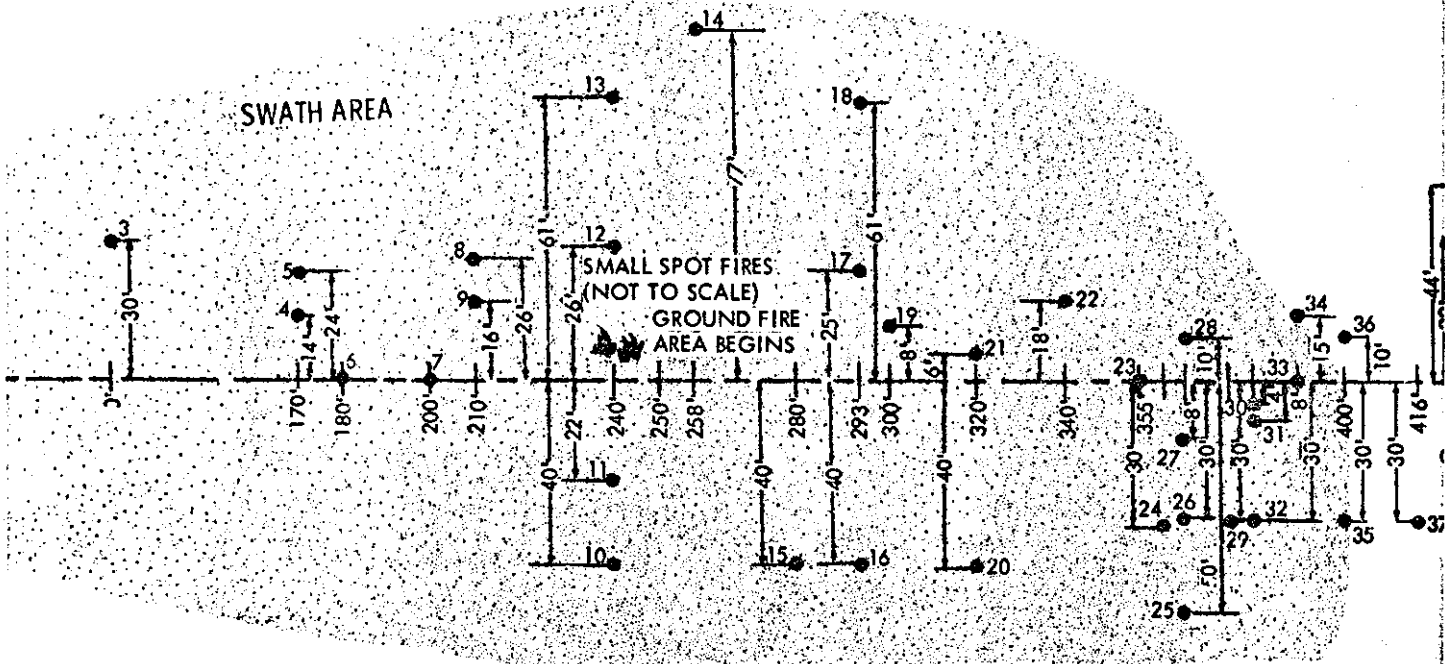
WRECKAGE DISTRIBUTION CHART
 GOLDEN EAGLE AVIATION INCORP. MARTIN 404, N646M
 NEAR SILVER PLUME, COLORADO

swath path indicated a left bank angle of approximately 31° . The distance between the first tree strike and the tail of the wrecked aircraft was 425 feet. First evidence of fire was discovered on the ground at approximately 185 feet from the first tree contact. The area of tree wreckage and burnout was approximately 350 feet in width at the widest point and 525 feet in length from the first tree strike. The slope of the terrain was 29° to 31° 7/

Many pieces of the aircraft were torn off as it descended through the trees. The wings were broken off at their attach points. They were torn apart and pieces were found along the tree swath path.

Fire occurred after ground impact. First evidence of fire was discovered on the ground approximately 185 feet from the first tree contact. The burned out area measured 350 feet wide and 525 feet long. The aircraft fuselage was reduced to molten aluminum from the aft pressure bulkhead forward, except for a small section of the nose cone.
