AIRCRAFT ACCIDENT REPORT: AIR EAST,
INCORPORATED. BEECHCRAFT 99A, N125AE,
JOHNSTOWN-CAMBRIA COUNTY AIRPORT,
JOHNSTOWN, PENNSYLVANIA, JANUARY 6, 1974

REPORT NUMBER: NTSB -AAR-75-3

AIR EAST, INC.
BEECHCRAFT 99A, N125AE
JOHNSTOWN - CAMBRIA COUNTY AIRPORT
JOHNSTOWN, PENNSYLVANIA
JANUARY 6, 1974

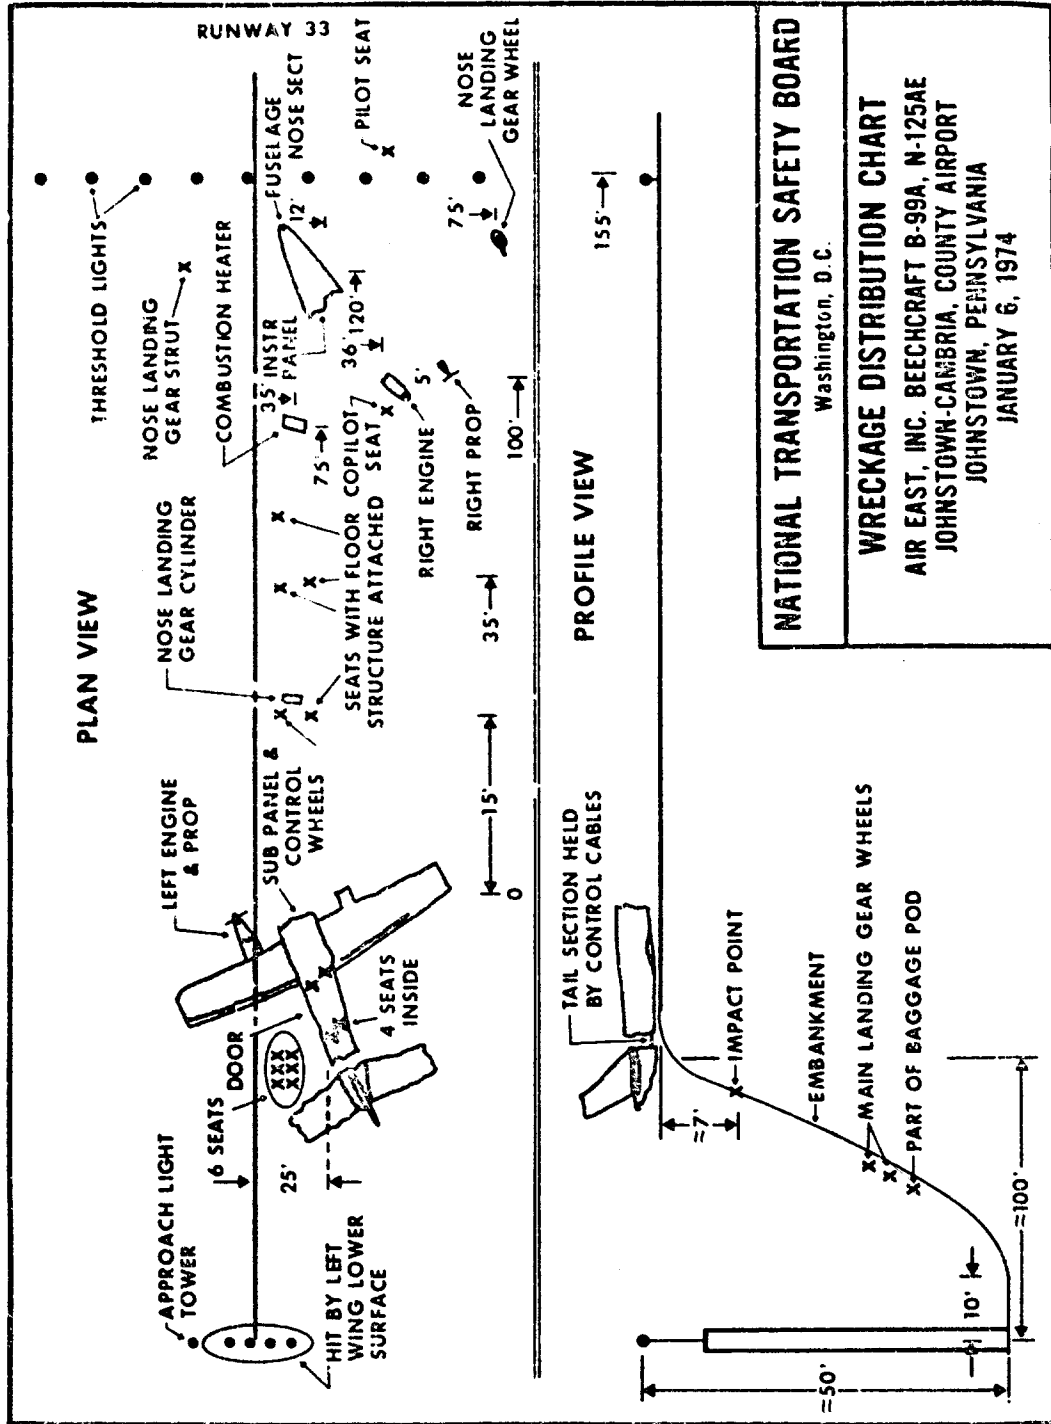
APPENDIX E

WRECKAGE DISTRIBUTION CHART
