**Special Investigation Report  
Wing Failure of Boeing 747-131  
Near Madrid, Spain, May 9, 1976**

WING FAILURE OF BOEING 747-131  
NEAR MADRID, SPAIN  
MAY 9, 1976

1. Report No. NTSB-AAR-78-12	2. Government Accession No.	3. Recipient's Catalog No.	
4. Title and Subtitle Special Investigation Report - Wing Failure of Boeing 747-131, Near Madrid, Spain, May 9, 1976		5. Report Date October 6, 1978

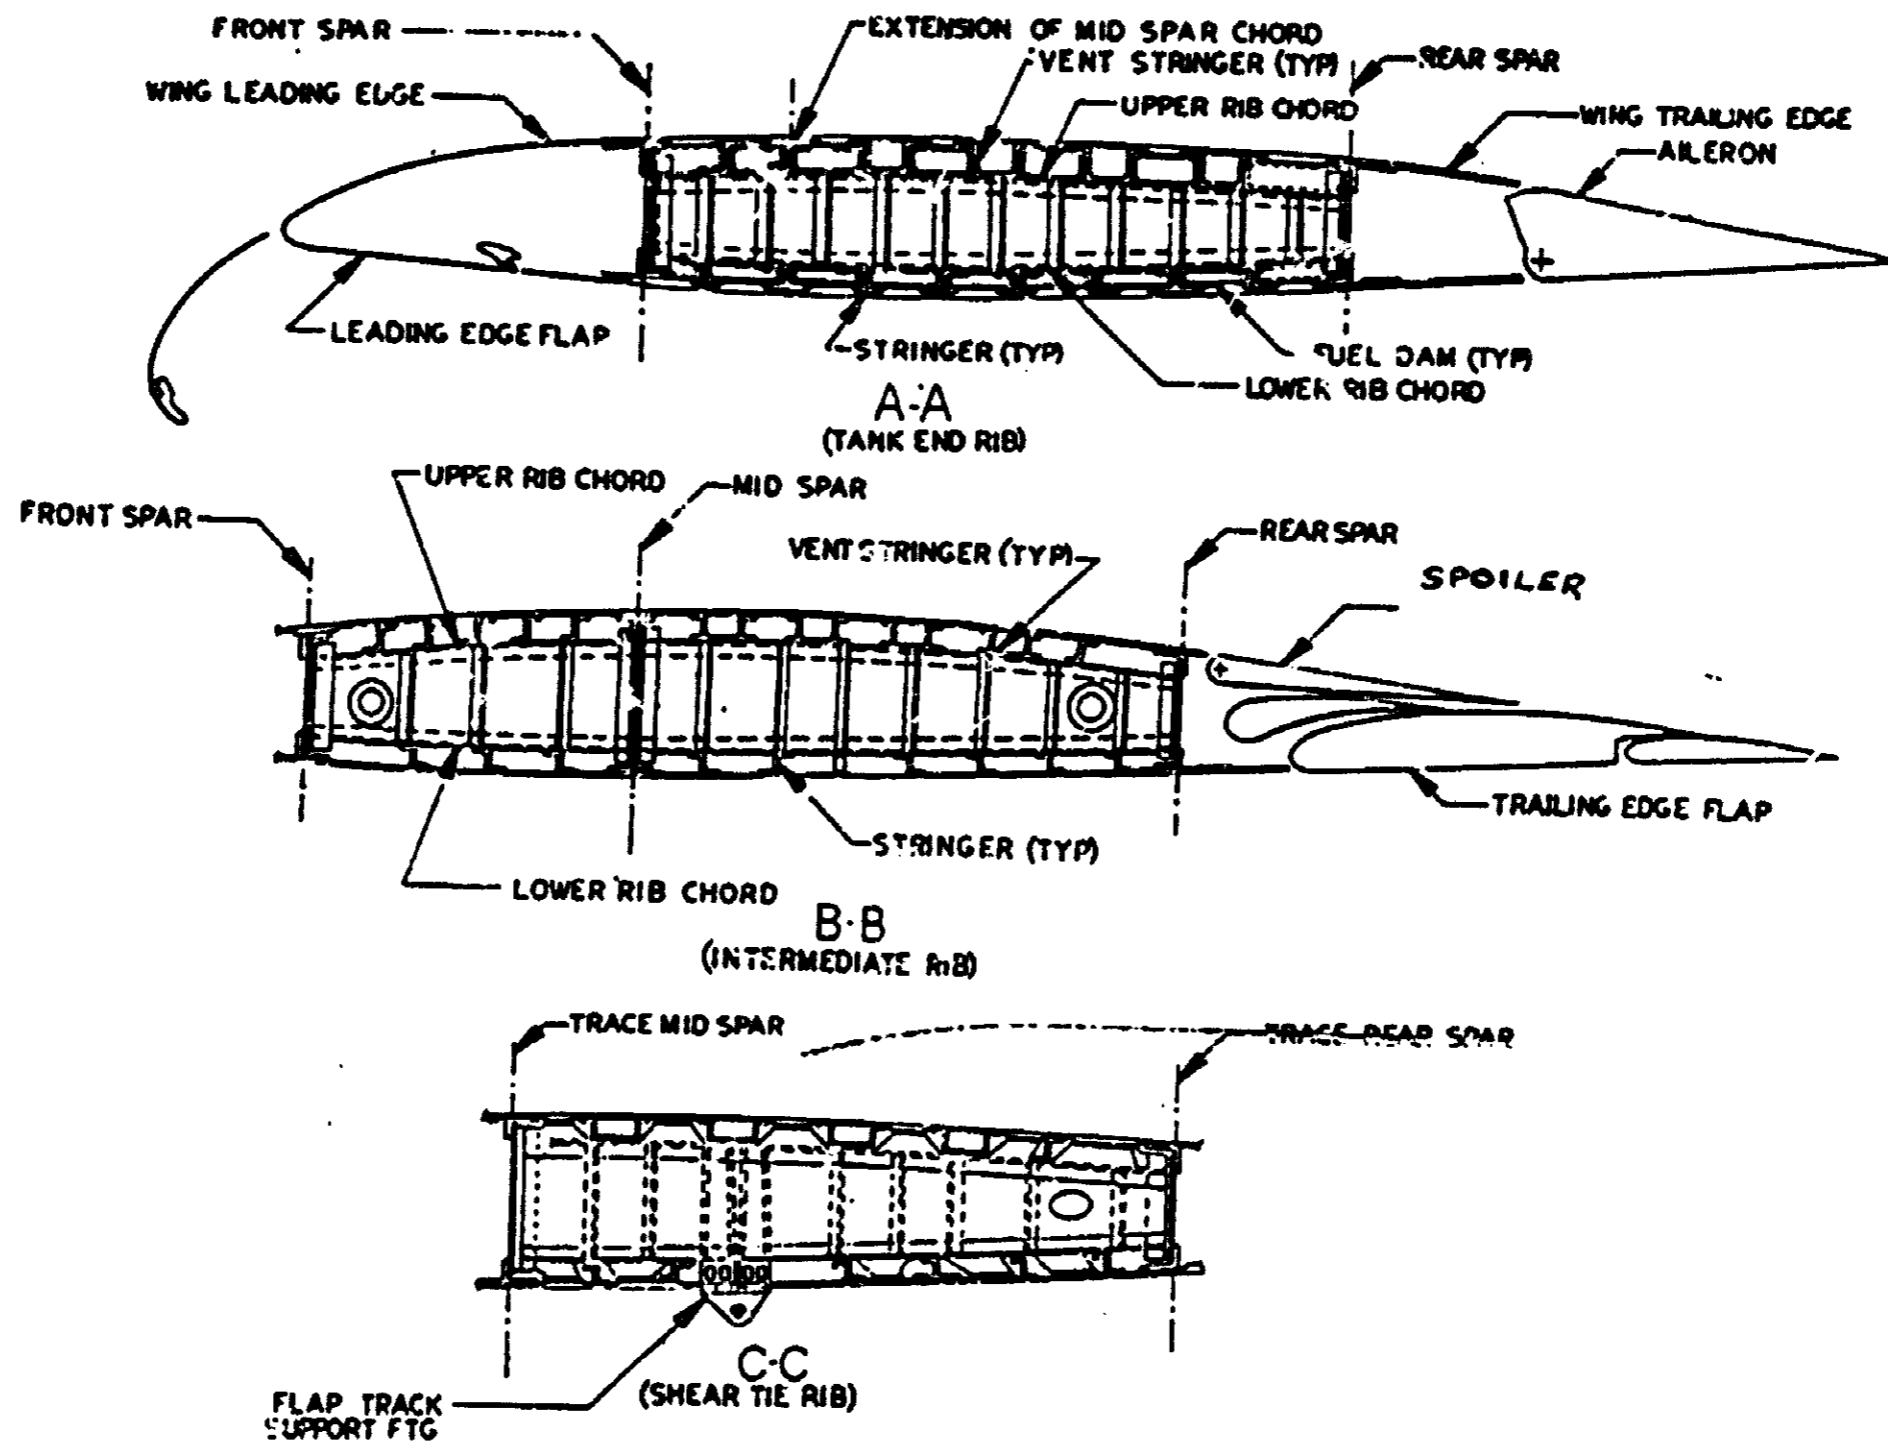
Pitting and localized burn areas typical of lightning attachment damage were found on the left wingtip and on the vertical fin at the VOR antenna. The left wing had separated into 15 major pieces before ground impact and parts of it were found at each location of wreckage. (See drawing on page 31.)

The left wing outboard of the No. 1 engine position separated in three major pieces and along three lines of fracture. The left wingtip, a piece about 20 ft long, separated on a line parallel to the fuselage centerline and roughly halfway between the end of the wing and the No. 1 engine. A second line of separation was just outboard of the No. 1 engine and ran parallel to the rib centerlines. The third line of separation spanned between the first two and ran along the front spar. The wingtip, consisting of the high frequency antenna and coupler, also separated from the wing.
