**Aircraft Accident Report. Alaska Airlines, Inc., Boeing  
727-81, N124AS, Ketchikan International Airport  
Ketchikan, Alaska, April 5, 1976**

1. Report No. NTSB-AAR-76-24		2. Government Accession No.		3. Recipient's Catalog No.	
4. Title and Subtitle Aircraft Accident Report Alaska Airlines, Inc., Boeing 727-81, N124AS Ketchikan, Alaska, April 5, 1976				5. Report Date December 22, 1976

ALASKA AIRLINES, INC.  
B-727-81, N124AS  
KETCHIKAN INTERNATIONAL AIRPORT  
KETCHIKAN, ALASKA  
APRIL 5, 1976

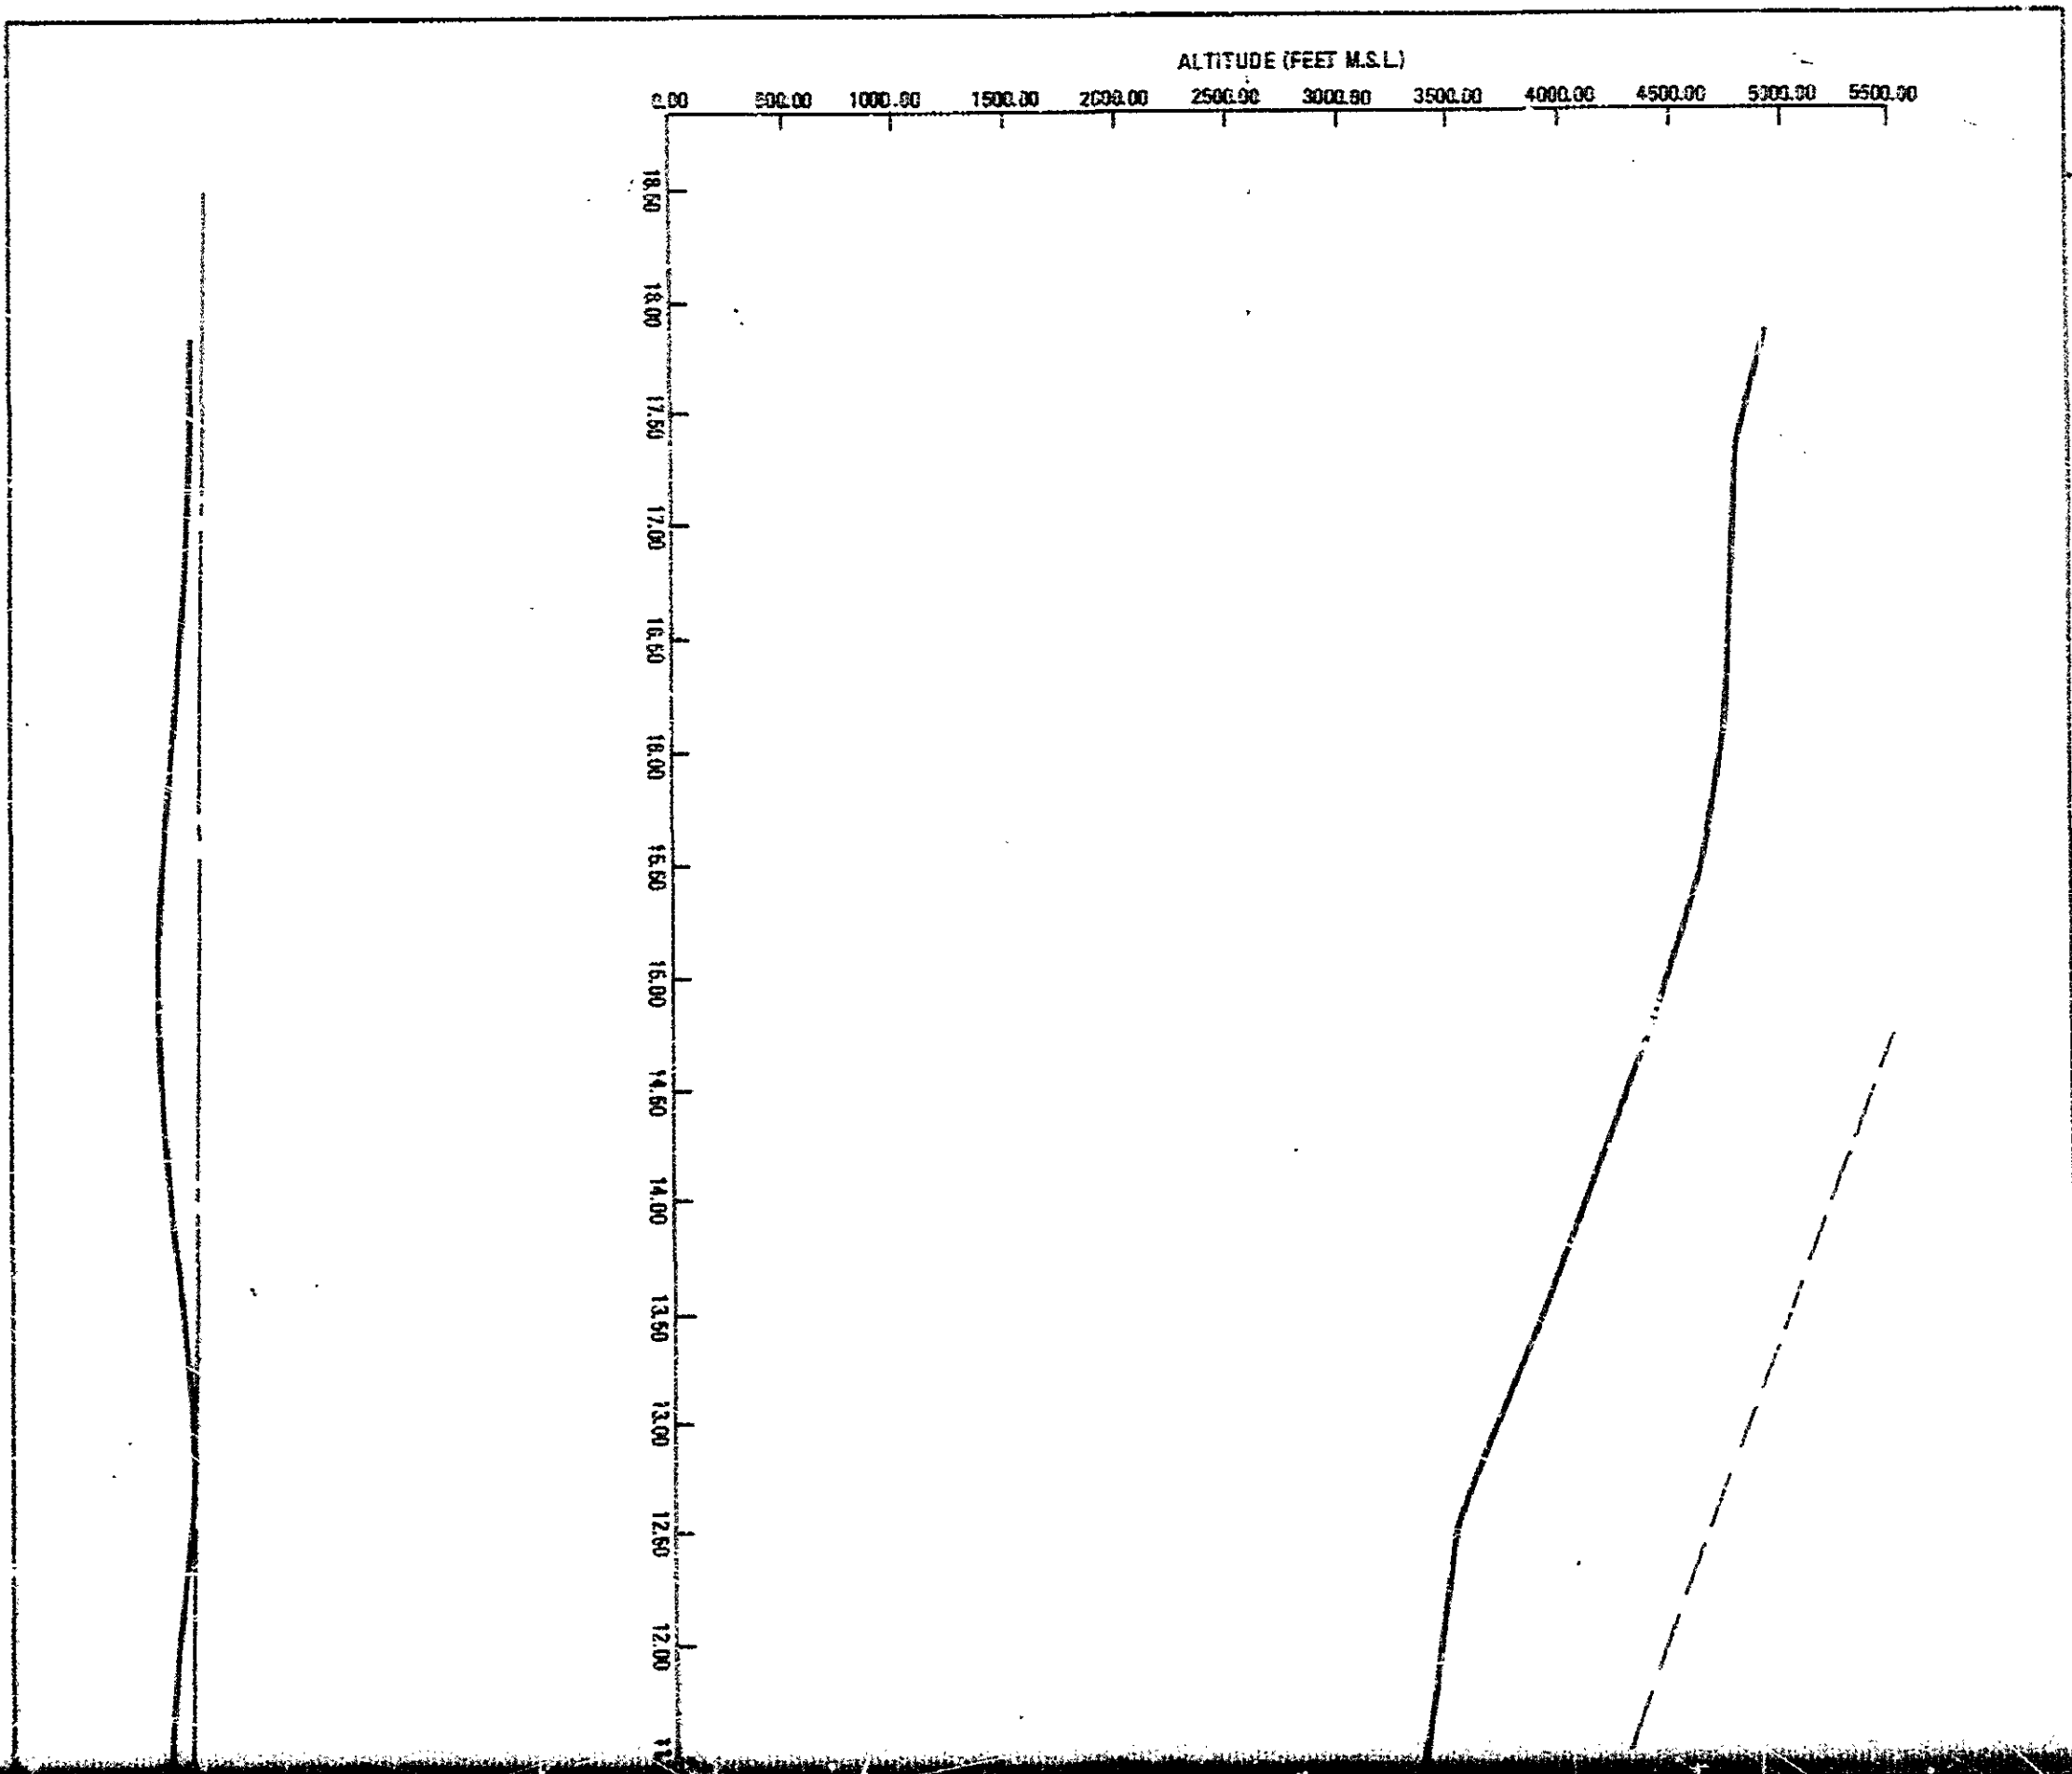
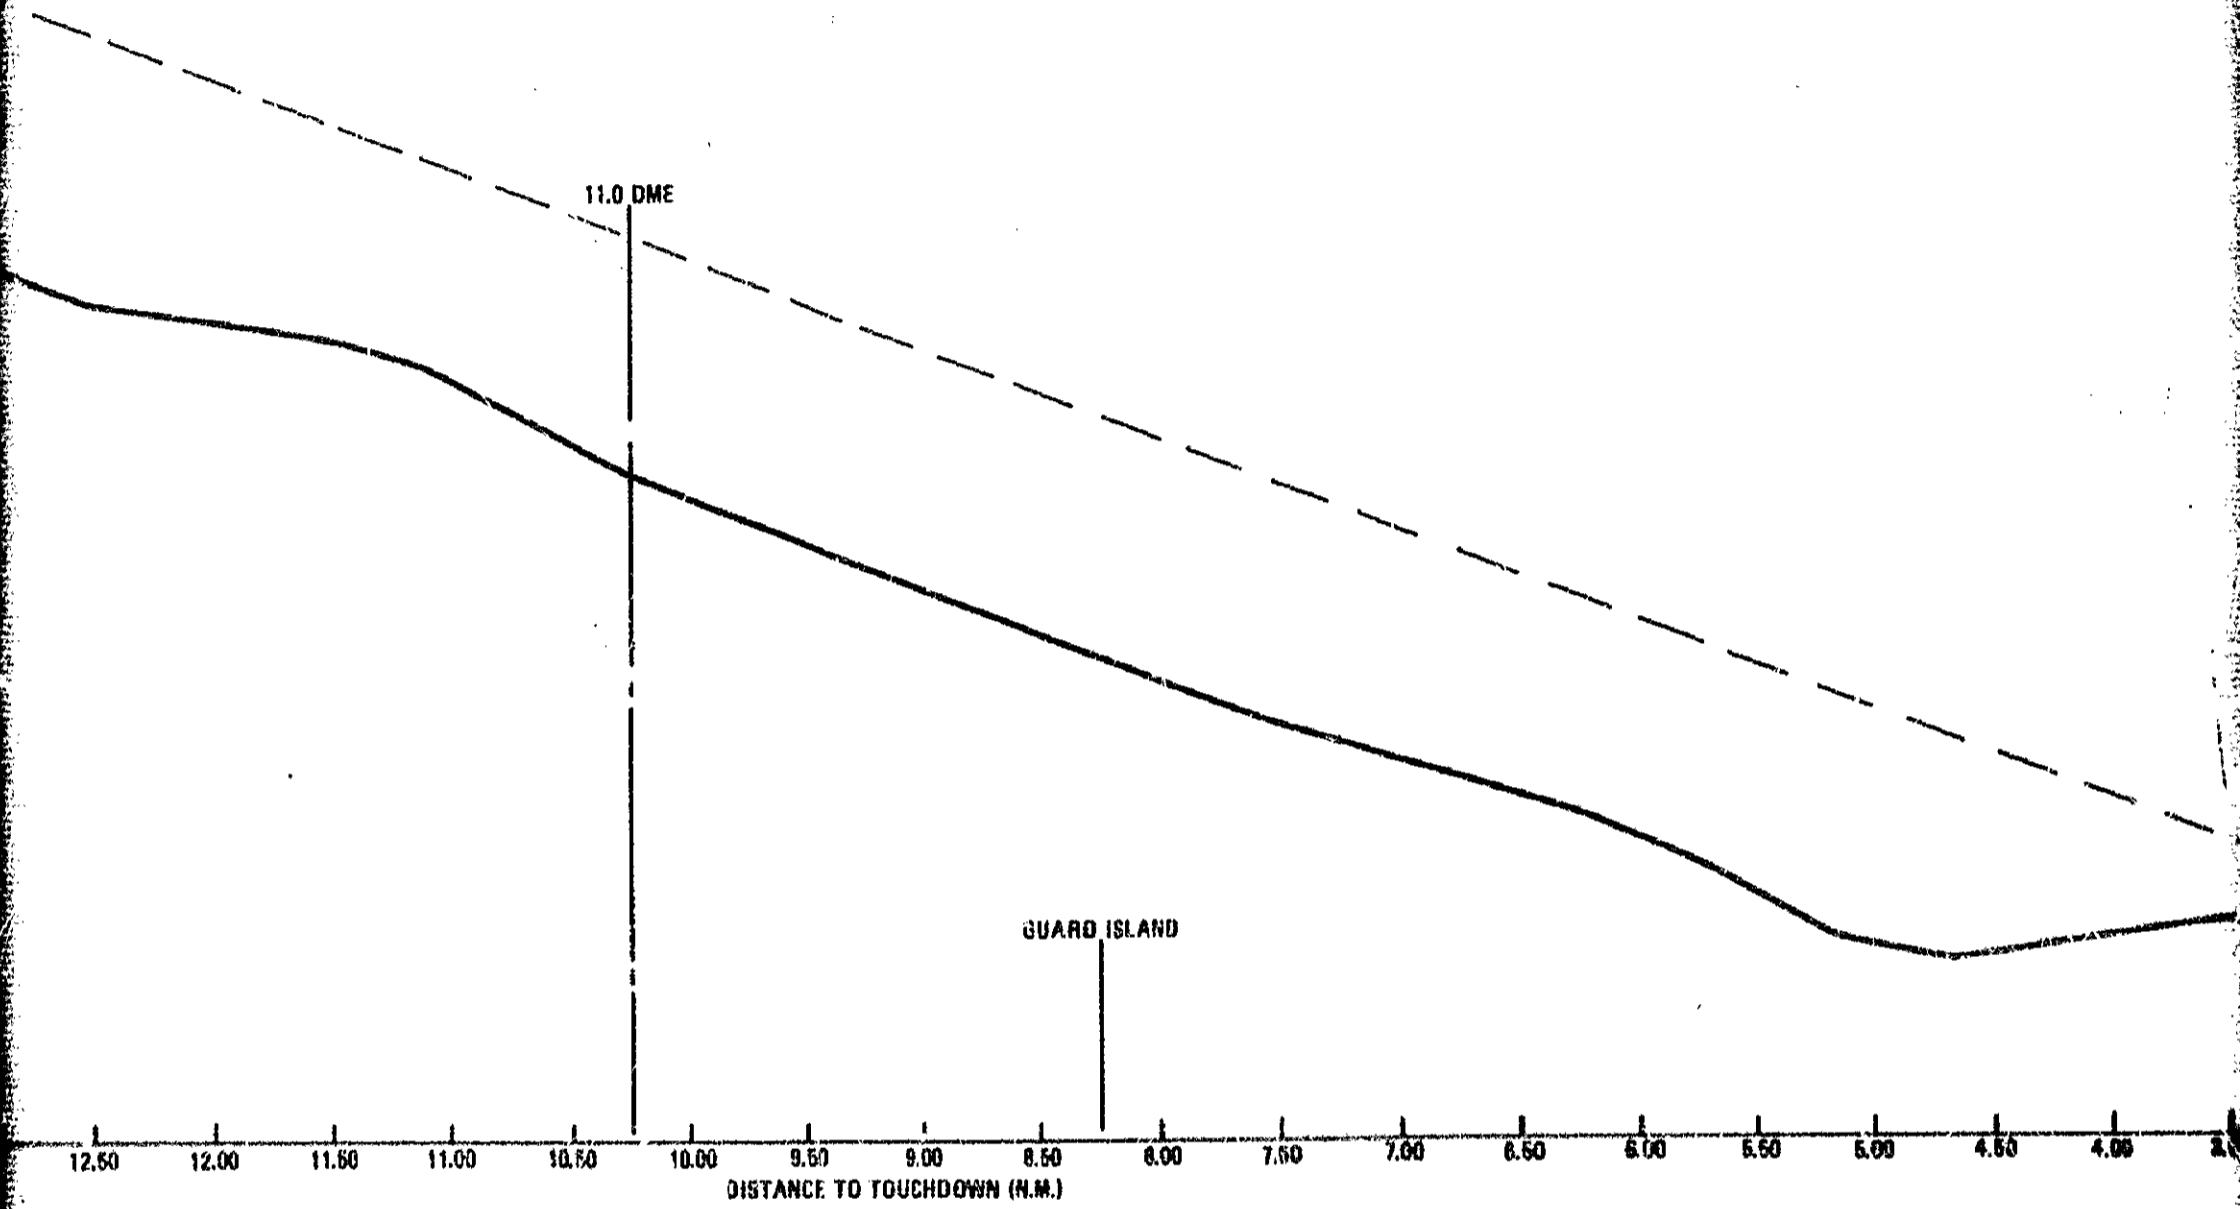
CALCULATED DESCENT PROFILE & GROUND TRACK  
BASED ON FDR DATA FROM ALASKA AIRLINES, INC.  
BOEING 727-81, N124AS  
KETCHIKAN INTERNATIONAL AIRPORT  
KETCHIKAN, ALASKA  
APRIL 5, 1976

The accuracy of the computed flight track and distance calculations depends on (1) the accuracy of the FDR measurements for this particular recorder, (2) the accuracy of the readout, (3) the accuracy of the wind information and its relationship to actual conditions, and (4) the accuracy of the assumed times of touchdown and leaving the overrun. Because of the unknown errors, the flight track distance computations must be considered approximations and are presented for comparison with other evidence.
