1. Report No. NTSB-AAR-78-7		2. Government Accession No.		3. Recipient's Catalog No.	
4. Title and Subtitle Japan Air Lines Co., Ltd. McDonnell-Douglas DC-8-62F, JA 8054, Anchorage, Alaska, January 13, 1977				5. Report Date January 16, 1979

AIRCRAFT ACCIDENT REPORT

JAPAN AIR LINES CO., LTD.  
MCDONNELL-DOUGLAS DC-8-62F, JA 8054  
ANCHORAGE, ALASKA  
JANUARY 13, 1977

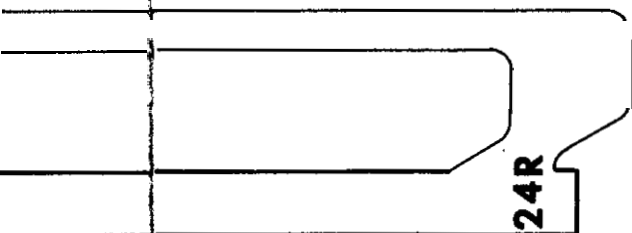
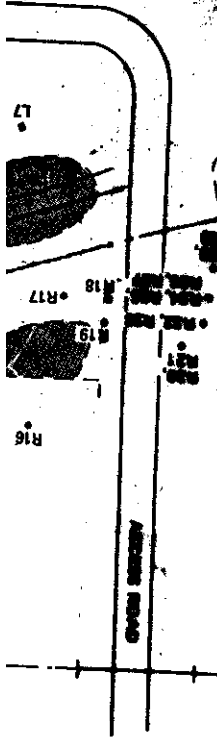
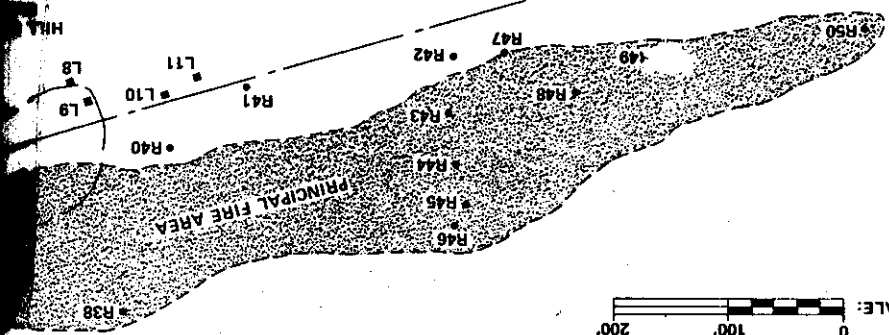
TAXIING ROUTE OF JAL 8054  
ANCHORAGE INTERNATIONAL AIRPORT  
JANUARY 13, 1977

In order to taxi to runway 24L, the crew had to taxi southeast on the parking ramp, northeast on a taxiway parallel to runway 24R, cross 24R, and taxi down a diagonal taxiway connecting the runways to the arrival end of runway 24L.

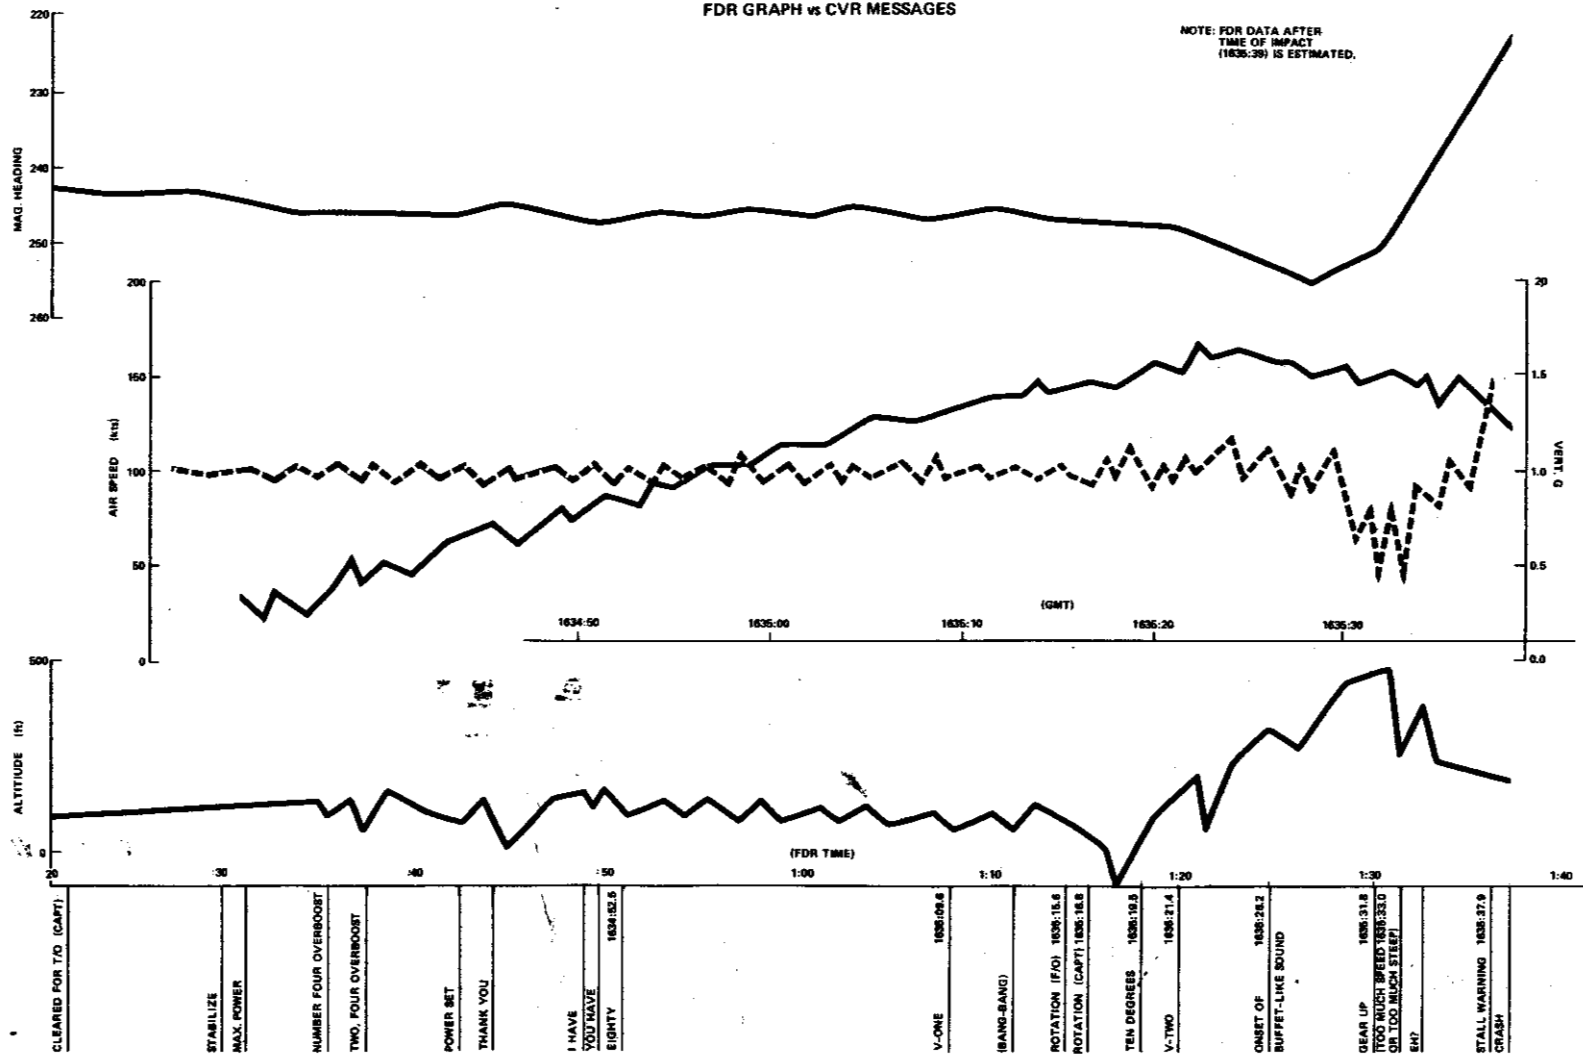
JA8054 ANC ACCIDENT  
FDR GRAPH vs CVR MESSAGES

~~aircraft buffet~~ was recorded. This sound became more frequent and continued until the sounds of impact. At 0635:32 the first officer called "Gear up" and at 0635:33 the flight engineer said "Too much speed (steep)." 3/ At 0635:38 the engineer called "stall" simultaneously the stickshaker sounded and continued until 0635:39.3, when impact was recorded.
