1. Report No. NTSB-AAR-78-3	2. Government Accession No.	3. Recipient's Catalog No.	
4. Title and Subtitle Aircraft Accident Report - Southern Airways Inc., DC-9-31, N1335U, New Hope, Georgia, April 4, 1977		5. Report Date January 26, 1978

AIRCRAFT ACCIDENT REPORT

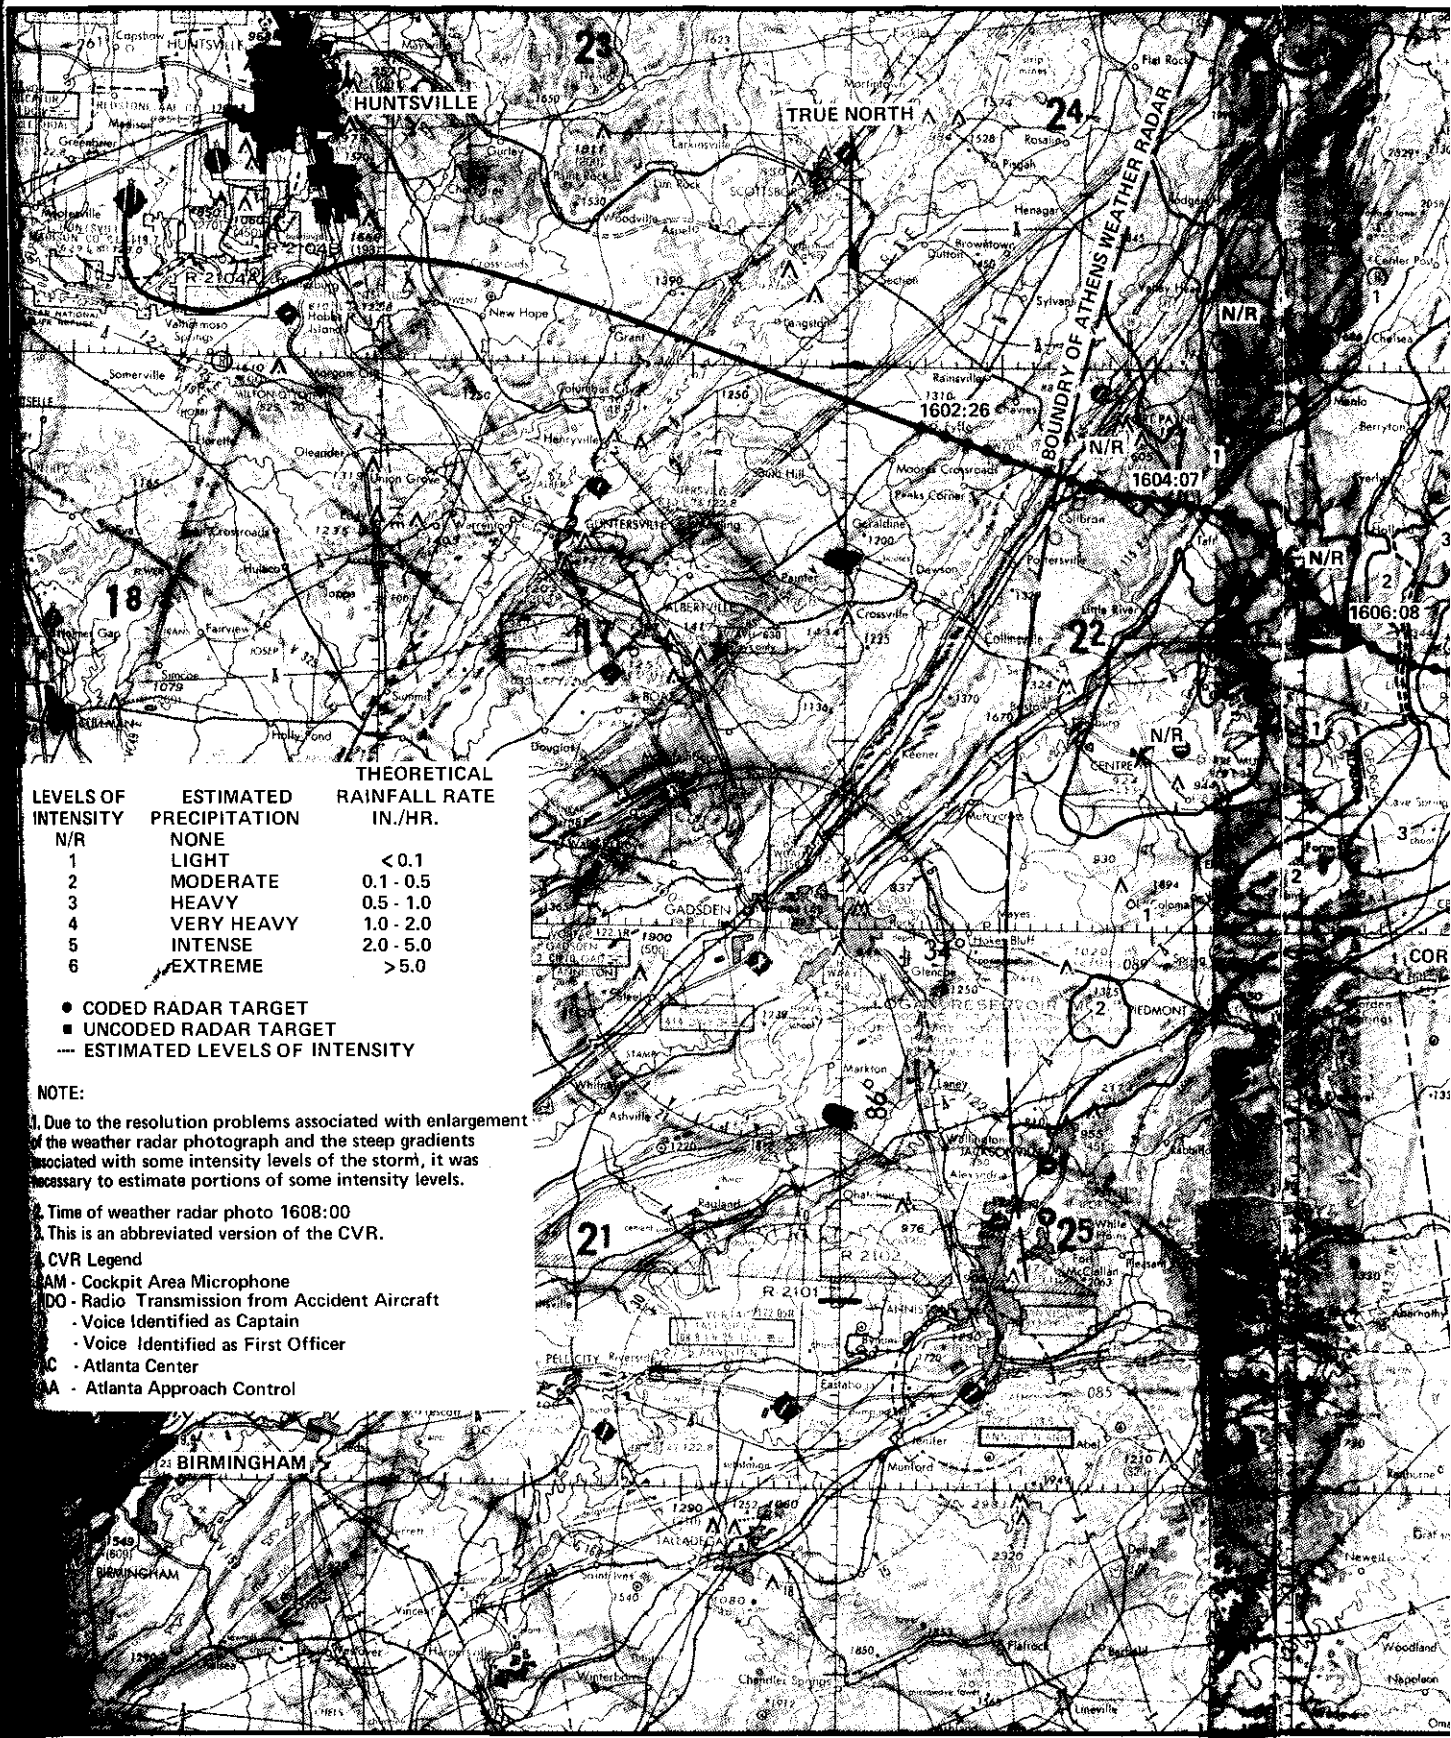
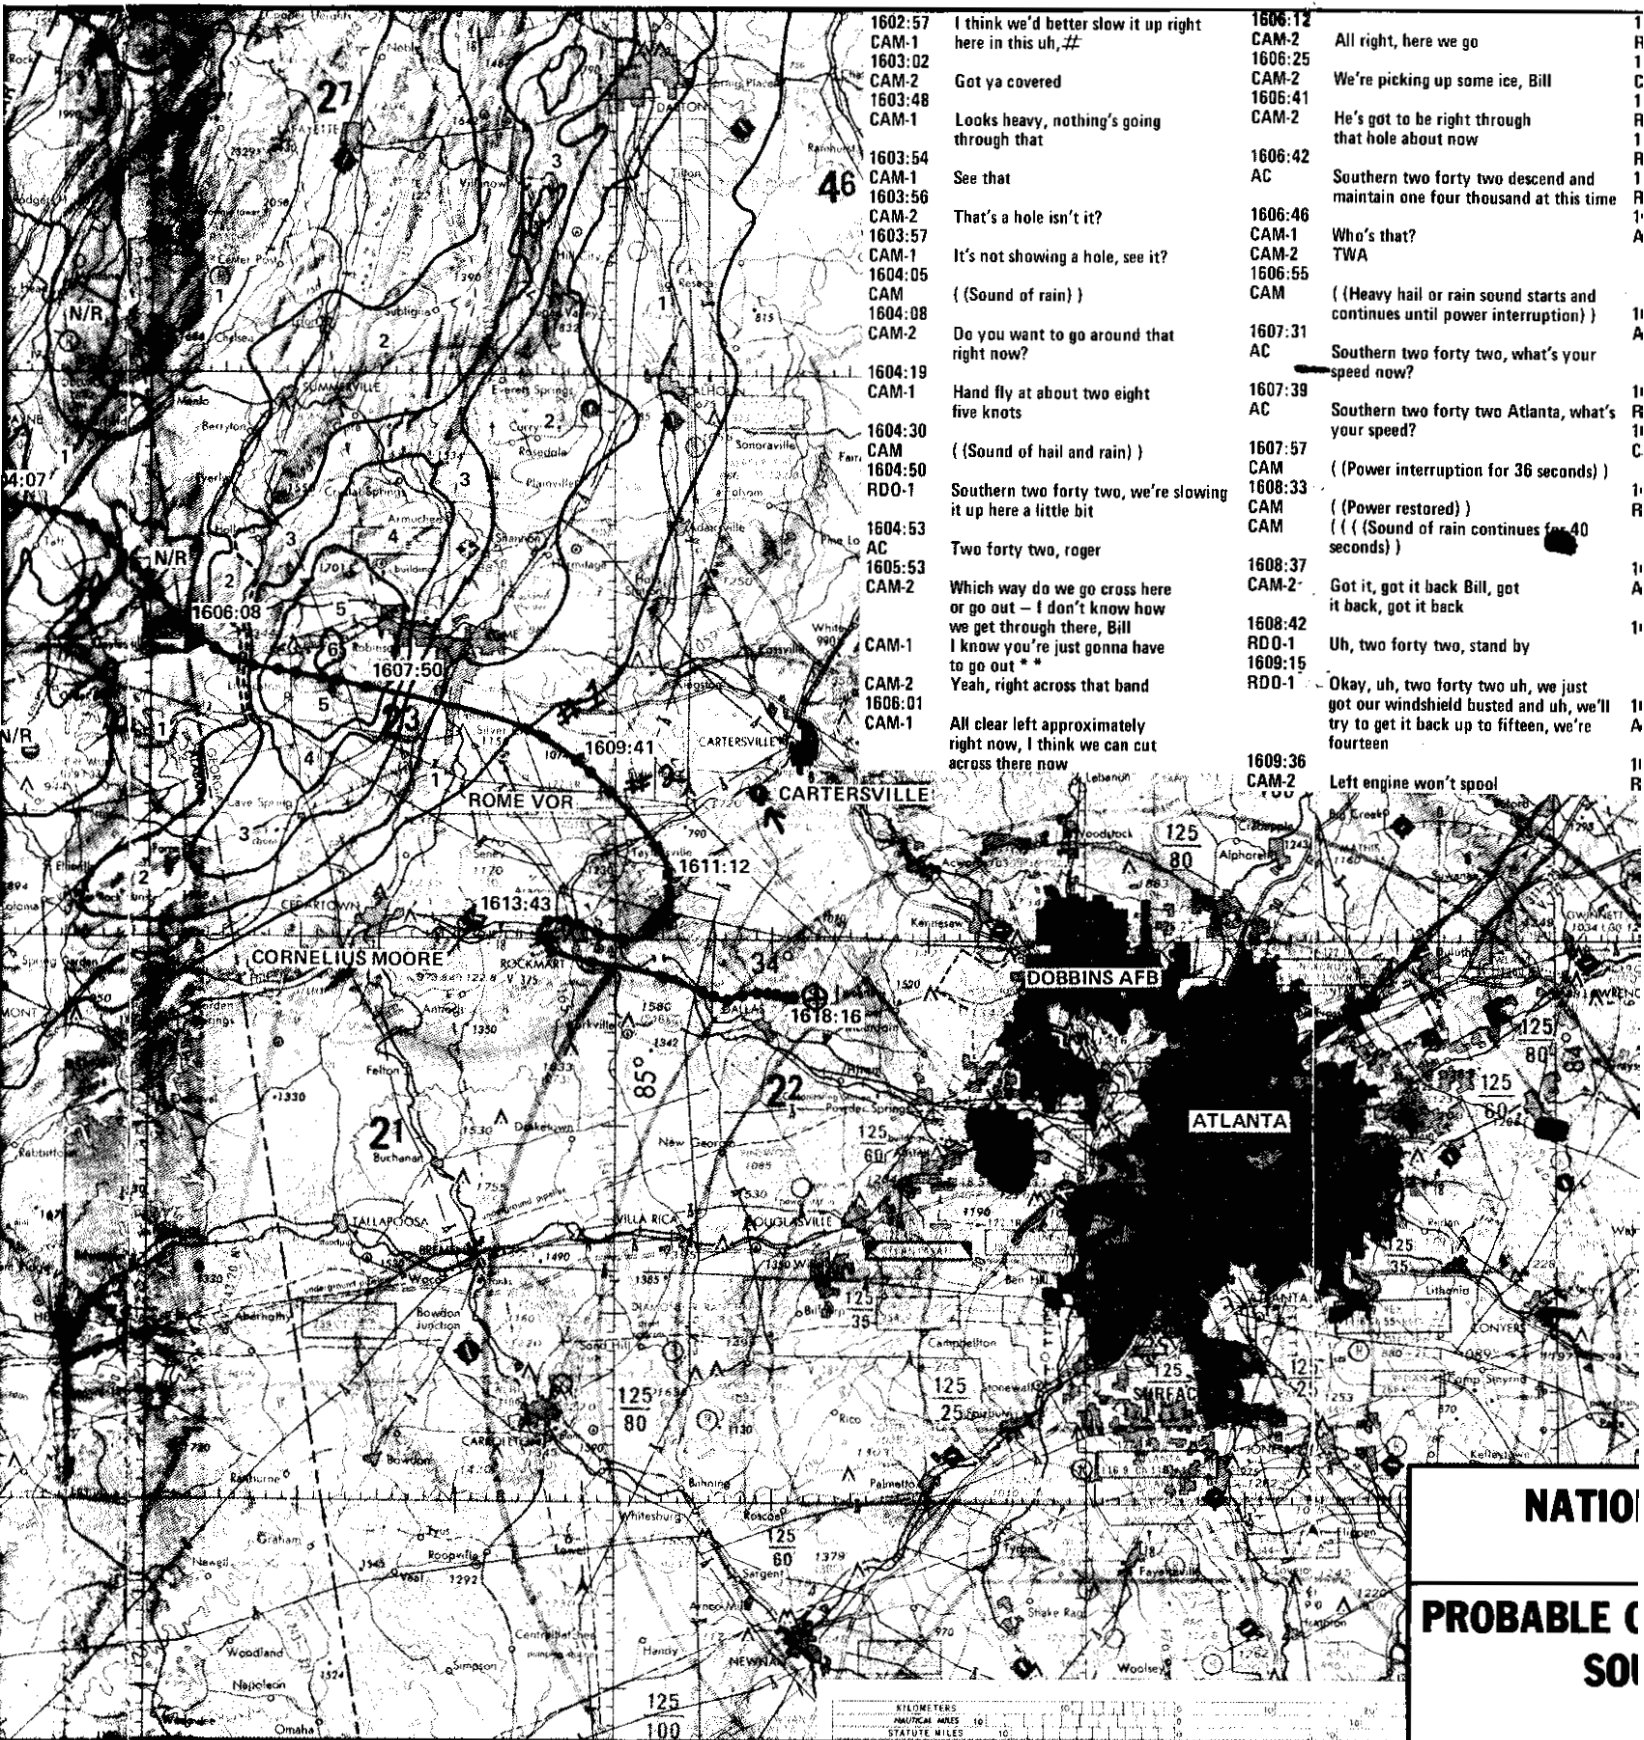
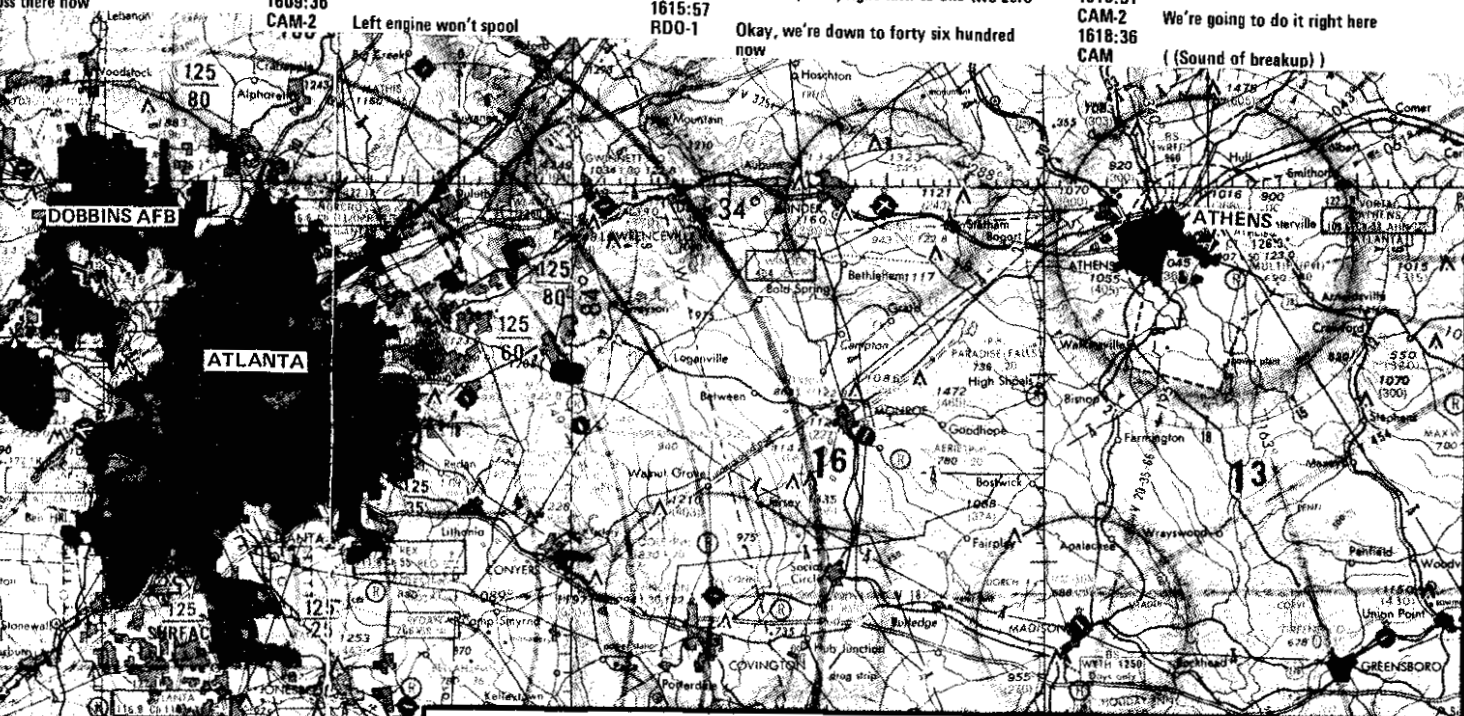
PROBABLE GROUND TRACK AND WEATHER RADAR PLOT
SOUTHERN AIRWAYS, INC., FLIGHT 242
NEW HOPE, GEORGIA, APRIL 4, 1977

A plot for Flight 242's probable ground track from Huntsville was derived from FDR data and NAS Stage-A D-log data from the Atlanta Center. Pertinent comments from the CVR transcript and the air traffic control transcripts were added to the plot. Additionally, the precipitation conditions in the Rome area as identified at 1608 by the NWS's WSR-57 weather radar at Athens, Georgia, were scaled and positioned on the plot. (See Appendix E.) The range of the radar was set at 125 mi; therefore, no weather west of a 125-mi radius of the Athens' radar was plotted. The radar's antenna was at 1° tilt above the horizon and the radar beam width was 2°. Therefore, the precipitation conditions for the Rome area shown on the plot were those between 6,500 ft and 20,500 ft. The precipitation conditions are labeled on the plot in terms of the standard NWS radar-identified intensity levels of precipitation as follows:

The probable ground track established by the radar data is believed to be accurate within \pm 1 mi. The weather radar plot of the precipitation areas west of the Rome VOR is believed accurate within the same tolerance. However, since the precipitation areas were established by the strongest radar returns between 6,500 ft and 20,500 ft, the conditions that existed at Flight 242's flight level may not have been precisely those shown on the plot. Nevertheless, the Safety Board believes that the precipitation areas shown represent a reasonable approximation of the conditions that existed between 17,000 and 14,000 ft. Additionally, a comparison of photographs of the Athens radar display taken from 1604 to 1608 disclosed only slight differences in the boundaries of the precipitation areas from those shown on the plot.
