# NATIONAL TRANSPORTATION SAFETY BOARD

## AIRCRAFT ACCIDENT REPORT

L & J COMPANY  
CONVAIR 240, N55VM  
GILLSBURG, MISSISSIPPI  
OCTOBER 20, 1977

REPORT NUMBER: NTSB-AAR-78-6

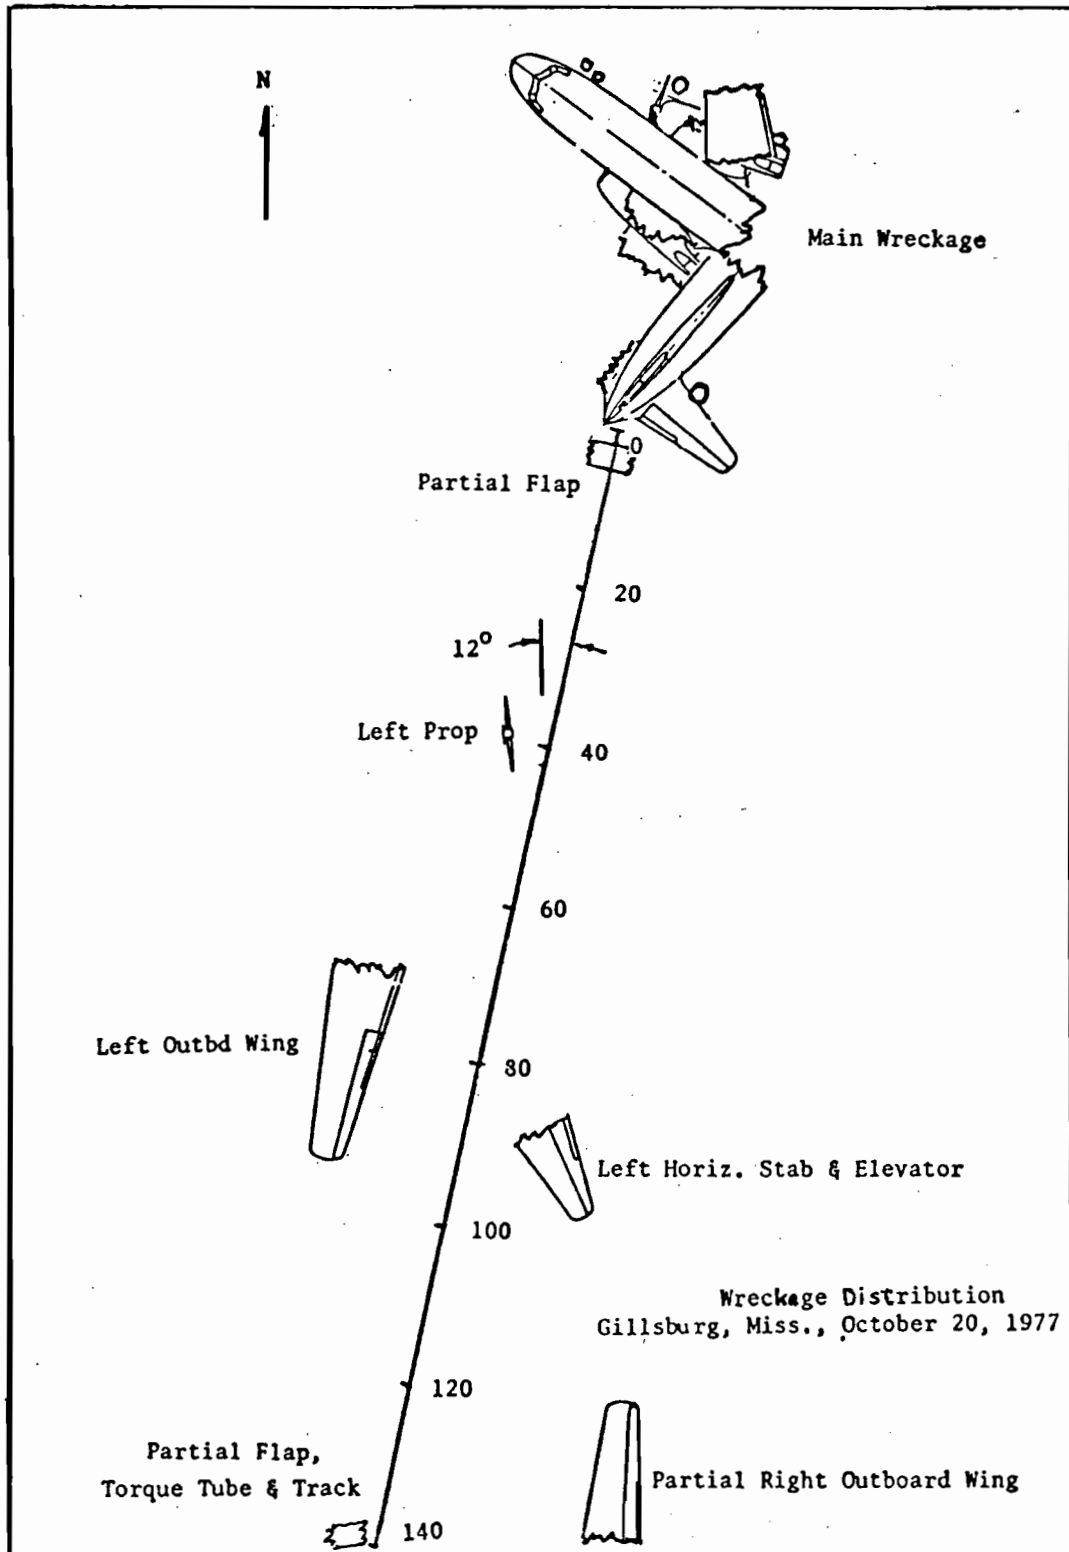
APPENDIX D

after the aircraft hit the second tree and continued the steeper angle until it hit the ground. The wreckage path was about 495 ft long. Trees as high as 80 ft and as large as 3 ft in diameter were struck during the final 300 ft of flight. The left horizontal stabilizer and the outboard section of both wings were torn from the aircraft and found 100 ft from the main wreckage along the wreckage path. The right outboard wing panel separated from the aircraft after initial contact with trees. The left horizontal stabilizer and the left outboard wing panel also struck trees and separated along the wreckage path. The wreckage distribution was on a magnetic heading of 012°. The fuselage continued forward on that heading and came to rest about 140 ft from the point of initial impact. The fuselage separated forward of the bottom leading edge of the vertical stabilizer. The center wing and engine nacelles were twisted to the left of the forward fuselage. The cockpit structure was crushed against trees. Cabin seats separated during the impact sequence. (See Appendix D.)

The crash rescue personnel had displaced the wreckage in order to rescue injured passengers and to recover bodies. The fuselage was fractured aft of the trailing edge of the wings and forward of the leading edge of the wings. The fractured portions of the fuselage were completely displaced and pointed in different directions. The cockpit and center portion of the aircraft was upright and essentially level.
