Aircraft Accident Report - L and J  
Company, Convair 240, N55VM,  
Gillsburg, Mississippi, October 20, 1977

1. Report No. NTSB-AAR-78-6	2. Government Accession No.	3. Recipient's Catalog No.	
4. Title and Subtitle Aircraft Accident Report -- L & J Company, Convair 240, N55VM, Gillsburg, Mississippi, October 20, 1977		5. Report Date June 19, 1978	
		6. Performing organization Code	
7. Author(s)		8. Performing Organization Report No.	
9. Performing Organization Name and Address National Transportation Safety Board Bureau of Accident Investigation Washington, D.C. 20594		10. Work Unit No. 2365	
		11. Contract or Grant No.	
12. Sponsoring Agency Name and Address  NATIONAL TRANSPORTATION SAFETY BOARD Washington, D. C. 20594		13. Type of Report and Period Covered Aircraft Accident Report October 20, 1977	
		14. Sponsoring Agency Code	
15. Supplementary Notes

L & J COMPANY  
CONVAIR 240, N55VM  
GILLSBURG, MISSISSIPPI  
OCTOBER 20, 1977

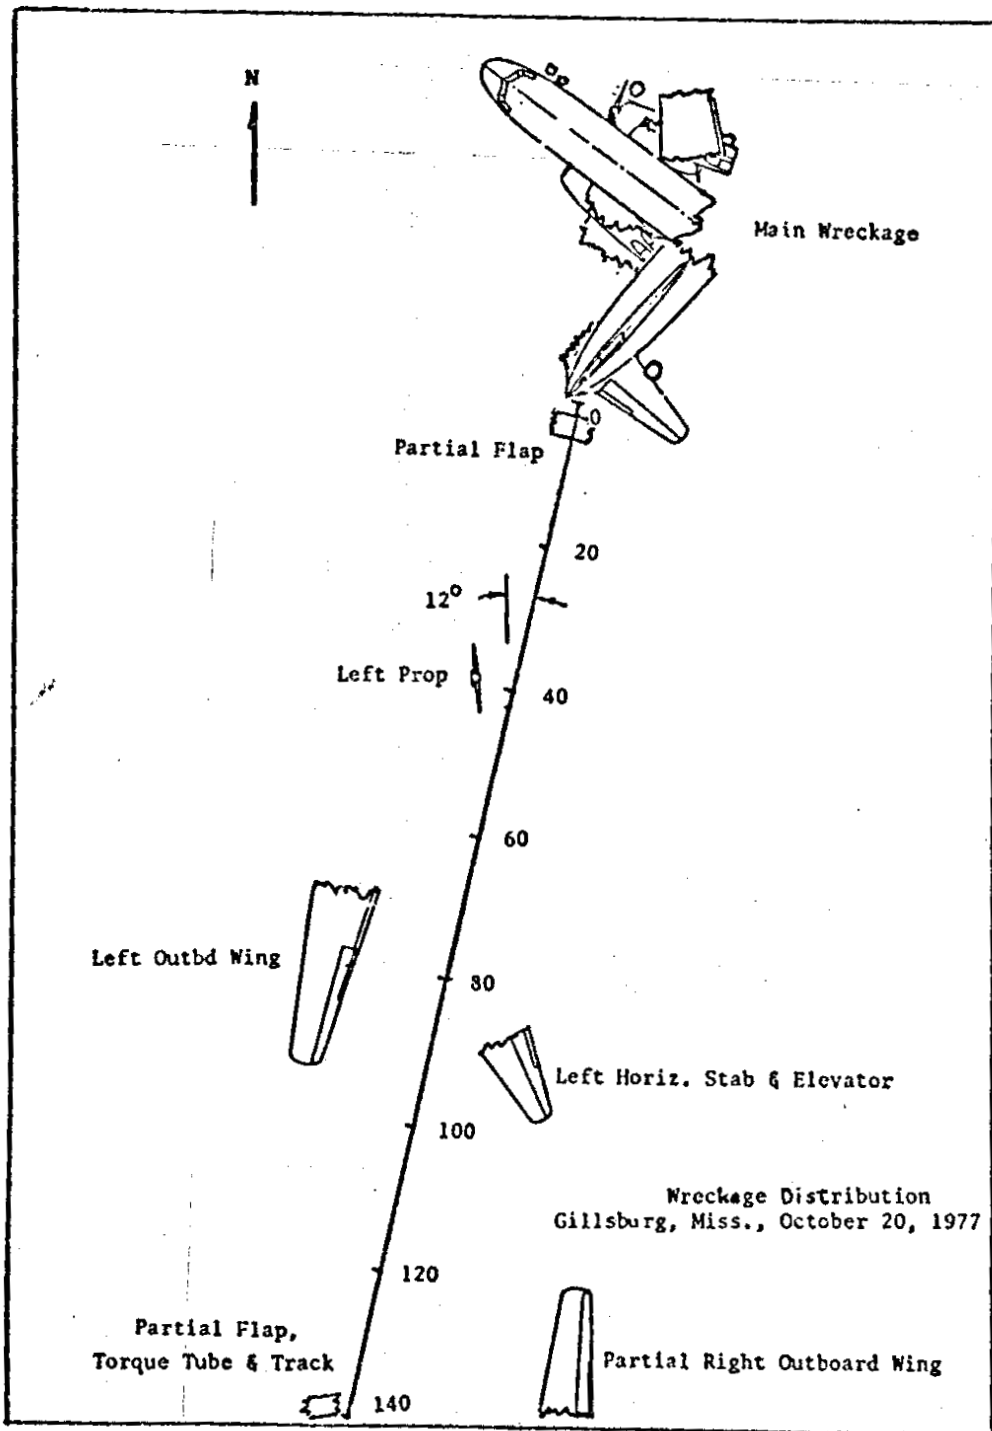
APPENDIX D

after the aircraft hit the second tree and continued the steeper angle until it hit the ground. The wreckage path was about 495 ft long. Trees as high as 80 ft and as large as 3 ft in diameter were struck during the final 300 ft of flight. The left horizontal Stabilizer and the outboard section of both wings were torn from the aircraft and found 100 ft from the main wreckage along the wreckage path. The right outboard wing pane' separated from the aircraft after initial contact with trees. The left horizontal stabilizer and the left outboard wing panel also struck trees and separated along the wreckage path. The wreckage distribution was on a magnetic heading of 012'. The fuselage continued forward on that heading and came to rest about 140 ft from the point of initial impact. The fuselage separated forward of the bottom leading edge of the vertical stabilizer. The center wing and engine nacelles were twisted to the left of the forward fuselage. The cockpit structure was crushed against trees. Cabin seats separated during the impact sequence. (Pee. Appendix D.)
