AIRCRAFT ACCIDENT REPORT

UNITED AIRLINES, INC.
McDONNELL-DOUGLAS, DC-8-61,
N8082U

PORTLAND, OREGON
DECEMBER 28, 1978

NTSB-AAR-79-7

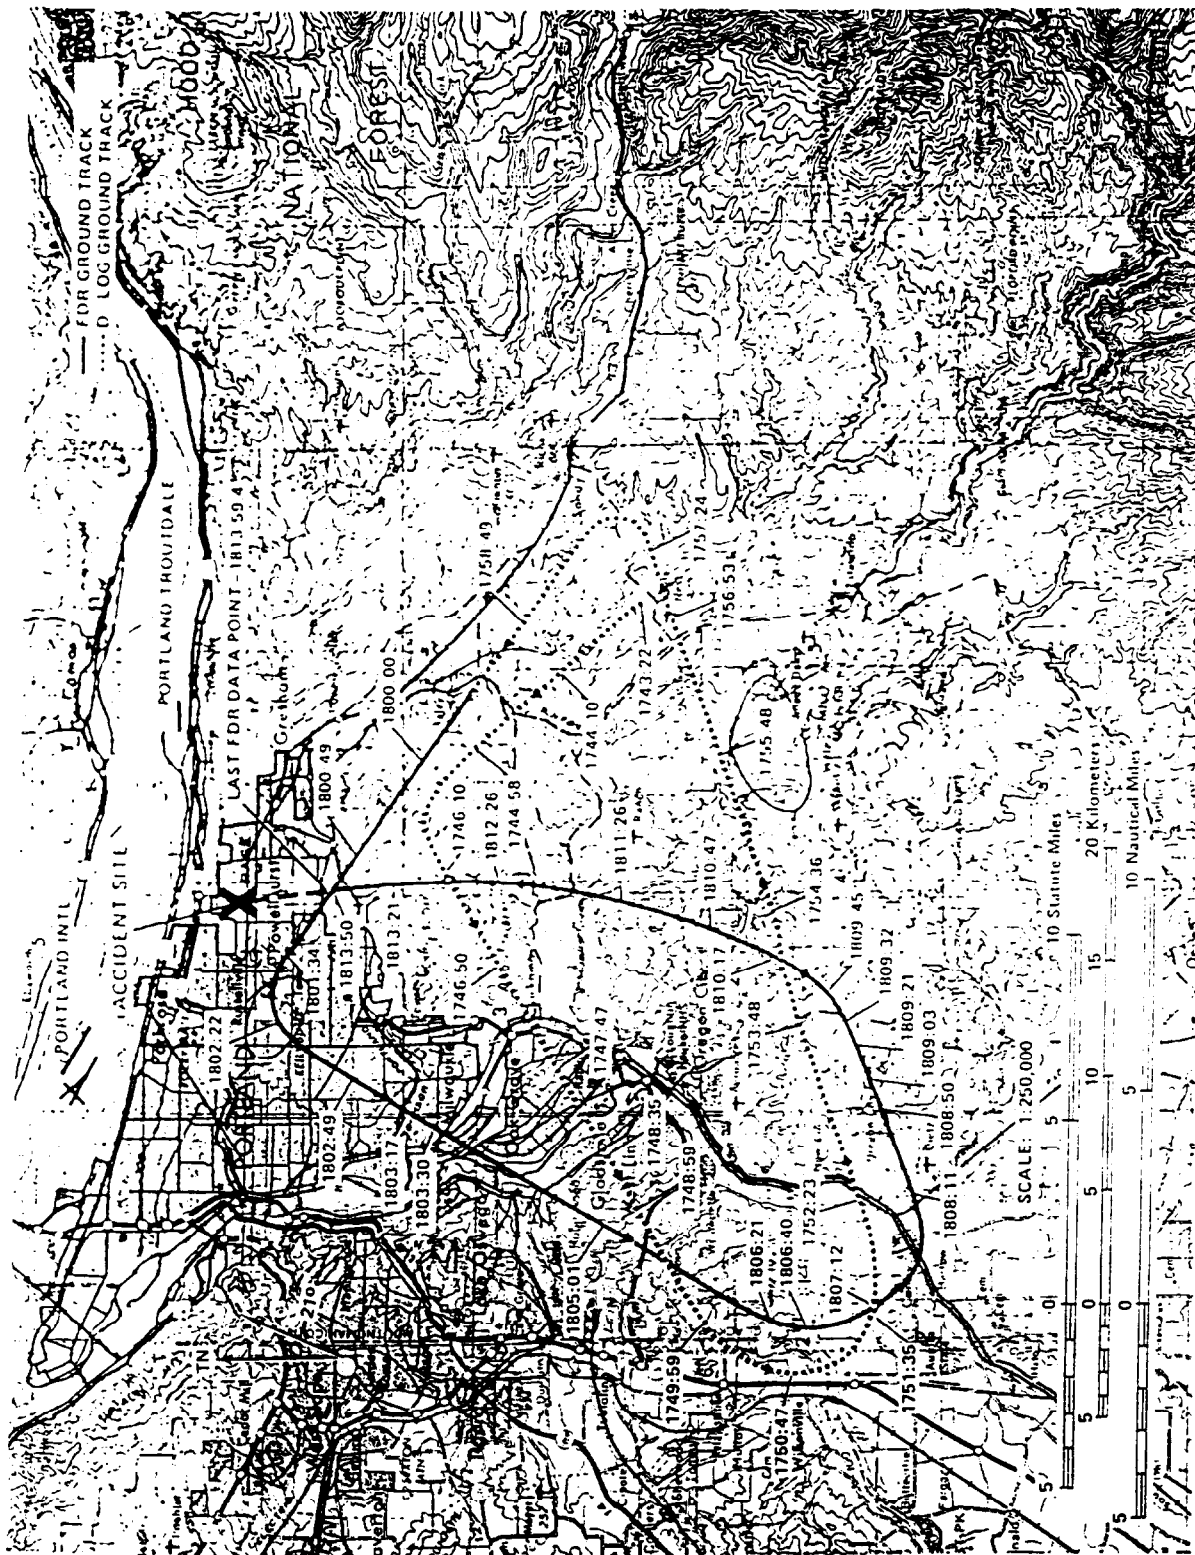
Figure 1 Flight track of 38082U

* About 1750:20, the captain asked the flight engineer to "Give us a current card on **weight**. Figure about another **fifteen** minutes." The first officer responded, "Fifteen minutes?" To which the captain replied, "Yeah, give us three or four thousand pounds on top of zero fuel weight." The flight engineer then said, "Not enough. Fifteen minutes is **gonna**—really run us low on fuel here." At 1750:47, the flight engineer gave the following information for the landing data card: "...Okay. Take three thousands pounds, two hundred and four." At this time the aircraft was **about 18** nmi south of the airport in a turn to the **northeast**.

* At 1751:35, the captain instructed the flight engineer to contact the company representative at Portland and apprise him of **the** situation and tell him that Flight 173 would land with **about** 4,000 lbs of fuel. From
