# NATIONAL TRANSPORTATION SAFETY BOARD

## AROCRAFT ACCIDENT REPORT

AMERICAN AIRLINES, INC.,  
DC-10-10, N110AA  
CHICAGO-O'HARE INTERNATIONAL AIRPORT  
CHICAGO, ILLINOIS  
MAY 25, 1979

NTSB-AAR-79-17

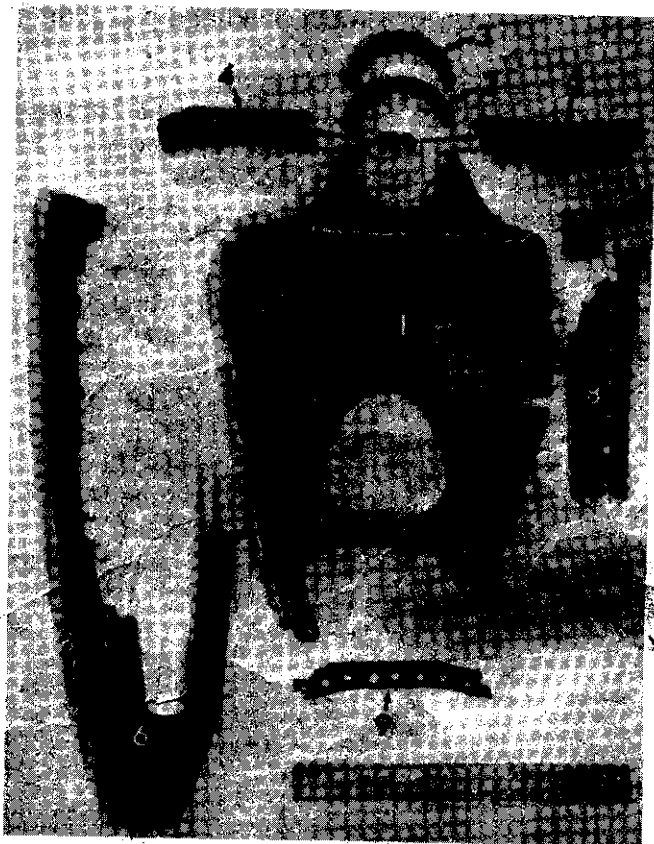
N110AA's pylon aft bulkhead was examined at the Safety Board's metallurgical laboratory. The examination disclosed a fracture of the upper forward flange. (See figure 4.) The larger part of this fracture was just forward of the radius between the flange and forward bulkhead plane and was about 10 inches long in the inboard-outboard direction. (See figure 5.) The fracture characteristics were typical of an overload separation. Chevron and tear marks on the fracture indicated that the rupture progressed downward at the center of the flange, then in inboard and outboard directions on the flange. The bottom portion of the fracture exhibited smearing consistent with the compression portion of a bending fracture. The smear was more prevalent—about 6 inches long—in the thinner center portion of the upper flange structure, but became less prevalent at the outer ends of the fracture. The 10-inch-long fracture resulted from overstress. The overstress was initiated by the application of a downward bending moment at the center section of the flange just forward of the fracture plane. The surface of the fracture appeared to be relatively free of oxidation and dirt.

Fatigue cracking was evident at both ends of the fracture. At the inboard end, the fatigue progressed inboard and aft; then, it progressed downward and inboard to the upper inboard fastener that attached the forward section of the bulkhead to the aft section. The fatigue progressed past the fastener a short distance before exhibiting rapid overstress characteristics in the downward direction as it proceeded along the inboard side of the side flange radius of the forward flange section. At the outboard end of the fracture, the fatigue propagated forward and slightly outboard toward the most forward outboard hole in the upper flange. The total length of the overstress fracture and fatigue cracks was about 13 inches. The remainder of the fractures on the bulkhead and within the pylon structure resulted from overload.

The examination also disclosed that three shims were installed on the upper surface of the forward upper flange. Two shims (Part No. AUB-7034-25) were installed, one on the inboard top shoulder of the upper flange and one on the outboard top shoulder. These shims are about 2 inches long, 1 inch wide, and .063 inch thick. A 10-inch-long, .050-inch-thick shim was installed during production to fill a gap between the upper flange and upper spar web. (See figure 6.) The manufacturer's drawings specify that the AUB-7034-25 shim may be required along the side of the bulkhead; however, they do not indicate that shims may be required on the upper surface of the flange. The fatigue propagation on the inboard and outboard ends of the overstress fracture began in the area underneath the .063-inch-thick shims.

Figure 4. Overall view of the wing pylon aft bulkhead installation portions. Pieces are numbered for identification purposes and placed in relative locations as if intact.

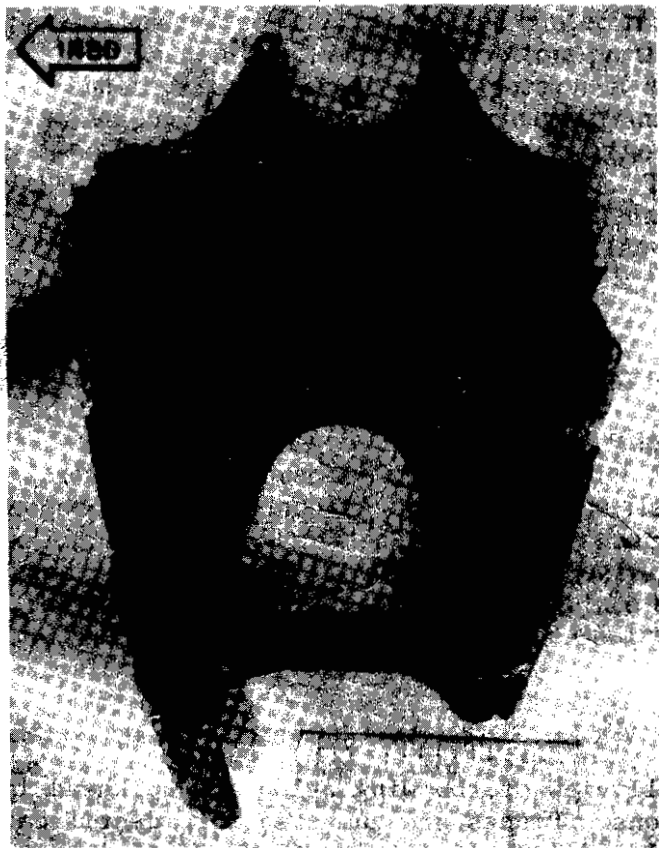
The aft fracture surface of the upper flange contained a crescent-shaped deformation which matched the shape of the lower end of the wing clevis. This deformation was in line with the vertical centerline of the aft bulkhead attachment hole as indicated by arrow "d" in figure 7. A deformation was noted in the lower surface of the aft wing support fitting's forward clevis lug in the area indicated by the brackets in figure 9. A small shallow gouge was apparent in the area of the arrow in figure 10. This gouge was in a position which would conform to a fastener location on the top flange assembly of the aft bulkhead.

Figure 5. View of the aft bulkhead piece indicated as Item 1 in Figure 4.

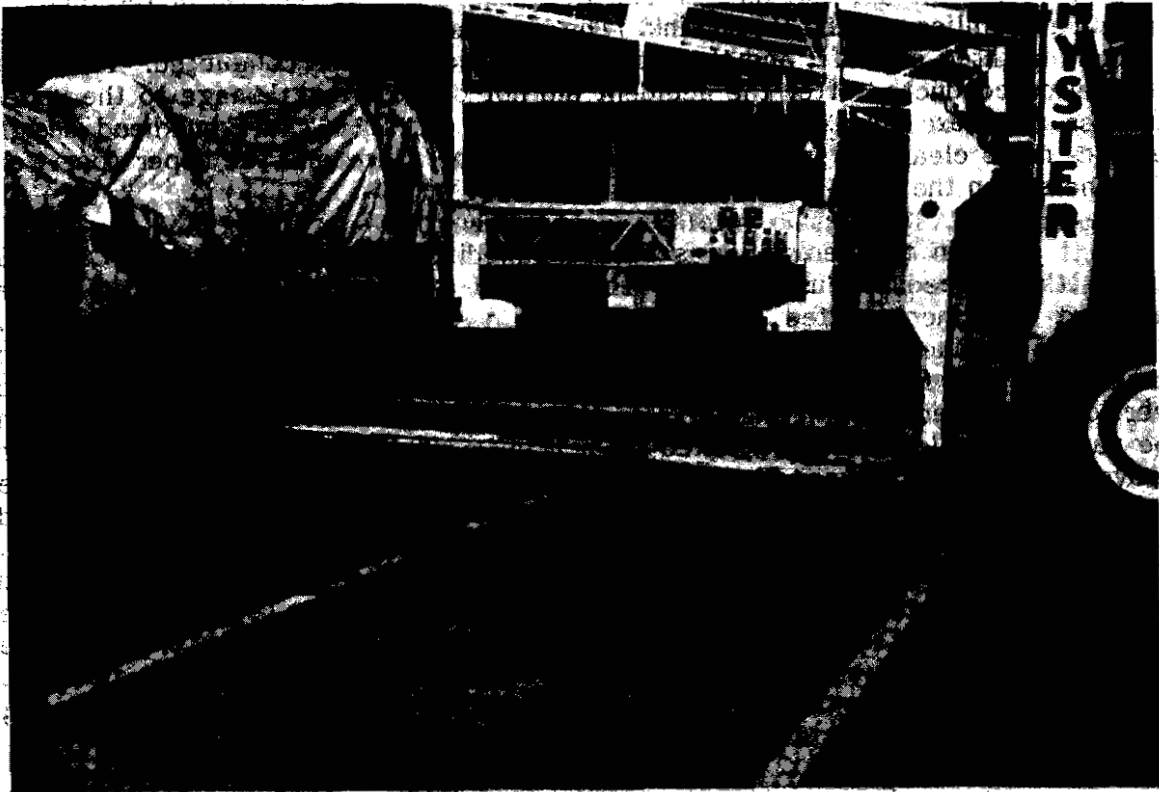
Figure 13. View of forklift and engine stand.

'American Airlines' maintenance personnel testified about their experiences with the forklift while handling the engine and pylon assembly. Directions were transmitted to the lift operator either by voice, hand signals, or both. The testimony varied regarding the capability to raise or lower the lifting forks a finite distance. One mechanic said it could be limited to .001 inch; the estimates of others ranged from .25 to .06 inch.

When the full weight of the engine and pylon assembly was on the lifting forks, the pressure gauge reading was 18,000 lbs. Maintenance personnel stated that a 2,000-lb to 3,000-lb pressure bleedoff on the pressure gauge was common; however, they all stated that the lifting forks did not move. Supervisory personnel stated that it was normal for the gauge reading to Meed off 2,000 to 3,000 lbs during a 15-min period without any perceptible load movement. The load remains fixed because of the frictional load on the mast and rollers. Although mechanics testified that the load did not move, they also said that they would manipulate the controls to restore the original reading on the pressure gauge. One mechanic stated that the pylon and engine assembly would "jump" as lowering began. He said the "jerking" motion moved the forks about 1 or 2 inches.

From March 29 through 31, 1979, the accident aircraft underwent the spherical bearing modification. On April 19, 1979, the forklift's maintenance log contained a writeup which noted, in part, "trouble shooting, forks creeping down under load." There was no record that any corrective action was taken. On May 17, 1979, the log showed "Inspect lift cylinder base per Engineering." There was no record of any findings. On June 20, 1979, the forklift was tested for drift down. An engine-pylon assembly was placed on the lifting forks, and the forks drifted down 1 inch in 30 min. A lift cylinder check valve was found to be defective and was replaced.
