NATIONAL TRANSPORTATION SAFETY BOARD

AIRCRAFT ACCIDENT REPORT

**AMERICAN AIRLINES, INC.,
DC-10-10, N110AA
CHICAGO-O'HARE INTERNATIONAL AIRPORT
CHICAGO, ILLINOIS
MAY 25, 1979**

NTSB-AAR-79-17

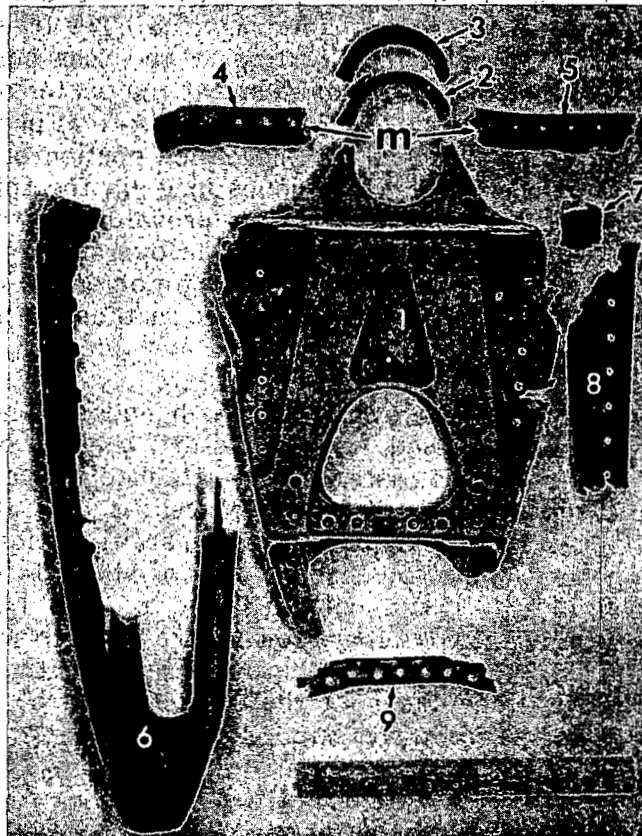
N110AA's pylon aft bulkhead was examined at the Safety Board's metallurgical laboratory. The examination disclosed a fracture of the upper forward flange. (See figure 4.) The larger part of this fracture was just forward of the radius between the flange and forward bulkhead plane and was about 10 inches long in the inboard-outboard direction. (See figure 5.) The fracture characteristics were typical of an overload separation. Chevron and tear marks on the fracture indicated that the rupture progressed downward at the center of the flange, then in inboard and outboard directions on the flange. The bottom portion of the fracture exhibited smearing consistent with the compression portion of a bending fracture. The smear was more prevalent—about 6 inches long—in the thinner center portion of the upper flange structure, but became less prevalent at the outer ends of the fracture. The 10-inch-long fracture resulted from overstress. The overstress was initiated by the application of a downward bending moment at the center section of the flange just forward of the fracture plane. The surface of the fracture appeared to be relatively free of oxidation and dirt.

Fatigue cracking was evident at both ends of the fracture. At the inboard end, the fatigue progressed inboard and aft; then, it progressed downward and inboard to the upper inboard fastener that attached the forward section of the bulkhead to the aft section. The fatigue progressed past the fastener a short distance before exhibiting rapid overstress characteristics in the downward direction as it proceeded along the inboard side of the side flange radius of the forward flange section. At the outboard end of the fracture, the fatigue propagated forward and slightly outboard toward the most forward outboard hole in the upper flange. The total length of the overstress fracture and fatigue cracks was about 13 inches. The remainder of the fractures on the bulkhead and within the pylon structure resulted from overload.

The examination also disclosed that three shims were installed on the upper surface of the forward upper flange. Two shims (Part No. AUB-7034-25) were installed, one on the inboard top shoulder of the upper flange and one on the outboard top shoulder. These shims are about 2 inches long, 1 inch wide, and .063 inch thick. A 10-inch-long, .050-inch-thick shim was installed during production to fill a gap between the upper flange and upper spar web. (See figure 6.) The manufacturer's drawings specify that the AUB-7034-25 shim may be required along the side of the bulkhead; however, they do not indicate that shims may be required on the upper surface of the flange. The fatigue propagation on the inboard and outboard ends of the overstress fracture began in the area underneath the .063-inch-thick shims.

Figure 4. Overall view of the wing pylon aft bulkhead installation portions. Pieces are numbered for identification purposes and placed in relative locations as if intact.

- Item 1. Aft bulkhead center section piece view looking aft.
- Items 2 & 3. Upper lug ears.
- Items 4 & 5. Two pieces of the forward portion of the upper flange. Those pieces mated together along the fracture indicated by arrows "m."
- Item 6. Side flanges and lower portion of the aft bulkhead.
- Item 7. Piece of the flange at the upper outboard corner.
- Item 8. Portion of the outboard side flange.
- Item 9. Piece of the intermediate flange.

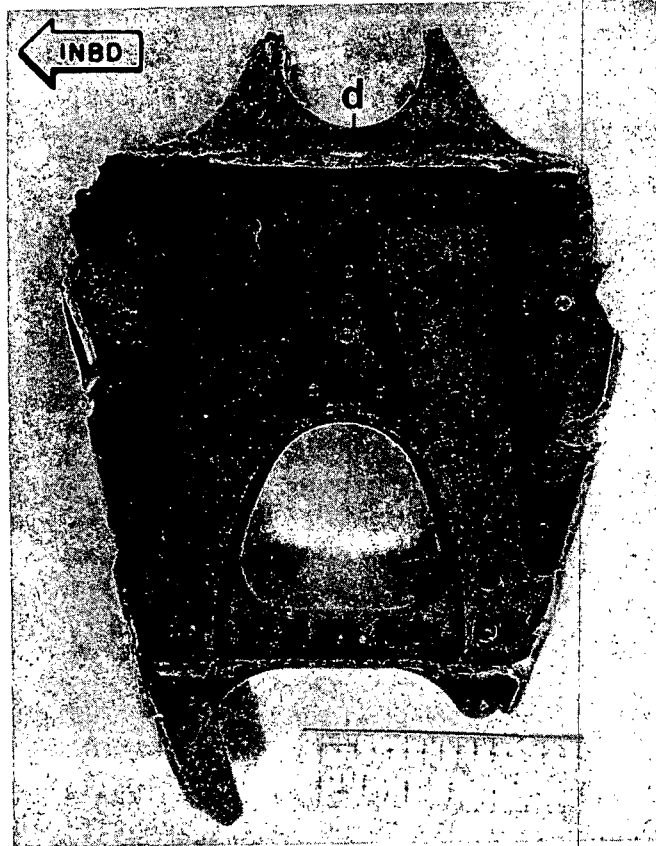
Figure 5. View of the aft bulkhead piece indicated as Item 1 in Figure 4.

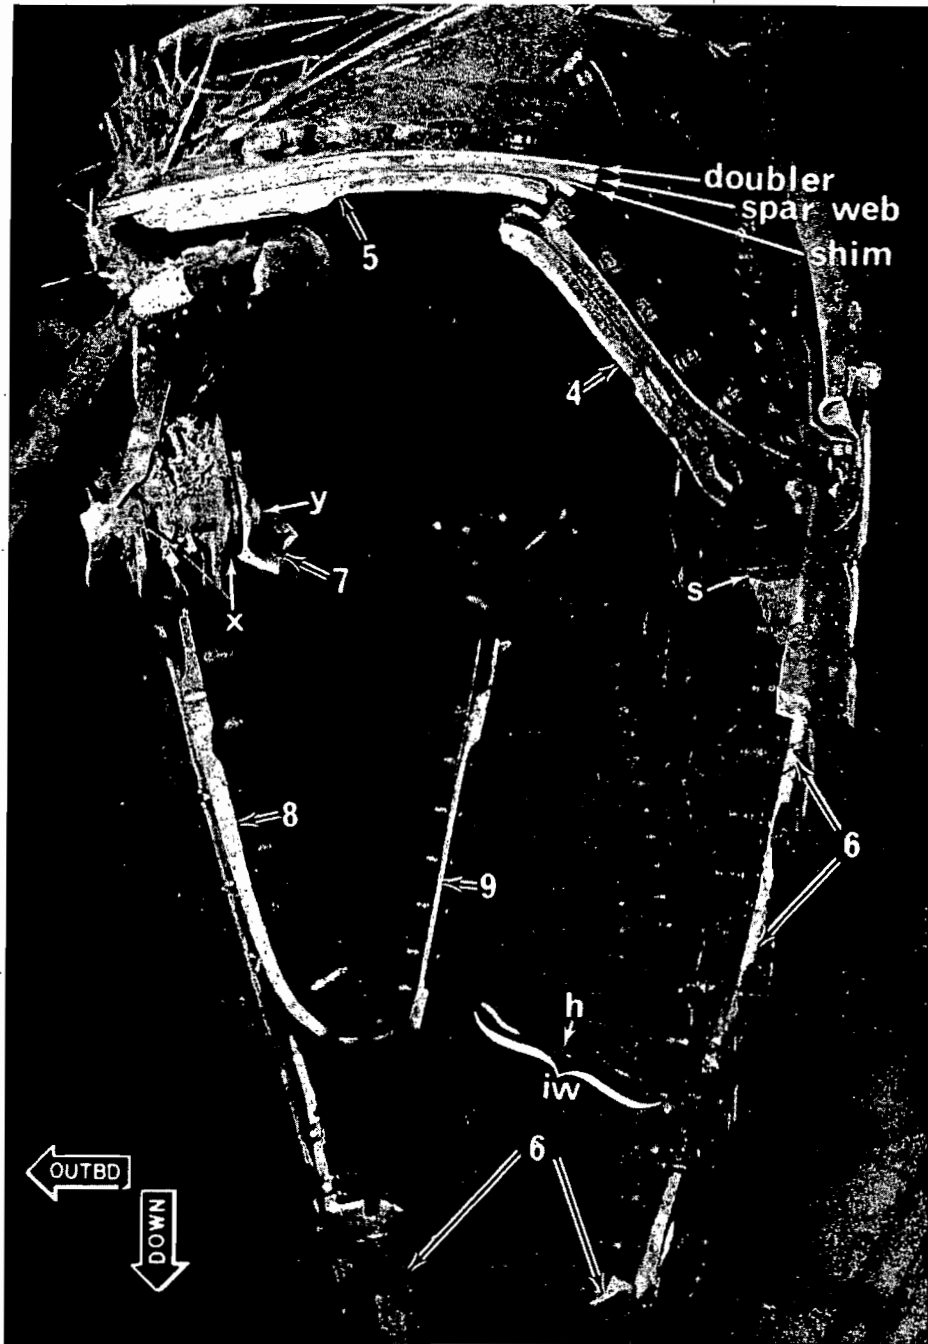
Figure 6. View looking forward and slightly down on the No. 1 pylon before disassembly of the flange pieces indicated as items 4 through 9 in Figure 4. Arrow "x" shows the shim on the outboard side between the angle and the top surface of the upper flange piece No. 7 held in place by the fastener arrowed "y". Arrow "s" shows the location for the shim on the inboard side between the angle and upper surface of the upper bulkhead flange.

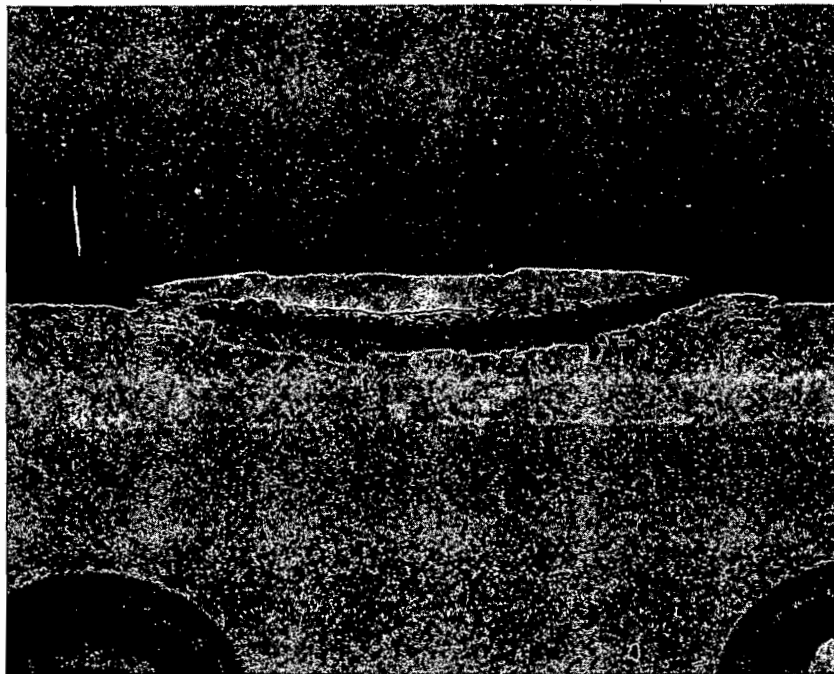
Figure 8. Detail of deformation denoted by arrows "d" in Figure 5 and 7.

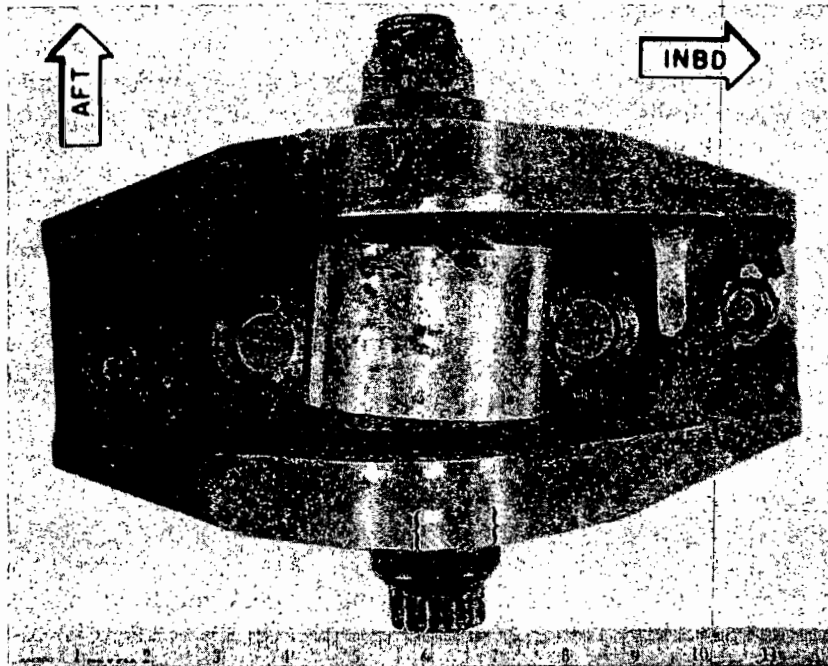
Figure 9. Overall view looking up on the wing mounted aft support fitting with spherical bearing attached.

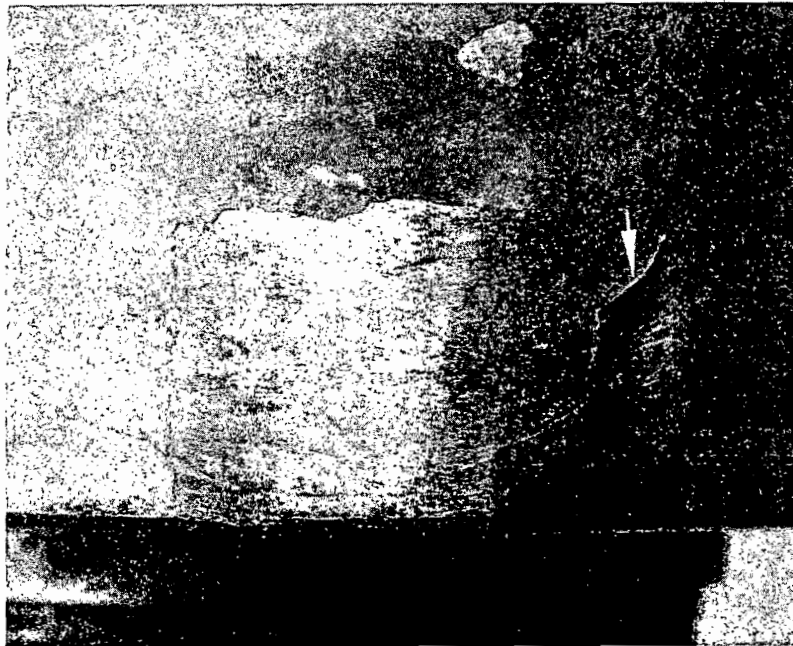
Figure 10. Close up view of damage in the area between the brackets of Figure 9.

The gouge appeared to be produced by a fastener head, hitting the clevis with a sliding movement. The upper flange aft fracture surface and radius appeared to have been deformed by the wing clevis' striking these surfaces in the downward direction.

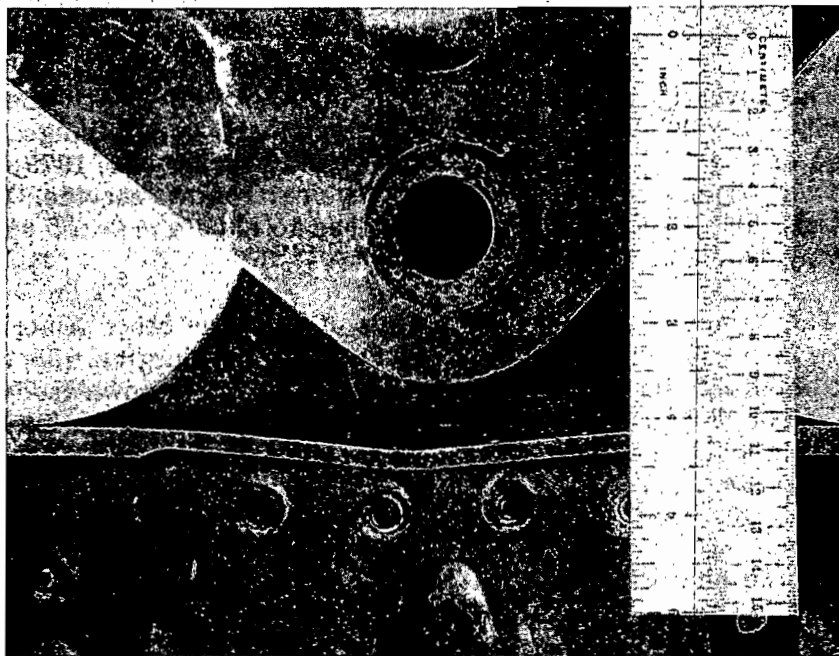
Figure 11. Wing pylon aft bulkhead from N119AA assembled to wing mounted aft support fitting of N110AA showing normal position of wing fitting clevis with respect to the upper forward flange of the aft bulkhead.

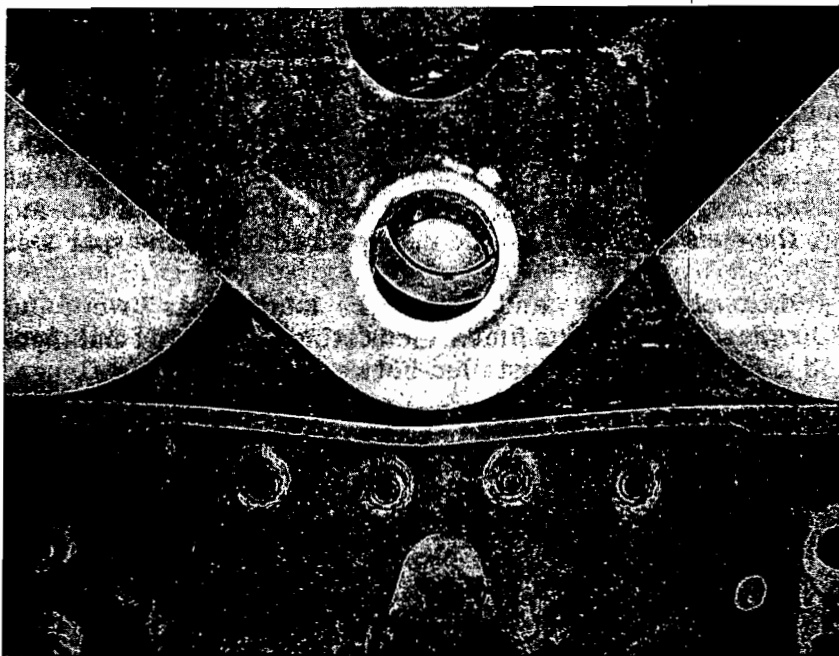
Figure 12. Same as Figure 11 except the attachment bushing was removed and the aft bulkhead was moved up against the far inside portion of the wing fitting. Note the location of the bottom portion of the wing fitting clevis with respect to the fracture on the bulkhead.

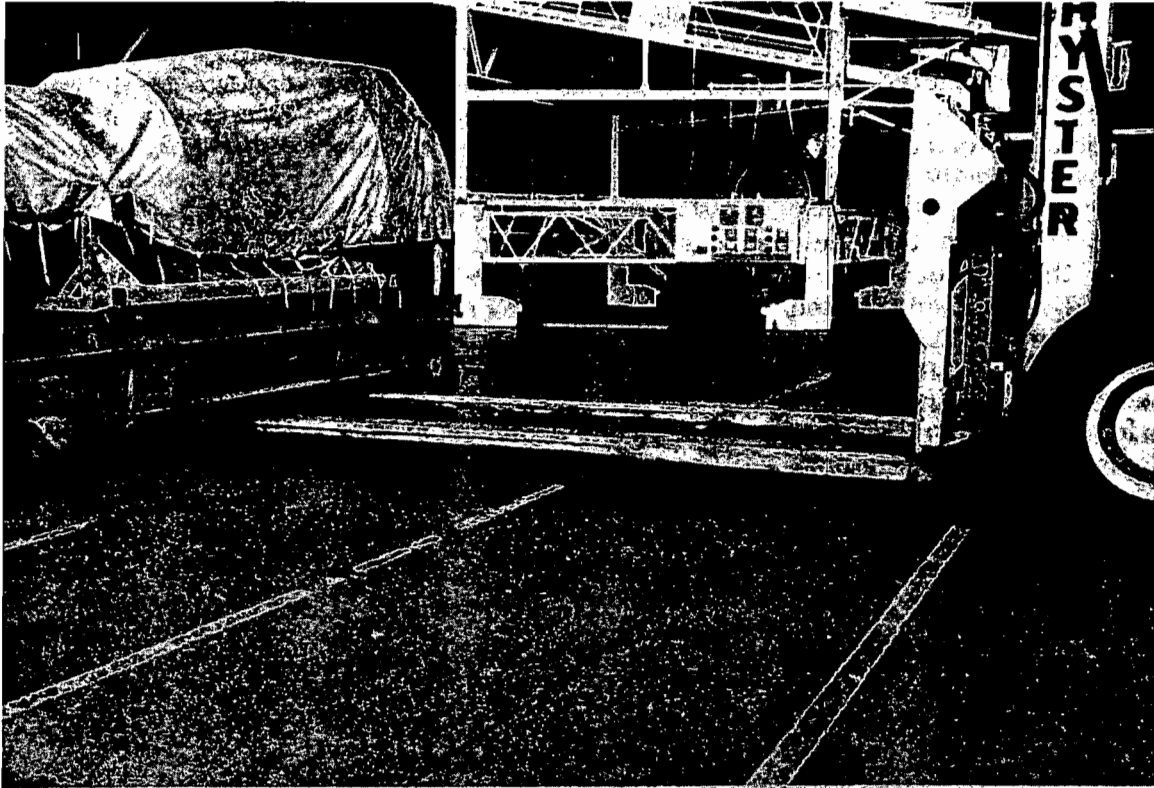
Figure 13. View of forklift and engine stand.

American Airlines' maintenance personnel testified about their experiences with the forklift while handling the engine and pylon assembly. Directions were transmitted to the lift operator either by voice, hand signals, or both. The testimony varied regarding the capability to raise or lower the lifting forks a finite distance. One mechanic said it could be limited to .001 inch; the estimates of others ranged from .25 to .06 inch.

When the full weight of the engine and pylon assembly was on the lifting forks, the pressure gauge reading was 18,000 lbs. Maintenance personnel stated that a 2,000-lb to 3,000-lb pressure bleedoff on the pressure gauge was common; however, they all stated that the lifting forks did not move. Supervisory personnel stated that it was normal for the gauge reading to bleed off 2,000 to 3,000 lbs during a 15-min period without any perceptible load movement. The load remains fixed because of the frictional load on the mast and rollers. Although mechanics testified that the load did not move, they also said that they would manipulate the controls to restore the original reading on the pressure gauge. One mechanic stated that the pylon and engine assembly would "jump" as lowering began. He said the "jerking" motion moved the forks about 1 or 2 inches.

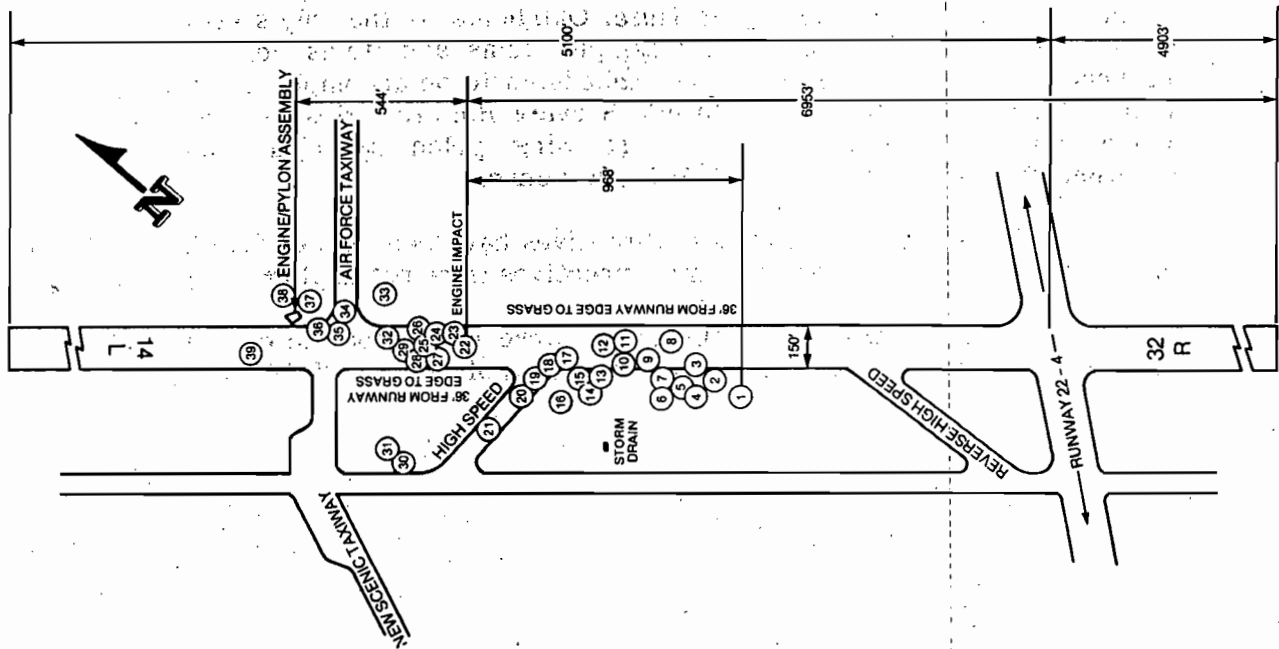
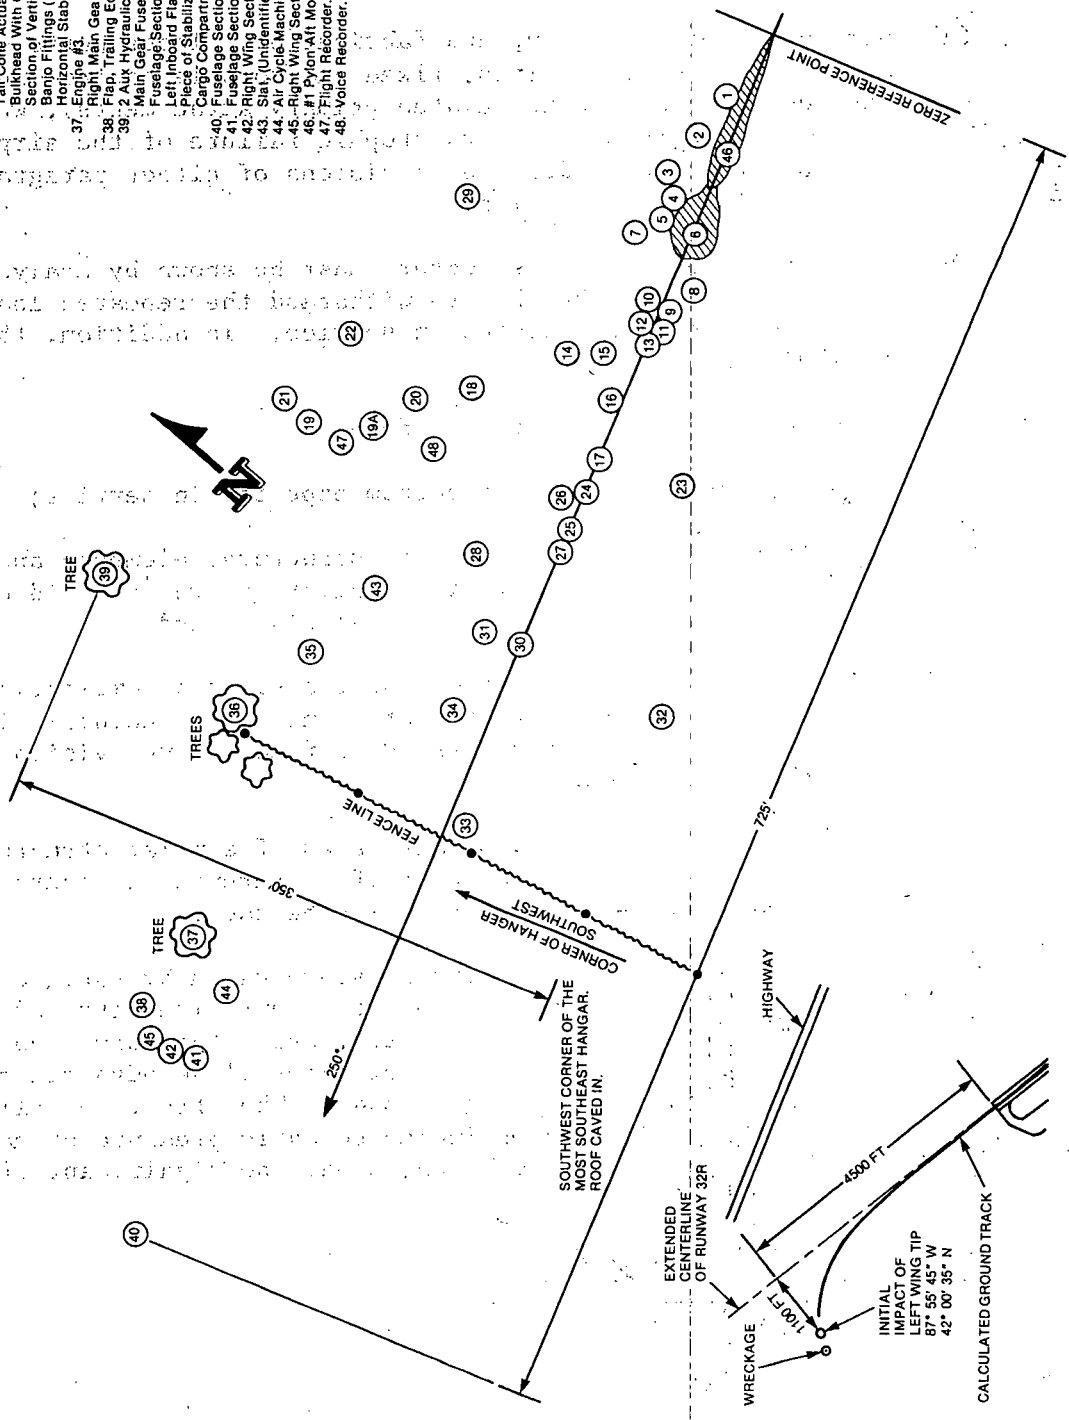
Wreckage Diagram
 American Airlines
 Flight No. 191
 Chicago O'Hare International Airport

- 1. Aileron Balance Panel—Burned and Separated.
- 2. Aileron Structure (Left)—Burned and Separated.
- 3. Wing Tip (Left)—Burned and Separated.
- 4. Thrust Line Wing Attach—Burned and Separated.

- 5. Aileron Outboard (Left)—Burned and Separated.
- 6. Slat Actuator (Left)—Partial Section, Burned.
- 7. Flap Inboard (Left)—Partial Section, Burned.
- 8. Slab Spar—Partial Section, Burned.

- 50. Fuselage Section With Cabin Door.
- 51. Right Wing Section, ARB-0941-2, Boost Pumps.
- 52. Slat, (Unidentified).
- 53. Air Cycle Machine.
- 54. Right Wing Section.

- 55. #1 Pylon Alt Monoball Mount.
- 56. Flight Recorder.
- 57. Voice Recorder.
