**Crash short, Downeast Airlines, Inc., DeHavilland DHC-6-200, N68DE,
Rockland, Maine, May 30, 1979**

Investigative Body: National Transportation Safety Board (NTSB), USA

**DOWNEAST AIRLINES, INC.
DeHAVILLAND DHC-6-200, N68DE
ROCKLAND, MAINE
MAY 30, 1979**

NTSB-AAR-80-5

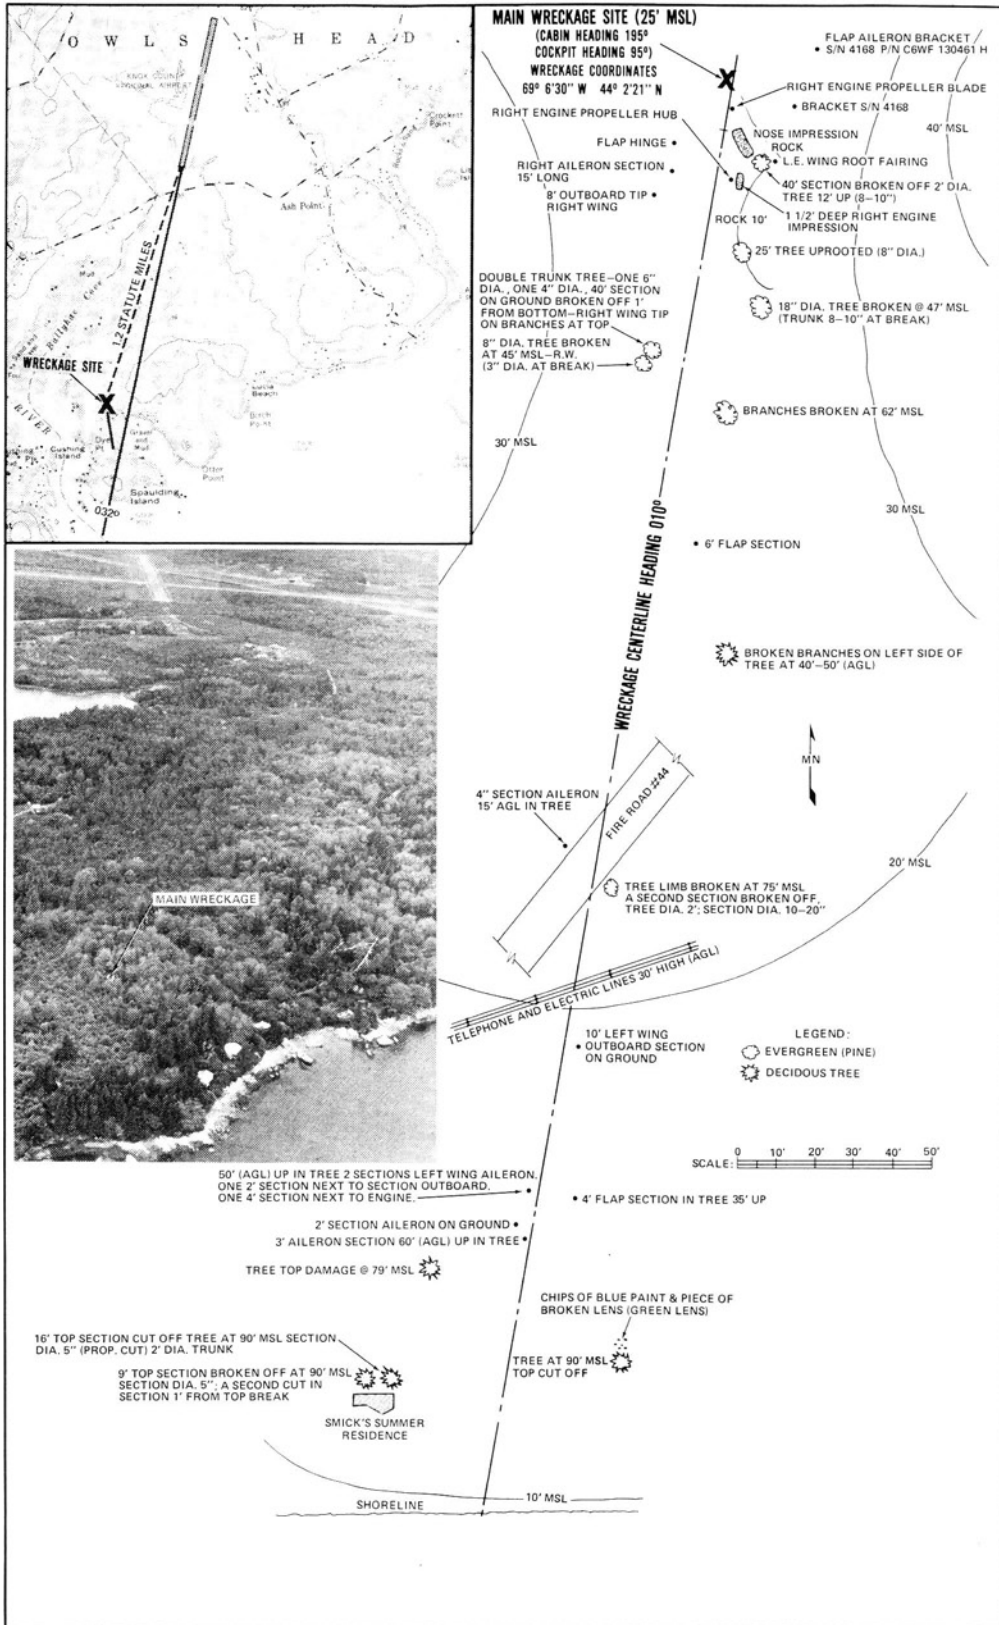
Figure 1.—Wreckage distribution.

The aircraft first struck two trees about 80 ft above the ground with its left wing. These trees were located about 35 ft inland from the shoreline at a ground elevation of 10 ft and about 340 ft from the point where the wreckage came to rest. About 4 ft farther along the flightpath, the aircraft's right wing struck a tree about 80 ft above the ground. The aircraft continued along a flightpath of about 010° striking several more trees, shedding numerous parts of its wing, ailerons, and flaps, and passing just above 30-ft-high telephone and electric lines located about 105 ft from the first trees. (See figure 1.)

The aircraft continued along a general heading of 010° striking several more trees, breaking some and uprooting others. Various wing and flap parts were torn from the aircraft. About 30 ft before the main wreckage area, large components of the aircraft were found to the left of the crash path including an 8-ft outboard section of the right wing and a 15-ft section of the right aileron. The right engine and the aircraft nose struck the ground about 22 ft and 17 ft, respectively, from where the main wreckage came to rest.

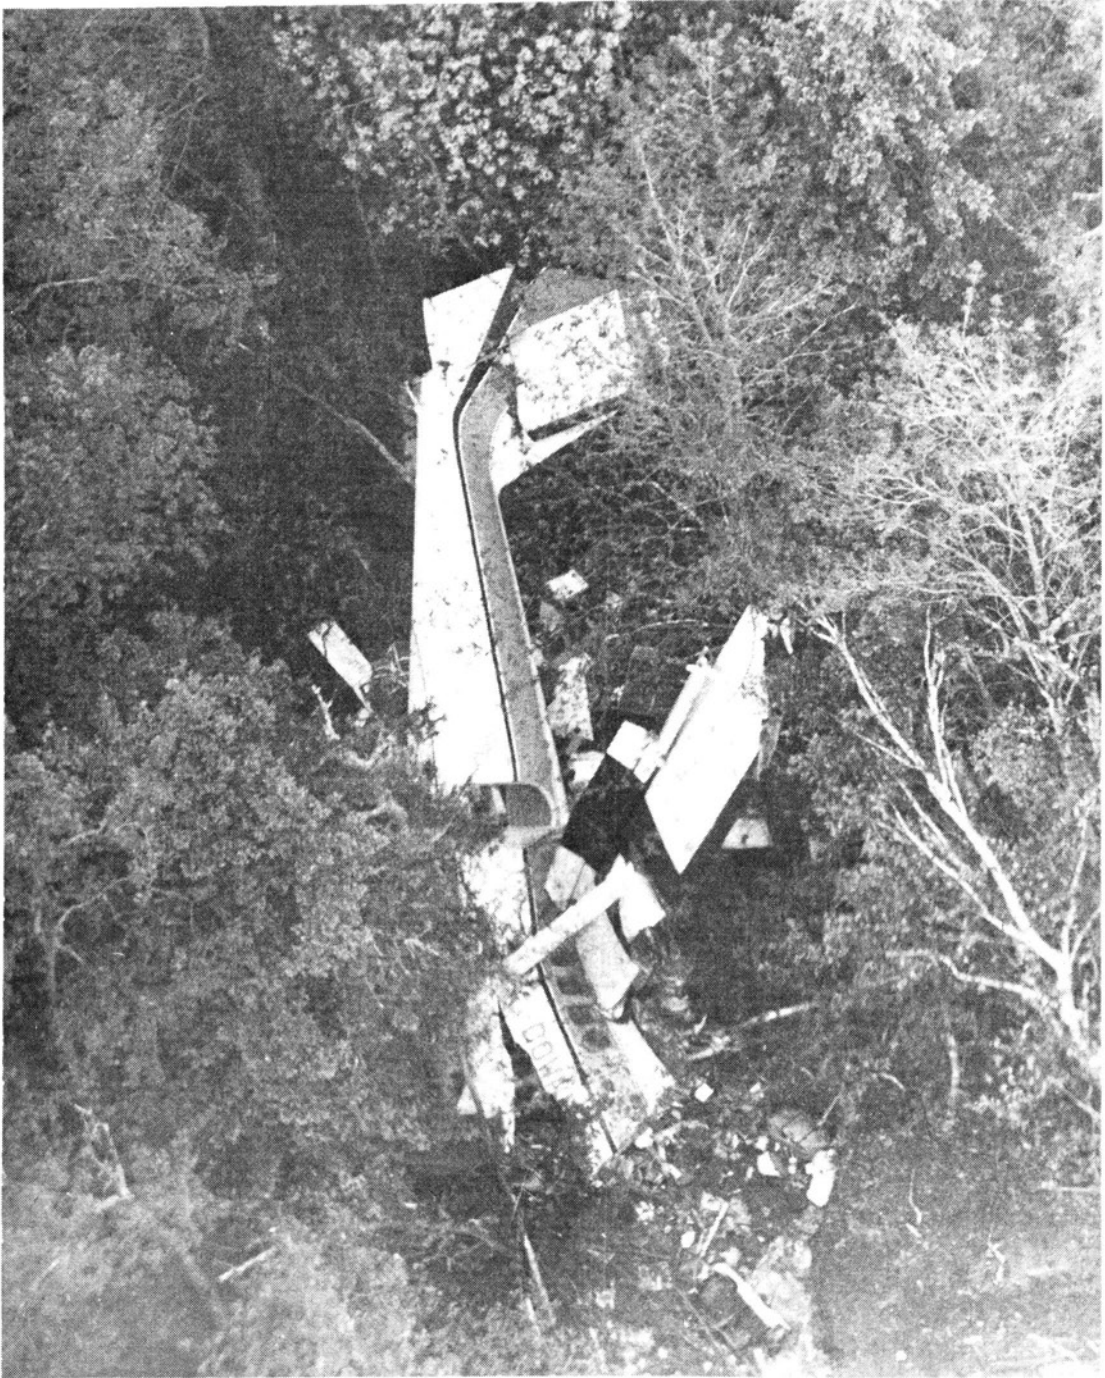
Figure 2.—Aerial view of accident aircraft.

The aircraft fuselage came to rest on its left side about 340 ft from the initial tree strikes in a near-vertical position supported by trees. (See figure 2.) The fuselage was oriented on a heading of about 195° with the empennage, still attached to the fuselage, canted in the direction of the airport. The crushed, twisted, and fragmented cockpit area was found in a near upright position next to the forward section of the fuselage and oriented on a heading of about 095°.

The right engine was hanging from the right wing by flex lines, electrical conduits, and engine control cables. Half of the engine cowling was separated from the engine. The right-engine propeller was attached to the engine but the propeller dome and one blade were separated from the propeller assembly.

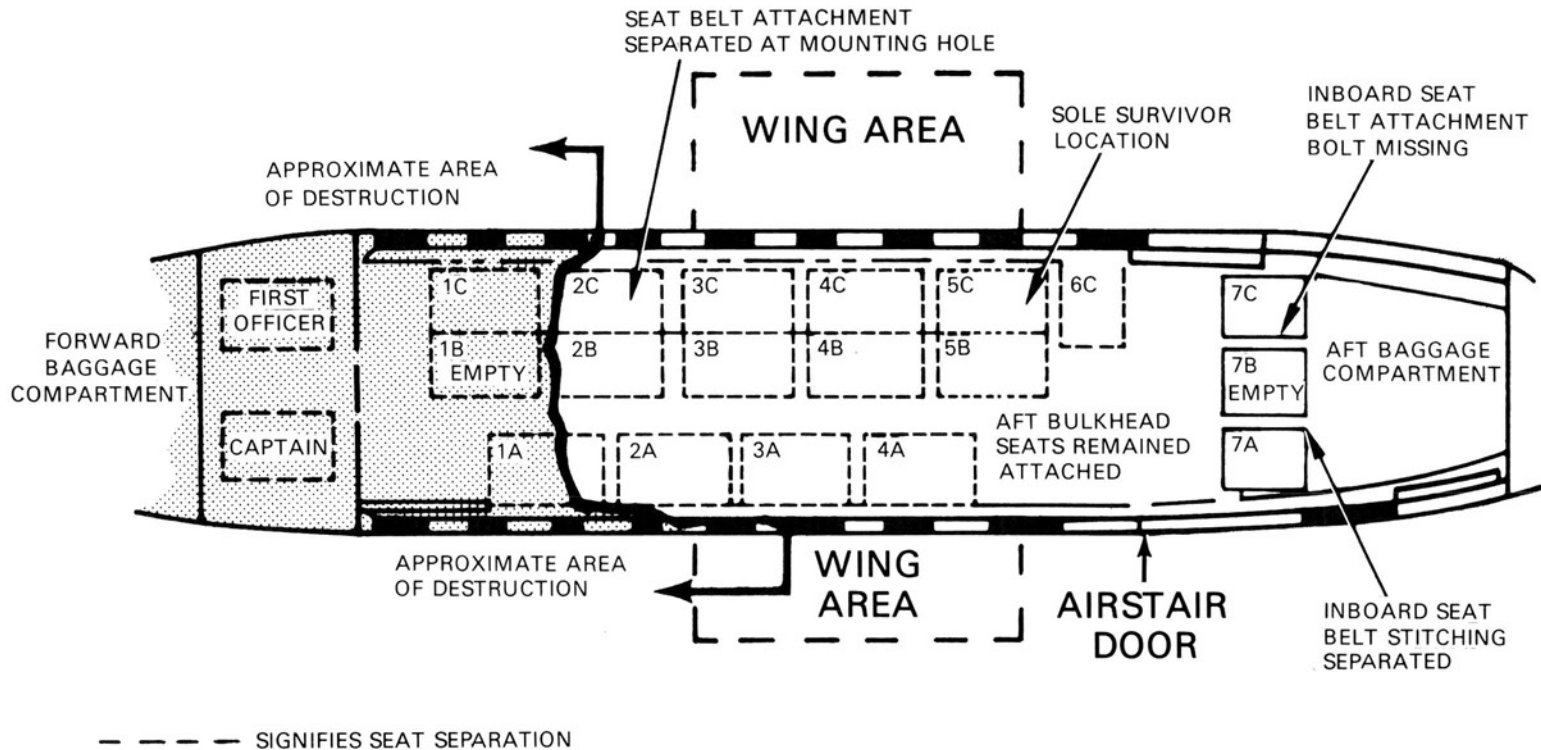
Figure 3.—Cockpit and cabin configuration.

The forward fuselage and flight deck were destroyed. Except for seat failures, there was relatively little damage to the cabin interior aft of the leading edge of the wings. The passenger cabin was 18 ft long; about 5 ft of the forward cabin was destroyed.

Seats in the destroyed area (rows 1 and 2) exhibited massive impact damage on their forward sides and had separated in the aft direction. Seat damage in rows 3 through 5 generally showed separation failures of the seat track tiedown fittings in the forward direction. Three of the four double-unit seats (located on the right side of the aircraft) also exhibited counterclockwise rotational damage. This damage is compatible with inboard lateral movement and the rotation of the seat pans after the primary impact had caused a separation of the anchor pins from the sidewall tracks. The only side-facing unit (6C) separated from its wall tiedown structure. The seats mounted on the aft bulkhead (row 7) were the only seats that did not fail. The bulkhead attachment fittings of these seats were undamaged. Large, fixed, metal ashtrays were attached to some of the seatbacks.

There were three seatbelt failures. The outboard metal belt-end attachment fitting of seat 2C fractured adjacent to its anchor bolt hole. No reason for this material failure could be found. The bolt had been attached to a seat which was located in an area of the forward fuselage which was destroyed.

The webbing, buckles, and attachment fittings of the seatbelt on seat 7C were intact. The bolt and nut securing the inboard belt attachment fitting on this seat were missing and not recovered. The mounting hole in both the seat structure and fitting of the seatbelt showed no evidence of elongation or damage. The 200-lb occupant in seat 7C would have generated forces beyond the required strength of the belt. The lack of damage to the mounting hole suggests the possibility that the nut or bolt or both were either defective, improperly installed, or were not installed. No data to conclusively support any of these possibilities were found.

Several undesirable seat design features were noted including: (1) the use of seat pan sidewall attachments, rather than conventional floor-mounted legs, which allowed the seat pans to separate and rotate freely when the sidewall was displaced because of impact forces; (2) the use of closely spaced seats with short, nonpivoting seatback frames of tubular construction which had a minimal amount of impact-absorbing material and increased the probability of head and chest injuries; and (3) the mounting of large, fixed ashtrays on the seatbacks which could produce penetrating head injuries.
