AIRCRAFT ACCIDENT REPORT

AIR NEW ENGLAND, INC.
DeNAVILLAND DMC-8-300, N383 EX
HYANNIS, MASSACHUSETTS
JUNE 17, 1979

1. Report No. NTSB-AAR-80-1		2. Government Accession No.		3. Recipient's Catalog No.	
4. Title and Subtitle Aircraft Accident Report - Air New England, Inc., deHavilland DHC-6-300, N383EX, Hyannis, Massachusetts, June 17, 1979				5. Report Date January 3, 1980

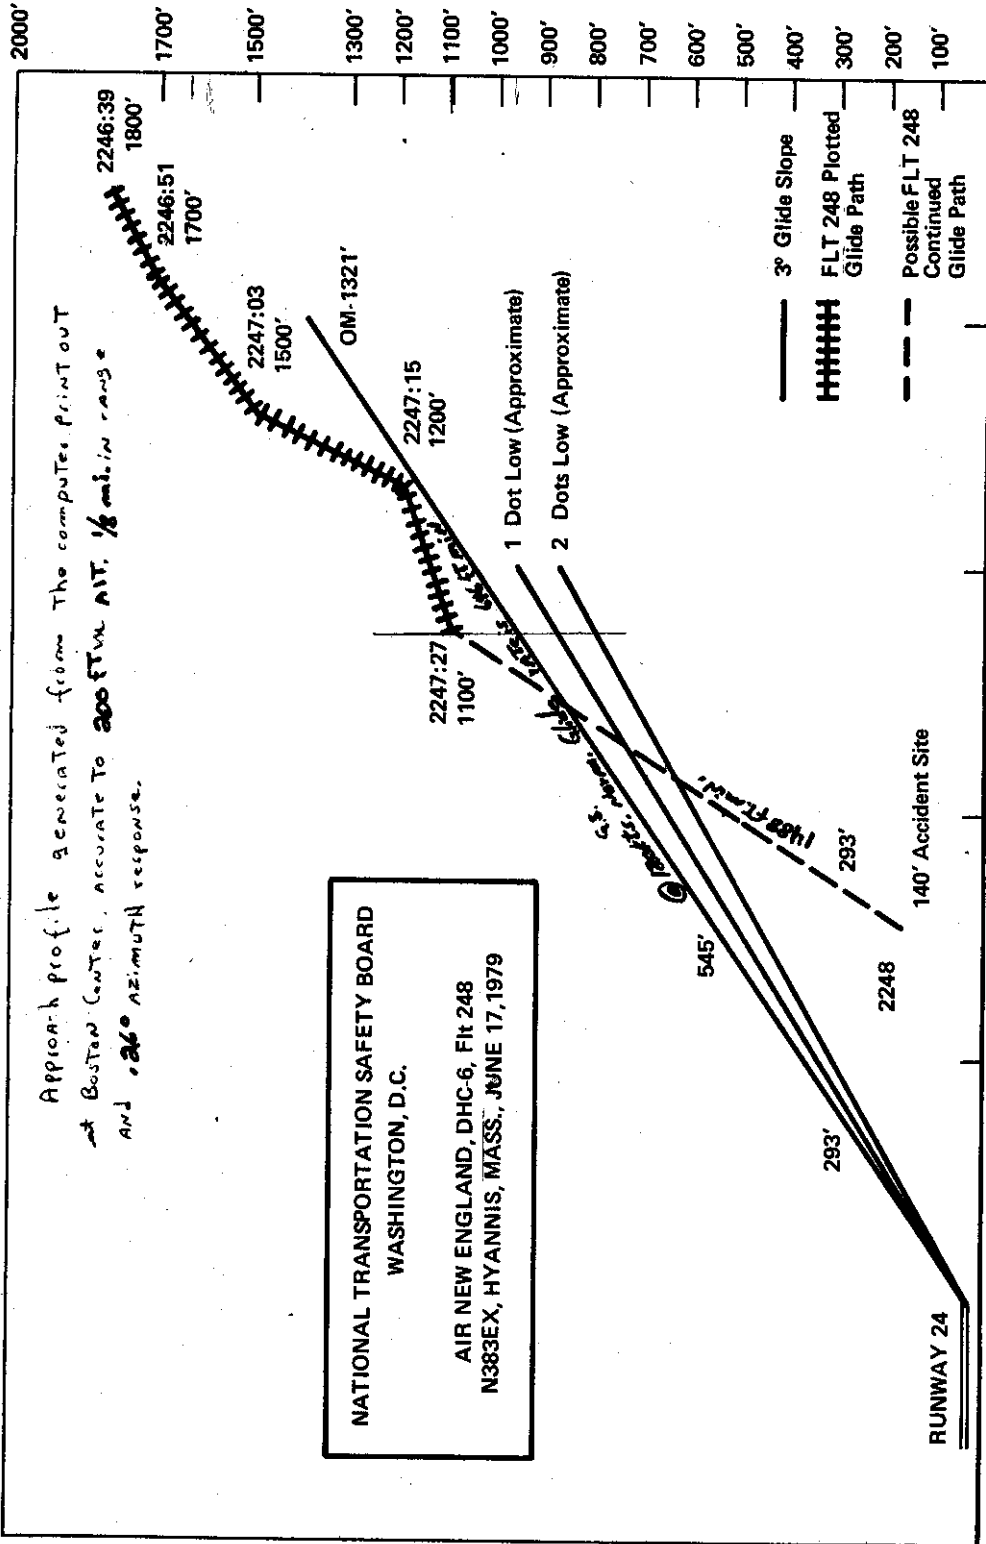
Figure 1.--Probable descent profile of N383EX determined from Boston Center data.

The Boston Air Route Traffic Control Center (Boston Center) was able to track Flight 248 to within 2.8 nmi of the intended touchdown point on runway 24. (See Figure 1.) Boston Center's computer printout showed the flight's position at 2246:51 about 0.35 nmi northeast of the ILS outer marker at 1,700 ft. It also showed the flight about 0.15 nmi southwest of the outer marker at 1,500 ft at 2247:03. The last radar position shown for the flight was about 1.1 nmi southwest of the outer marker at 2247:27 at 1,100 ft.
