**AIRCRAFT ACCIDENT REPORT**

**SCANDINAVIAN AIRLINES SYSTEM  
FLIGHT 901**

**MCDONNELL DOUGLAS DC-10-30**

**FEBRUARY 28, 1984**

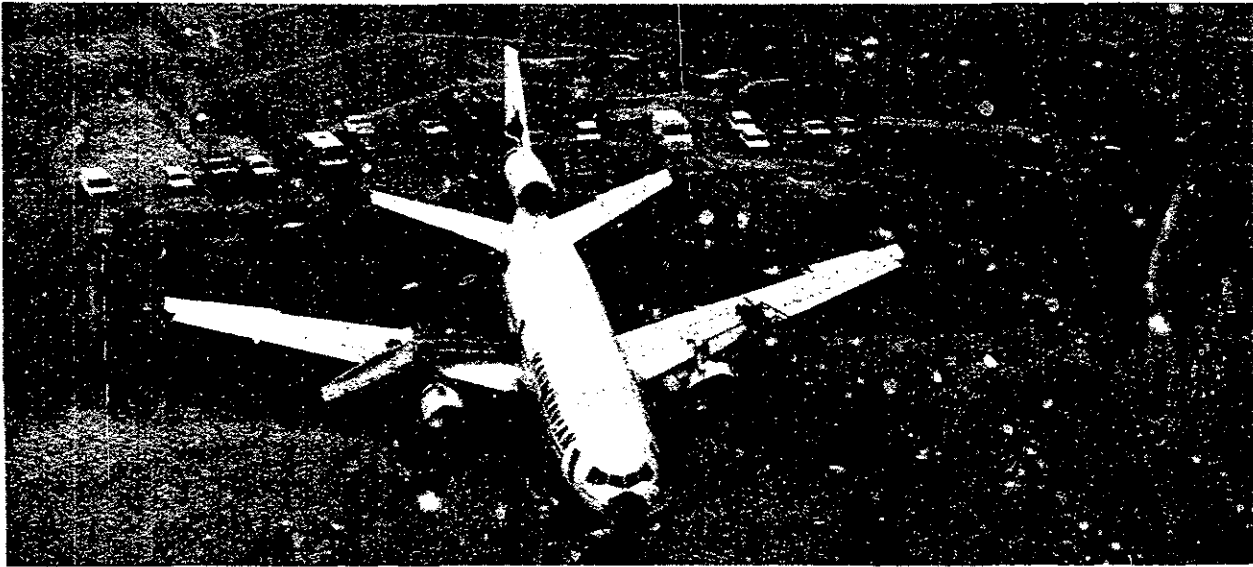
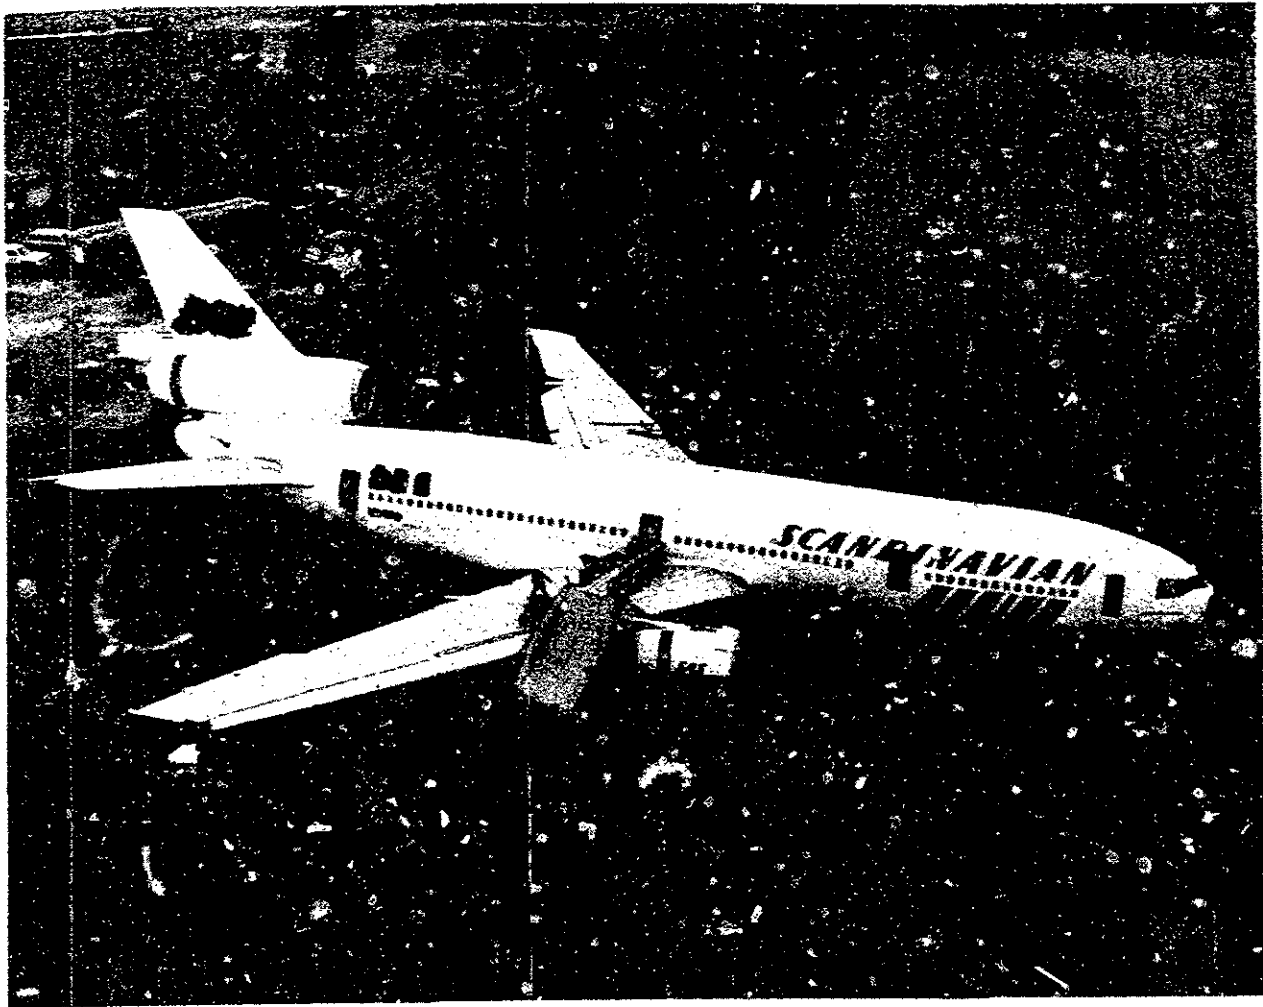
Figure 2.—Flight 901 at rest in Thurston Basin.

The forward section of the airplane fuselage came to rest in Thurston Basin, a tidal waterway about 600 ft (182.88 meters) from the runway 4R departure end. The airplane was damaged substantially. (See figure 2.) The captain immediately began to execute the memory items of the "On-Ground Emergency Check List." However, neither he nor the systems operator could move the engine fire selectors or fuel cutoff levers to their full off positions.

The aft portion of the fuselage remained generally intact. There was major damage at the lower nose area, to the radome, and to the forward pressure bulkhead at fuselage station (FS) 275. The nose landing gear structure had collapsed under the fuselage. The drag braces were fractured and had separated from their attachment fittings. The interior of the forward fuselage area was deformed and exhibited fractures at the flight deck and galley floor locations. Several floor beams below the galley floor were fractured and twisted.

The wings, leading edge slats, and flaps sustained moderate damage from impact with the wooden pier structure. The leading edge slats were extended fully and the trailing edge flaps were extended to the 40° position.

The No. 1 engine pylon structure was buckled and twisted; the No. 2 and 3 engine pylons exhibited no major structural damage. The No. 1 and No. 3 engines sustained major impact and salt water damage. The No. 2 engine sustained no impact damage. All three fan and turbine thrust reversers were in the fully deployed (reverse thrust) positions.

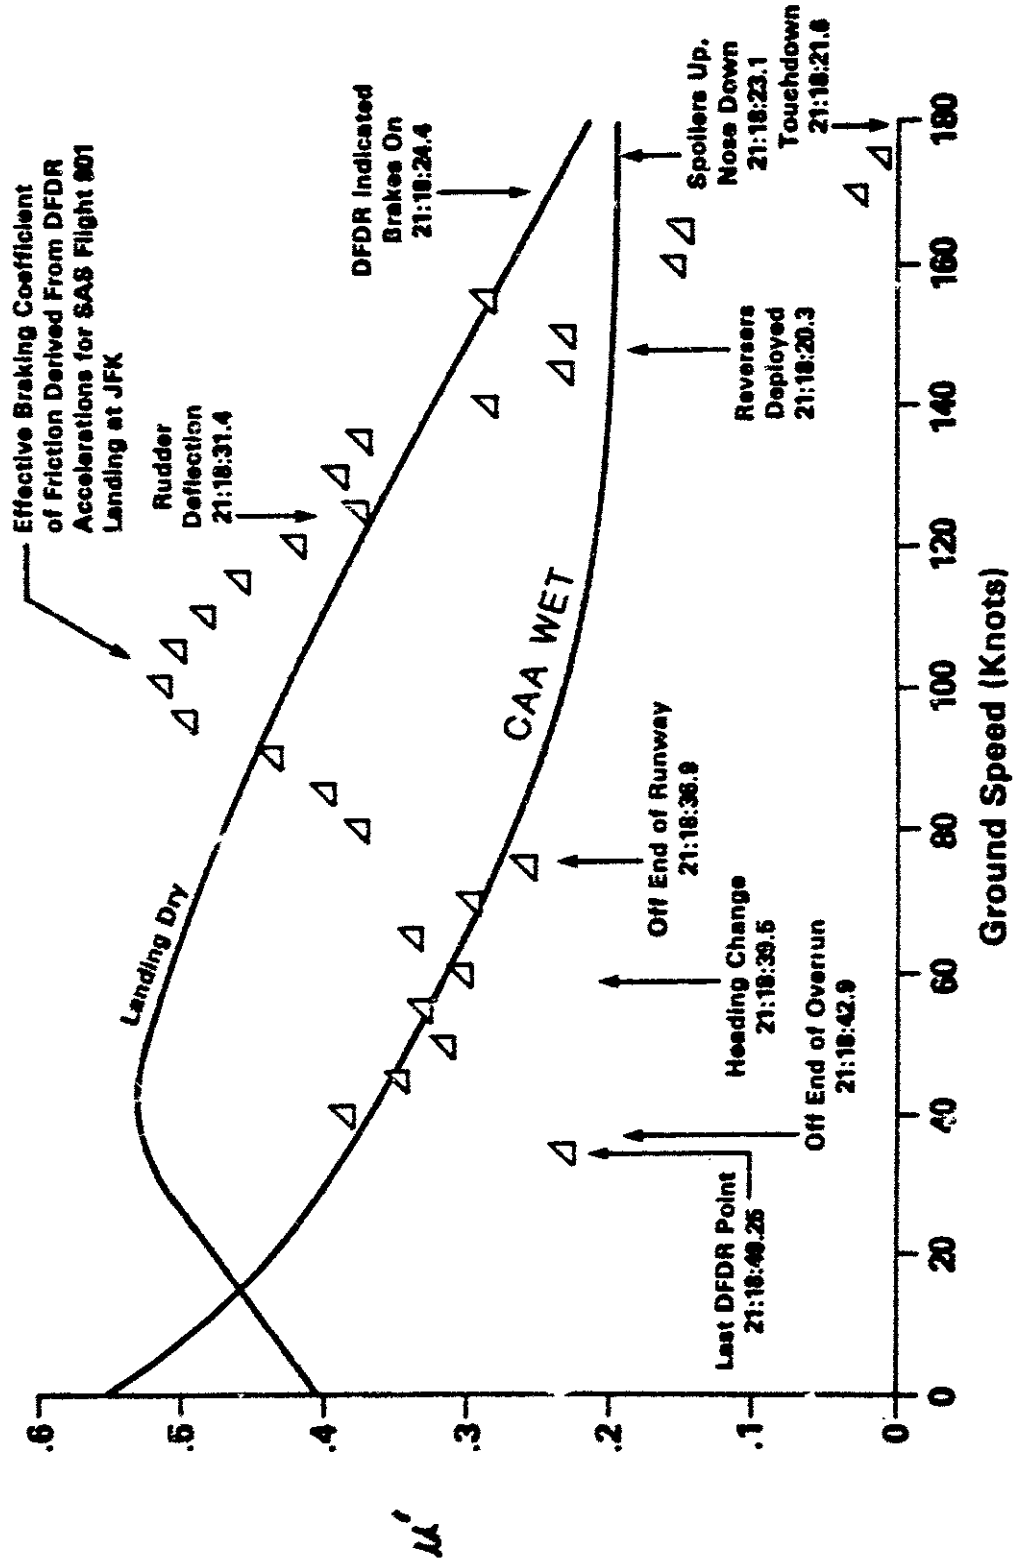
Figure 5.—Effective Braking Coefficient Derived from DFDR.

**Effective Braking Coefficient Derived From  
DFDR Decelerations - CF6-50 Engine  
Turbine Reversers Inoperative**
