AIRCRAFT ACCIDENT REPORT

**MIDAIR COLLISION OF
WINGS WEST AIRLINES BEECH C-99 (N6399U) AND
AESTHETEC, INC.,
ROCKWELL COMMANDER 112TC N112SM
NEAR SAN LUIS OBISPO, CALIFORNIA
AUGUST 24, 1985**

NTSB / AAR-85 / 07

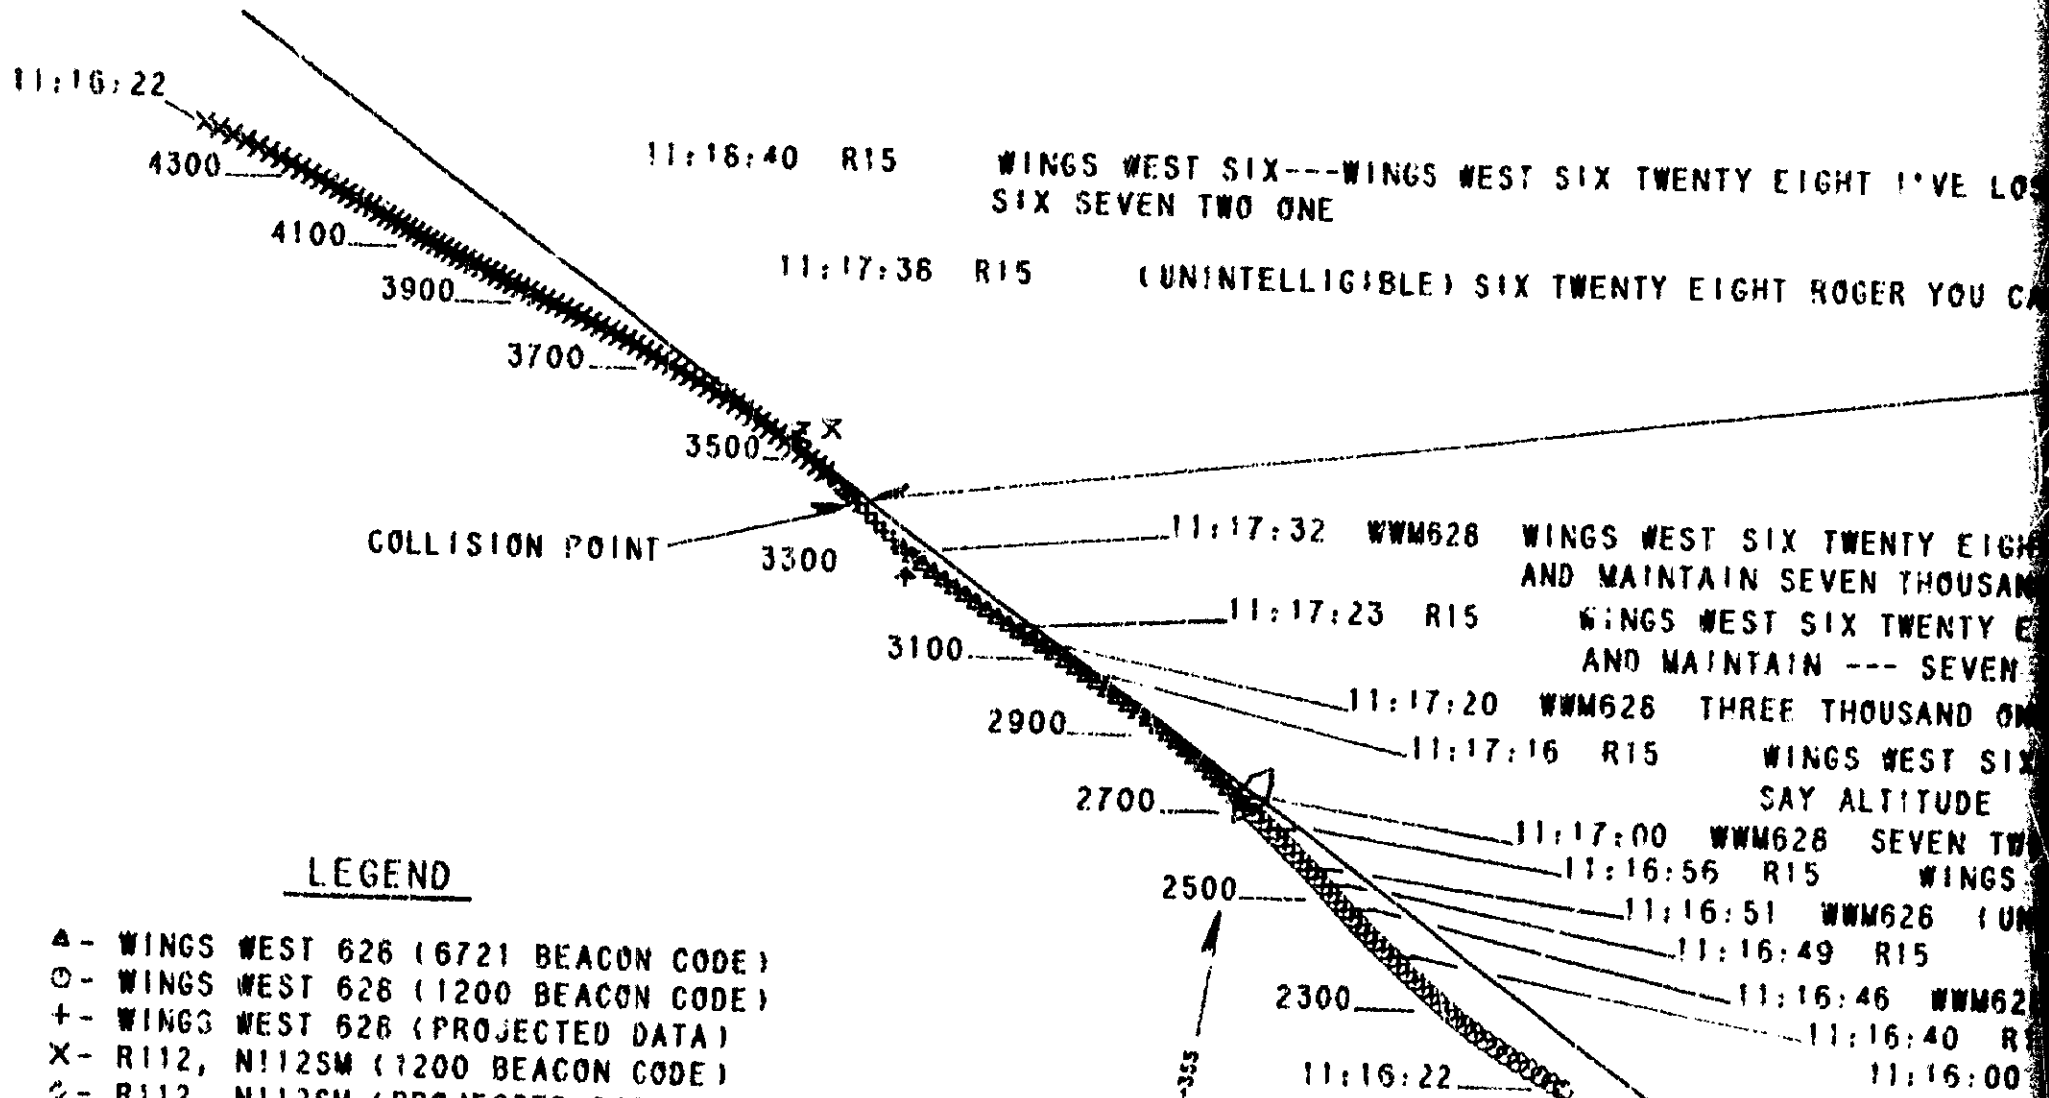
RADAR GROUND TRACK PLOT
MIDAIR COLLISION WINGS WEST FLT. 628 - ROCKWELL
SAN LUIS OBISPO, CA. AUGUST 24, 1984

The Safety Board then sought to determine whether the performance of the ATC controllers, or the ATC system itself, either caused or contributed to the accident. The radar ground track plot showed that the accident occurred at 1117:38 and that Flight 628's radar return (initially as a 1200 code) was not displayed until 1116:22. The evidence showed that the developmental controller initially communicated with Flight 628 at 1116:40. At 1116:56, he assigned a discrete transponder code to the flight, and, at 1117:16, 22 seconds before the collision, he told Flight 628 that he had it "in radar contact." Thereafter, he read the flight's IFR clearance to it and listened to the readback. At 1116:22, the airplanes were about 6.9 nmi apart and the Rockwell was almost directly in front of Flight 628. Between 1116:22 and the collision, the airplanes closed on each other at about 544 fps and, except for the Rockwell Commander's slight right turn, their headings remained the same.

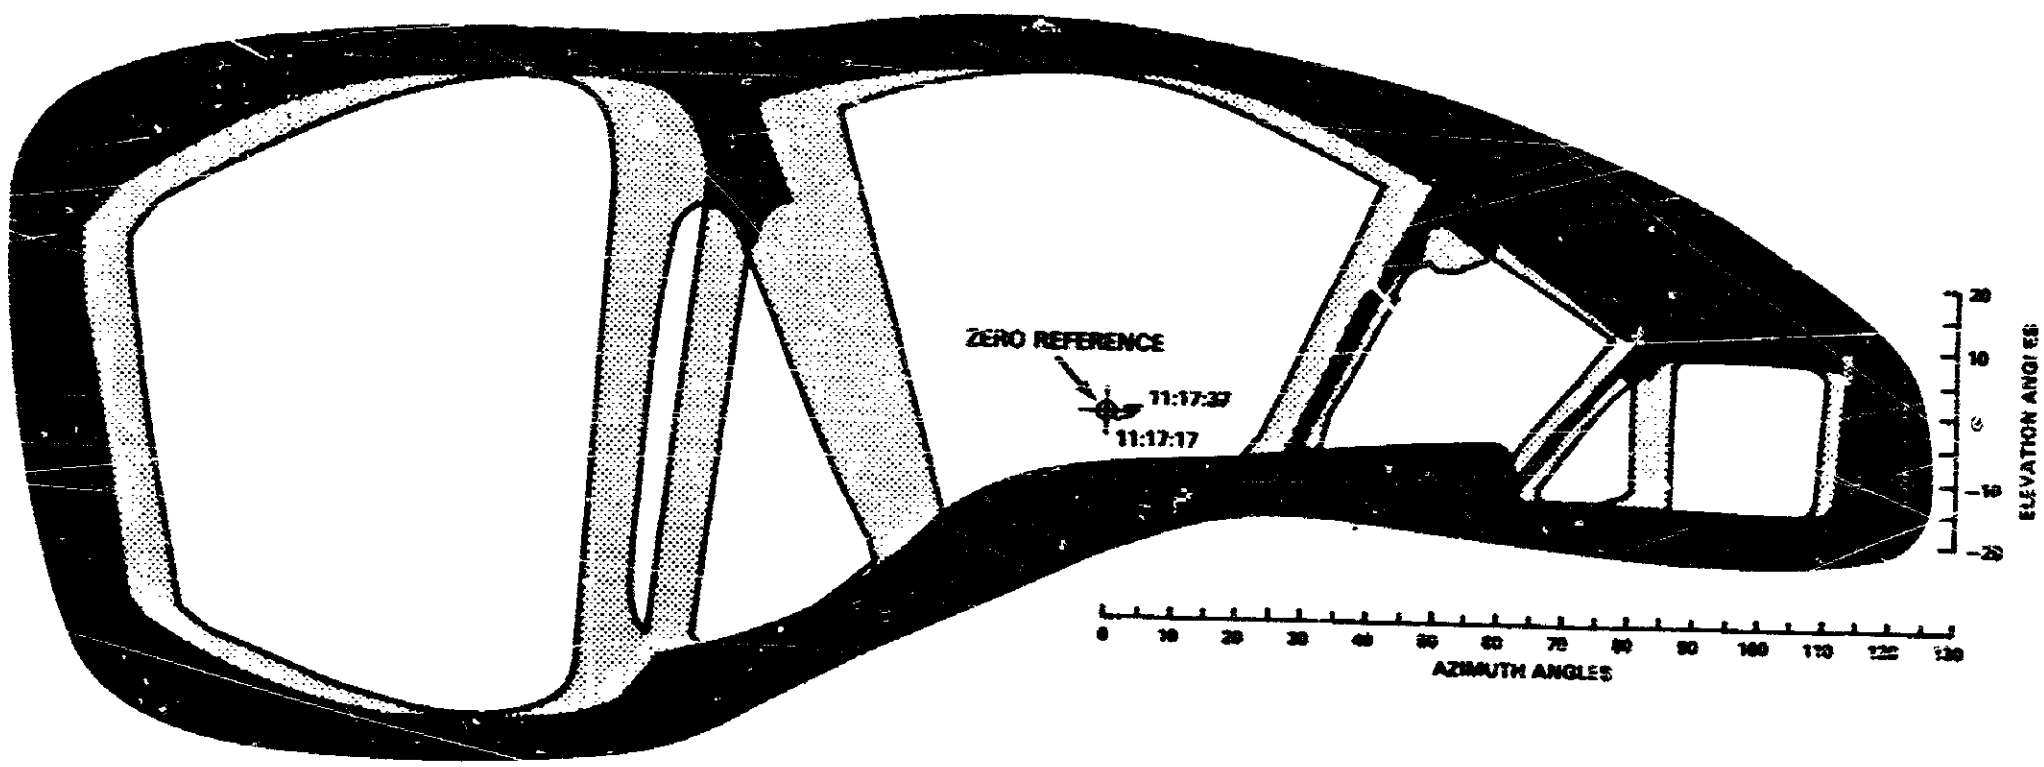
Captain

Had the pilots of the Beech C-99 been able to sight the Rockwell Commander at the precise moment its visual angle subtended the minimum 0.2 degree of arc, they would have had 17 seconds to avoid colliding with it. Based on the values in table I, there was time available to execute an evasive maneuver. However, since less than ideal sighting conditions existed, the Board believes that it would have been highly unlikely that they could have sighted the Rockwell precisely at 17 seconds before the collision. In addition, the visual angle of 0.4 was not reached until the airplane was within 12 seconds of colliding with the Rockwell Commander--less than the 12.5 seconds required to detect and evade as shown in table I. Given these data, the Safety Board concludes that the conditions on the day of the accident were such that it may have been impossible for the pilots of each airplane to see and avoid the other or, at best, the possibility of their doing so was marginal.

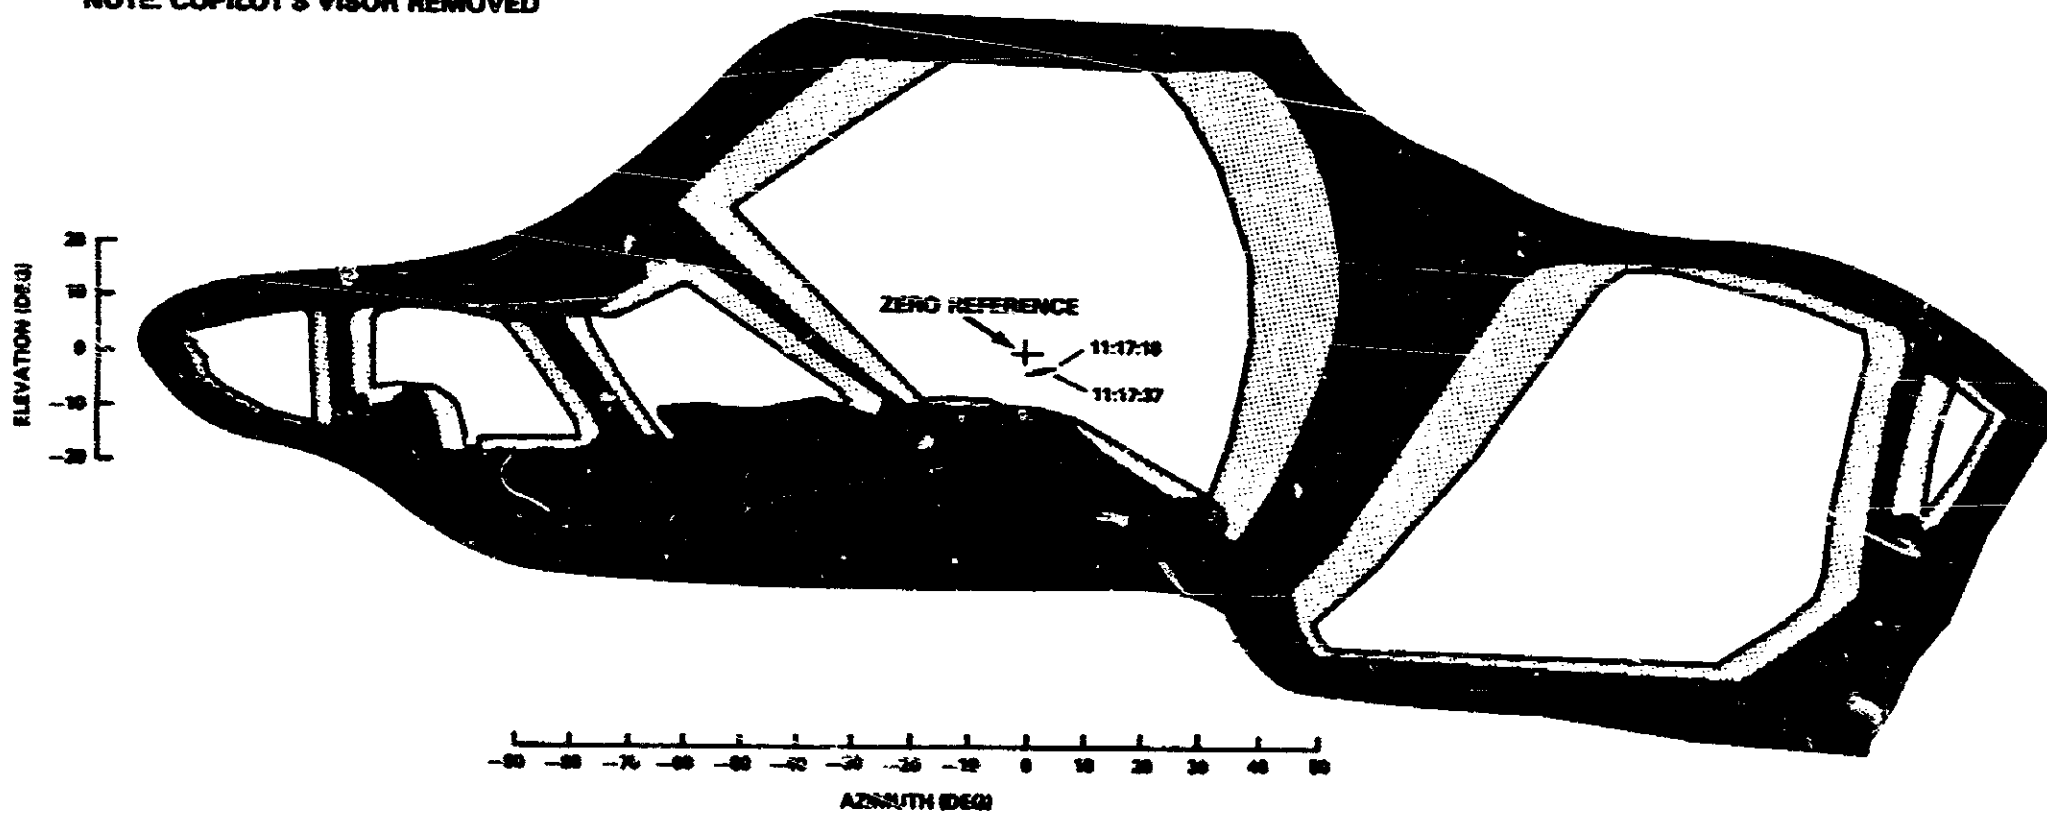
Instructor

From these figures, it can be determined that the pilots of the Rockwell had more time (6 seconds) to see and avoid the Beech C-99. Under ideal conditions, theoretically they first would have been able to detect the Beech about 23 seconds before the collision and, based on the values in table I, would have had time to sight the Beech

C-99 and to avoid it. However, conditions were less than ideal because both airplanes were painted white with either green or orange trim and the predominantly white coloration would have washed out any color contrast in the existing bright daytime conditions. In addition, the head-on closure would have resulted in little or no relative movement by either airplane across the windshields of the other airplane and would have reduced further the ability of the pilots to see the other airplane at the precise moment the sighting angle subtended the minimum 0.2 degree of arc required for visual detection. With regard to sighting the Beech C-99, when the visual angles increased by factors of two and three so as to be more readily recognizable (based on the cited research), the pilots of the Rockwell would have detected the Beech C-99 about 12 and 8 seconds before the collision, respectively. In the first case, a successful evasive maneuver would have been marginally possible; in the second case, the collision would have been unavoidable.
