AIRCRAFT ACCIDENT REPORT

MIDAIR COLLISION OF
WINGS WEST AIRLINES BEECH C-99 (N6399U) AND
AESTHETEC, INC.,
ROCKWELL COMMANDER 112TC N112SM
NEAR SAN LUIS OBISPO, CALIFORNIA
AUGUST 24, 1985

NTSB / AAR-85 / 07

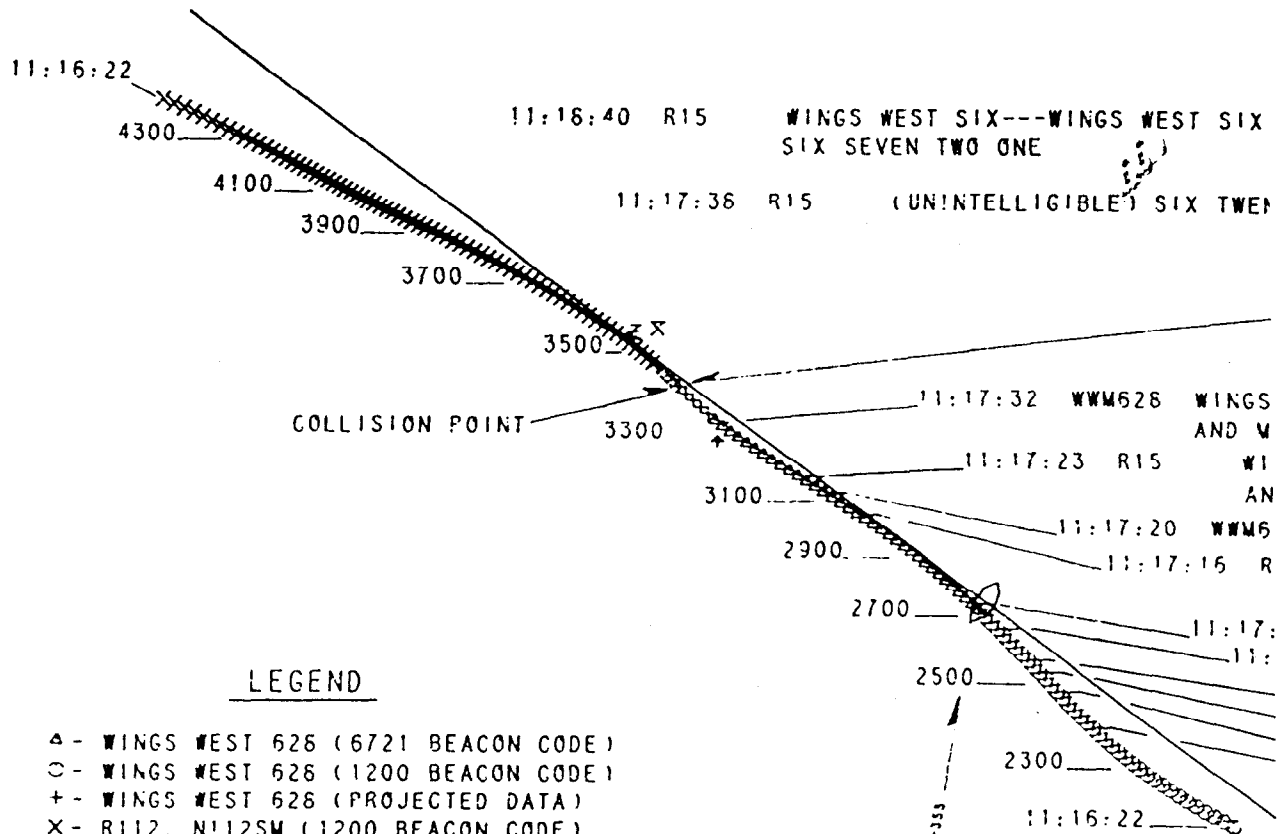
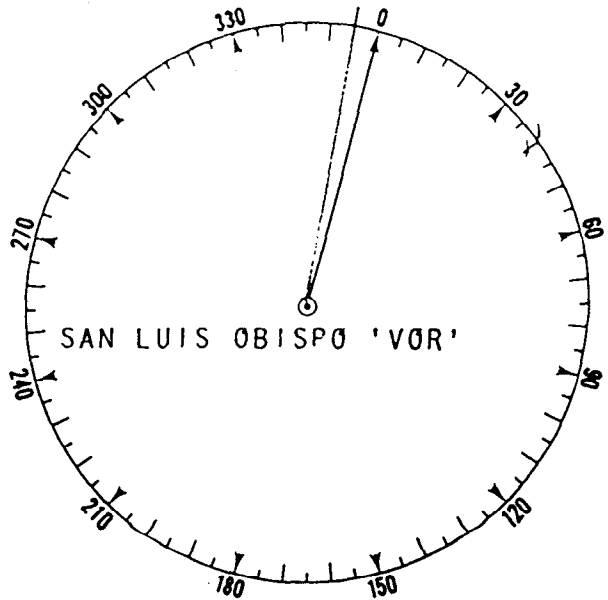
RADAR GROUND TRAJECTORY
MIDAIR COLLISION WINGS WEST FLT. 628
SAN LUIS OBISPO, CA. AUGUST 1954

The Safety Board then sought to determine whether the performance of the ATC controllers, or the ATC system itself, either caused or contributed to the accident. The radar ground track plot showed that the accident occurred at 1117:38 and that Flight 628's radar return (initially as a 1200 code) was not displayed until 1116:22. The evidence showed that the developmental controller initially communicated with Flight 628 at 1116:40. At 1116:56, he assigned a discrete transponder code to the flight, and, at 1117:16, 22 seconds before the collision, he told Flight 628 that he had it "in radar contact." Thereafter, he read the flight's IFR clearance to it and listened to the readback. At 1116:22, the airplanes were about 6.9 nmi apart and the Rockwell was almost directly in front of Flight 628. Between 1116:22 and the collision, the airplanes closed on each other at about 544 fps and, except for the Rockwell Commander's slight right turn, their headings remained the same.

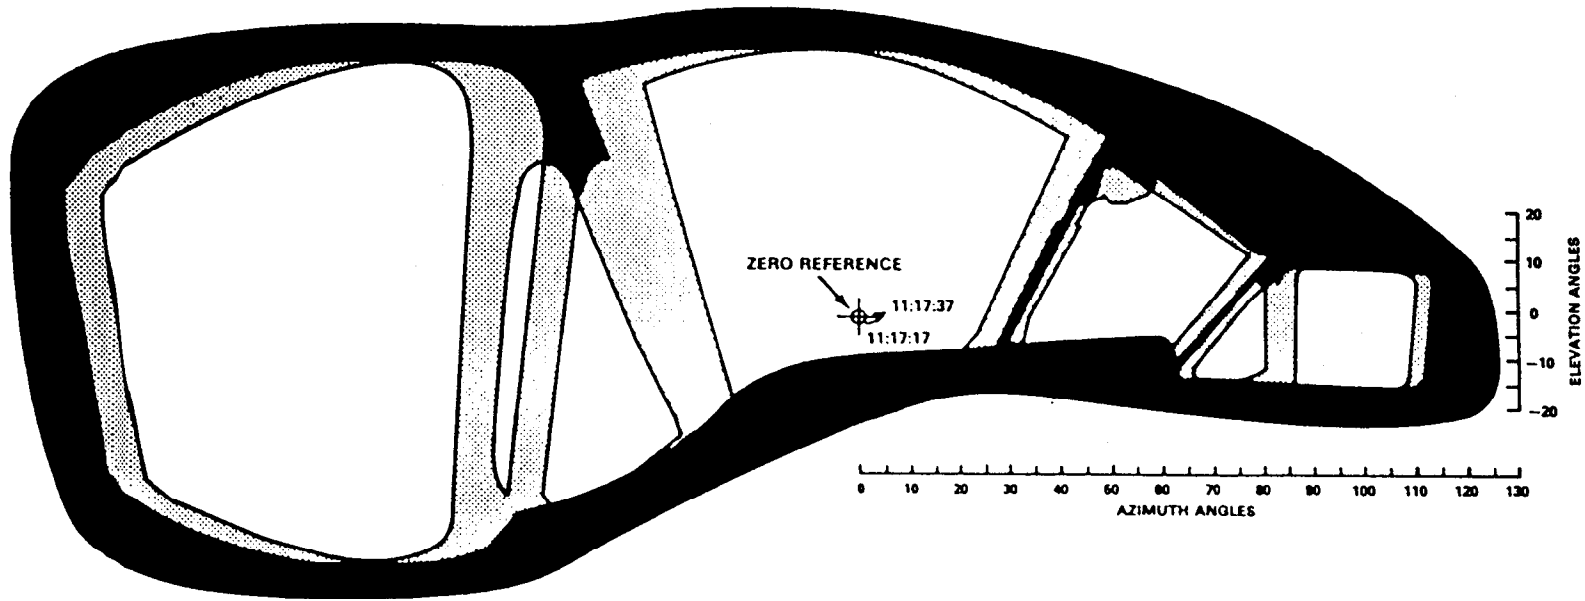
Captain

Had the pilots of the Beech C-99 been able to sight the Rockwell Commander at the precise moment its visual angle subtended the minimum 0.2 degree of arc, they would have had 17 seconds to avoid colliding with it. Based on the values in table I, there was time available to execute an evasive maneuver. However, since less than ideal sighting conditions existed, the Board believes that it would have been highly unlikely that they could have sighted the Rockwell precisely at 17 seconds before the collision. In addition, the visual angle of 0.4 was not reached until the airplane was within 12 seconds of colliding with the Rockwell Commander--less than the 12.5 seconds required to detect and evade as shown in table I. Given these data, the Safety Board concludes that the conditions on the day of the accident were such that it may have been impossible for the pilots of each airplane to see and avoid the other or, at best, the possibility of their doing so was marginal.

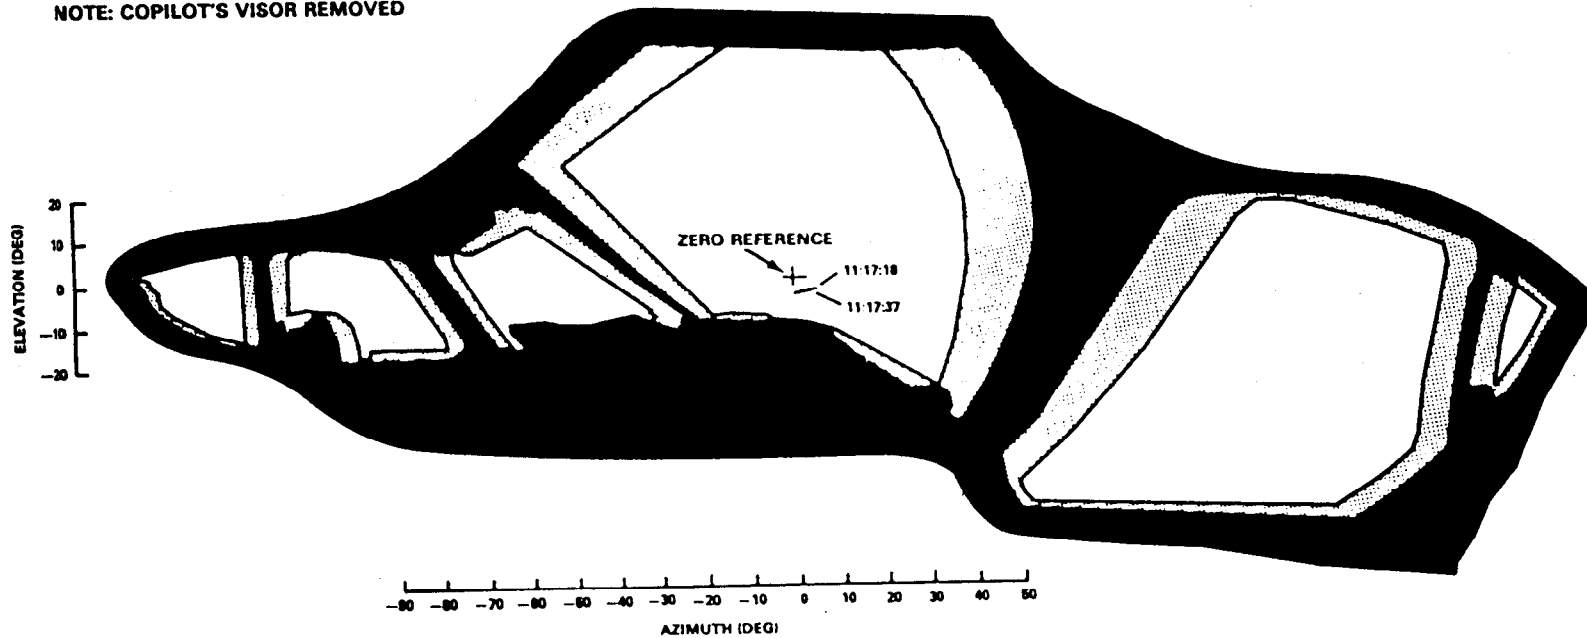
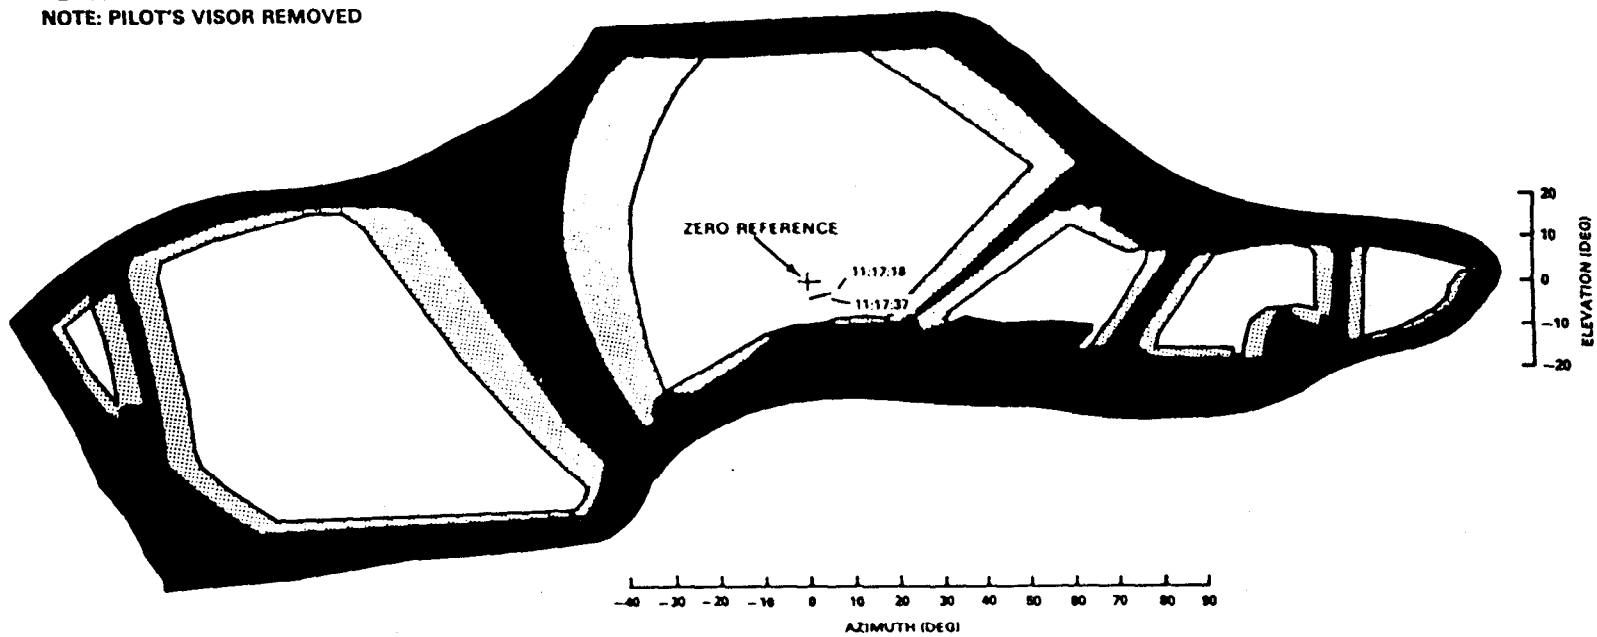
From these figures, it can be determined that the pilots of the Rockwell had more time (6 seconds) to see and avoid the Beech C-99. Under ideal conditions, theoretically they first would have been able to detect the Beech about 23 seconds before the collision and, based on the values in table I, would have had time to sight the Beech

C-99 and to avoid it. However, conditions were less than ideal because both airplanes were painted white with either green or orange trim and the predominantly white coloration would have washed out any color contrast in the existing bright daytime conditions. In addition, the head-on closure would have resulted in little or no relative movement by either airplane across the windshields of the other airplane and would have reduced further the ability of the pilots to see the other airplane at the precise moment the sighting angle subtended the minimum 0.2 degree of arc required for visual detection. With regard to sighting the Beech C-99, when the visual angles increased by factors of two and three so as to be more readily recognizable (based on the cited research), the pilots of the Rockwell would have detected the Beech C-99 about 12 and 8 seconds before the collision, respectively. In the first case, a successful evasive maneuver would have been marginally possible; in the second case, the collision would have been unavoidable.
