AIRCRAFT ACCIDENT REPORT

**CHINA AIRLINES BOEING 747-SP, N4522V
300 NAUTICAL MILES NORTHWEST OF
SAN FRANCISCO, CALIFORNIA
FEBRUARY 19, 1985**

NTSB/AAR-86/03

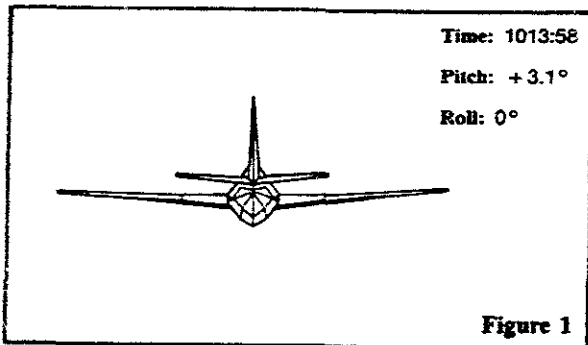
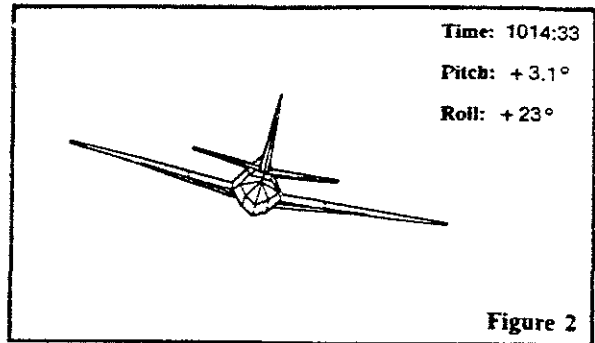
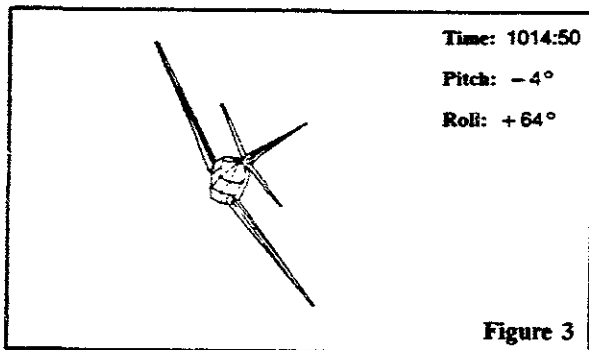
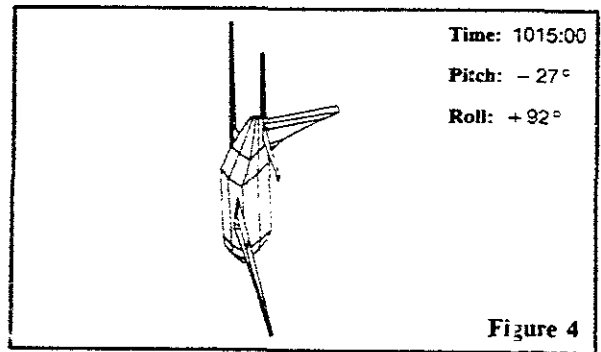
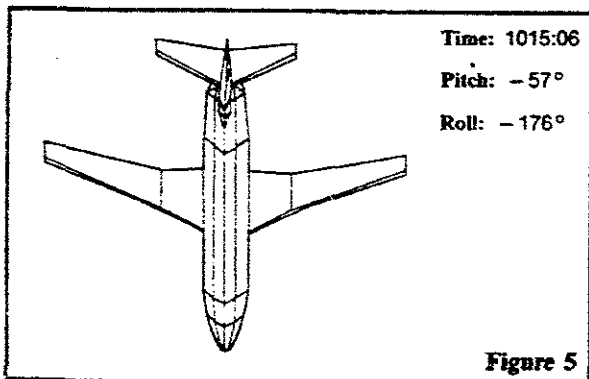
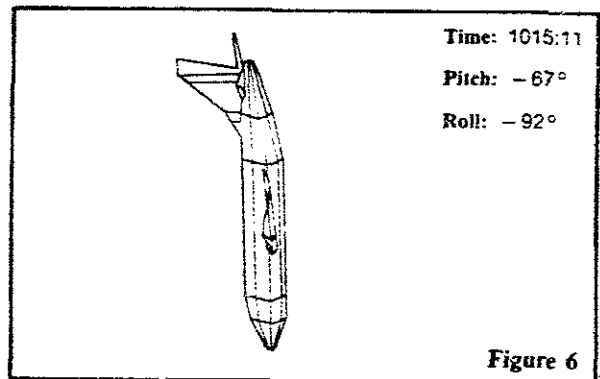
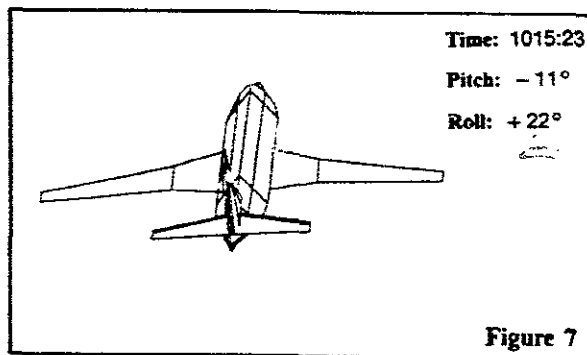
Figures 1.--Excerpts from Computer Animation.

At 1011:10, after the airspeed had decreased to about 251 KIAS, the EPRs on engines 1, 2, and 3 began increasing and, by about 1011:30, they had reached about 1.5 EPR. (At 41,000 feet, 0.85M, and with two air conditioning packs operating, the "max cruise" EPR limit is 1.543 EPR.) Thereafter, these three EPRs remained at about 1.5 until shortly after the start of the upset. During this period, the No. 4 engine's EPR

increased from 0.9 to about 1.02 and remained fairly constant at that reading until 1012:06. Between 1012:06 and 1012:41, the No. 4 EPR increased slightly to about 1.05.

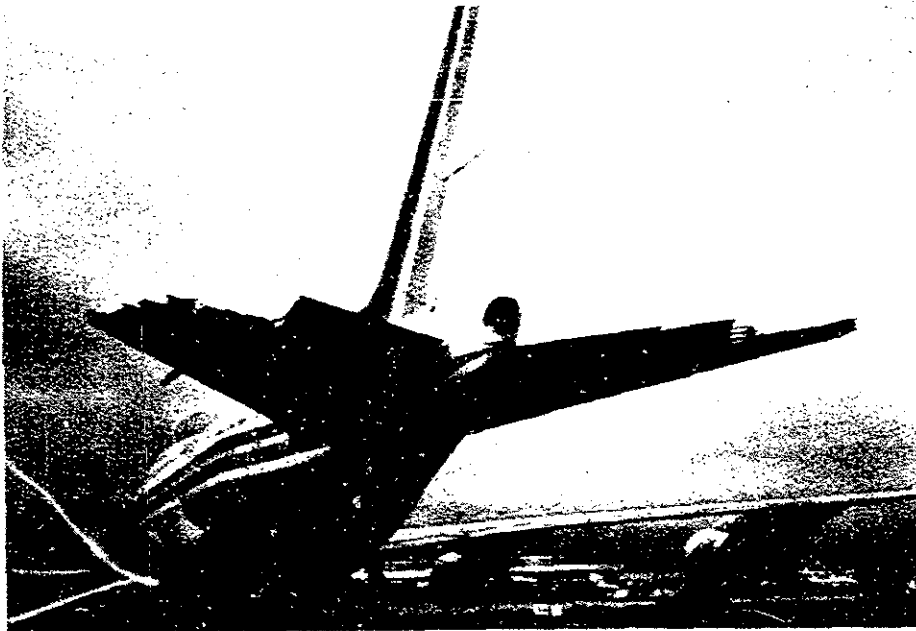
Figure 8.—Photograph of Empennage.

Empennage.--The major damage to the empennage was limited to the Auxiliary Power Unit (APU) compartment, the horizontal stabilizers, and elevators. The APU had separated from its mounts and was resting on the two lower tail cone access doors. The forward side of the APU fire bulkhead appeared to be deflected forward in the area adjacent to the two lower attachment fittings and the two lower support rods had buckled. In the area of the APU, there were several punctures in an outward direction on both sides of the tail cone.
