**NATIONAL
TRANSPORTATION
SAFETY
BOARD**

AIRCRAFT ACCIDENT REPORT

**DELTA AIR LINES, INC.,
LOCKHEED L-101 1-385-1, N726DA
DALLAS/FORT WORTH -
INTERNATIONAL AIRPORT, TEXAS
AUGUST 2, 1985**

NTSB/AAR-86/05

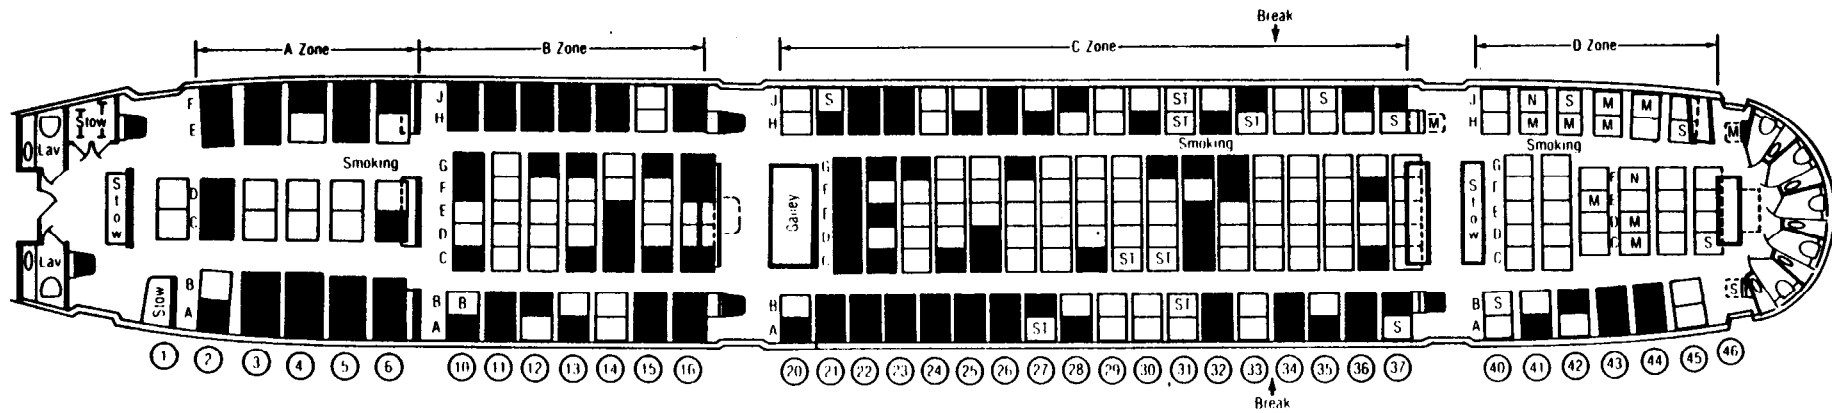
Except for the left cabin wall, which was missing, the remainder of the separated rear cabin section from row 40 aft to row 46 was relatively undamaged. Six passengers seated along the missing left cabin wall were killed. The remaining 16 occupants of this cabin section, including 2 flight attendants, sustained serious and minor injuries, and 2 passengers were not injured.

The rear cabin section came to rest on its left side. The survivors were either flung from the airplane in their seats or released themselves from their seats and exited at the forward end of the separated fuselage section or through the missing left wall. One flight attendant and three passengers could not escape from the cabin because of injuries and were removed by fellow passengers and rescue personnel. Two other flight attendants had only minor injuries and were able to escape unaided after shouting commands to the passengers to get out of the cabin. The flight attendant seated at the right rear (R-4) exit had difficulty releasing her **seatbelt** because the buckle was located on her left hip and her weight was on the buckle. The passengers and flight attendants were covered with fuel and some had fuel on their hands and in their eyes, which caused difficulties in climbing down the cabin to the hole created by the missing left cabin wall. Some persons were able to climb downward to the hole over seats while others fell the width of the cabin to the ground.

Figure 3.--L-1011 cabin seat diagram.
