**NATIONAL  
TRANSPORTATION  
SAFETY  
BOARD**

**AIRCRAFT ACCIDENT REPORT**

**HENSON AIRLINES FLIGHT 1517  
BEECH B99, N339HA  
GROTTOES, VIRGINIA  
SEPTEMBER 23, 1985**

**NTSB/AAR-86/07**

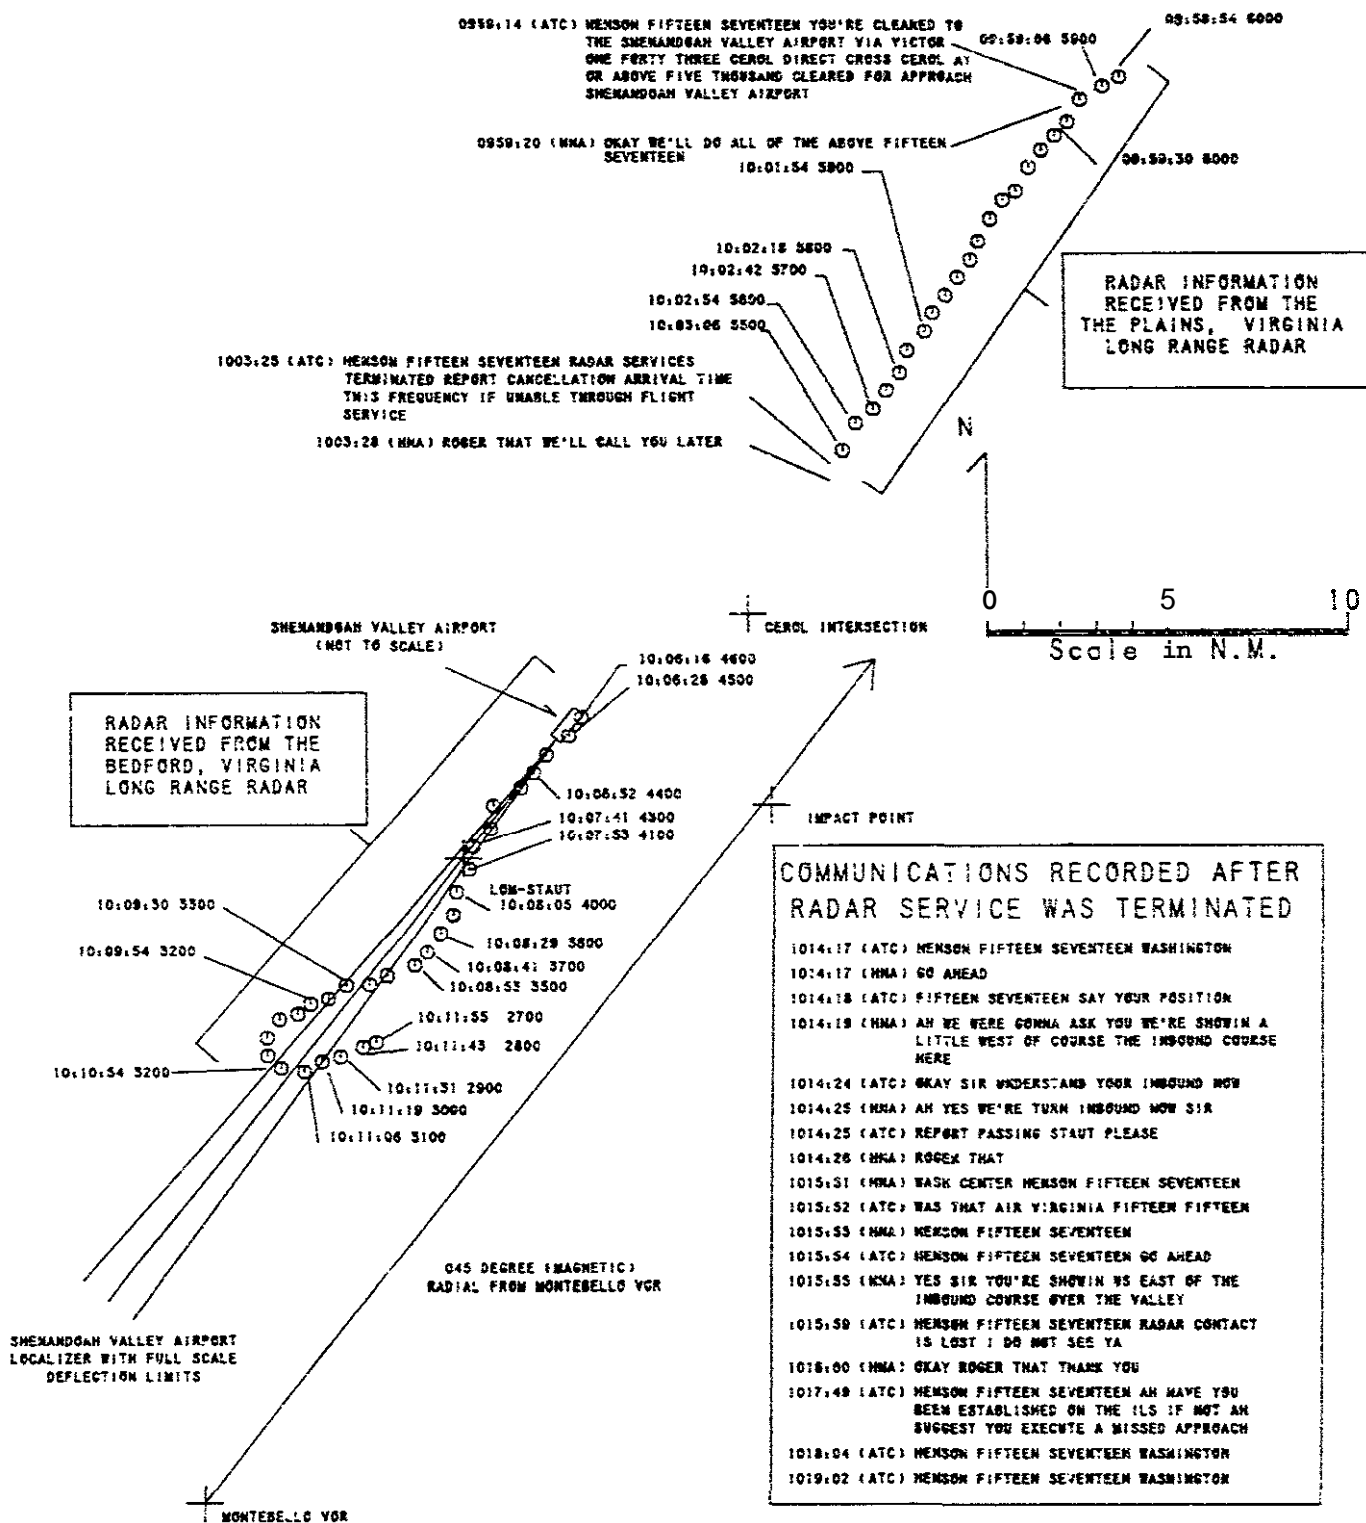
Figure 3.—Recorded radar flightpath reconstruction.

HENSON FLIGHT 1517  
 RECORDED RADAR FLIGHT PATH RECONSTRUCTION  
 ( Note : Axes are oigned with true north )

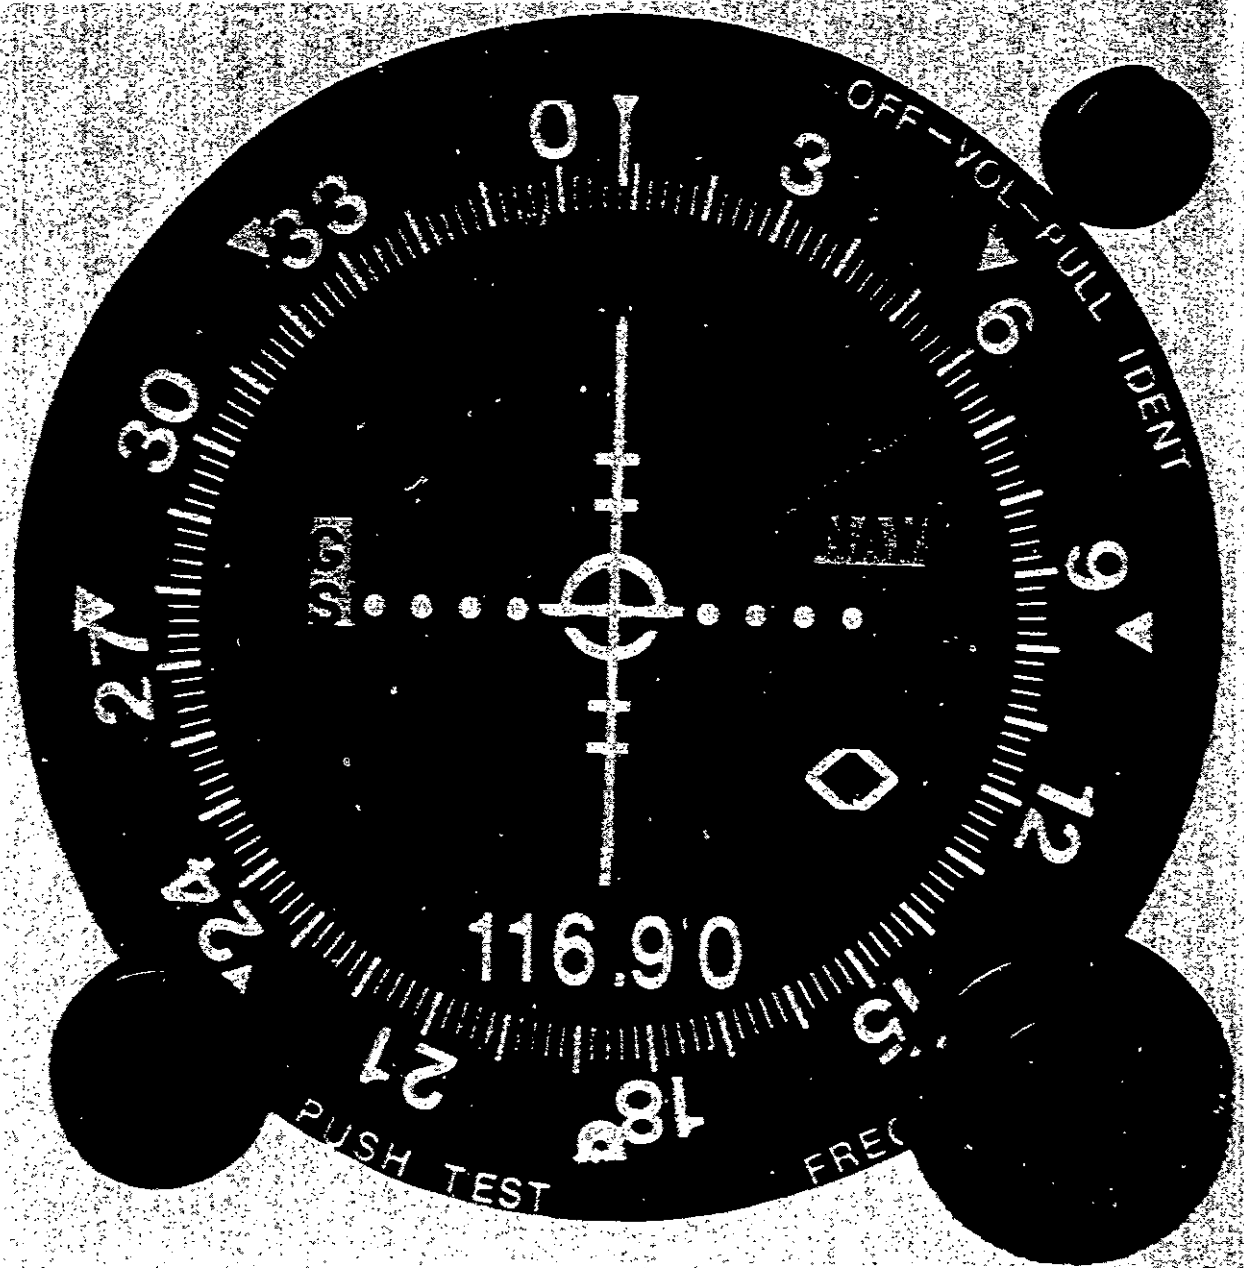
Figure 5.—Enlarged front view NAV 122 and NAV 122A.  
(Courtesy of NARCO Avionics, Inc.)

9/ Navigational displays consist of omnibearing selector (OBS), course deviation indicator (CDI), glideslope (GS), TO/FROM indicators, On/Off flags, and a scale to indicate the degrees of deflection from the centerline of the selected VOR radial or the localizer and the glideslope. (See figure 5.)

September 26, 1985. The No. 1 navigation radio frequency selector was found tuned to 110.5 MHz and the No. 2 navigation radio frequency selector was found tuned to either 109.5 MHz or 110.5 MHz. The No. 3 navigation receiver, a self-contained NAV/LOC/GS receiver-indicator, could have been tuned to any of four possible frequencies: 110.5 MHz, 110.05 MHz, 115.5 MHz, or 115.05 MHz. Damage was too severe for any more precise determination of frequencies. The Nos. 1 and 2 omnibearing selectors (OBS) had been installed on the captain's (left) instrument panel, and the No. 3 OBS had been installed on the first officer's (right) instrument panel.

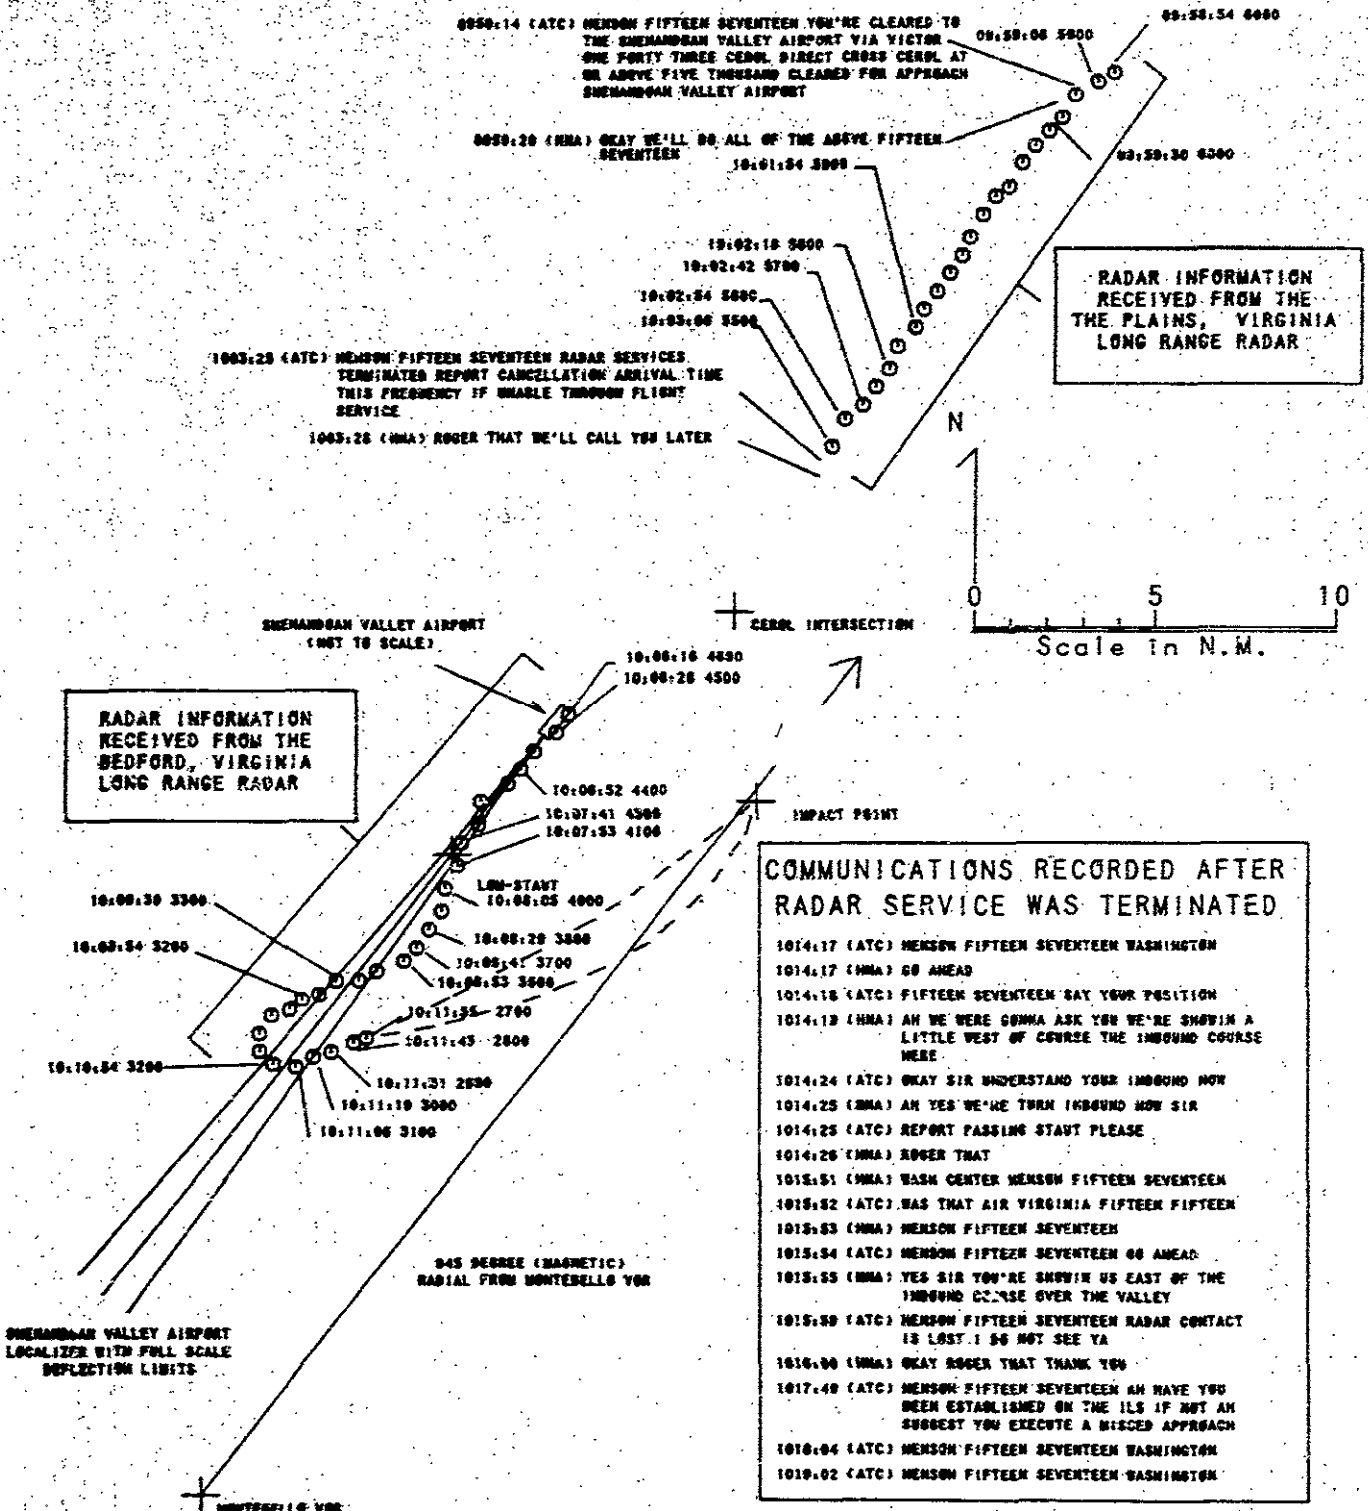
Figure 6.--Projected flightpath of flight 1517.

After the flightcrew intercepted what they thought was the localizer course and turned inbound, they must have descended below the glideslope intercept altitude of 2,700 feet since they struck the mountain at 2,400 feet, about 371 feet below its peak altitude and about 200 feet below a ridge in the flightpath of flight 1517. There are two possible explanations for the airplane crashing: at 2,400 feet along the 045° radial of the MOL VOR.

One explanation for the final phase of the flight is that the flightcrew flew along the 045° radial of MOL and allowed the airplane to drift down to 2,400 feet as they waited for passage of STAUT. Eventually, they became uncertain as to their location after noting a slow swing of the ADF needle, no marker beacon indication, and no glideslope indication. The captain's contact with ATC at 10:15:55 about being east of course supports such an explanation. Further, there would be a time delay after turning inbound on the localizer before the crew would have expected to receive the marker beacon or an ADF needle swing indicating passage of STAUT. Thus, once the crew intercepted the 045° radial of MOL, thinking it was the localizer, the crew would not have expected to receive an immediate indication that they had passed STAUT. Once the crew realized that sufficient time had passed for outer marker passage, either the captain or the first officer may have noted the ADF needle pointing toward the left wing. This would indicate that the airplane was east of course and could account for the captain's inquiry to ATC. The flightcrew may have finally realized that they were not on the localizer course or, in response to the controller's suggestion that they execute a missed approach, they may have initiated a climb to a minimum safe altitude. However, the airplane collided with the ground before it could begin a left turn to STAUT according to the missed approach instructions, since the airplane struck the trees in a wing's level fuselage attitude.

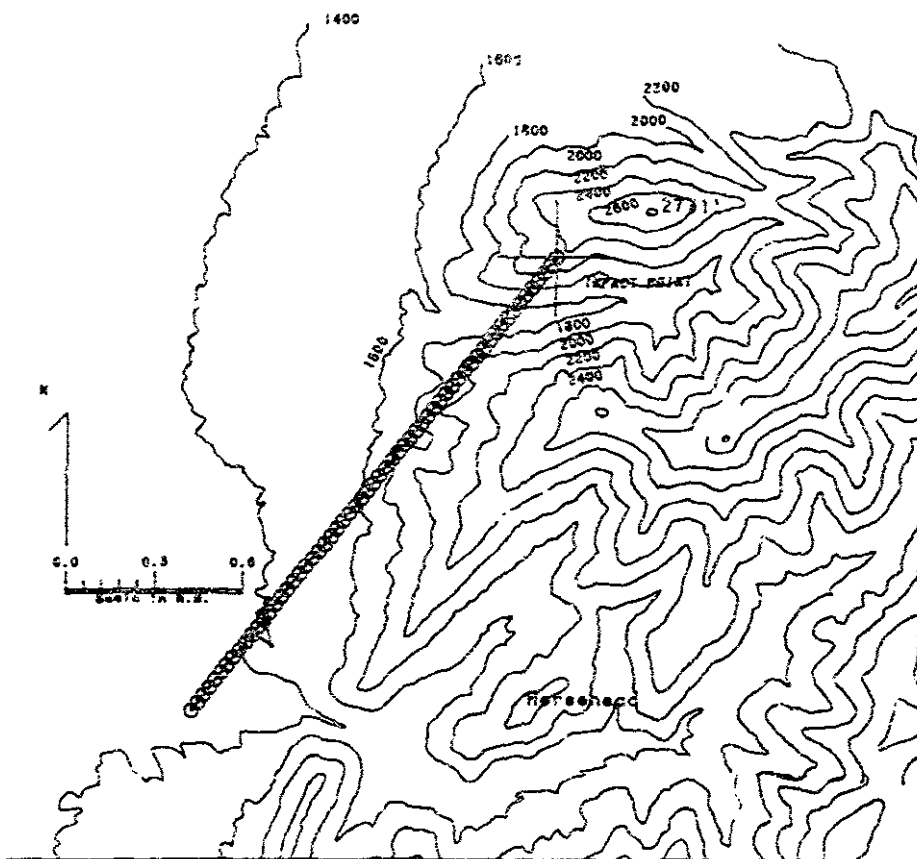
Figure 7.—Topography of flightpath.

NATIONAL TRANSPORTATION SAFETY BOARD  
BUREAU OF TECHNOLOGY  
WASHINGTON, D.C.  
ESTIMATED GROUND TRACK FOR THE LAST MINUTE OF FLIGHT  
EACH CONTOUR LINE REPRESENTS AN ELEVATION CHANGE OF 200 FEET

- Assumed Conditions :
- Altitude : 2400 Feet MSL
  - Airspeed : 120 Knots Indicated
  - Track Angle (Heading) : 045 Degrees Magnetic
  - Winds Aloft : Less Than 10 Knots

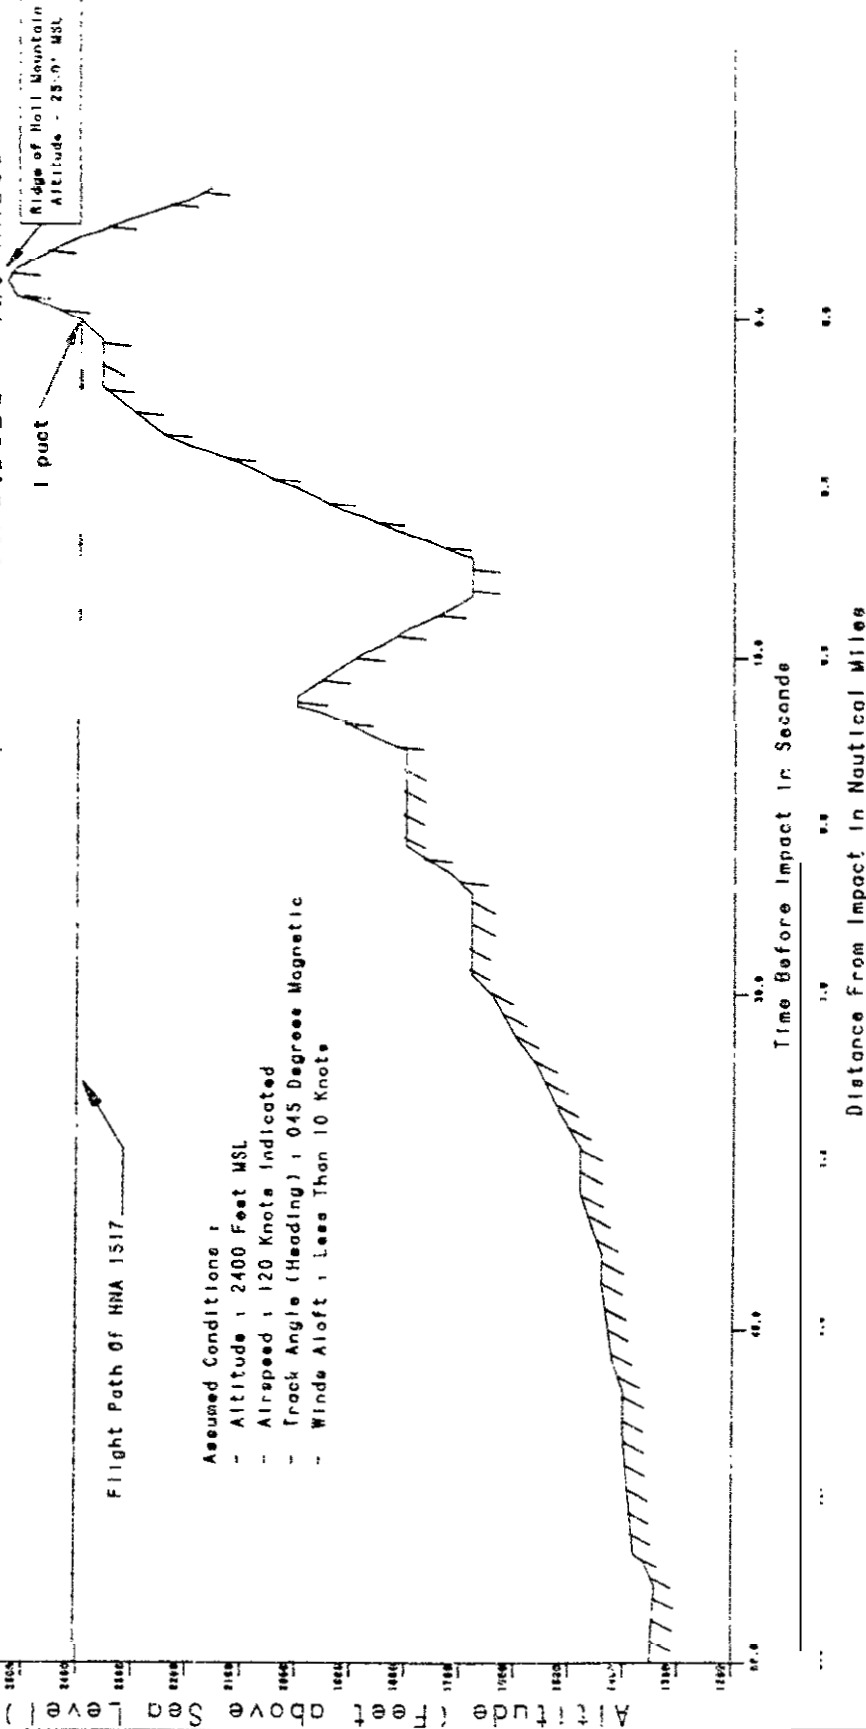
Figure 8. --Estimated flight/ground profile vs. time before impact.

Estimated Flight and Ground Elevation Profile V<sub>6</sub> Time Before Impact  
For Last Minute of Flight

Note: It is Assumed That Airspeed = Groundspeed = 120 Knots

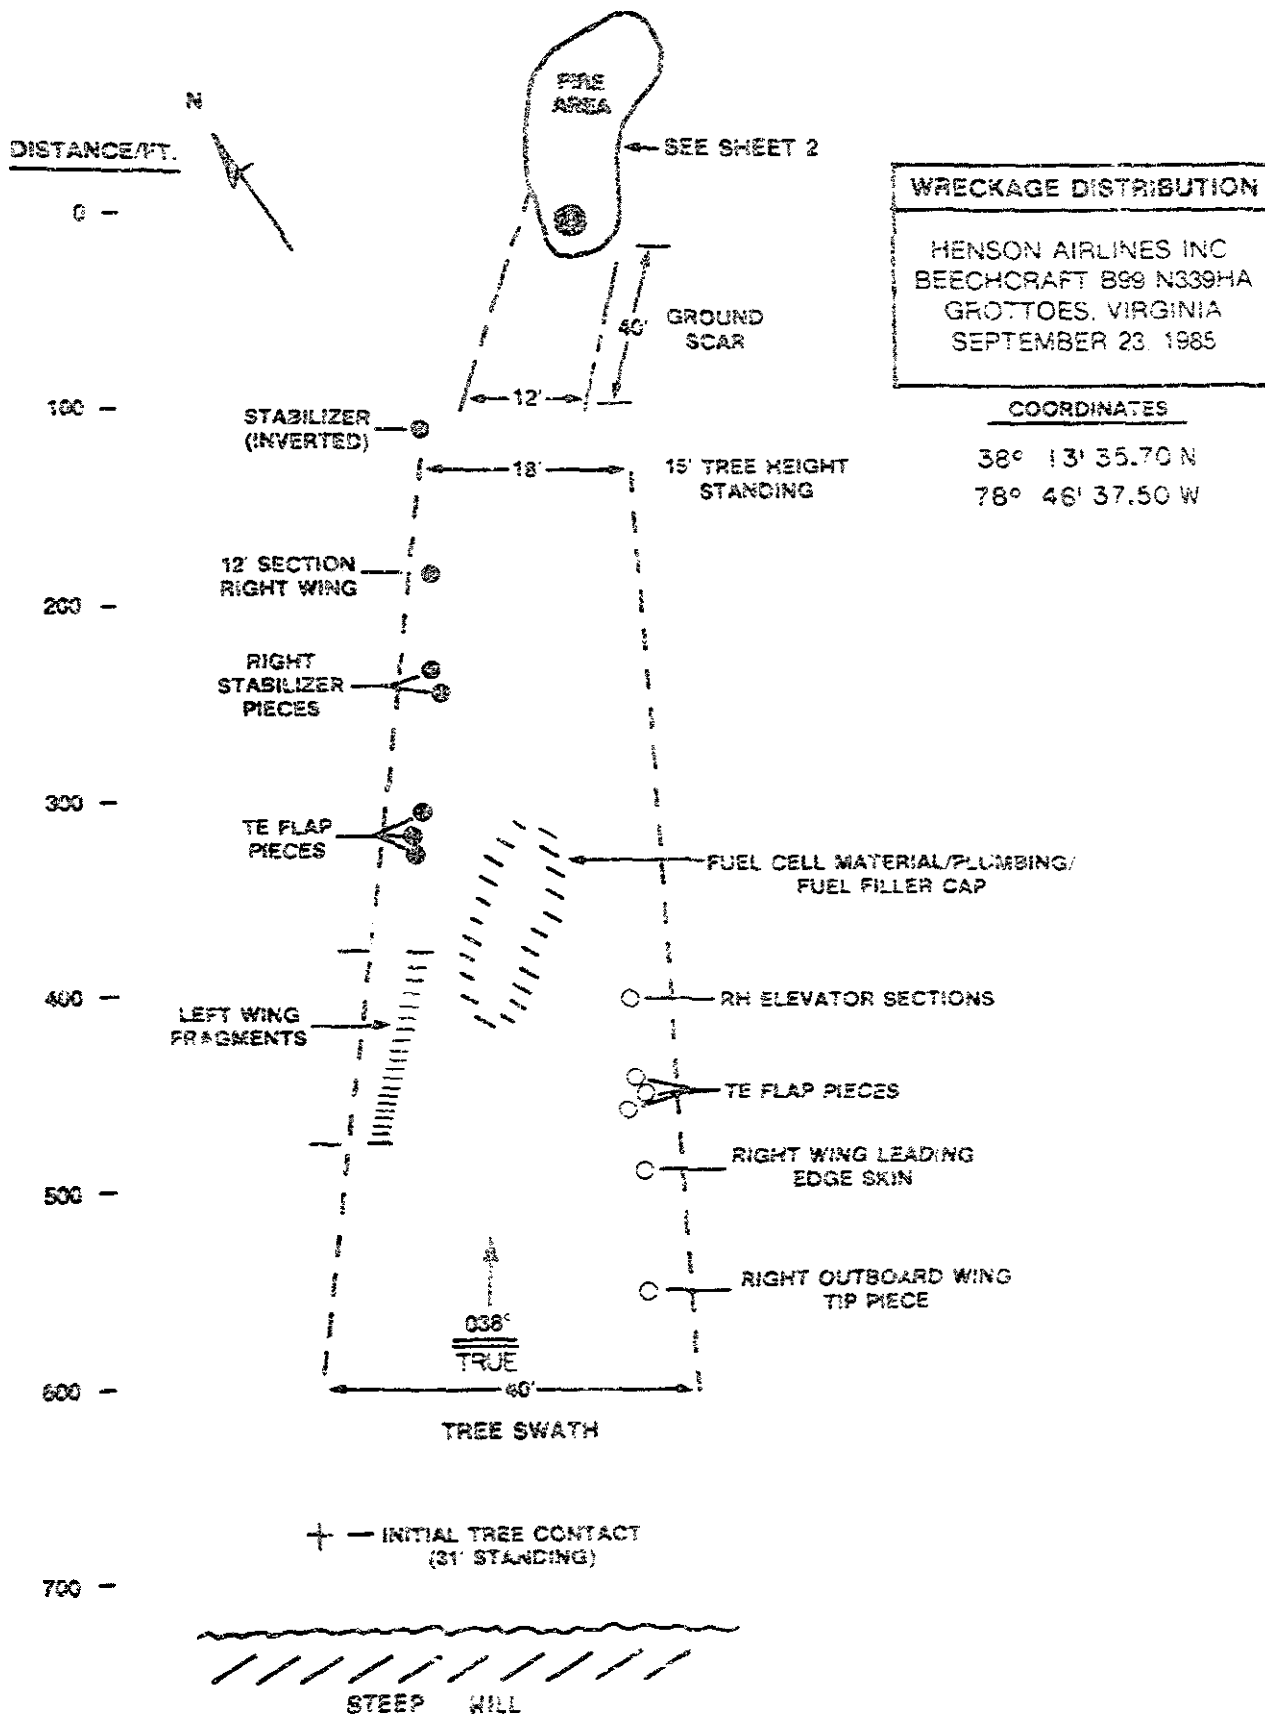
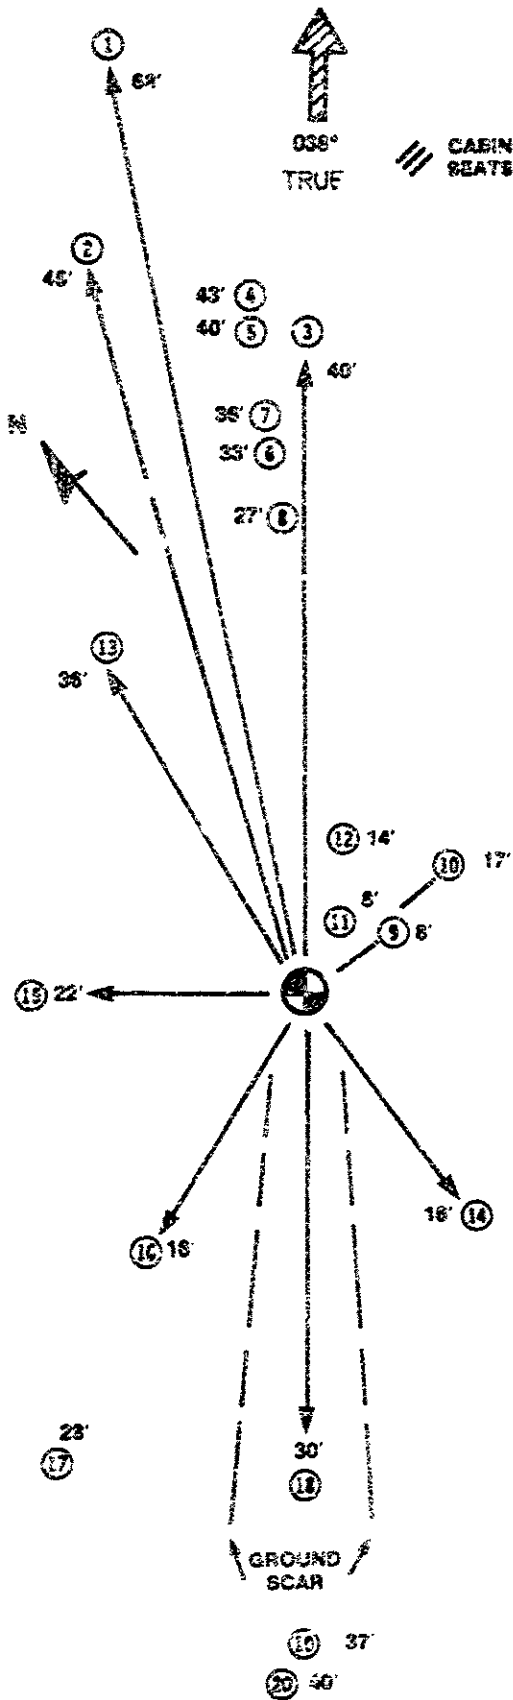
**WRECKAGE DISTRIBUTION**  
**HENSON AIRLINES INC.**  
**BEECHCRAFT B99 N339HA**  
**GROTTOES, VIRGINIA**  
**SEPTEMBER 23, 1985**

The airplane struck the first tree at 31 feet a.g.l. This tree was located about 100 feet northeast of a very steep drop in the terrain. The airplane continued to travel in the northeasterly direction (045° magnetic). Damage to fallen tree tops, limbs, and branches indicated that the airplane was in a wings level, fuselage level attitude. Propeller slash marks on the fallen tree limbs were identified on both sides of the tree swath centerline. The tree swath was initially 40 feet wide and narrowed down to about 18 feet just before ground impact. There was no appreciable descent angle until just before ground impact. A 40-foot ground scar was noted with two deeper impressions located 12 feet apart. The ground scar terminated at the foot of an uprooted oak tree which was estimated to be about 50 feet high and about 2 feet in diameter. The cockpit/cabin area of the airplane came to rest northeast of the base of the uprooted tree. Both engines and propellers were located northeast of the tree base with the No. 1 (left) powerplant on the left side and the No. 2 (right) powerplant on the right side. There was no fire damage to any of the structures which separated before the ground scar. (See appendix E.)

A section of the aft tail cone and the right horizontal stabilizer, with elevator attached, was found near the beginning of the ground scar. The left horizontal stabilizer, complete with a section of the elevator attached, was located to the left and northeast of the initial ground strike. The complete rudder, with trim tab attached, had separated from the vertical stabilizer and was located southwest and to the right of the uprooted tree.

The left wing section, outboard of the engine nacelle, had been fragmented as the airplane cut through the trees. Pieces of the leading edge skin, spar structure, wing tip, aileron, and trim tab were distributed along the wreckage path to the left of the tree swath centerline and before the beginning of the ground scar. The inboard and outboard flap sections were found near the uprooted tree. The No. 1 engine had separated from the nacelle and came to rest to the left and northeast of the uprooted tree, about 15 feet forward of the left propeller.

The right wing section outboard of the engine nacelle separated as a unit and was located about 100 feet southwest of the beginning of the ground scar and near the left edge of the tree swath. No fire damage was evident. About 5 feet of leading edge skin and spar were missing. Several pieces of leading edge skin were located along the wreckage path to the right of the tree swath, as were trailing edge flap pieces. A portion of the right inboard flap was found northeast of the uprooted tree. The No. 2 engine had separated from the nacelle and was located in two sections to the right of and adjacent to the base of the uprooted tree, about 6 feet forward of the right propeller.

The wing center section and the left and right inboard wing sections were located about 25 feet northeast of the uprooted oak tree: it had been badly damaged by fire. The inboard sections were attached by the spar strap, with bolts in place. This area also contained the main landing gear wheel wells. Examination of the landing gear actuators, the positions of several trailing edge flap tracks, and two separated flap actuators indicate that the main landing gear end flaps were retracted at the time of impact.
