NATIONAL TRANSPORTATION SAFETY BOARD

AIRCRAFT ACCIDENT/INCIDENT SUMMARY REPORTS

NTSB/AAR-87/02/SUM

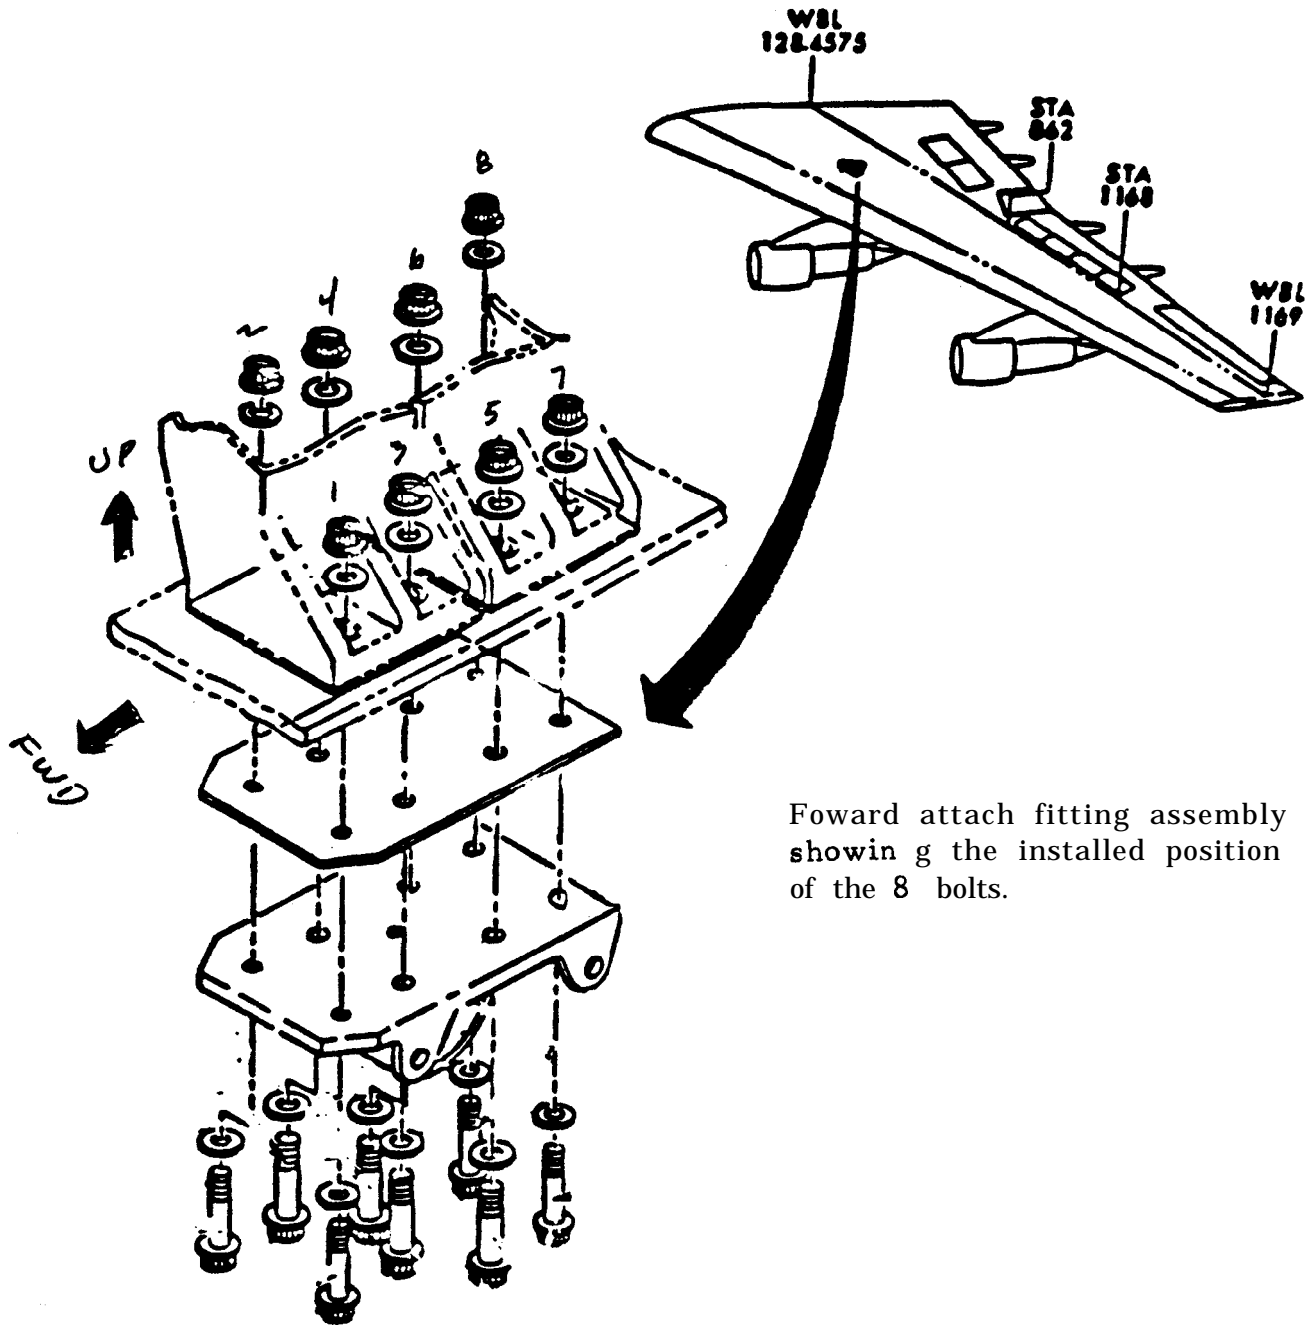
Eight bolts secure the forward attachment fitting of the No. 3 flap track to the lower wing skin and a shear tie rib in the No. 2 fuel tank. They are arranged longitudinally in two rows of four. The four bolts in the forward and aft corners are **7/16** inch in diameter, manufactured to Boeing specification **BACB30MT7T28**, while the four middle bolts in the pattern are **1/2** inch in diameter, manufactured to Boeing specification **BACB30MT8T28**. All of the bolts are made of H-11 steel alloy, which has low fracture toughness and is, therefore, susceptible to failure with small cracks. When the attachment fitting is installed on the wing, the bolts are oriented vertically with the heads down and the washers and self-locking nuts up. Inside the No. 2 fuel tank, **3/4** installation torque is 440 inch-pounds for the **7/16-inch** diameter bolts and 580 inch-pounds for the **1/2** inch diameter bolts.

Examination of the remaining five bolts revealed similar fracture surface features. On **all** of these bolts, the fracture features emanated from the aft side of the bolt, as installed on the airplane, between the bolt head and shank. Examination of the fractures with a scanning electron microscope revealed flat, crescent-shaped fracture regions containing features typical of fatigue cracking. The fatigue zones emanated from multiple origins and progressed a short way into the bolt before separation. This fatigue cracking and fretting on the fitting indicated that the bolts were loose or undertorqued. Fracture features beyond the fatigue zones consisted of a mixture of ductile dimples and what appeared to be intergranular features, consistent with an overstress region stemming from the fatigue zones. The examination also indicated that the bolts met the specifications for dimensions, material, finish, and strength.

Forward attach fitting assembly showing the installed position of the 8 bolts.

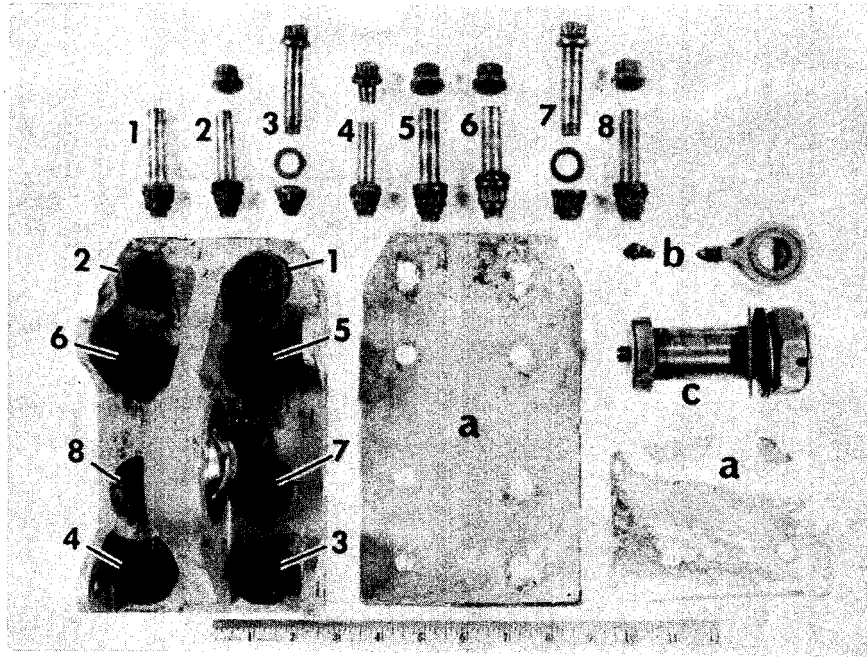
The Safety Board's metallurgical laboratory examined the No. 3 flap track forward attachment fitting and hardware, with the exception of one bolt head that was sent to the United Kingdom for examination, and the inboard nut and bolt from the aft attachment position, which were not significantly damaged. Examination of the forward fitting components revealed areas of fretting on the upper surface of the fitting. Fretting was particularly heavy on the forward portion of the fitting and between the **aftmost** bolt holes. Corresponding areas of fretting were found on the shims **that** space the fitting from the **wing's** lower surface. In addition, wear or heavy contact was found on the inboard edge of the spherical bearing.

Figure 1. Overall view of the forward attachment fitting components, including the fitting shims (a), grease fittings (b) and the spherical bearing bolt and nut (c).

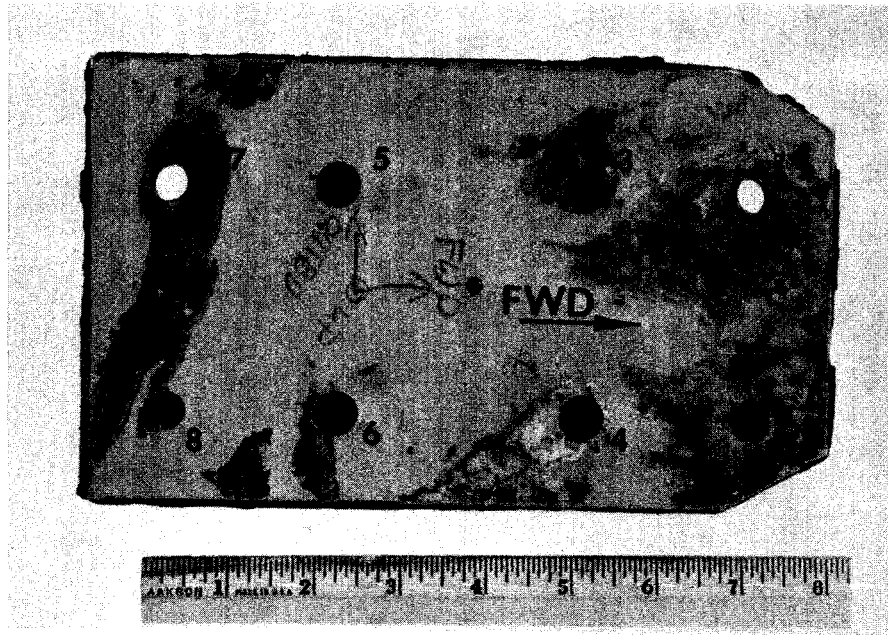
Figure 2. View of the top face of the No. 3 flap track forward attachment fitting.
