# **NATIONAL TRANSPORTATION SAFETY BOARD**

## **AIRCRAFT ACCIDENT REPORT**

**FISCHER BROS. AVIATION, INC.,  
dba NORTHWEST AIRLINK, FLIGHT 2268  
CONSTRUCCIONES AERONAUTICAS, S.A. (CASA)  
C-212-CC, N160FB  
DETROIT METROPOLITAN WAYNE COUNTY AIRPORT  
ROMULUS, MICHIGAN  
MARCH 4, 1987**

**NTSB/AAR-88/08**

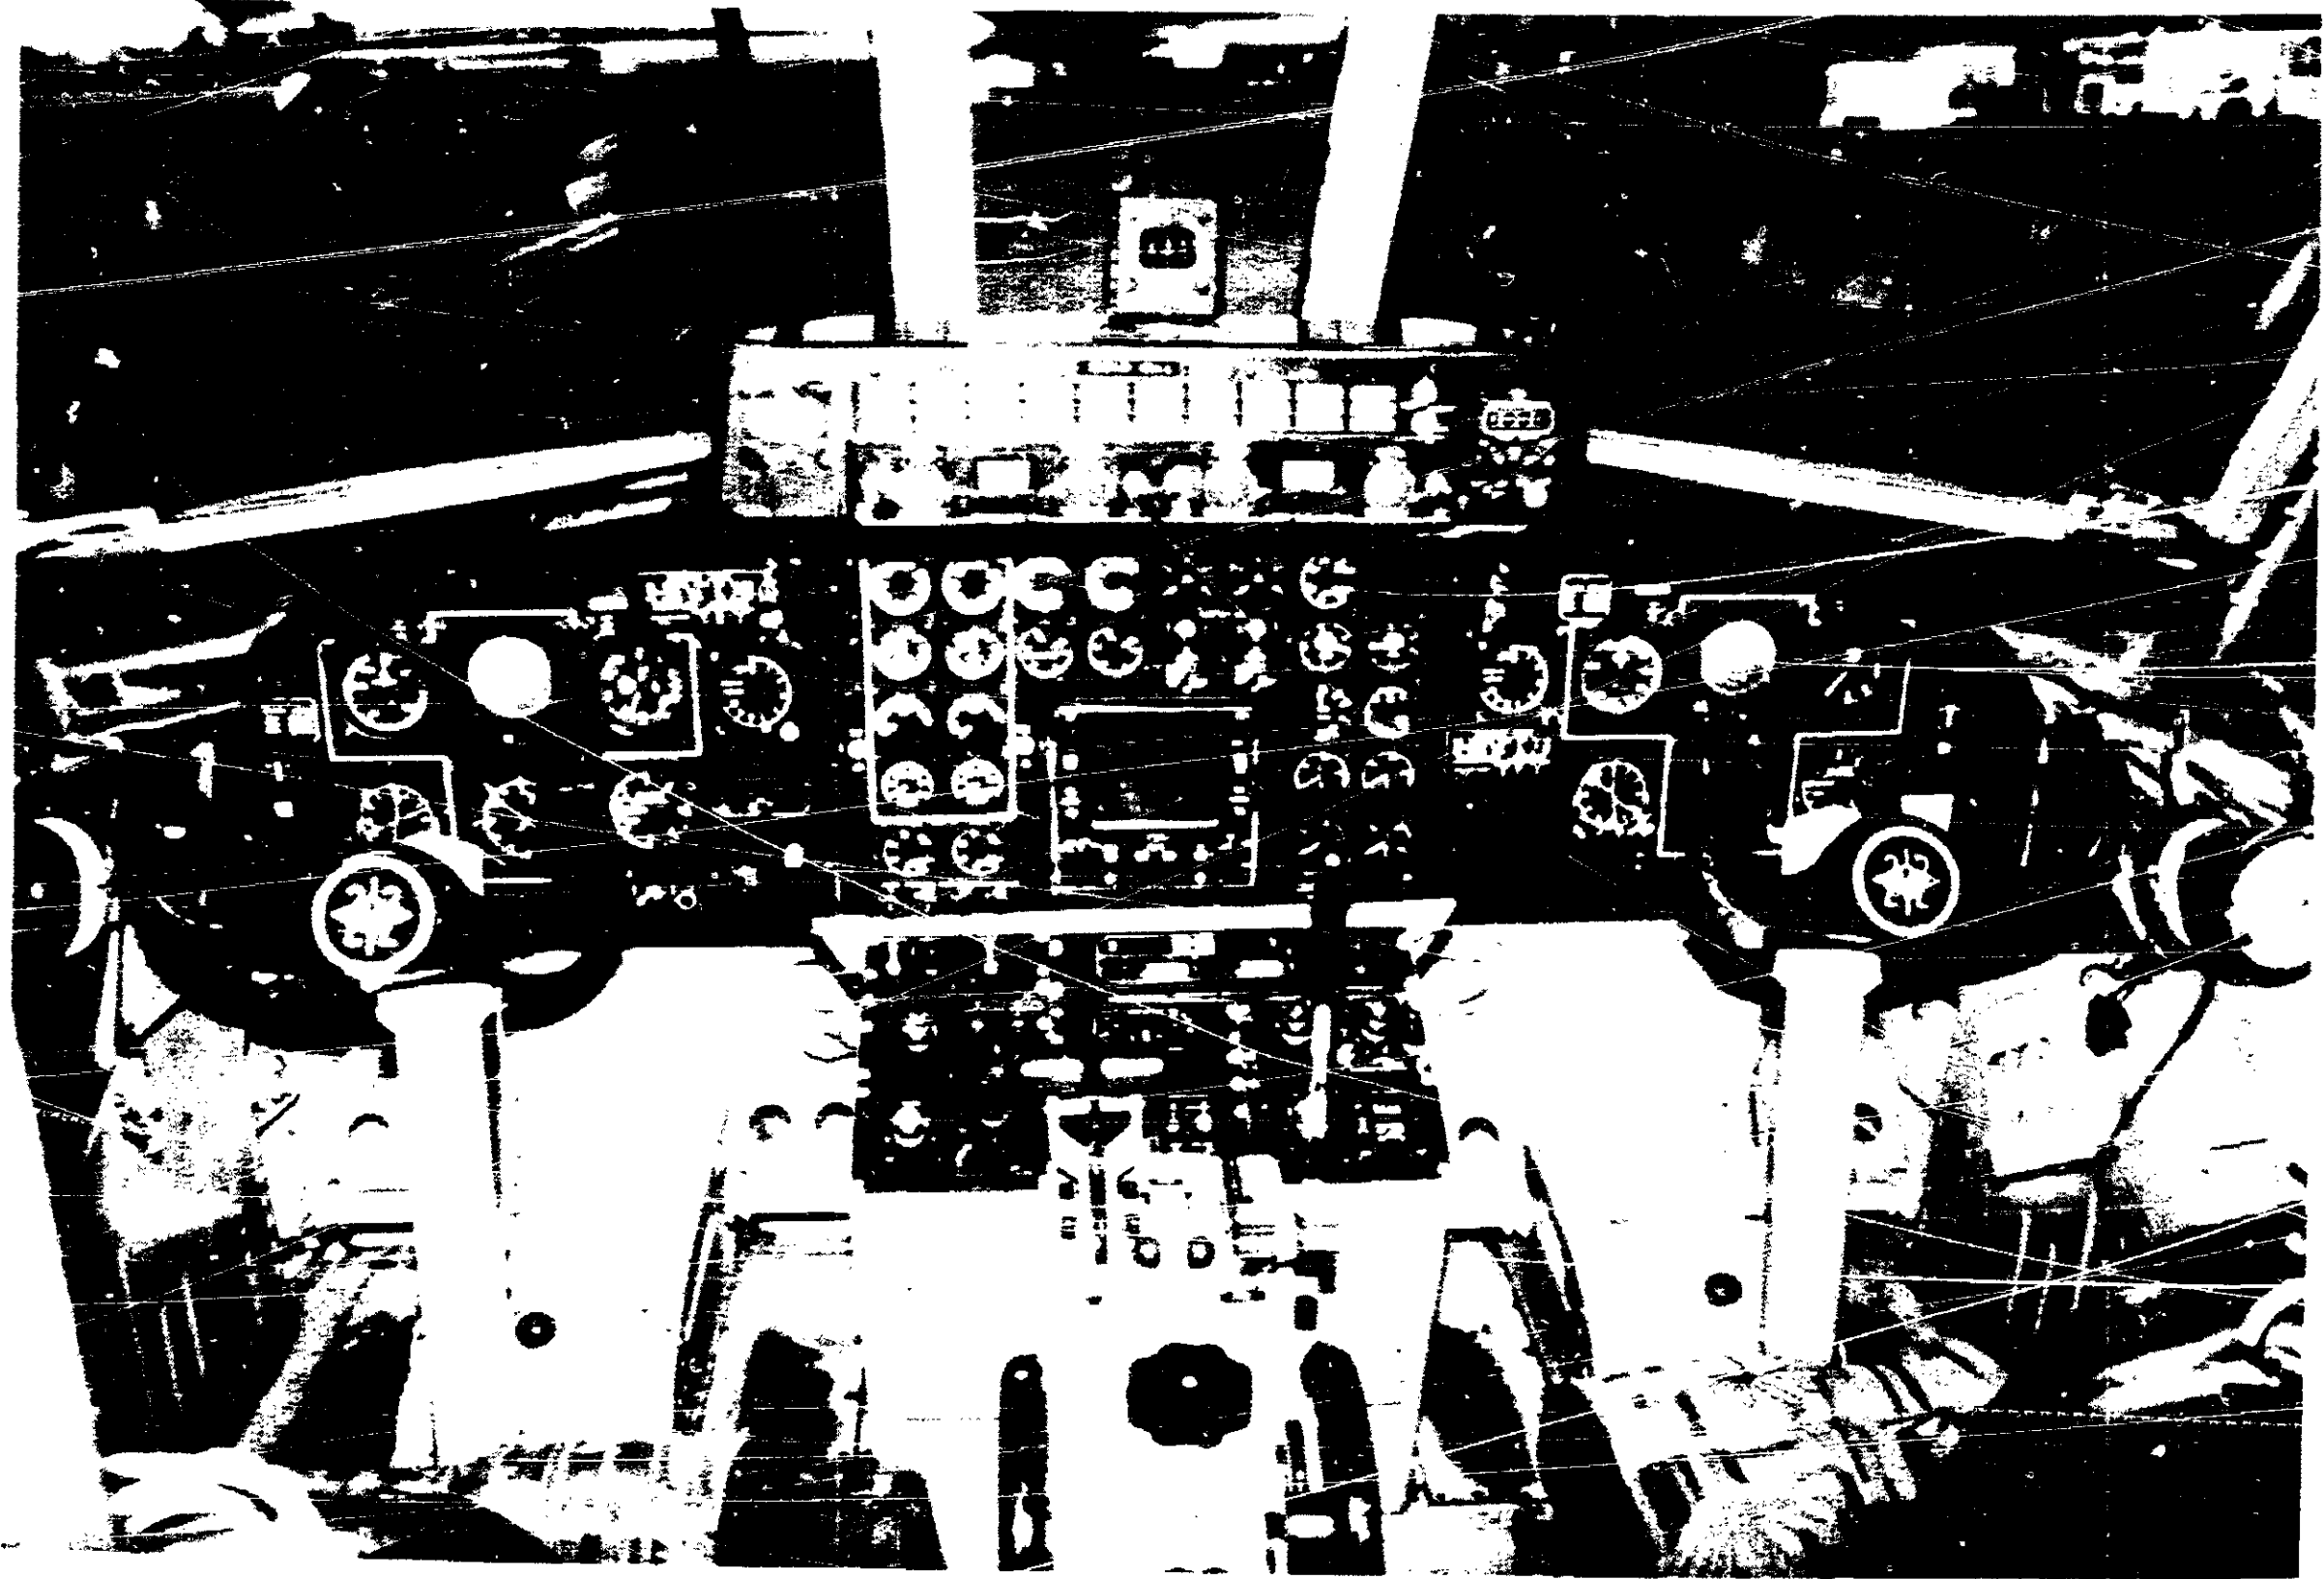
Figure 9.--Cockpit layout of a Fischer Bros. CASA C-212-CC.

- With the right hand placed with the palm on top of the PL knobs, the fingers can easily touch the beta latch arm (flight idle latch arm) without moving the hand and could be done unconsciously. (See figures 9, 10, and 11.)

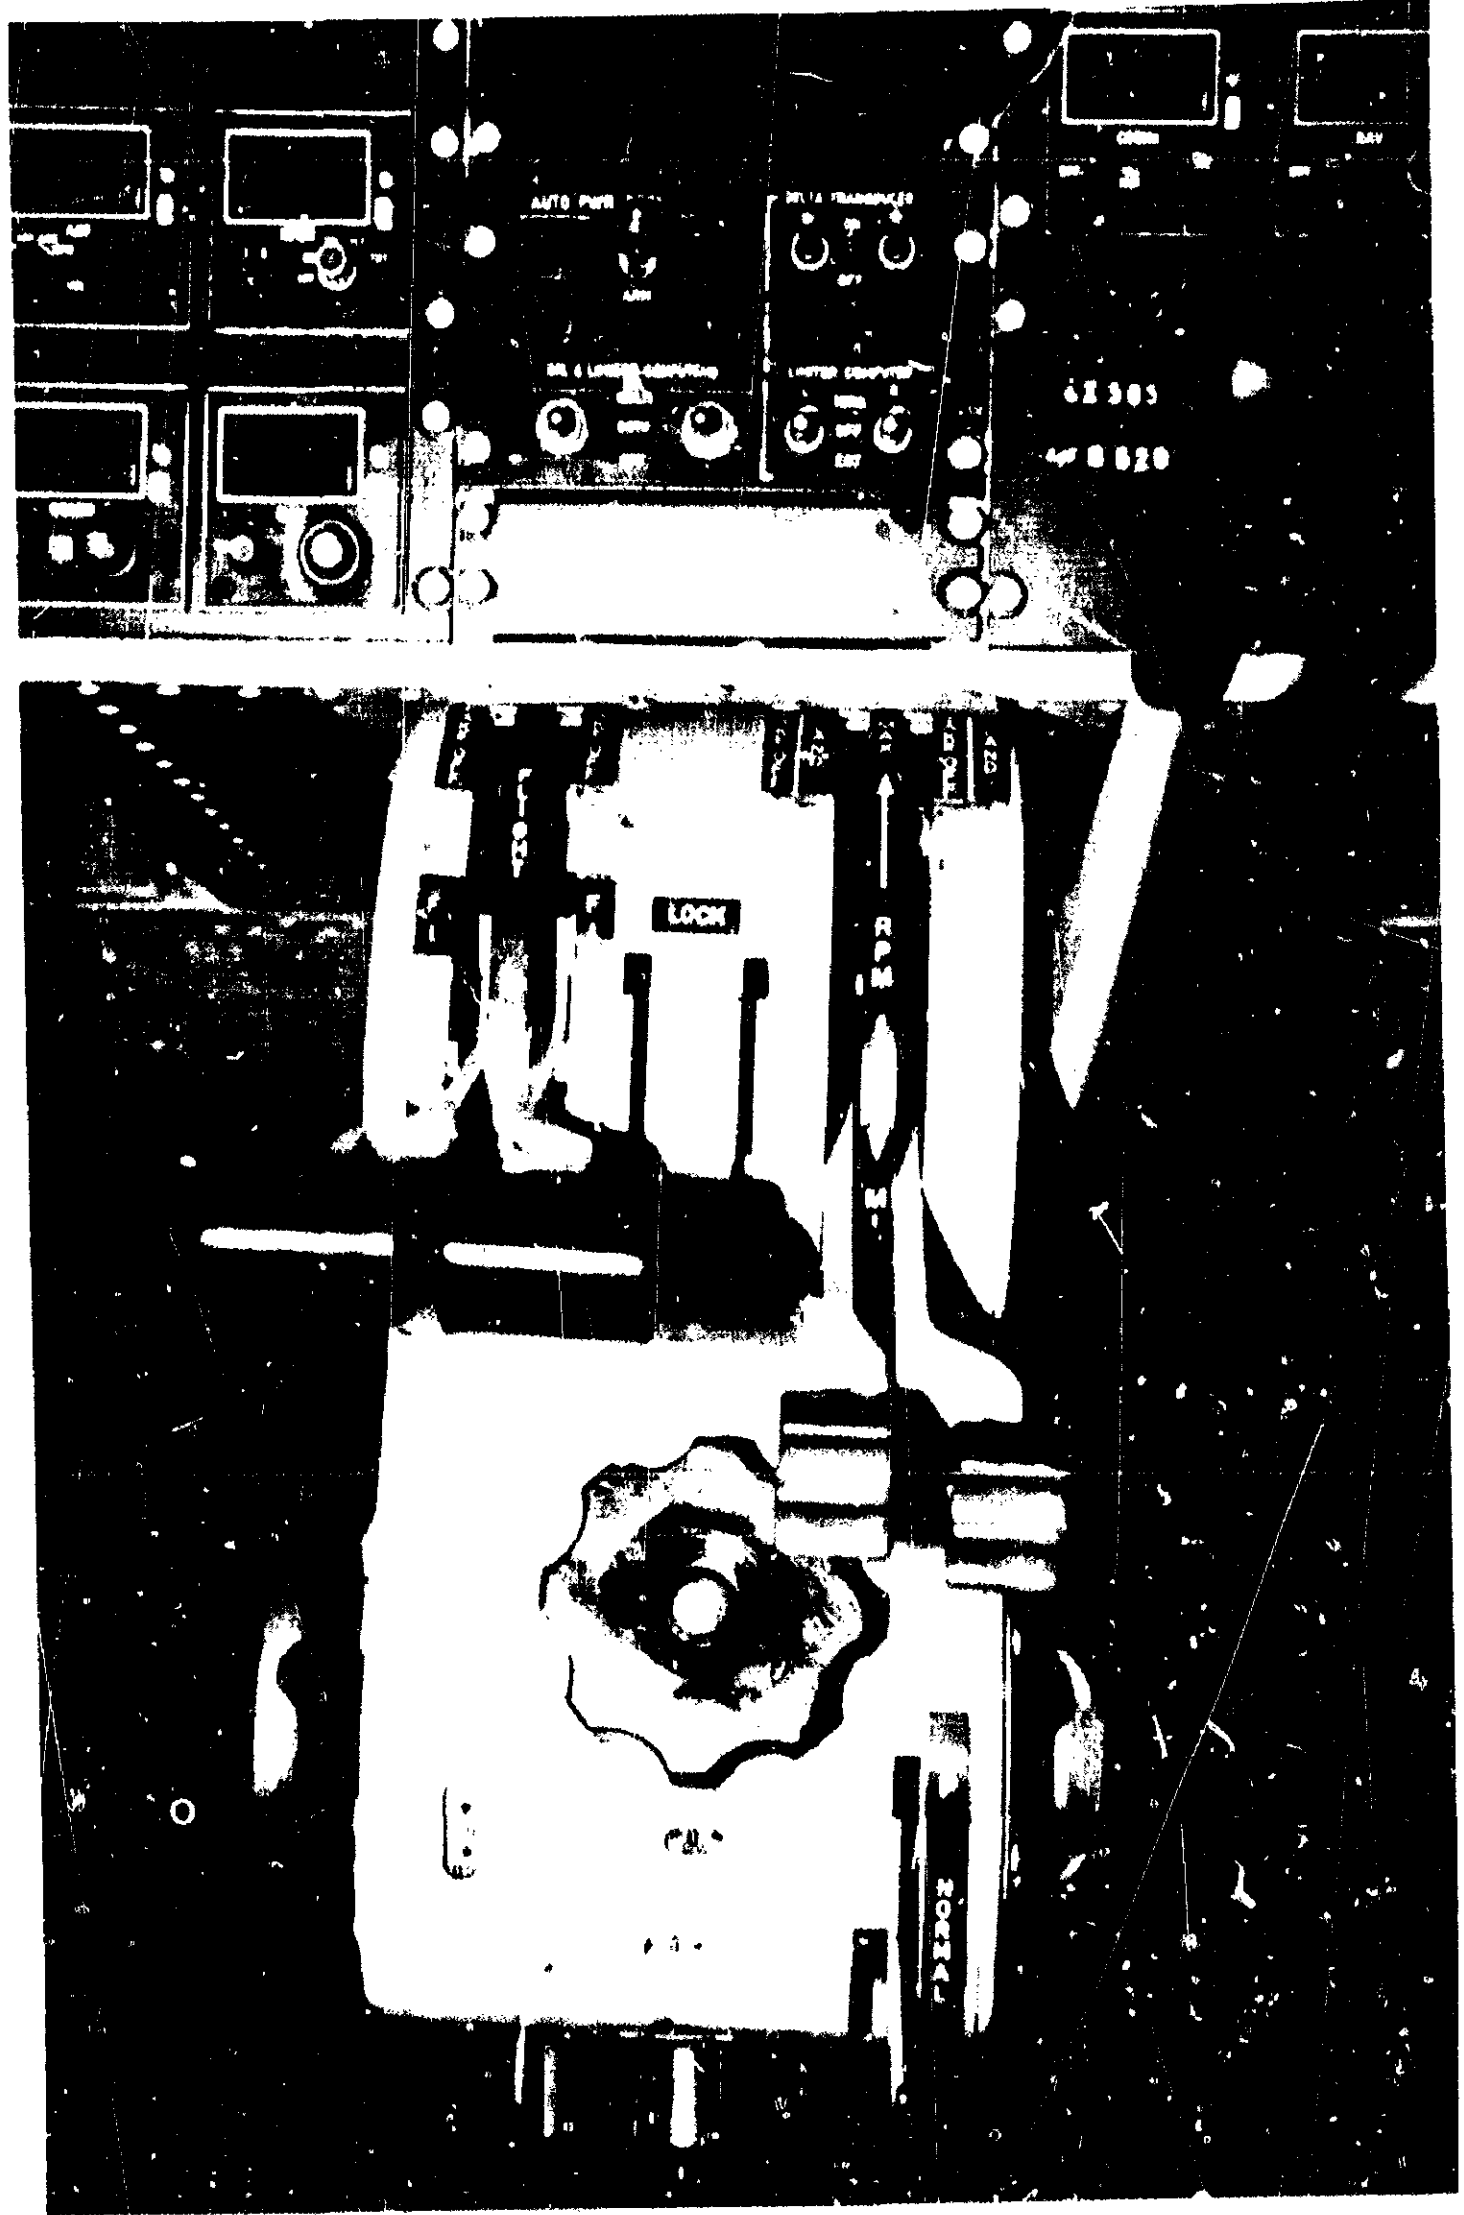
Figure 11.--Top view of PL quadrant.

- The beta latch mechanism was easy to move upward, requiring only finger movement. The latch had to move 1/2 inch, from full retraction to full extension, to clear the flight idle gate. It was noted that movement of the latches was more difficult if the PLs were against the flight idle gate than if they were at an intermediate position in front of the gate. This was attributed to the resistance of the latch plate against the gate.
