Hazardous Materials Incident Report In-Flight
Fire, McDonnell Douglas DC-9-83, N569AA
Nashville Metropolitan Airport
Nashville, Tennessee, February 3, 1988

(U.S.) National Transportation Safety Board
Washington, DC

1. Report No. NTSB/HZM-88/02	2. Government Accession No. PB88-917006	3. Recipient's Catalog No.	
4. Title and Subtitle Hazardous Materials Incident Report-- In-Flight Fire, McDonnell Douglas DC-9-83, N569AA, Nashville Metropolitan Airport, Nashville, Tennessee, February 3, 1988		5. Report Date September 13, 1988

NTSB/HZM-88/02

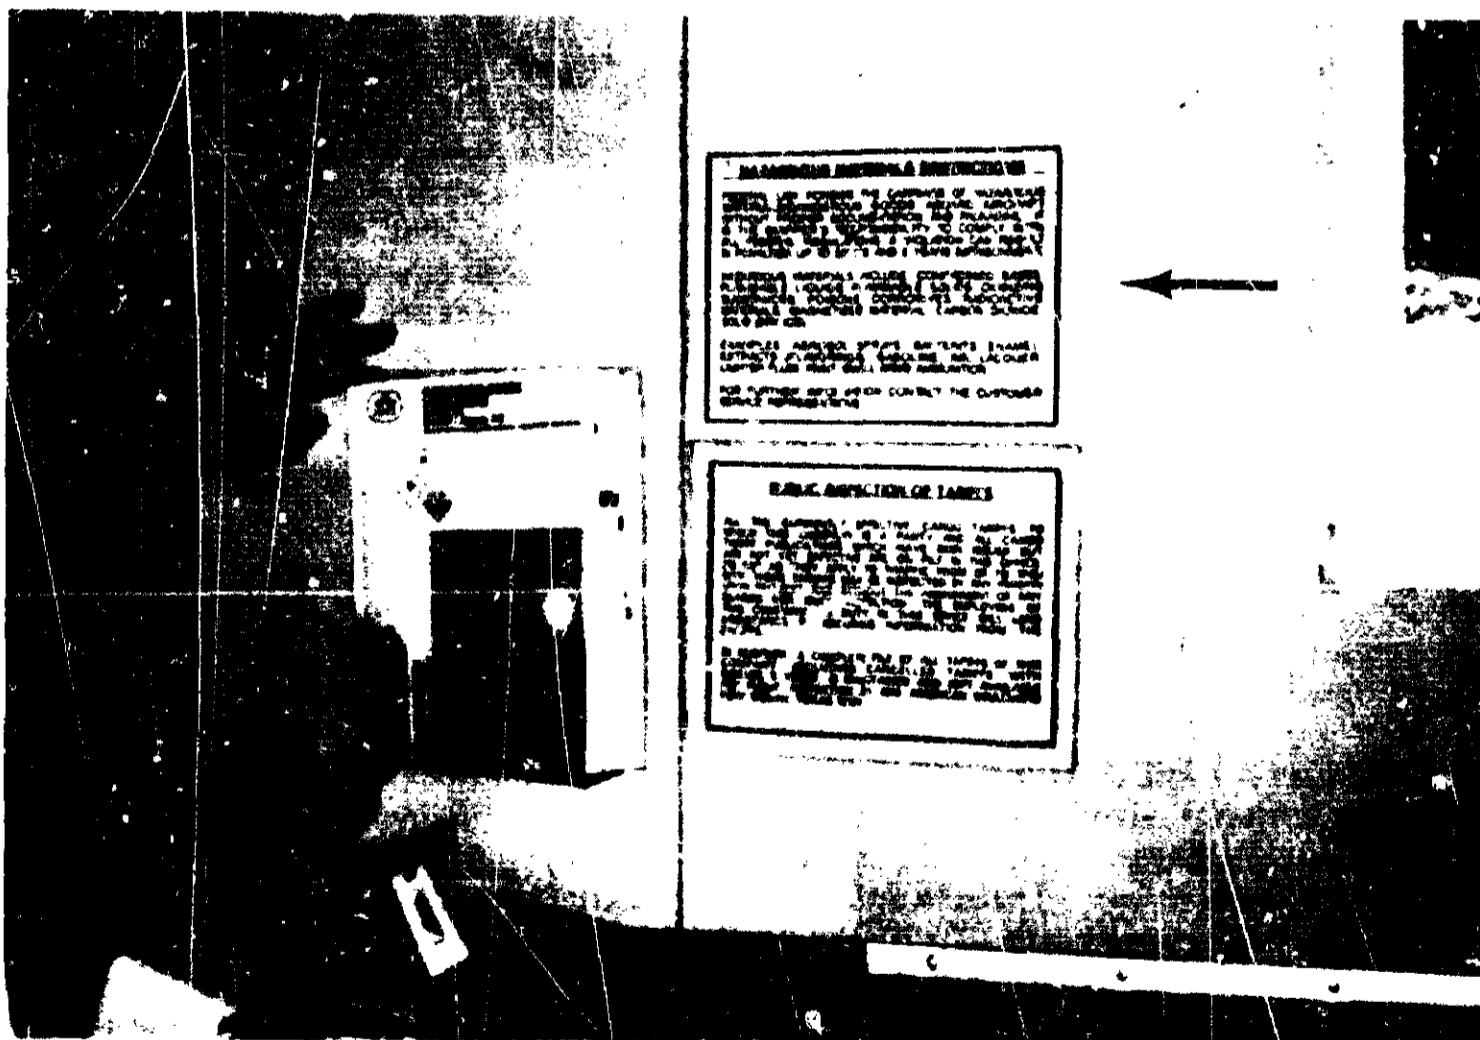
Although not required by the FAA, American Airlines posts a notice in cargo freight offices to warn shippers about hazardous materials restrictions. The notice in the Austin office is approximately 9 inches high by 11 inches wide, the lettering meets minimum size requirements for passenger check-in areas, and it is typical of notices posted throughout the carrier's cargo system. (See figure 7.) The notice is attached to a wall at the end of the customer service counter about eye level, about an arms length away, and on the customer's immediate right (approximately 90°) when the customer faces the freight service clerk behind the counter.

Figure 7.--Hazardous materials restriction notice posted on the wall in the American Airlines air freight office in Austin, Texas.
